**Re: Site Assessment, Remediation, and Closure Request
 Oklahoma 32 Fee #5
 API No. 30-015-39081
 GPS: Latitude 32.7071495 Longitude -104.4011459
 UL "G", Sec. 32, T18S, R26E
 Eddy County, NM
 NMOCD Ref. No. NAB1819157134**

Paragon Environmental, LLC (Paragon) has been contracted by Spur Energy Partners (Spur) to perform a spill assessment, and conduct remediation activities for the release site known as the Oklahoma 32 Fee #5 (Oklahoma). Details of the release are summarized below:

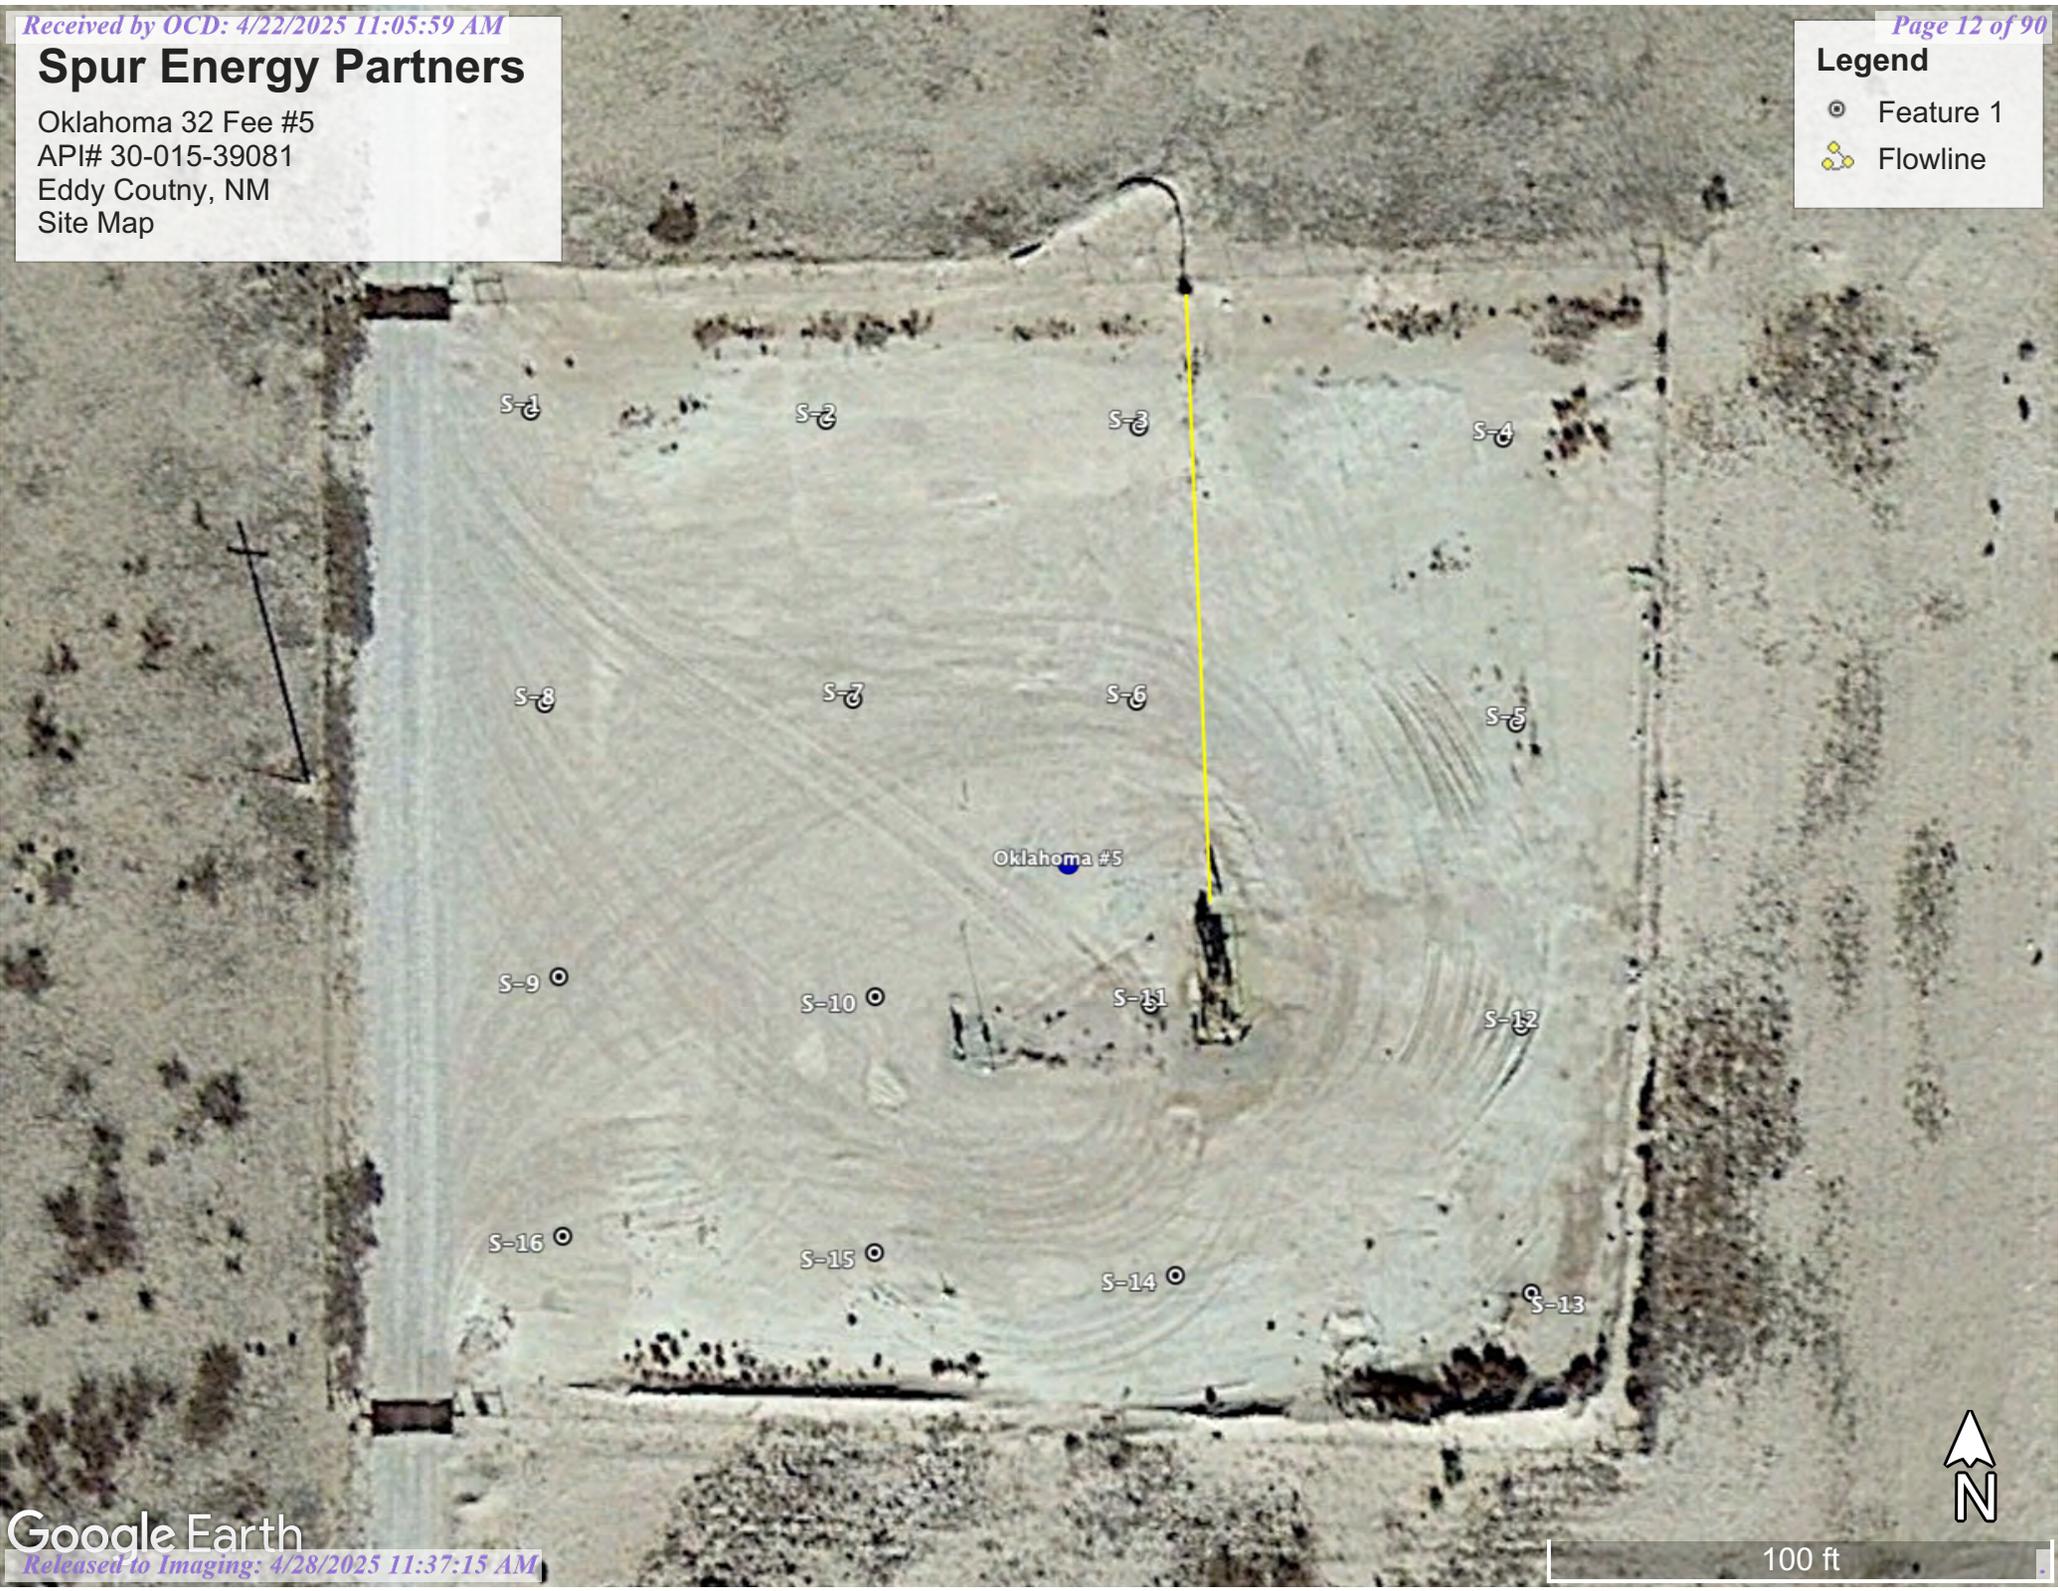
Oklahoma 32 Fee #5
API# 30-015-39081
Eddy Coutny, NM
Topo Map

- Feature 1
- ⬢ Flowline

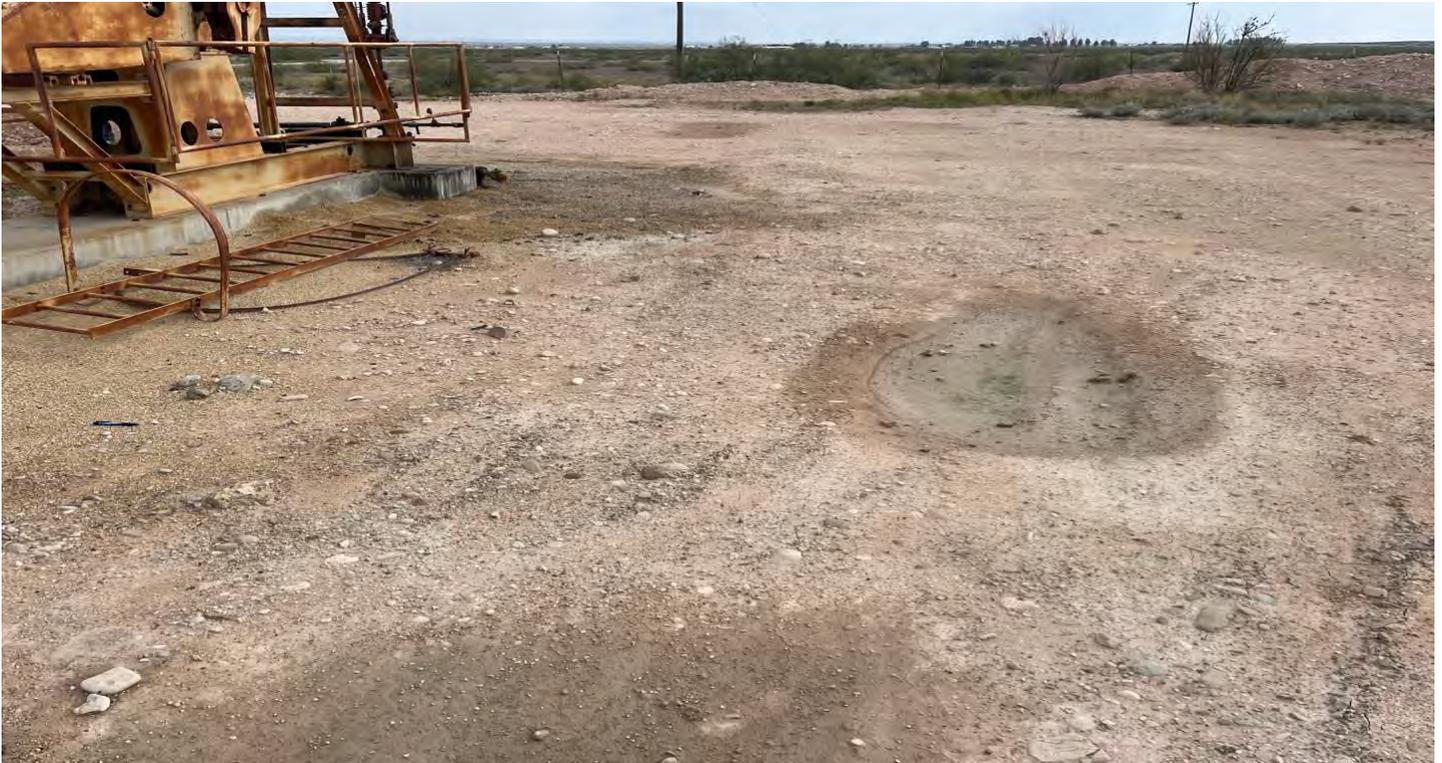
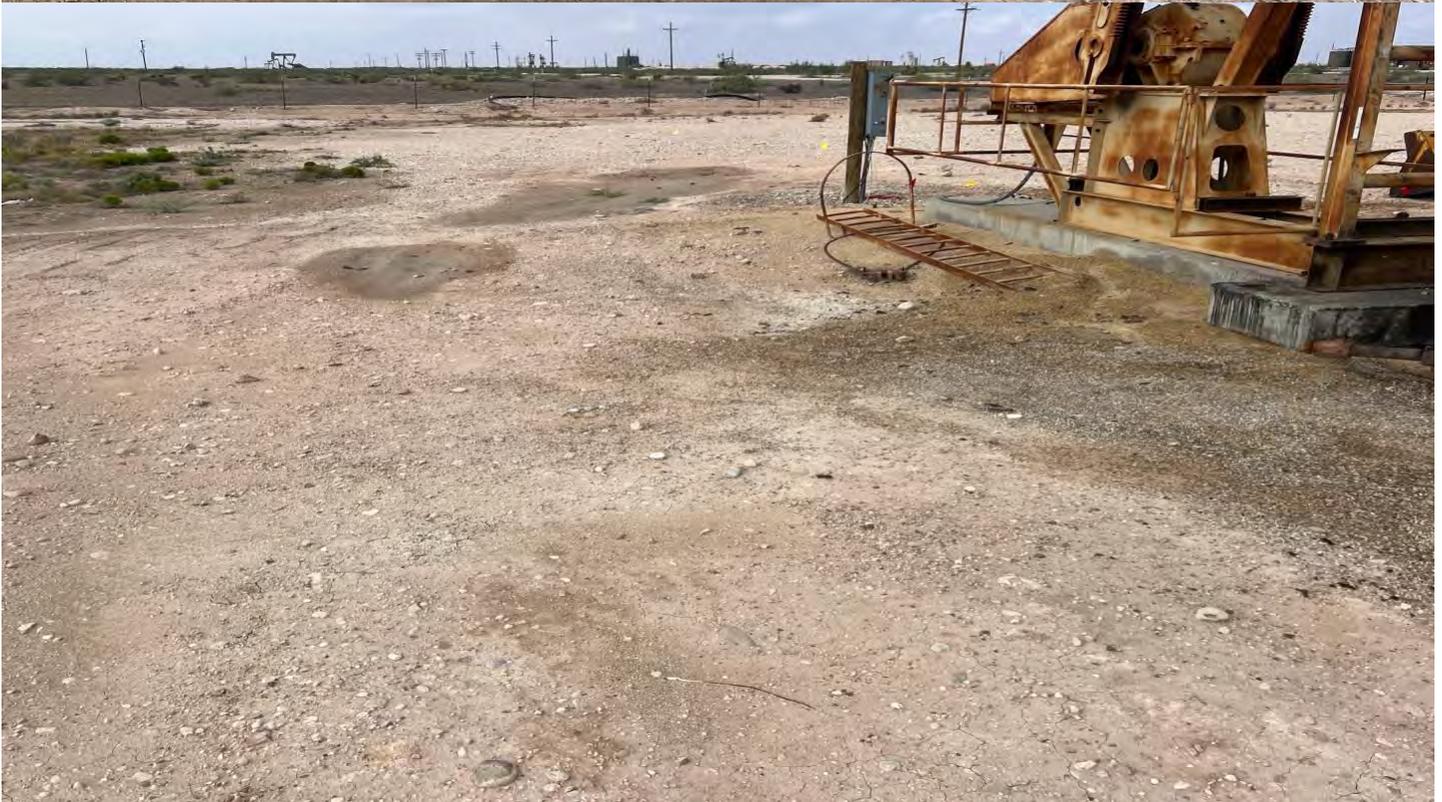
Photographic Documentation
Before Remediation

Release Details			
Type of Release:	Produced Water / Crude Oil	Volume of Release:	50 bbls
		Volume Recovered:	36 bbls
Source of Release:	Flow Line	Date of Release:	6/30/18
Was Immediate Notice Given?	Yes	If, Yes, to Whom?	Mike Bratcher, NMOCD
Was a Watercourse Reached?	No	If Yes, Volume Impacting Watercourse:	N/A
Surface Owner:	Private	Mineral Owner:	Private
A buried steel flowline developed a leak due to internal corrosion.
