# Remediation Summary and Closure Report

January 21, 2025

**West Eumont Unit #115  
Produced Water Release  
Incident No. nAPP2316654395  
Lea County, New Mexico**

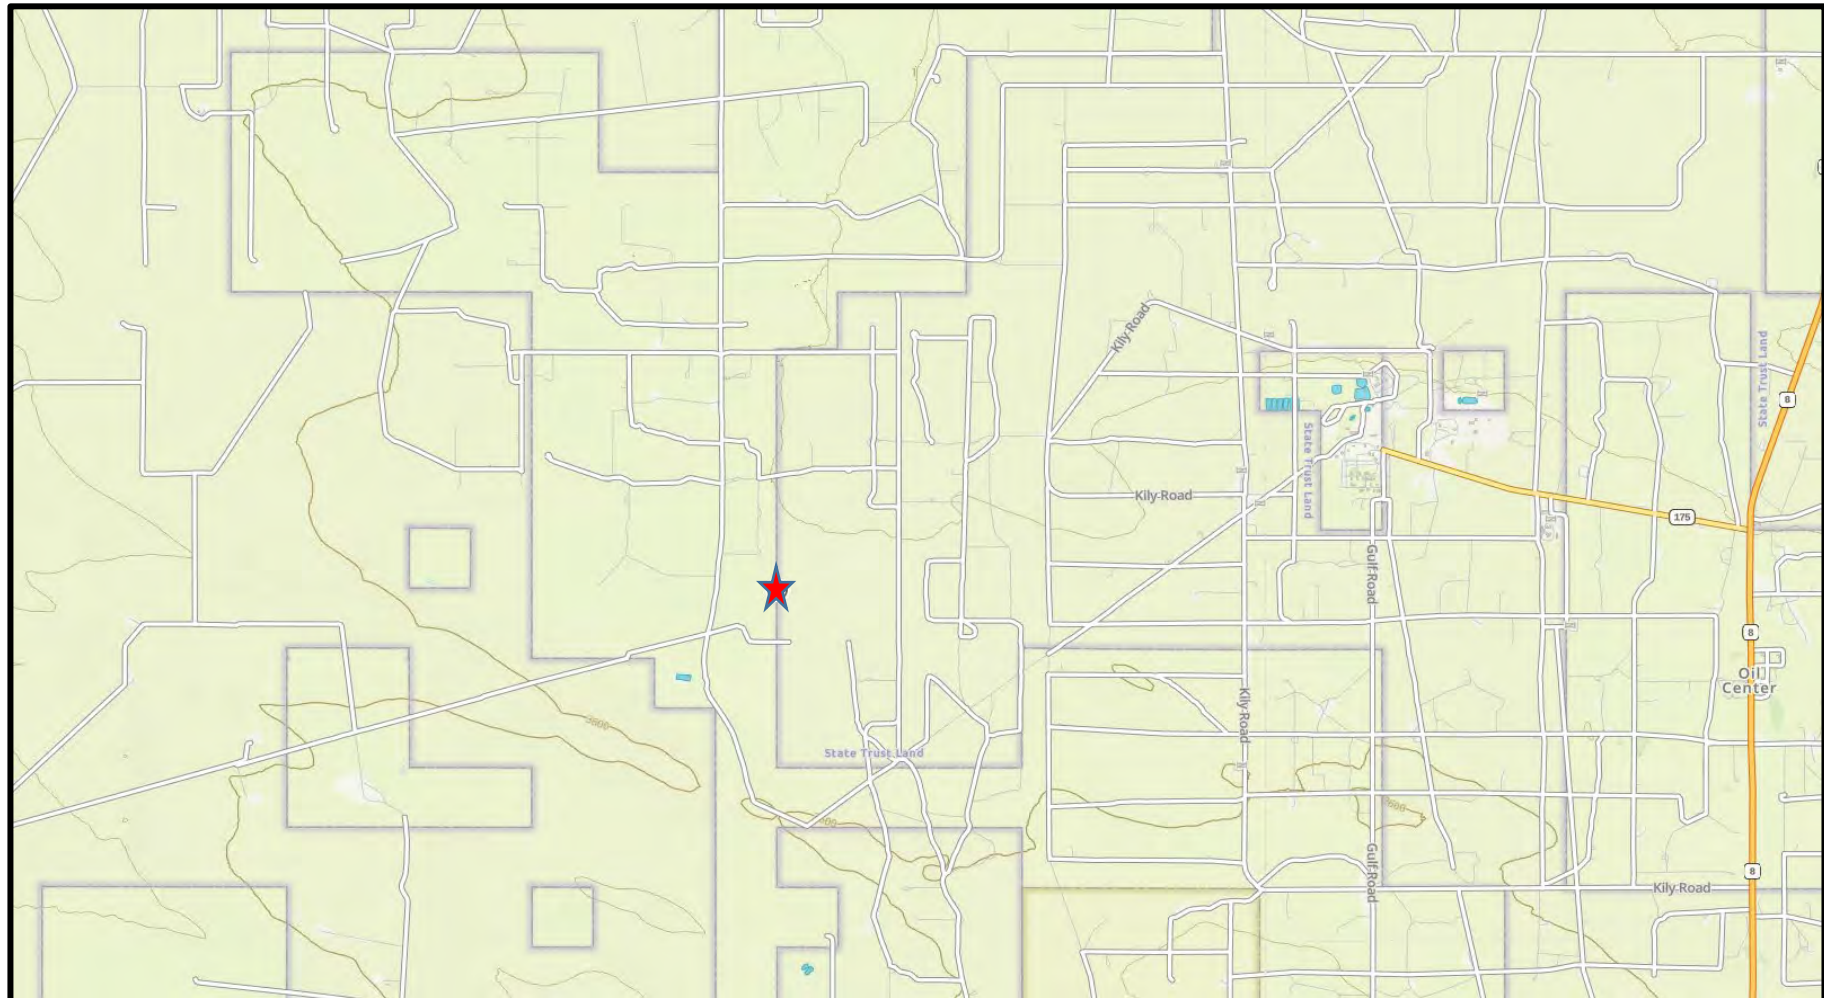
**Figure 1****Site Location Map**

CE reviewed recent aerial photographs, topographic maps, the NMOSE Point of Discharge (POD) GIS website, and information available from the Lea County, New Mexico Central Appraisal District website. As shown on Figure 1, the Site is not located:

- Within 300 feet of any continuously flowing watercourse or any other significant watercourse.
  - No continuously flowing watercourses (rivers, streams, arroyos, etc.) are apparent within 300 feet of the Site in the topographic map (Figure 1).

- Within 200 feet of any lakebed, sinkhole or playa lake (measured from the ordinary highwater mark).
  - The topographic map (Figure 1) indicates there is not a lakebed, sinkhole or playa lake located within 200 feet of the Site.

- Within 300 feet from an occupied permanent residence, school, hospital, institution or church.
  - The Site Location Map (Figure 1) and information available from the Lea County, New Mexico Central Appraisal District do not show or list any permanent residence, school, hospital, institution or church located within 300 feet of the Site.

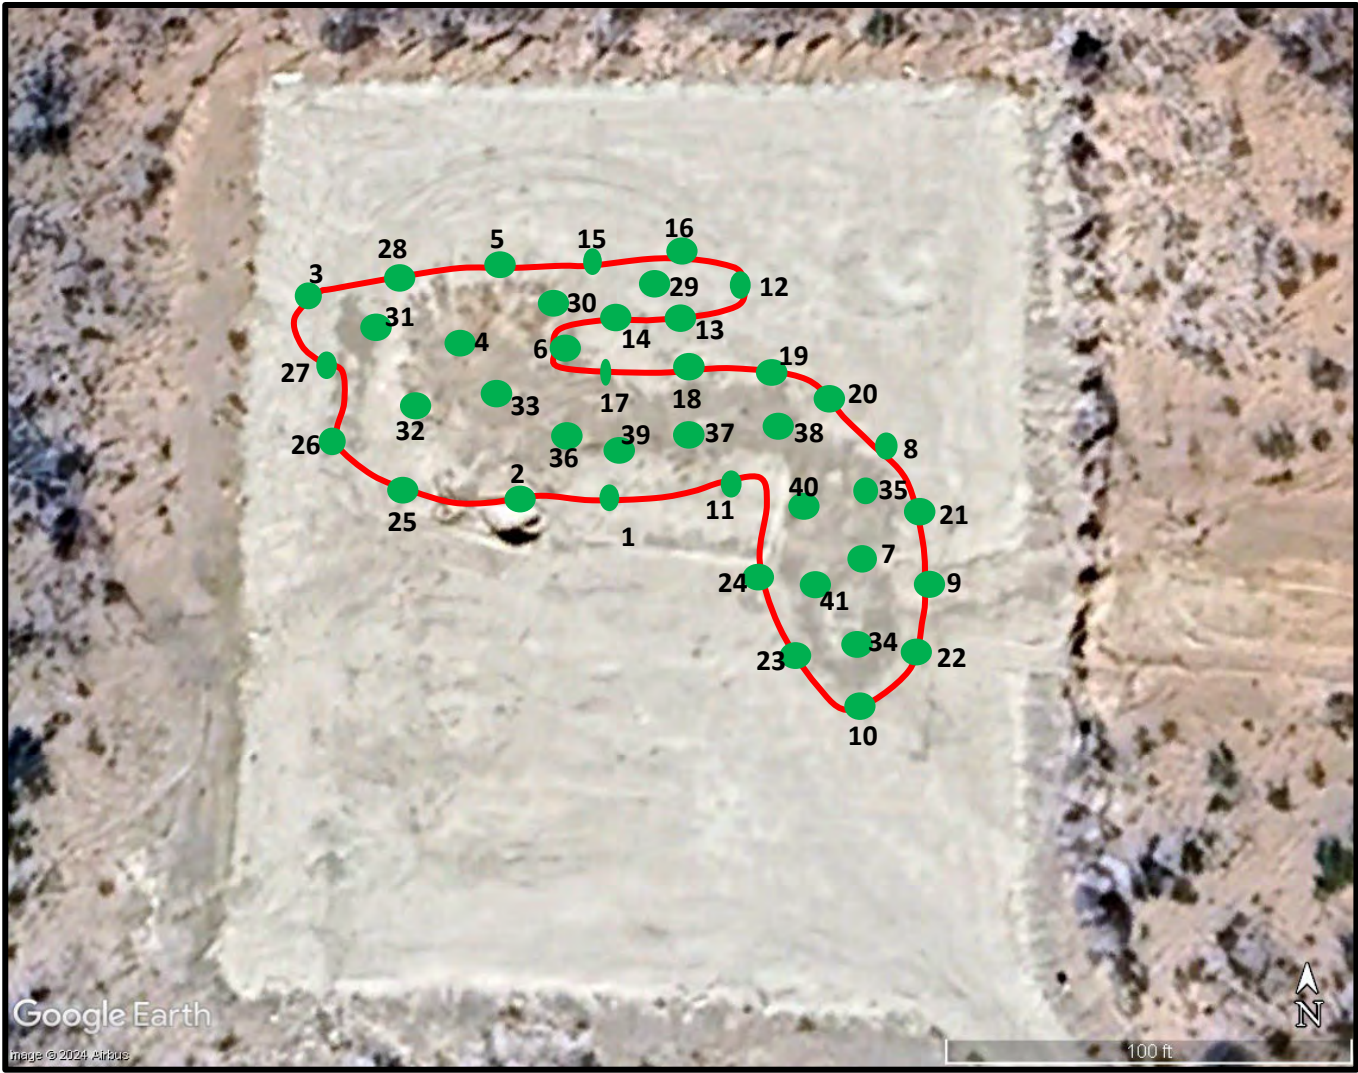
<b>LEGEND:</b> <div><div>● 1</div><div>Soil Sample Location with Sample Number (DS ...)</div></div> <div><div>●</div><div>Release Point</div></div> <div><div></div><div>Highlighting Indicates Concentration Above the Closure Criteria</div></div> <div><div></div><div>Highlighting Indicates Soil was Excavated and Treated.</div></div> <div><div></div><div>Excavation Boundary</div></div>	<b>Figure 2</b> <b>Soil Sample Location Map</b>  Forty Acres Energy, LLC West Eumont Unit #115 Lea County, New Mexico		
		Drafted by: CC   Checked by: CC	
		Draft: Jan. 19, 2025	
		GPS: 32.504256° -103.329739°	
		Base Map from Google Earth Pro

As required by 19.15.29.11 NMAC, a scaled diagram showing significant Site infrastructure, sample point locations, and known subsurface features such as utilities is provided as Figure 2.

Table 1 provides a summary of the laboratory results, and sample locations are provided on Figure 2. The laboratory reports and chain-of-custody documentation are provided in Appendix C. Photographic documentation of the release point is provided in Appendix D.

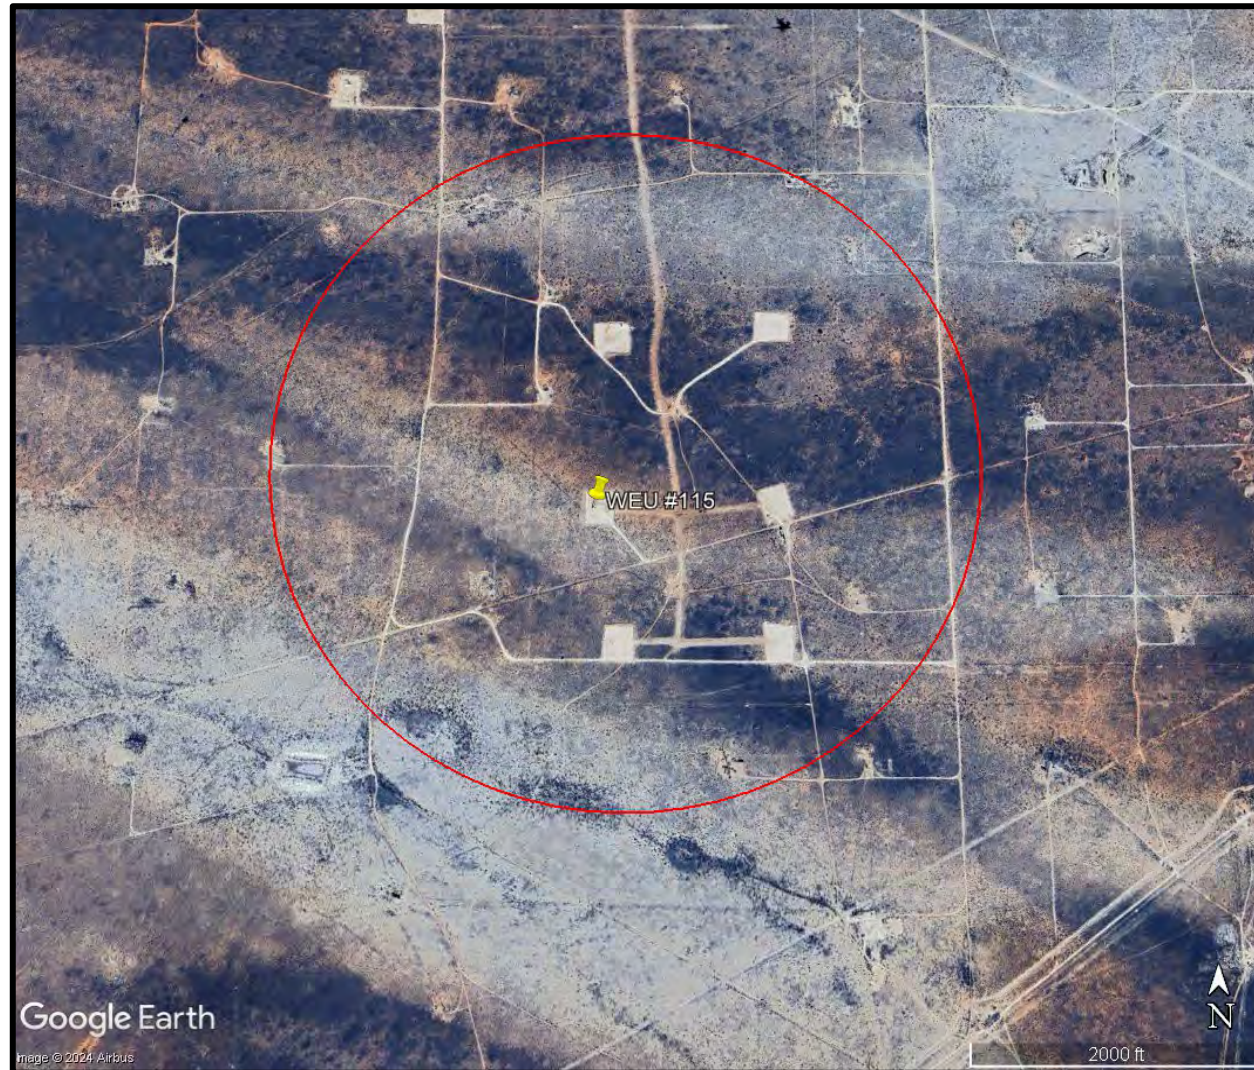
**Figure 3****Wellhead Protection Area Map**

The 0.5-mile wellhead protection area is shown on Figure 3. No known water wells are located within 0.5 mile of the Site. There were no other water sources, springs, or other sources of freshwater extraction identified within 0.5-mile of the Site.

A review of the New Mexico Office of the State Engineer (NMOSE) records indicated there were no water wells located within 0.5 mile of the Site; therefore, the Closure Criteria applicable to the Site will be based on the most stringent regulatory guidelines associated with groundwater depths of less than 50 feet below ground surface (bgs). A summary of the Closure Criteria is provided in the table below and in Table 1. Figure 3 provides a 0.5-mile radius circle around the Site.

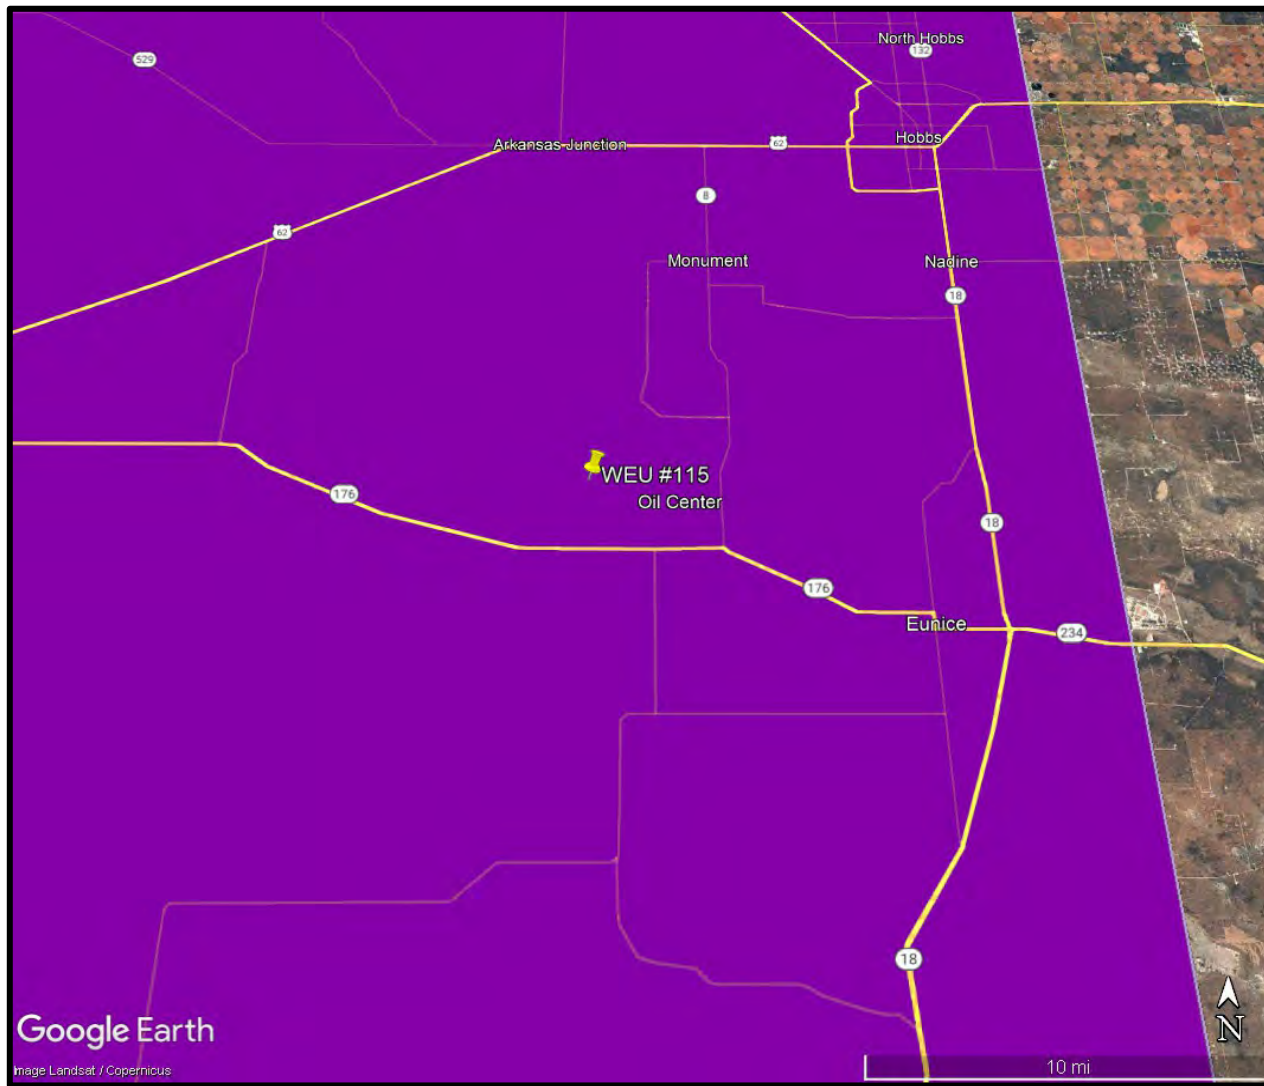
A review of the United States Fish and Wildlife Service (USFWS) wetlands map indicated the Site is not located within 300 feet of a wetland. The New Mexico Bureau of Land Management (BLM) karst potential map indicates the Site is located within a “low karst potential” area. Finally, review of the Federal Emergency Management Act (FEMA) floodplain map indicates the release at the Site is located outside of a 100-year floodplain. Figures 4, 5, and 6 depict the USFWS map, the FEMA floodplain map, and the karst potential map, respectively.

<b>LEGEND:</b> <div><div></div> Low Karst Potential</div> <div><div></div> Medium Karst Potential</div> <div><div></div> High Karst Potential</div> Base Map from Google Earth Pro	<b>Figure 6</b> <b>Karst Potential Map</b>  Forty Acres Energy, LLC West Eumont Unit #115 Lea County, New Mexico

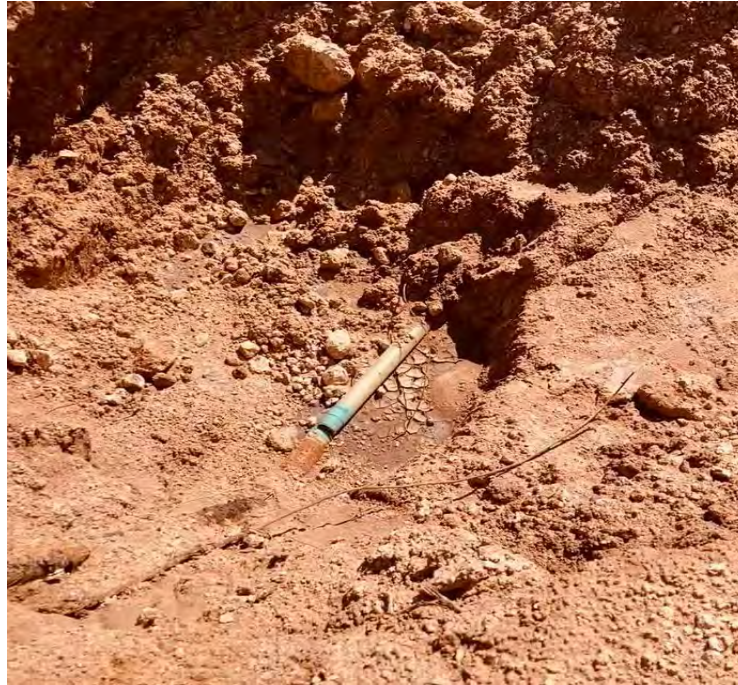
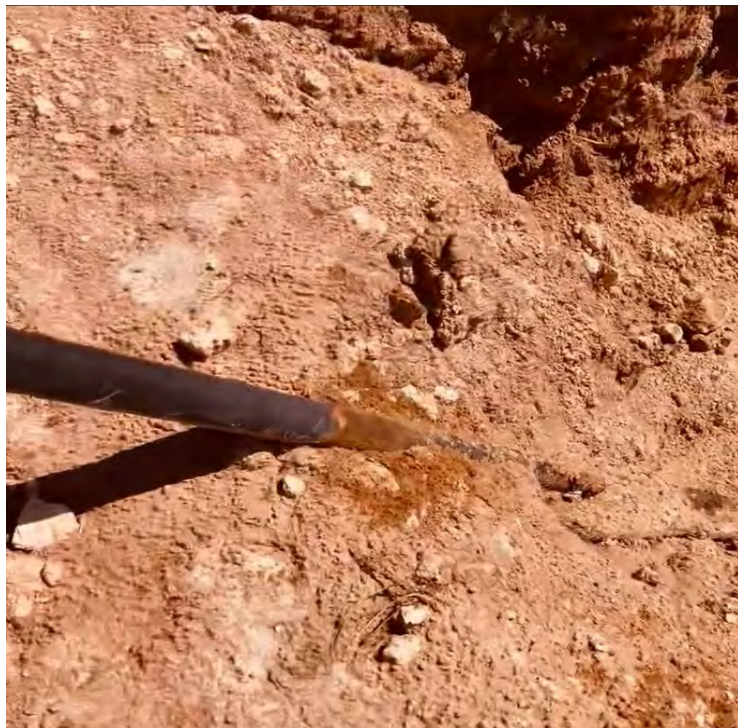
On May 26, 2023, a release from an injection line located at the West Eumont Unit #115 was discovered. As a result of corrosion of the line, approximately 15 barrels (bbls) of produced water were released. Immediately following the release, the area was secured, a vacuum truck was mobilized to the Site, and the line was repaired. The released fluid covered a surface area of approximately 3,000 square feet on the well pad. Approximately 5 bbl of fluid were recovered. The release point and the surface extent of the release are depicted on Figure 2.

View of release point (5/26/23).

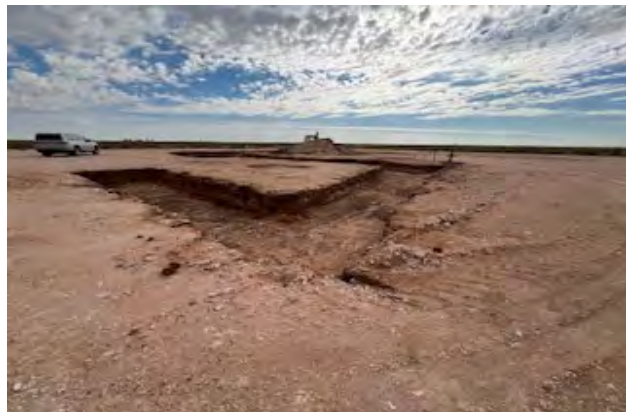
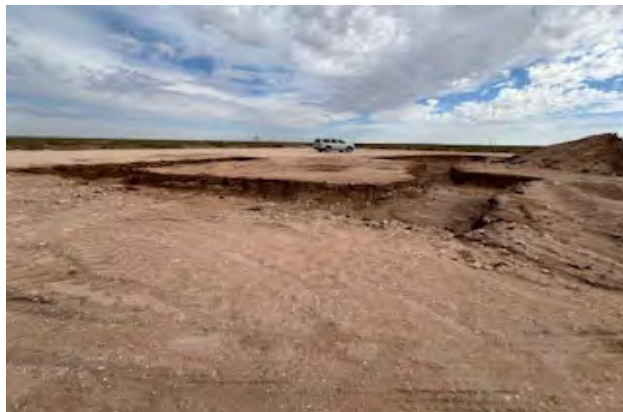
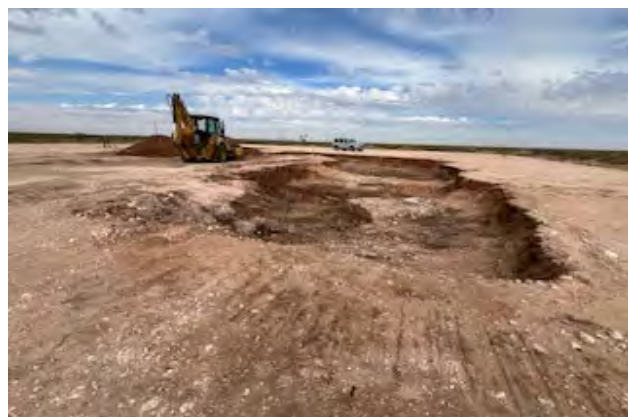
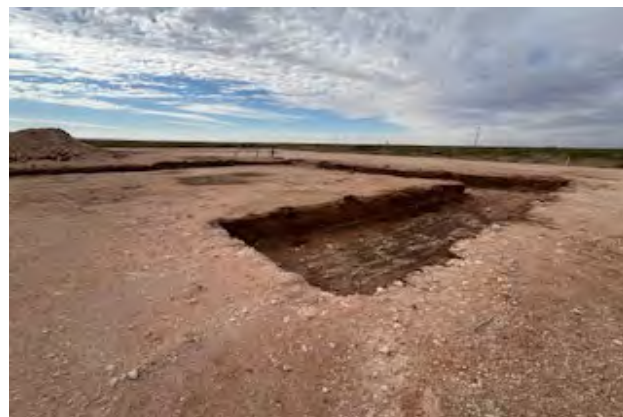
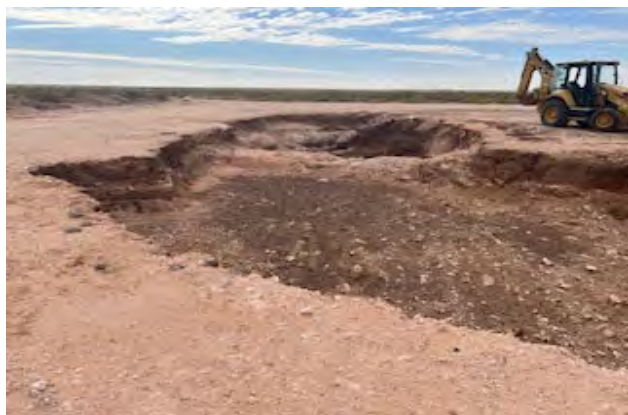
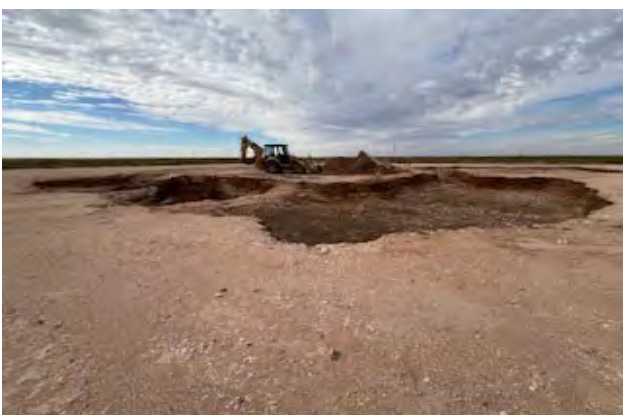
View to SE of excavation (12/5/24).

View to E of excavation (12/5/24).

View to N of excavation (12/5/24).

View to SW of excavation (12/5/24).

View to S of excavation (12/5/24).

Following approval of the *Site Characterization Report and Remediation Workplan* on July 22, 2024, excavation was continued until confirmation samples collected from the bottom and sidewalls on December 5, 2024, reported chloride concentrations below the NMOCD Closure Criteria.

All affected soil has been excavated, and 780 cubic yards (cy) were hauled to disposal at J&L Landfarm. Waste Manifests are provided in Appendix E.

Upon NMOCD approval of this Closure Report, the excavation will be backfilled to grade with non-impacted similar material obtained from a landowner pit. Pursuant to 19.15.29.13 NMAC, the surface area will be restored to pre-release conditions. Surface grading will be performed to near original conditions and contoured to prevent erosion and ponding, promote stability, and preserve storm water flow patterns.
