RECLAMATION REPORT

PREPARED FOR:
DEVON ENERGY PRODUCTION, LP.

LOCATION: Sea Snake 35 State #001H

NMOCD REF. NO. NAPP2101437181

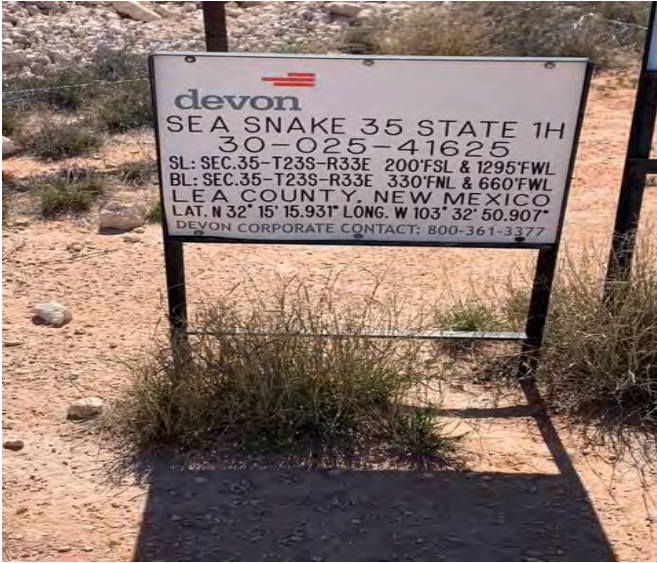
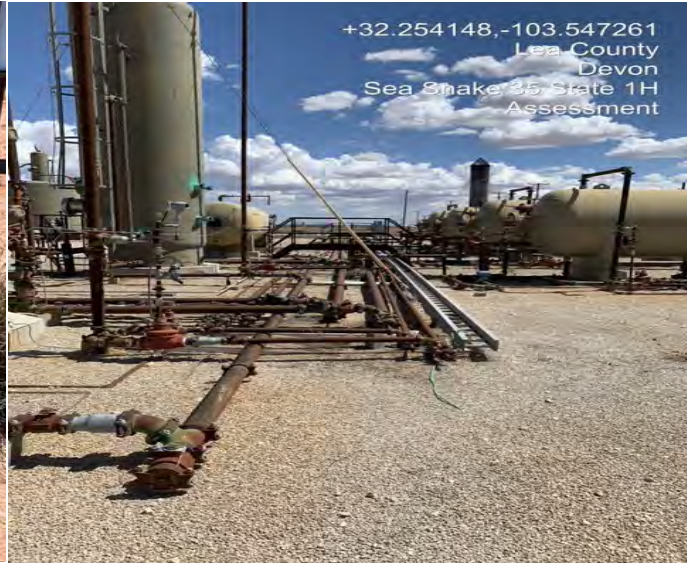
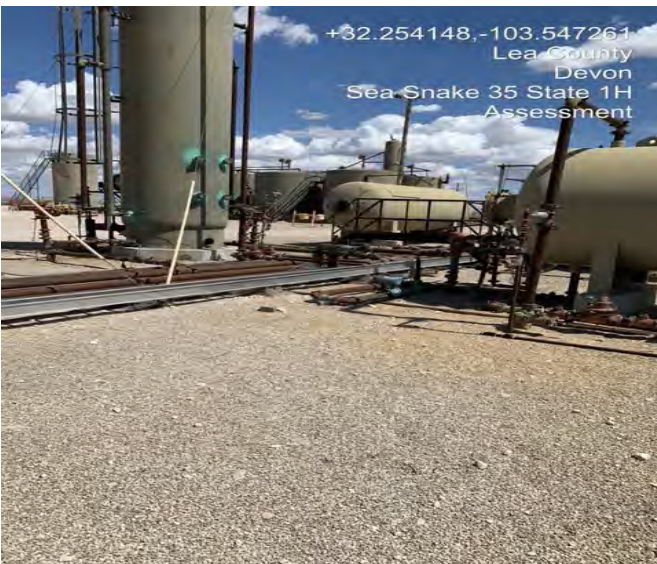
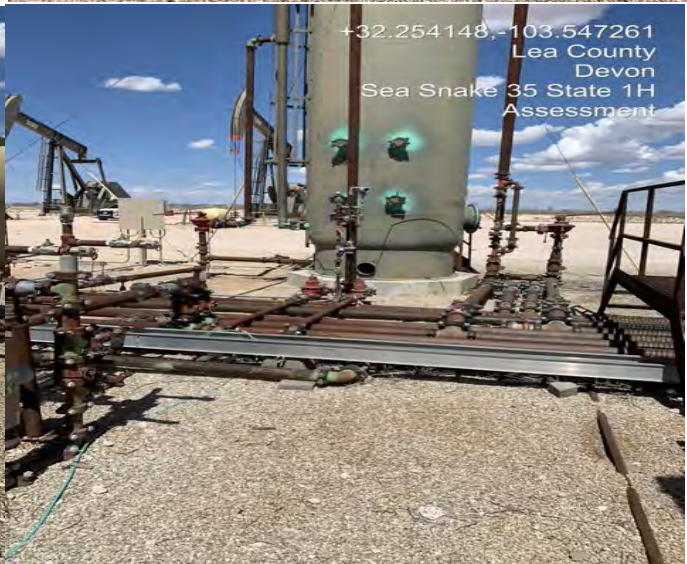
Assessment

On March 22, 2024, Pima Environmental conducted a site assessment and obtained soil samples. The laboratory results of this sampling event can be found in Figure 4. Analytical Laboratory Reports can be found in Appendix D. Photographic Documentation can be found in Appendix C.

The areas of concern do not require reclamation at this time as the conditions of the areas that were reported to have been affected were non-waste containing, uncontaminated, earthen material with chloride concentrations less than 600 mg/kg and TPH concentrations less than 100 mg/kg. To support this the Laboratory Analytical Reports are available in Appendix D. Furthermore, Photographic Documentation to prove that the ground has not been affected is available in Appendix C.
