## RECLAMATION REPORT

PREPARED FOR:  
DEVON ENERGY PRODUCTION, LP.

PREPARED BY:  
PIMA ENVIRONMENTAL SERVICES, LLC.

**LOCATION:** White Dove 17 Federal Com #022H

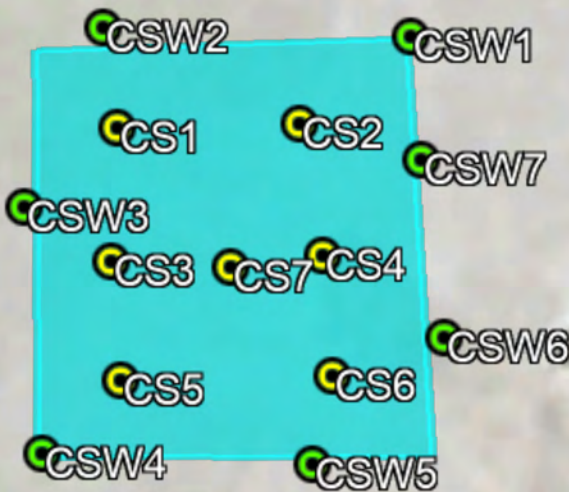
On August 13, 2024, after sending a 48-hour notification (application ID: 371943, Appendix C), Pima returned to the site to collect 5-point confirmation sample from the excavation. The 5-point composite sample was taken from the exposed excavation sidewalls and bottom samples were collected at 2' feet deep. All samples were put on ice, jarred, and delivered to Envirotech Analytical Laboratories, an NMOCD-approved laboratory for official analysis for all constituents listed in Table 1 19.15.29.12 NMAC. The laboratory results of this sampling event can be found in Figure 5 as well as the analytical laboratory reports available in Appendix E. A corresponding Confirmation Sample Map can be found in Figure 7.

- 2' Deep Bottom Composite Confirmation Samples
- Sidewalls 0 to 2' feet Composite Confirmation samples
- White Dove 17 Federal 22H

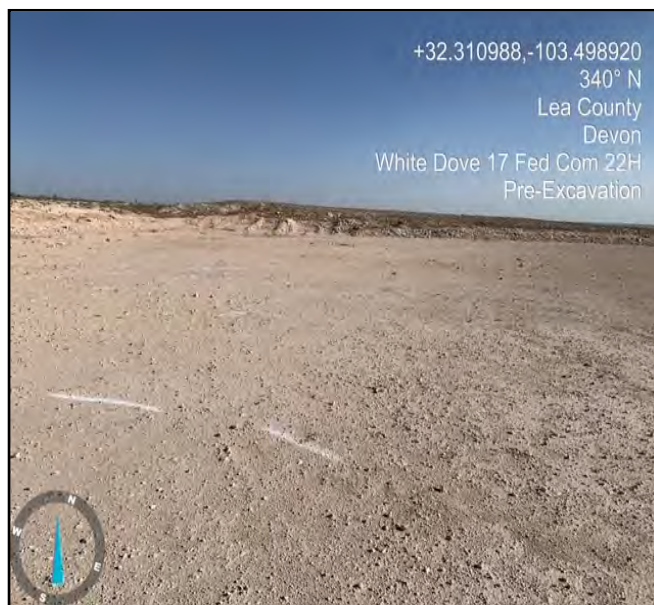
Photo of outline of the excavation area facing Northwest.

Photo of outline of the excavation area facing Northeast.

Photo of outline of the excavation area facing Southeast.

Photo of outline of the excavation area facing Southwest.

Photo of outline of the excavation area facing West.

Photo of outline of the excavation area facing North.

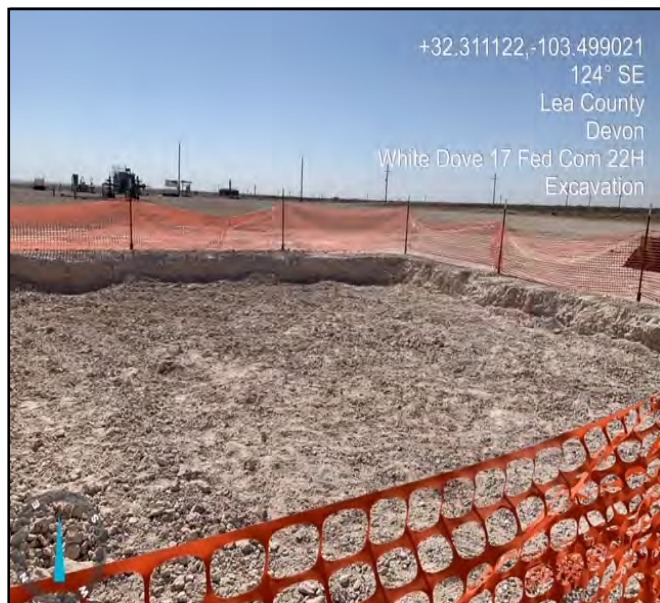
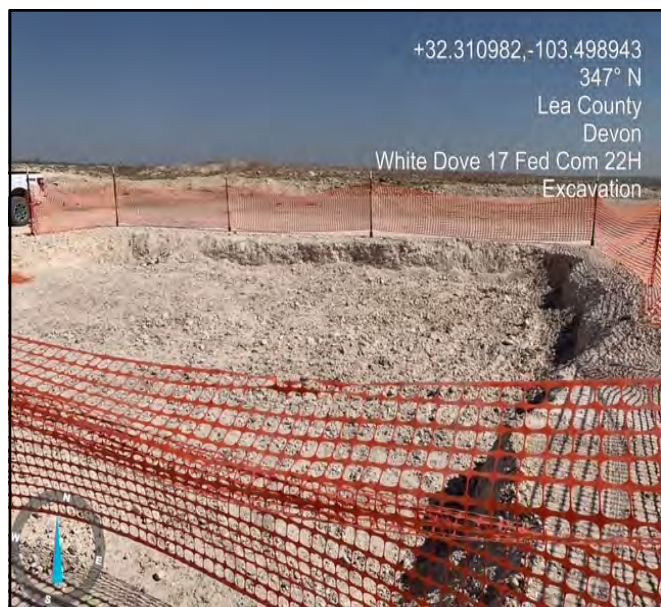
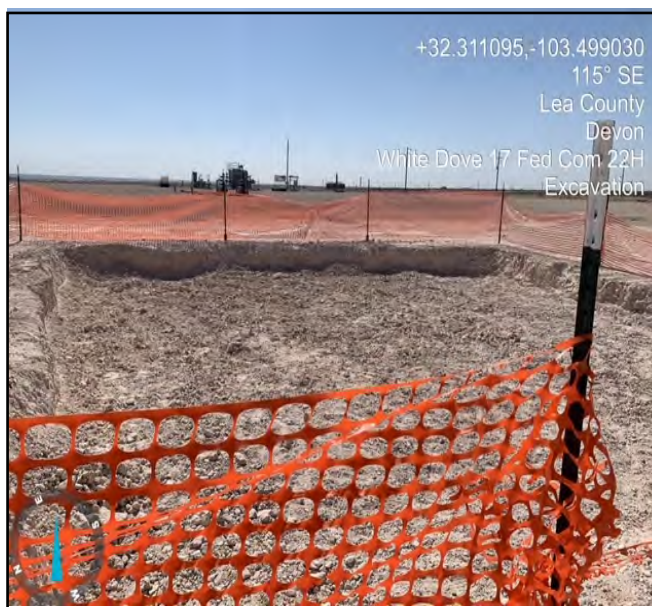
Photo during excavation facing Southeast.

Photo during excavation facing Southwest.

Photo during excavation facing North.

Aerial photo taken during excavation.

On August 7, 2024, the Devon Construction Department mobilized personnel and equipment to initiate immediate remediation activities. They began excavating the area to a depth of 2' foot below ground surface (BGS). A total of 95 cubic yards of contaminated soil was hauled to Northern Delaware Basin Landfill, an approved, lined disposal facility and clean backfill material was brought in.

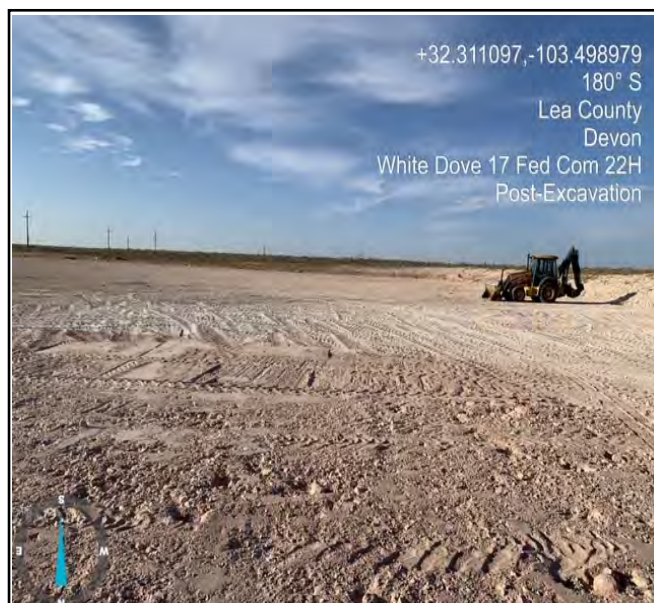
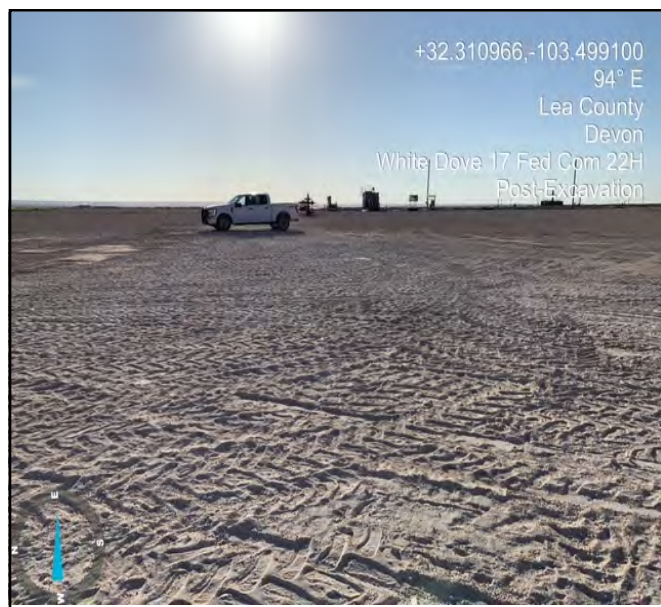
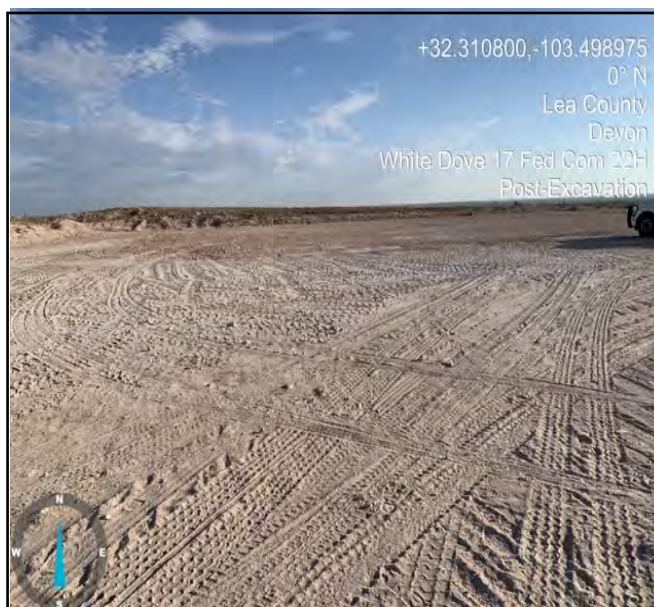
Photo taken pursuant to excavation, taken facing West.

Photo taken pursuant to excavation, taken facing South.

Photo taken pursuant to excavation, taken facing East.

Photo taken pursuant to excavation, taken facing North.

Aerial photo taken pursuant excavation.

Based on the sample results, the bottoms and sidewalls were below NMOCD Closure Criteria 19.15.29 NMAC. The contaminated material was sufficiently removed and then transported to Northern Delaware Basin Landfill, an NMOCD approved disposal site. See Appendix D for Photographic Documentation.
