SUBJECT: Confirmation Sampling Plan for the State Land 76 #001 Well Tank Battery (State Land 76) Release (nOY1716629707), Lea County, New Mexico

On behalf of Cofer & Co, LLC Strata Resources (Strata) has prepared this Confirmation Sampling Plan that describes the proposed confirmation closure sampling following the remediation of the release of liquids related to the activities at the State Land 76 #001 Well and Tank Battery (State Land 76). The site is on state land in Unit J, Section 2, Township 16S, Range 32E, Lea County, New Mexico.

FIGURE 1  
State Land 76  
Drone imagery  
Surveyed Areas

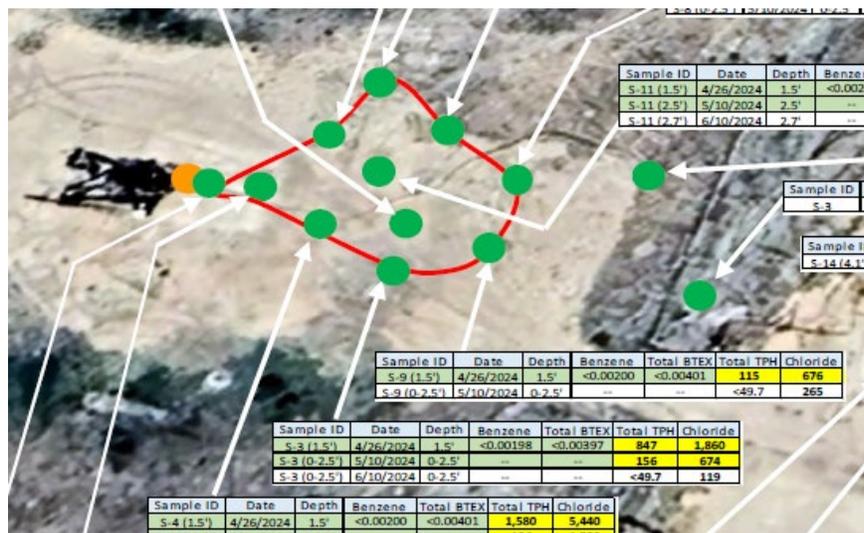
Crain Environmental Figure February 4, 2025

On June 15, 2017, a Release Notification and Corrective Action form (C-141) was submitted to the OCD. The C-141 was approved on June 15, 2017, and the release was assigned Spill No. 1RP-4722 and Incident # nOY1716629707. The release point and the surface extent of the release were depicted in the July 30, 2024 Closure Report.

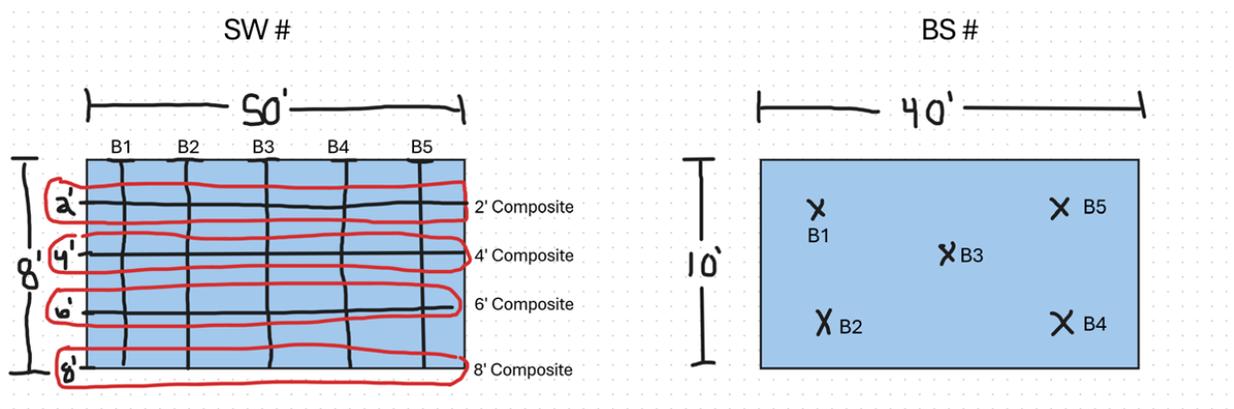
All confirmation BH samples will comprise 5-point composite samples, each representing 200 ft<sup>2</sup> surface area. Shown in Illustration 1 below BH boreholes will be 5-point composite samples. Similarly, the yellow box represents the 200 ft<sup>2</sup> area around SP4 and the 5 boreholes locations as shown in Illustration 1. Sidewall samples will be collected based on Illustration 1 composites of each interval at depth along the sidewall.

Illustration 1 is method only not square feet

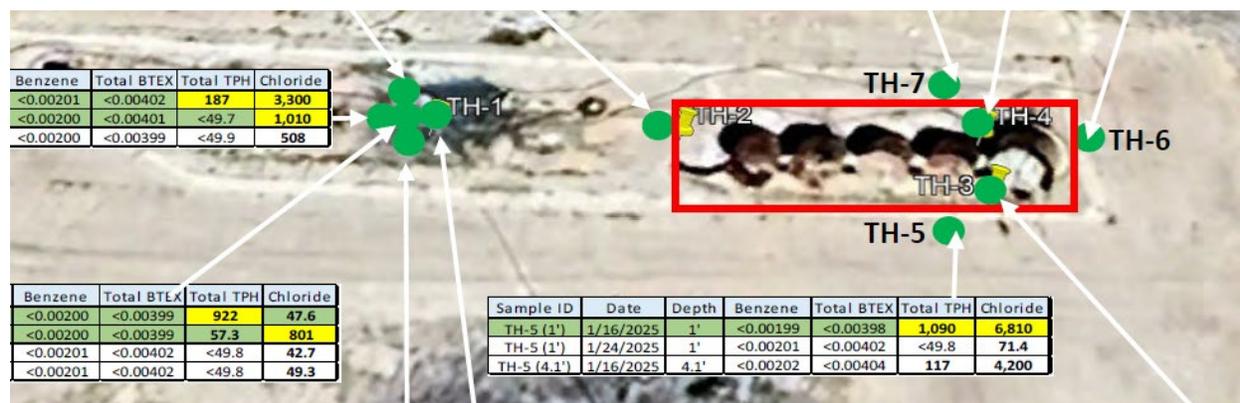
Crain Environmental Figure February 4, 2025

As stated in the February 4, 2025 an updated Remediation Summary and Closure Report, “Three test holes were dug to the south (TH-5), east (TH-6), and north (TH-7) of the tank battery to provide vertical and horizontal delineation of TPH and chloride impacts. Soil samples were collected from depths of 1’ and 4.1’ bgs at each test hole on January 16, 2025. On January 24, 2025, soil samples were collected from each test hole at a depth of 1’ bgs from the side of the hole farthest from the battery.”

Strata proposes an updated battery delineation to address the NMOCD's concerns about the sample areas TH1-TH7.

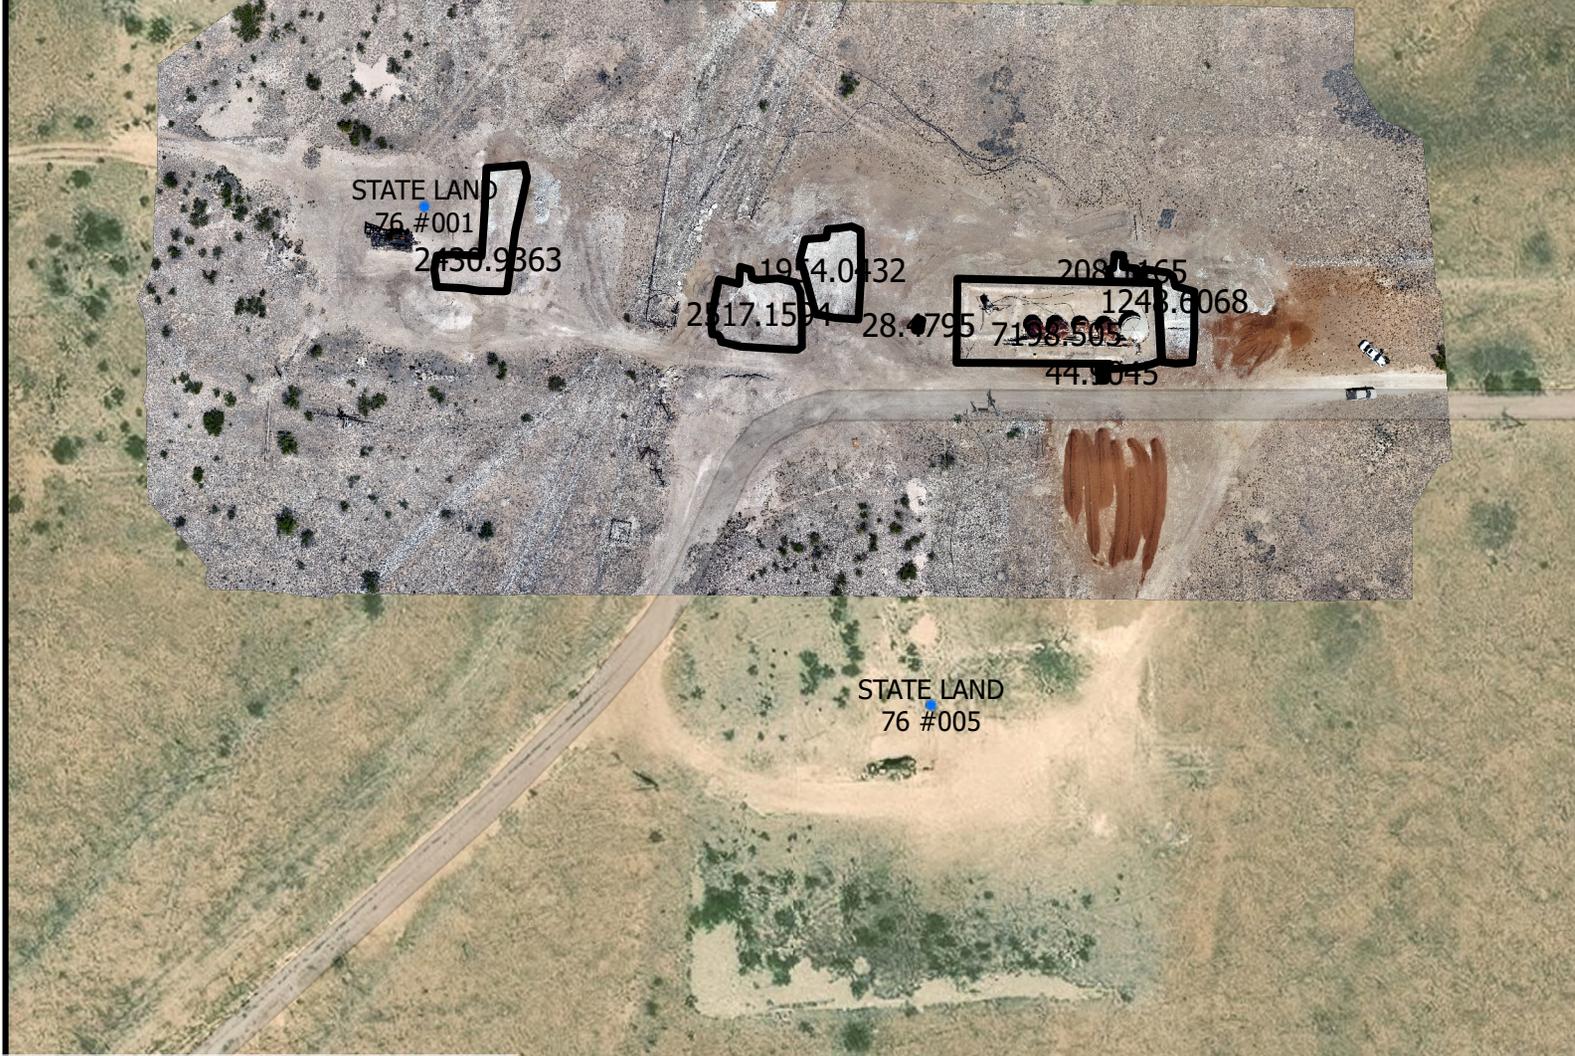
Because of the discrepancy between the actual excavation and the previously submitted figure imagery, on May 23, 2017, and February 4, 2025, Strata had a licensed New Mexico Surveyor mobilize to the location. On April 30<sup>th</sup>, 2025, Atkins Engineering Associates, INC.(Atkins) set up a base station to tie the surveyor rover unit and DJI drone to an AEA-established local network for RTK-GPS observations to get survey-quality positional data. The control point(s) and base were set up to the site's southwest. All attached figures include the geo-referenced drone imagery collected by Atkins April 30<sup>th</sup>. As shown in Figure 1, starting from the State Land 76 #001 wellhead and moving east, the excavations are

1. Center 32.95089 -103.73479 has an area of 2430.94 ft<sup>2</sup> (nOY1716629707)
2. Center 32.95597 -103.73423 has an area of 2517.16 ft<sup>2</sup> (nOY1716629707)
3. Center 32.95604 -103.73407 has an area of 1954.04 ft<sup>2</sup> (nOY1716629707)
4. Center 32.95595 -103.73389 has an area of 28.42 ft<sup>2</sup> (possibly TH1)
5. Center 32.95586 -103.73349 has an area of 44.90 ft<sup>2</sup> (possibly TH5)
6. Center 32.95604 -103.73345 has an area of 208.12 ft<sup>2</sup> (possibly TH7)
7. Center 32.95594 -103.73333 has an area of 1248.61 ft<sup>2</sup> (possibly TH6)

The area within the fenced battery was found to be 7198.51 ft<sup>2</sup>. All areas are based on the apparent edge of the excavation as found on April 30<sup>th</sup>, 2025 and verified by the excavator.

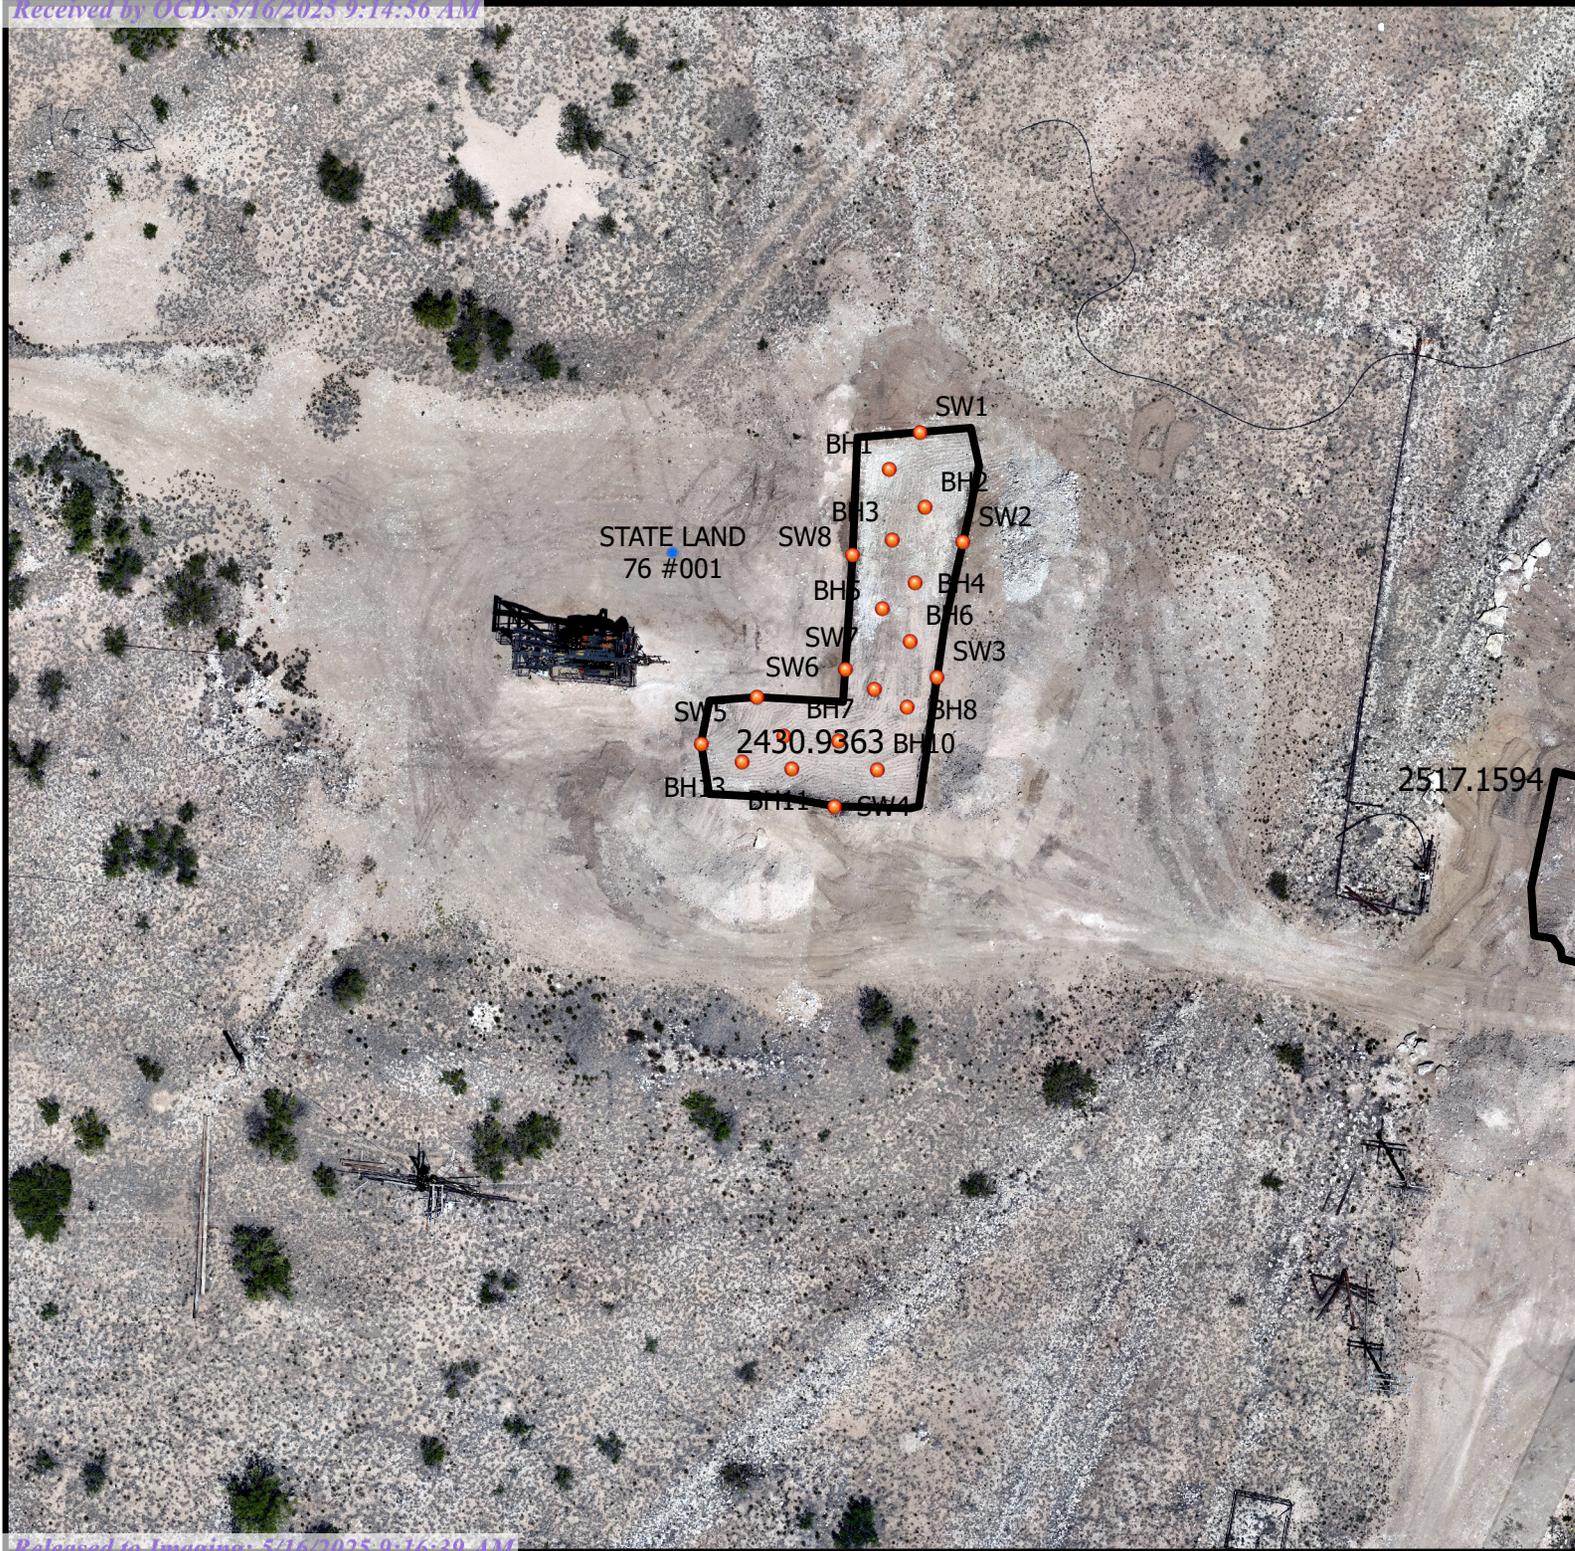
FIGURE 2  
State Land 76  
Proposed Sample Locations

1. Center 32.95089 -103.73479 has an area of 2430.94 ft<sup>2</sup> (nOY1716629707) 2430.94/200=12.15, Thirteen (13) bottom hole (BH) BH1-BH13 five-point composite samples will be collected as seen in Figure 2. With an excavation perimeter of 262 feet and a maximum depth of 5.5ft, the number of sidewall (SW) samples needed is (262X5.5)/200 =7.21 samples, or eight (8) SW1-SW8.

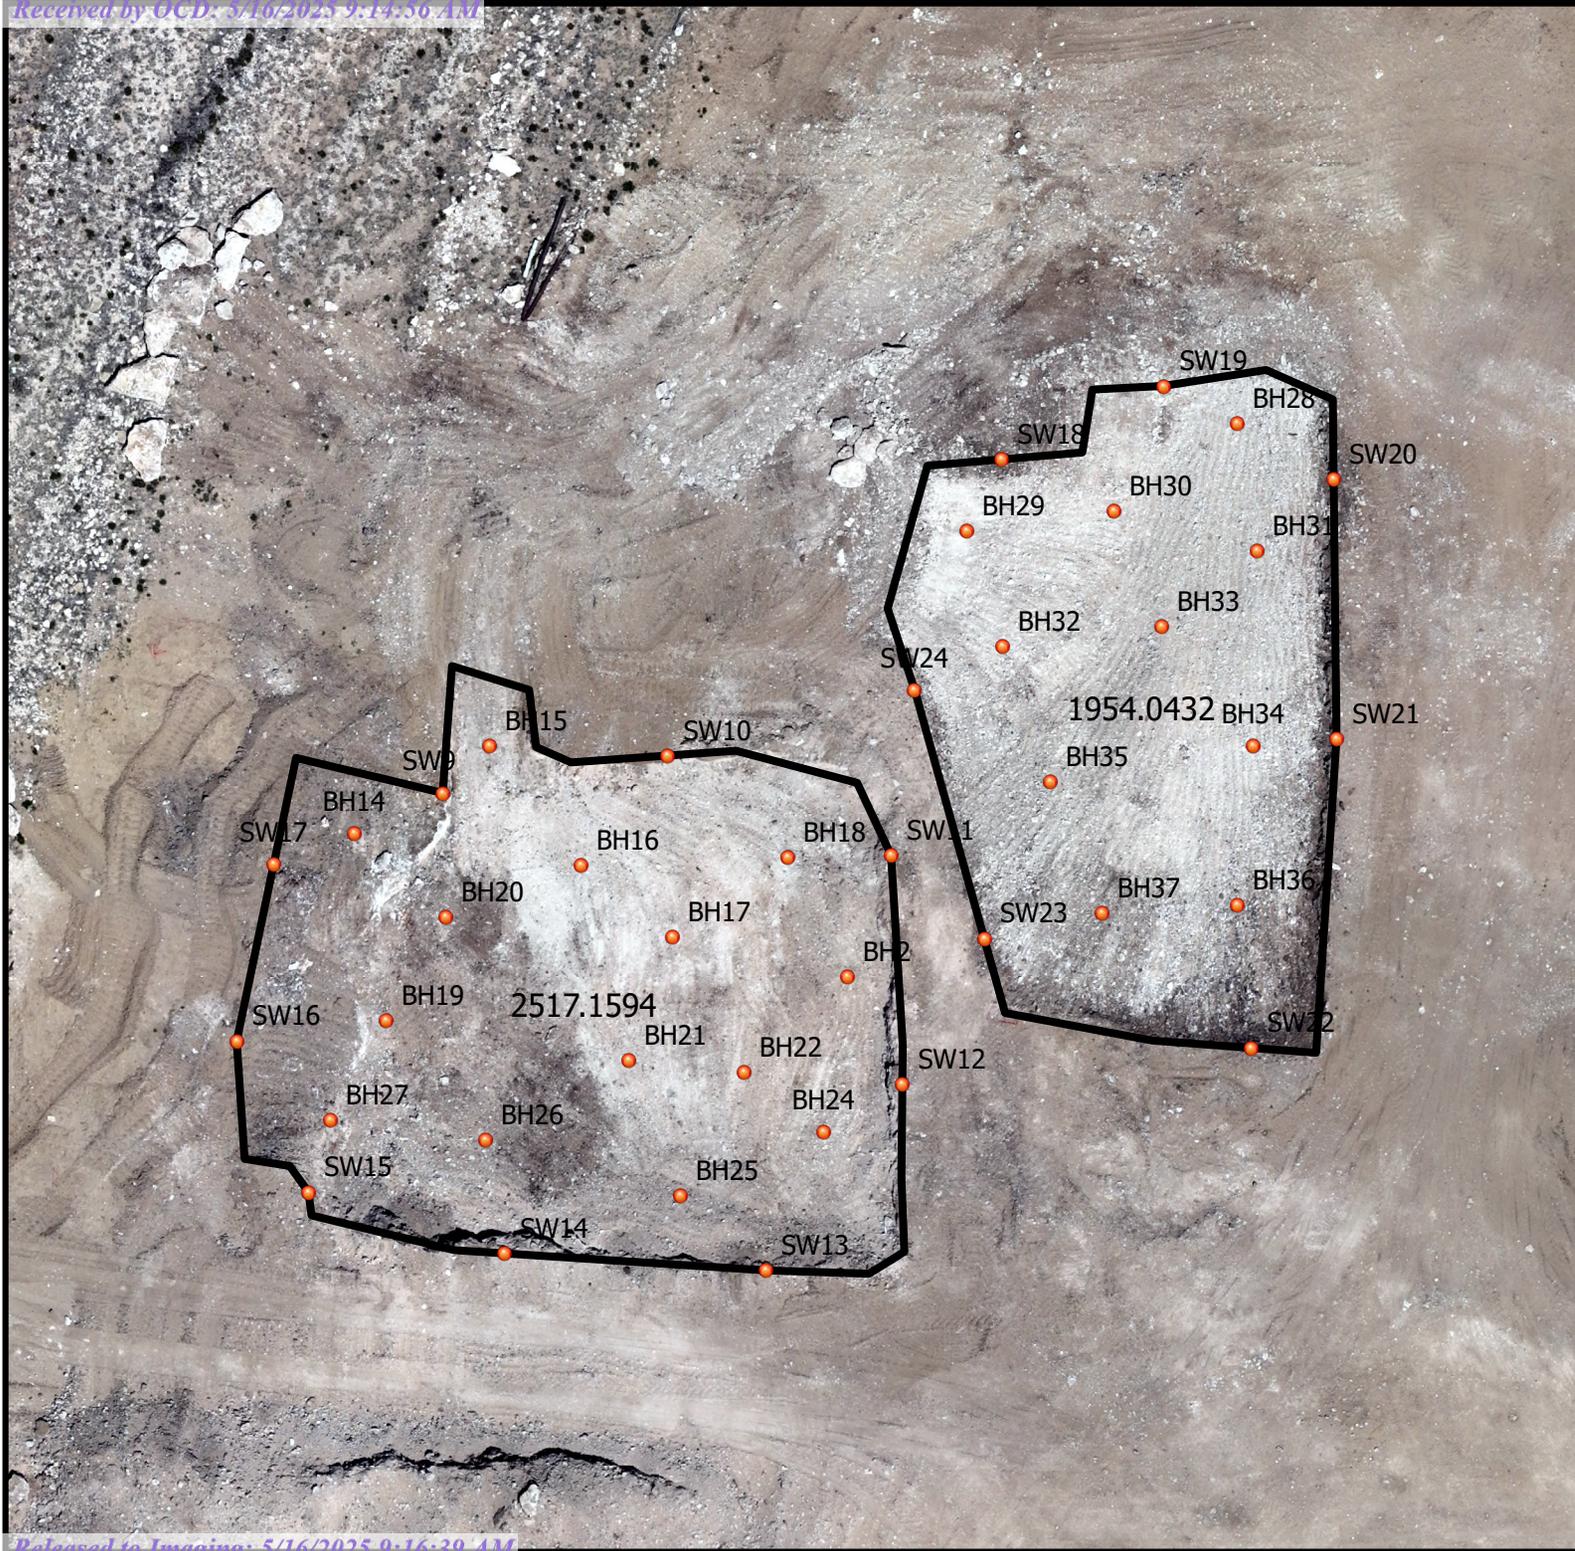
FIGURE 3  
State Land 76  
Proposed Sample Locations

2. Center 32.95597 -103.73423 has an area of 2517.16 ft<sup>2</sup> (nOY1716629707) 2517/200=12.58, Thirteen (13) bottom hole (BH) BH14-BH27 five-point composite samples will be collected as seen in Figure 3. With an excavation perimeter of 405.33 feet and a maximum depth of 4 feet, the number of sidewall (SW) samples needed is (405.33 × 4)/200 =8.06 samples, or eight (8) SW9-SW17.

3. Center 32.95604 -103.73407 has an area of 1954.04 ft<sup>2</sup> (nOY1716629707) 1954.04/200=8.77 or Nine (9) bottom hole (BH) BH28-BH37 five-point composite

samples will be collected as seen in Figure 3. With an excavation perimeter of 179.03 feet and a maximum depth of 4 feet, the number of sidewall (SW) samples needed is  $(179.03 \times 4)/200 = 3.58$  samples, or six (6) SW18-SW24.

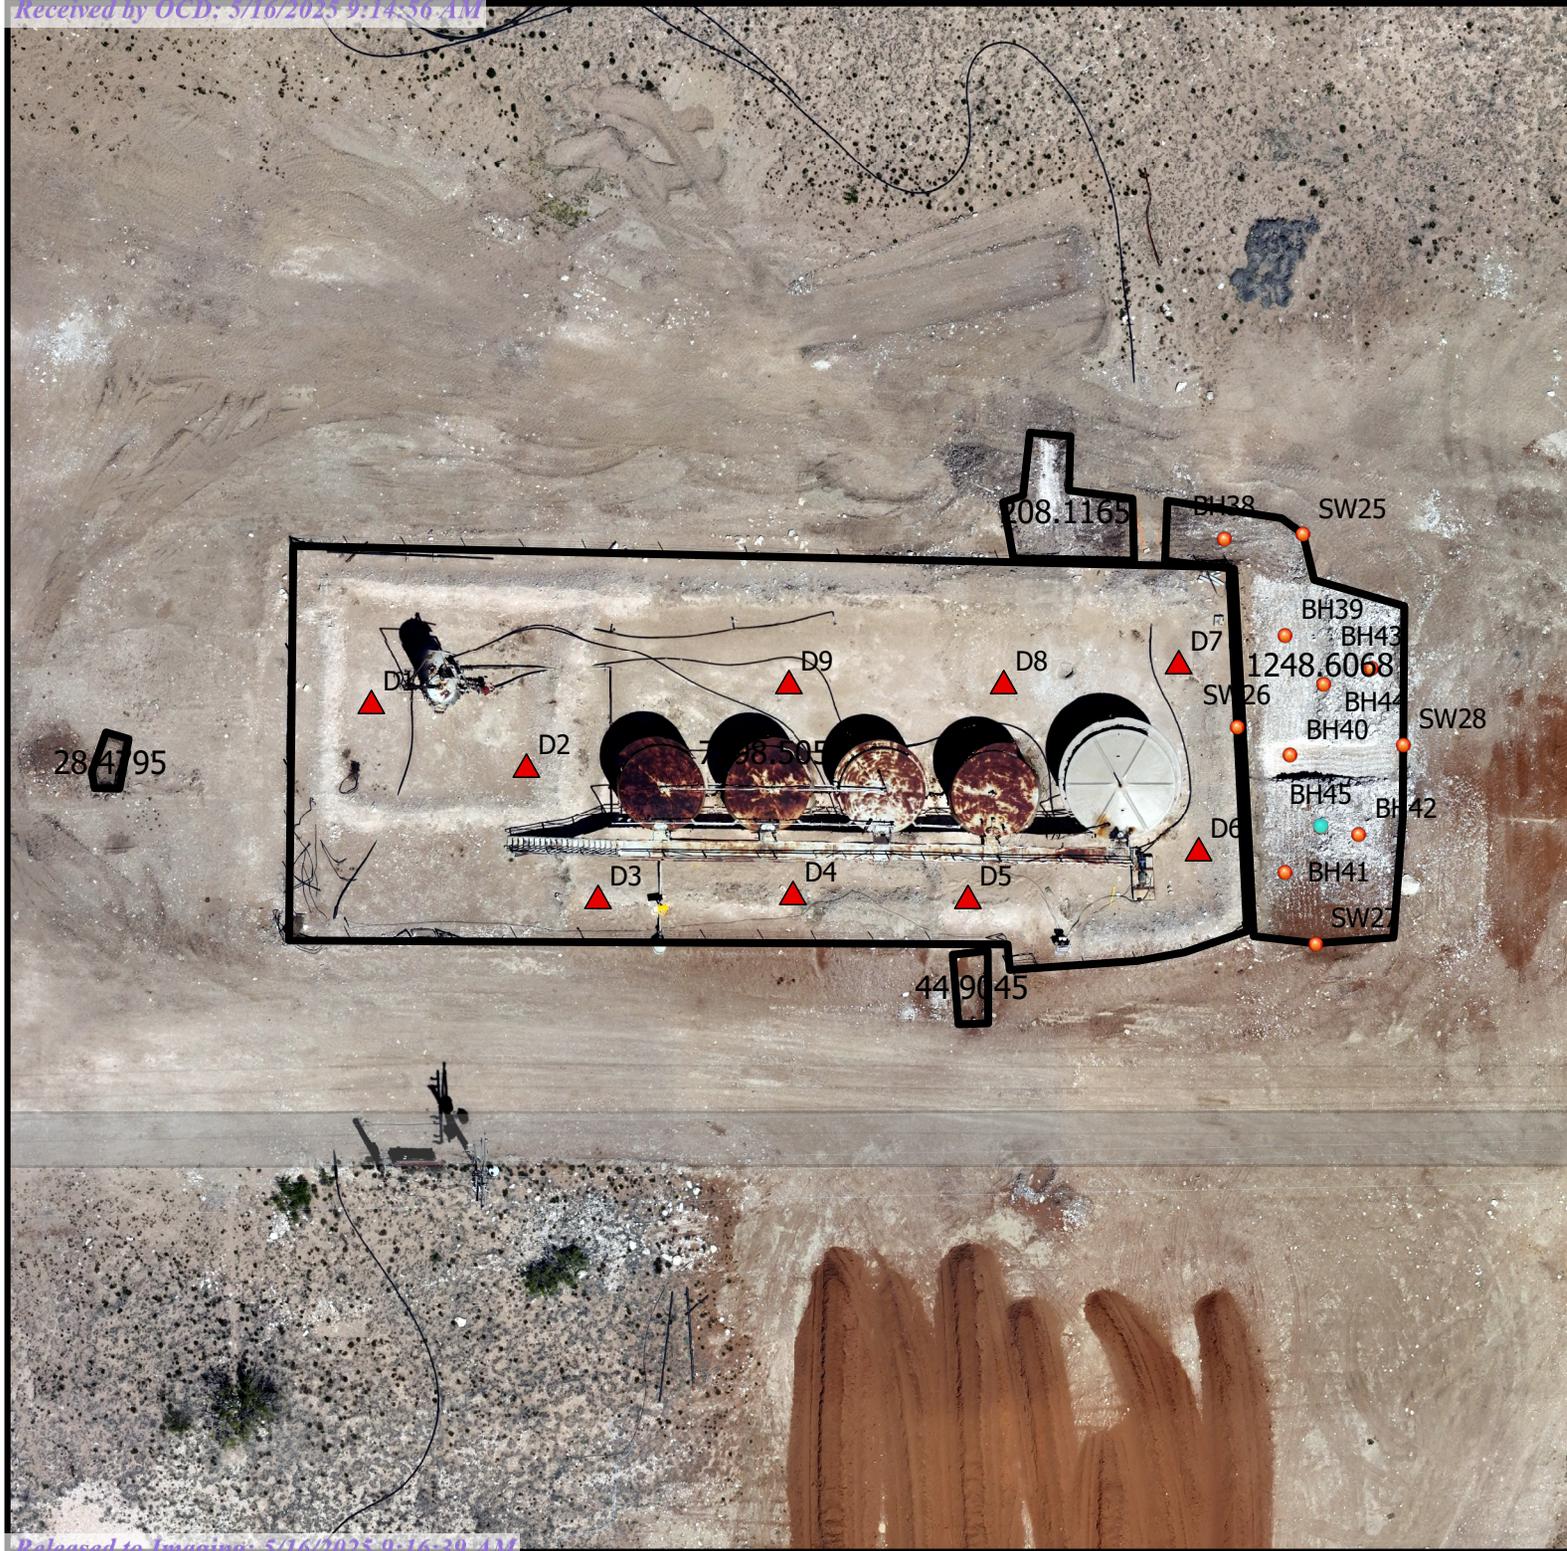
FIGURE 4  
State Land 76  
Proposed Sample Locations

Strata will delineate the areas of concern in and around the fenced battery, see proposed sample locations in Figure 4 labeled Delineation (D) D1-9.

Strata respectfully selected sample areas as close to the equipment as possible to prevent production disruption and avoid safety hazards caused by line strike or fire. As shown in Figure 4, the impacted soil has been removed from the site except for the soil within three feet of the storage tanks. Work will be scheduled after NMOCD and client approval of the sampling plan.
