**Closure Report**  
**Little Betty 20 701 H (04.13.2025)**  
**Incident ID: NAPP2510433552**  
**Eddy County, New Mexico**  
**Unit A, Sec 20, T21S, R28E**  
**32.469602, -104.100716**

**Produced Water and Crude Oil Release**  
**Point of Release: Hammer union leaking from the wellhead flowline**  
**Release Date: 04.13.2025**  
**Volume Released: 10 Barrels of Crude Oil and 10 Barrels of Produced Water**  
**Volume Recovered: 0 Barrels of Crude Oil and 0 Barrels of Produced Water**

Re: **Closure Report**  
**Little Betty 20 701H (04.13.2025)**  
**Incident ID: NAPP2510433552**  
**Coterra Energy Operating Co.**  
**Site Location: Unit A, S11, T21S, R28E**  
**32.469602, -104.100716**  
**Eddy County, New Mexico**

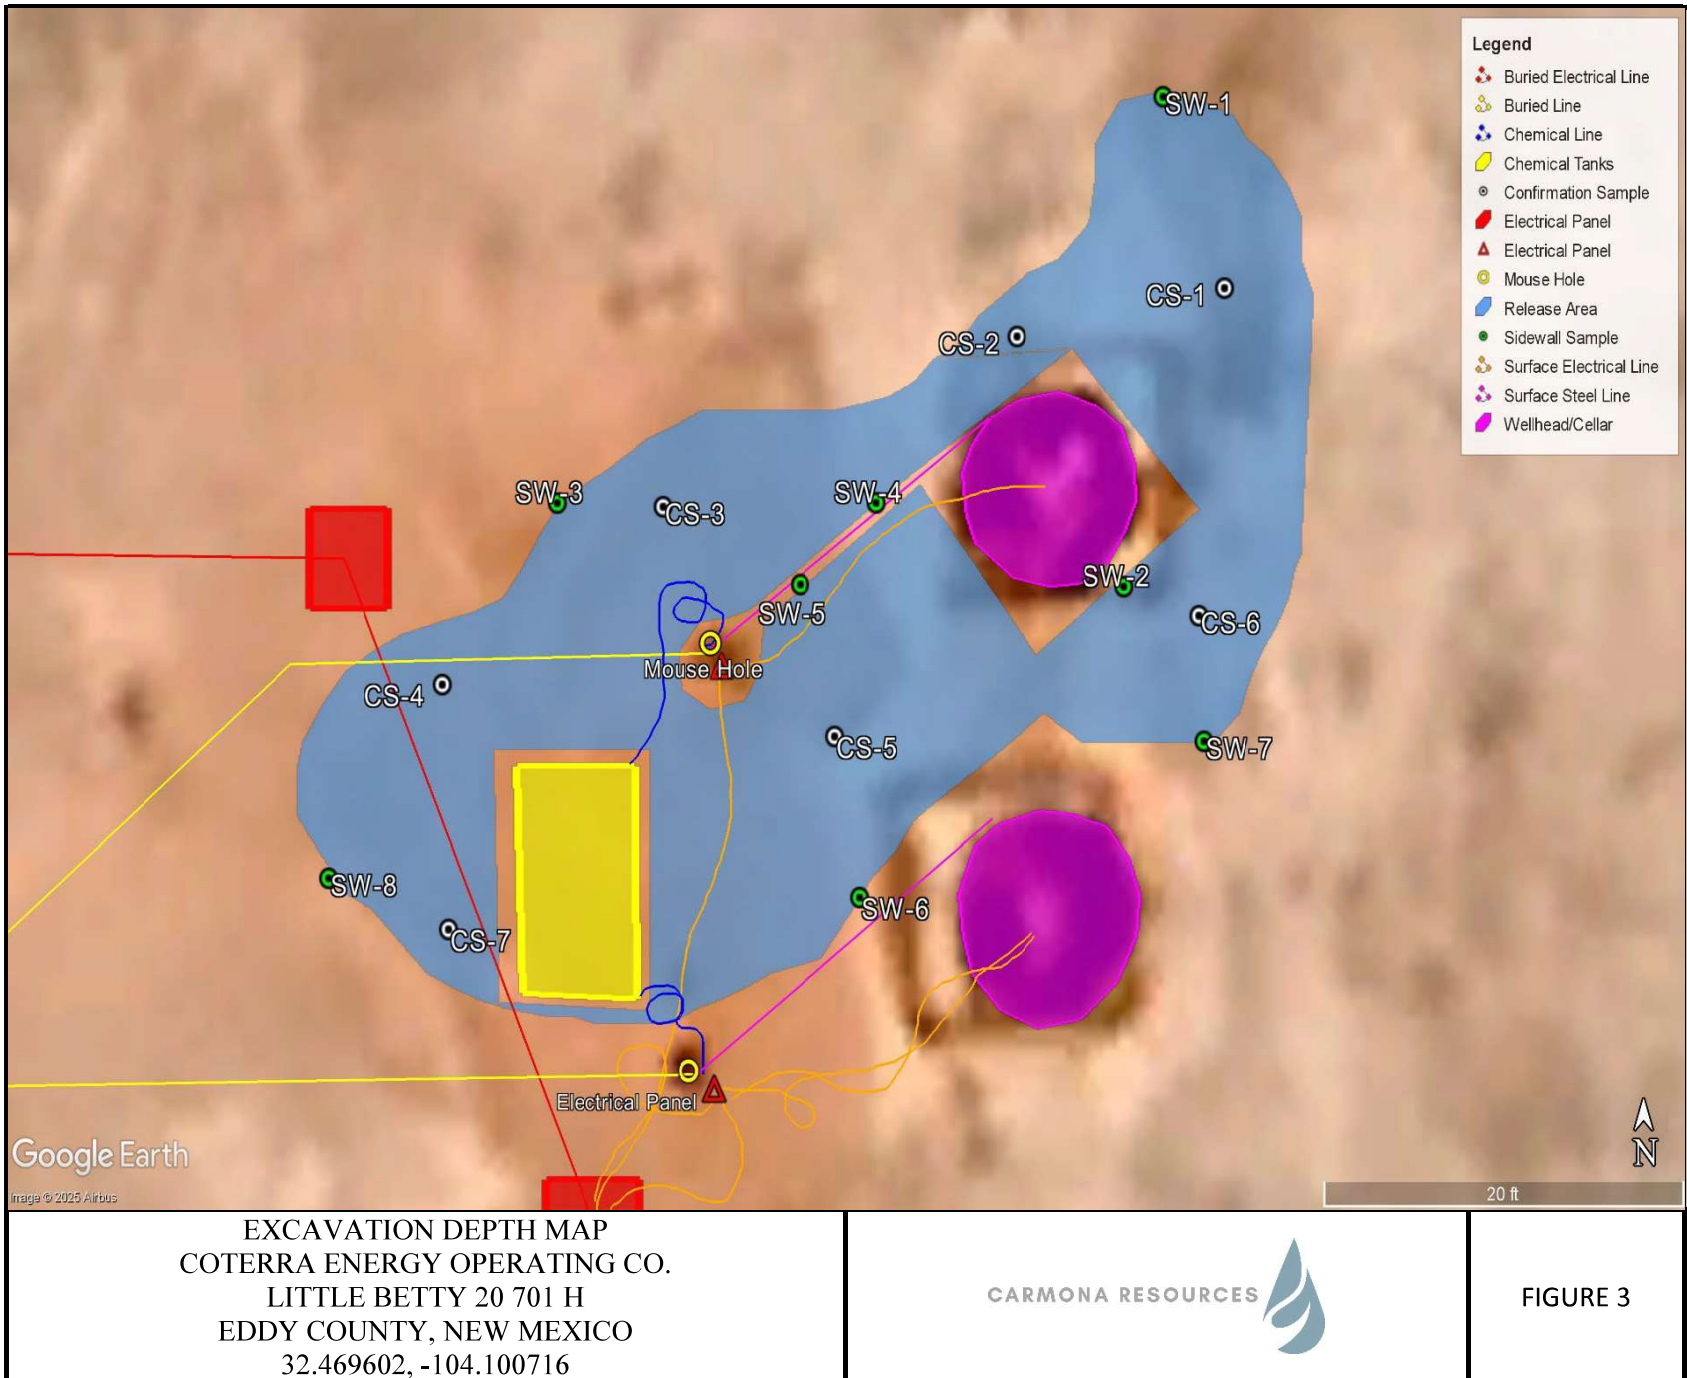
FIGURE 3      EXCAVATION DEPTH

Based on the initial C-141 obtained from the New Mexico Oil Conservation Division (NMOCD), the release was discovered on April 13, 2025, due to a hammer union leaking from the well head flow line. It resulted in approximately ten (10) barrels of produced water and ten (10) barrels of crude oil being released on pad, with zero (0) barrels recovered. The release area is approximately 1,049 sq ft. The spill boundaries are shown in Figure 3. The initial C-141 form is attached in Appendix C.

All final confirmation samples were below the regulatory requirements for TPH, BTEX, Chlorides. Refer to Table 1. The excavation depths and confirmation sample locations are shown in Figure 3.

Before collecting composite confirmation samples, the NMOCD division office was notified via NMOCD portal on April 23, 2025, and May 1, 2025, per Subsection D of 19.15.29.12 NMAC. See Appendix C. The areas of CS-1 to CS-7 were excavated to a depth of 1' bgs. A total of seven (7) confirmation floor samples were collected (CS-1 through CS-7), and eight (8) sidewall samples (SW-1 through SW-8) were collected every 200 square feet to ensure the proper removal of the contaminated soils. For chemical analysis, the soil samples were collected and placed into laboratory-provided sample containers, stored on ice, and transported under the proper chain-of-custody protocol to Eurofins Laboratories in Midland, Texas and Cardinal Laboratories in Hobbs, New Mexico accordance with established chain-of-custody protocols. All collected samples were analyzed for TPH analysis by EPA method 8015 modified, BTEX by EPA Method 8021B, and Chloride by EPA method 300.0 and 4500. Copies of laboratory analysis and chain-of-custody documentation are included in Appendix E. The excavation depths and confirmation sample locations are shown in Figure 3.

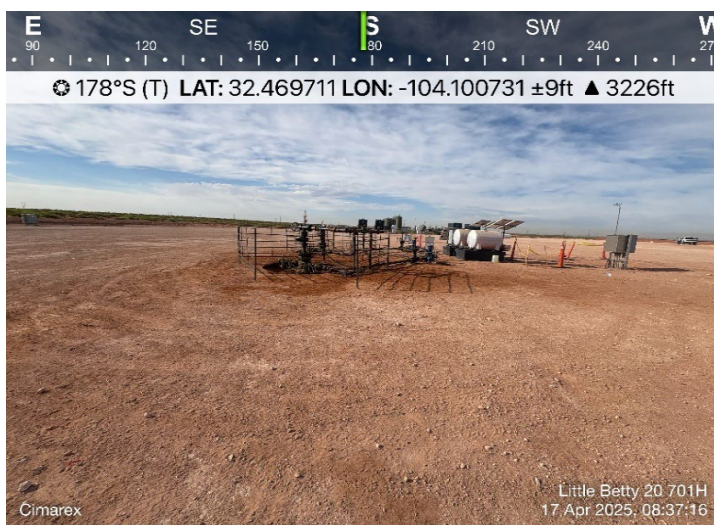
## Photograph No. 1

View South, area of concern prior to remediation.

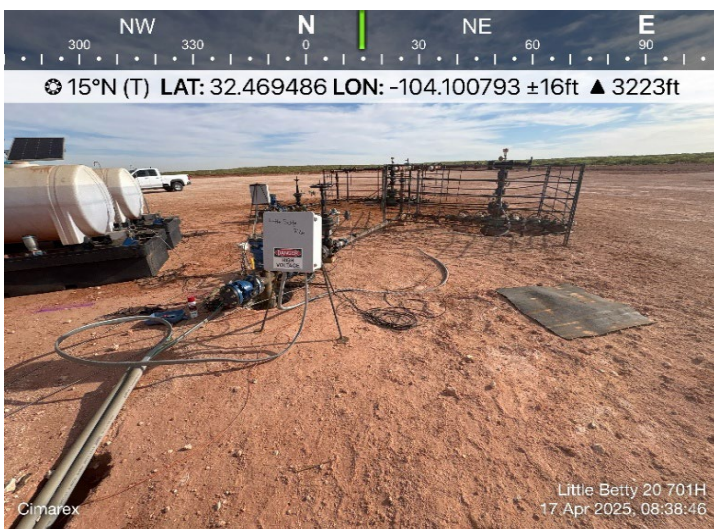
## Photograph No. 2

View North, area of concern prior to remediation.

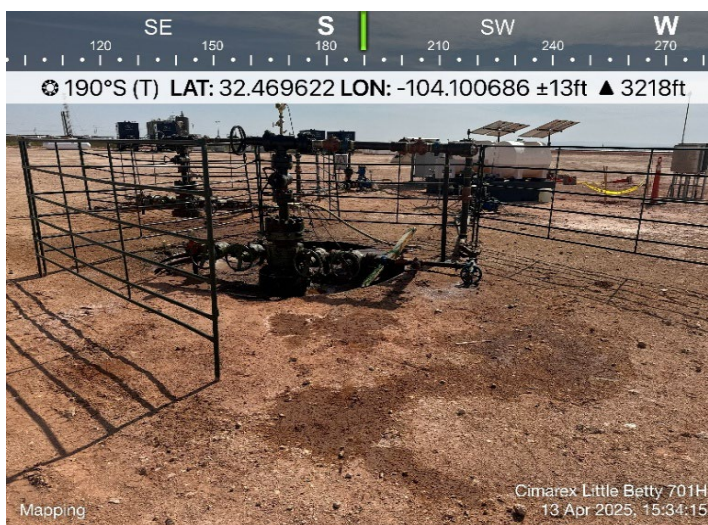
## Photograph No. 4

View South, area of concern prior to remediation.

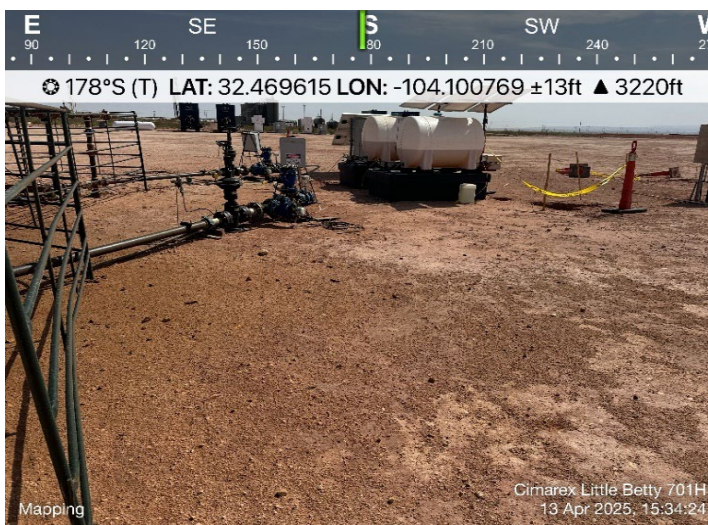
## Photograph No. 5

View South, area of concern prior to remediation.

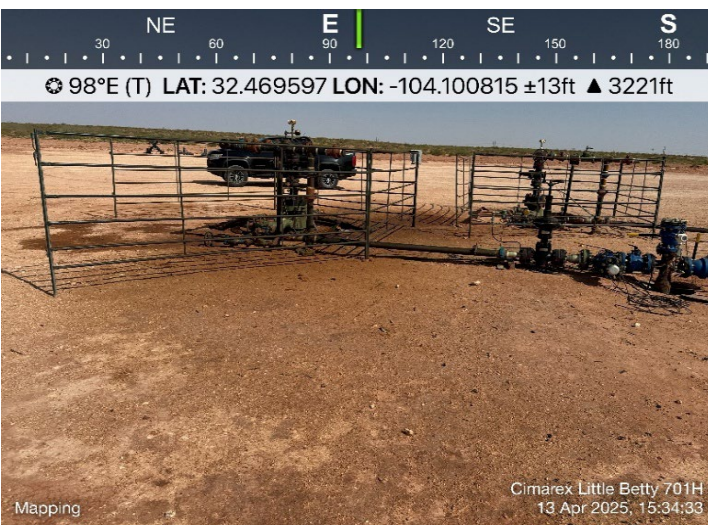
## Photograph No. 6

View East, area of concern prior to remediation.

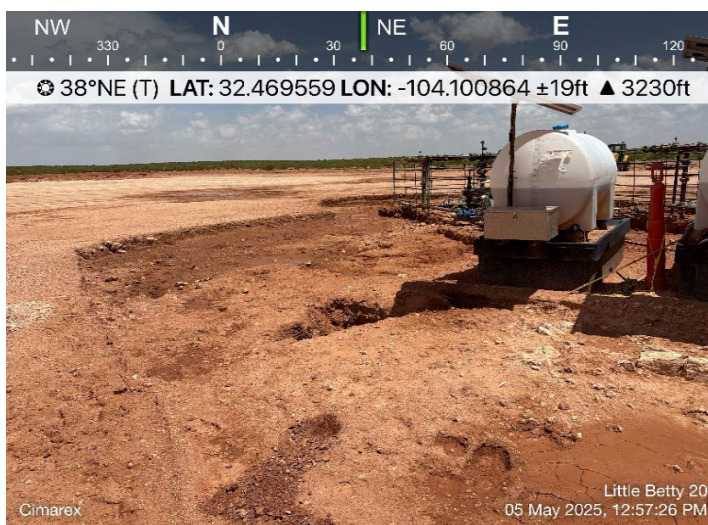
**PHOTOGRAPHIC LOG****Coterra Energy Operating Co.****Photograph No. 7****Facility:** Little Betty 20 701H (04.13.2025)**County:** Eddy County, New Mexico**Description:**

View Northeast, Excavated area of SW-3, SW-8, CS-3 and CS-7

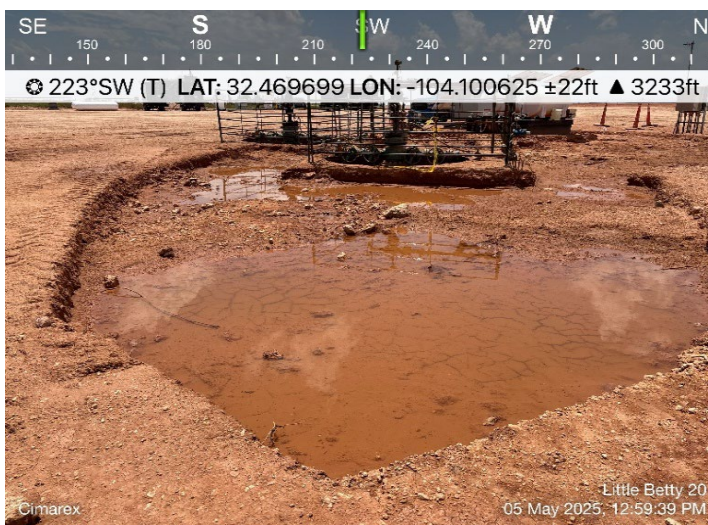
**Photograph No. 8****Facility:** Little Betty 20 701H (04.13.2025)**County:** Eddy County, New Mexico**Description:**

View Southwest, Excavated area of CS-1, CS-2, and SW-1

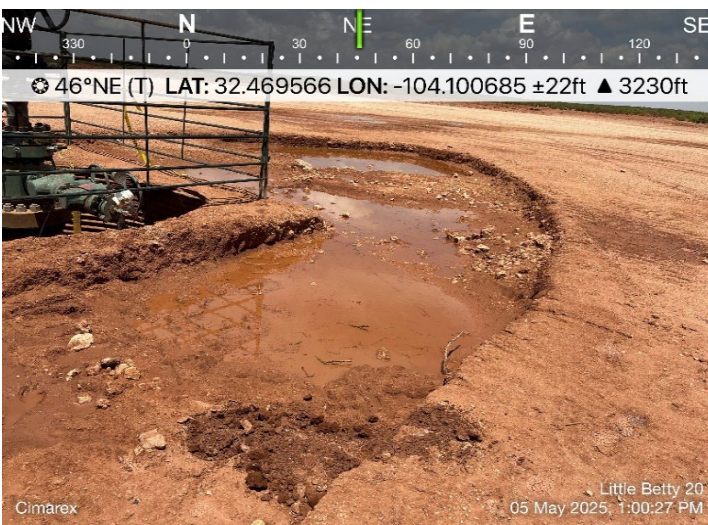
**Photograph No. 9****Facility:** Little Betty 20 701H (04.13.2025)**County:** Eddy County, New Mexico**Description:**

View Northeast, Excavated area of SW-2, SW-7 and CS-6

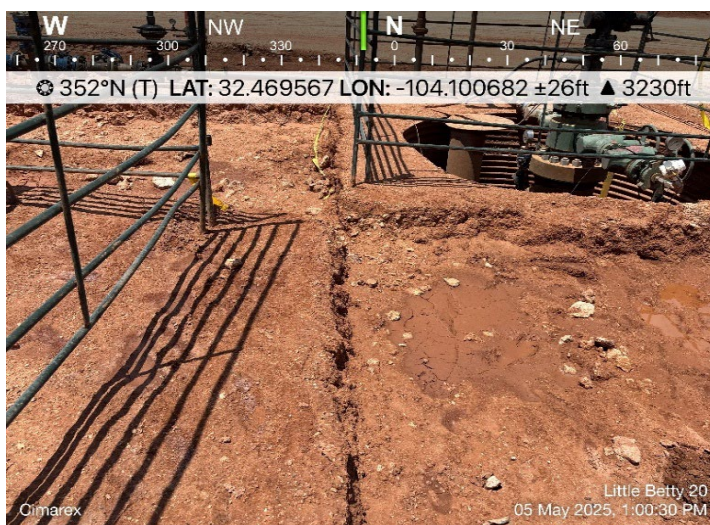
## Photograph No. 10

View North, Excavated area of SW-2 and CS-6

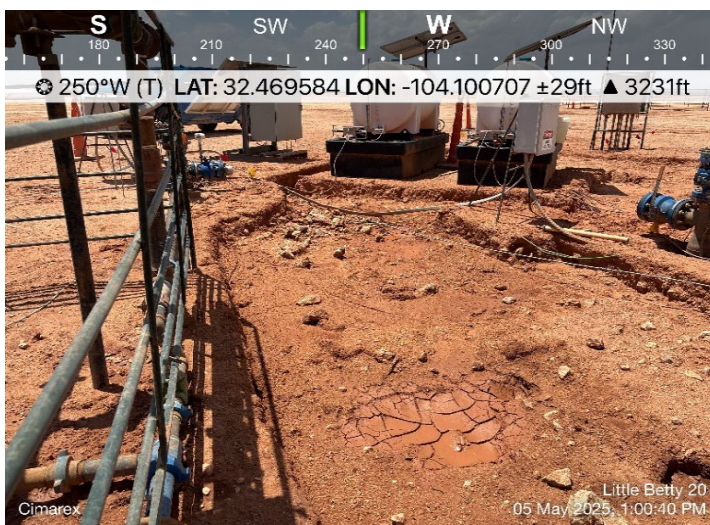
## Photograph No. 11

View West, Excavated area of CS-5, SW-4, SW-5, and SW-6

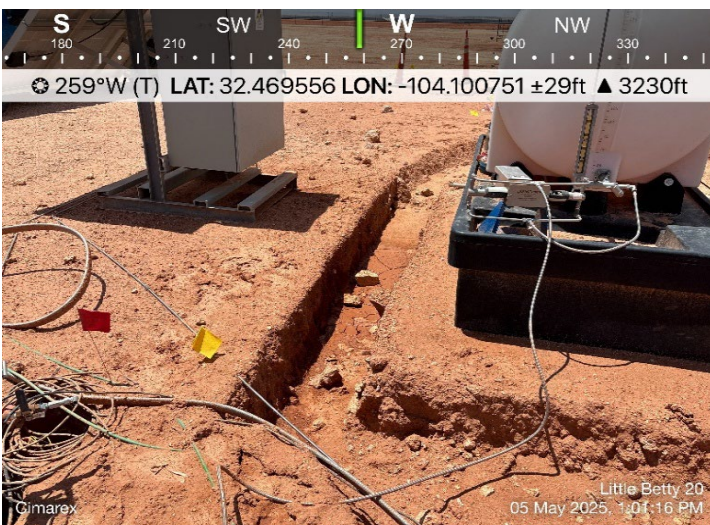
## Photograph No. 12

View West, Excavated area of CS-7 and SW-8

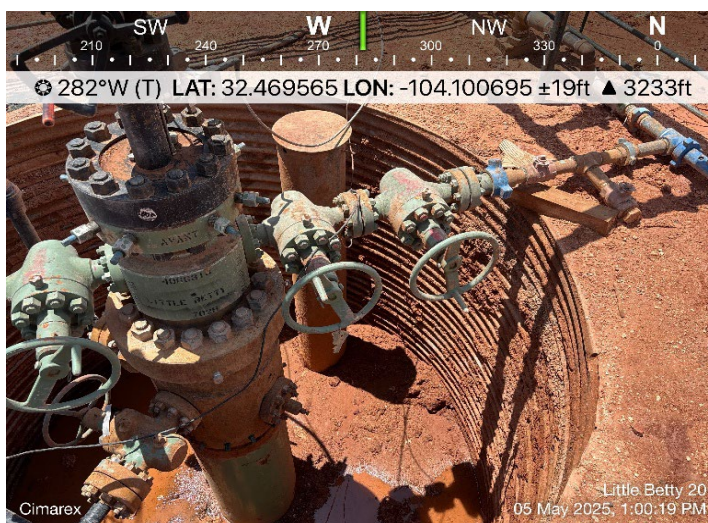
## Photograph No. 13

View West, Cellar of wellhead with fluid removed and power washed.

Before conducting the liner inspection, a crew was onsite to remove all freestanding fluids within the cellar of the wellhead. Once the cellar for the well head was thoroughly cleaned, the NMOCD division office was notified via NMOCD portal on April 23, 2025 per Subsection D of 19.15.29.12 NMAC. See Appendix C for the NMOCD correspondence prior to performing the liner inspection. On April 29, 2025, Carmona Resources, LLC conducted liner inspection activities to assess the cellar for the wellheads' integrity and determined there were no integrity issues. Refer to the Photolog in Appendix B. Appendix C also contains a Liner Integrity Certification.

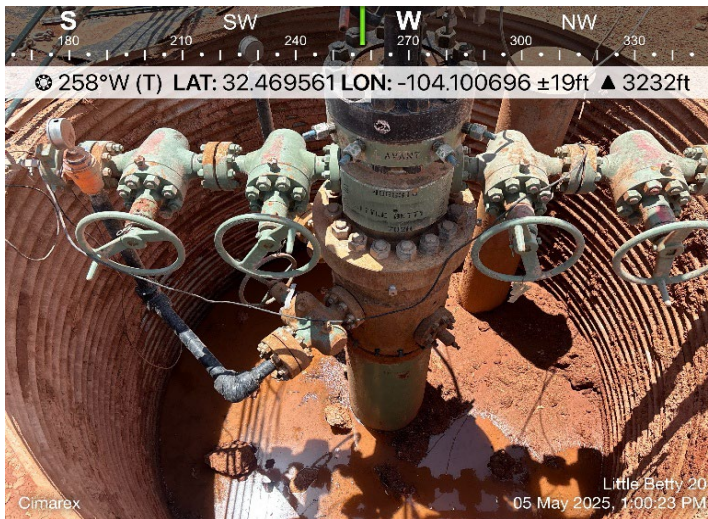
## Photograph No. 14

View West, Cellar of wellhead with fluid removed and power washed.

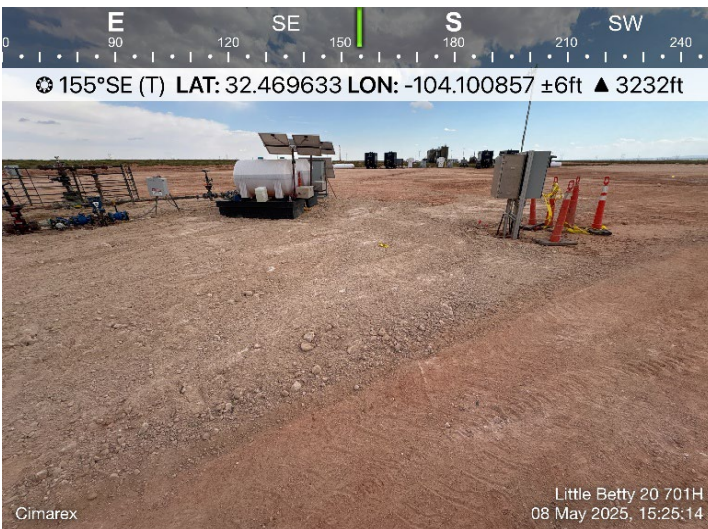
## Photograph No. 15

View Southeast, Backfilled area.

Once the remediation activities were completed, the excavated areas were backfilled with clean material to surface grade. A composite sample from the Fred Beard Backfill Pit, located at 32.161928, -104.316363. Approximately 120 cubic yards of material were excavated and transported offsite for proper disposal. See Table 1 & Appendix E for laboratory analysis of the backfill sample.

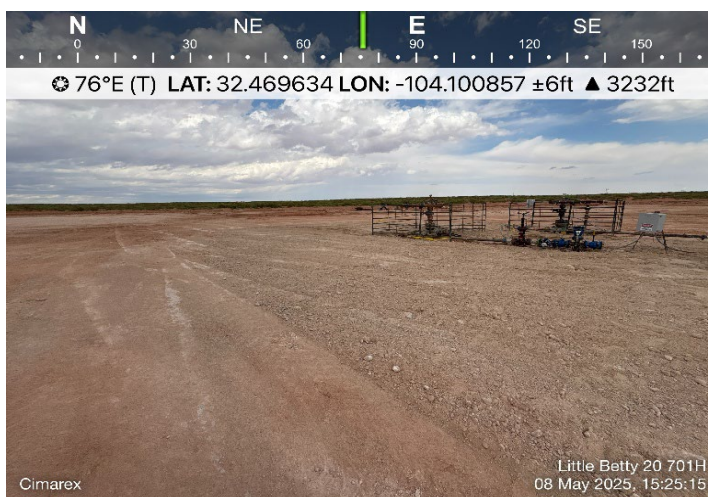
**PHOTOGRAPHIC LOG****Coterra Energy Operating Co.****Photograph No. 16****Facility:** Little Betty 20 701H (04.13.2025)**County:** Eddy County, New Mexico**Description:**

View East, Backfilled area.

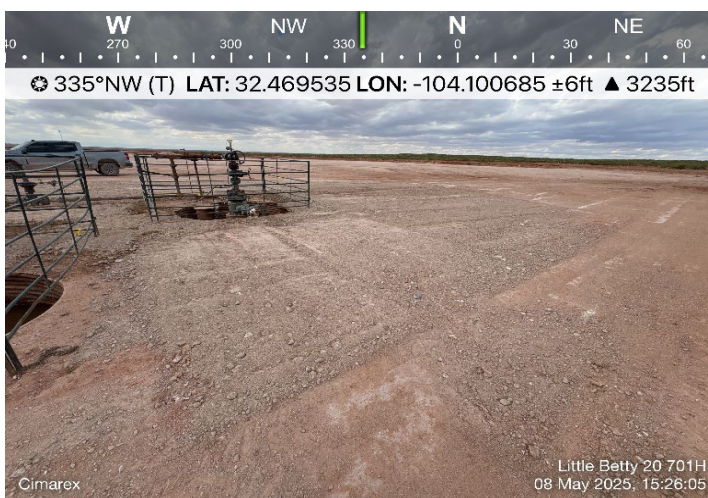
**Photograph No. 17****Facility:** Little Betty 20 701H (04.13.2025)**County:** Eddy County, New Mexico**Description:**

View Northwest, Backfilled area.

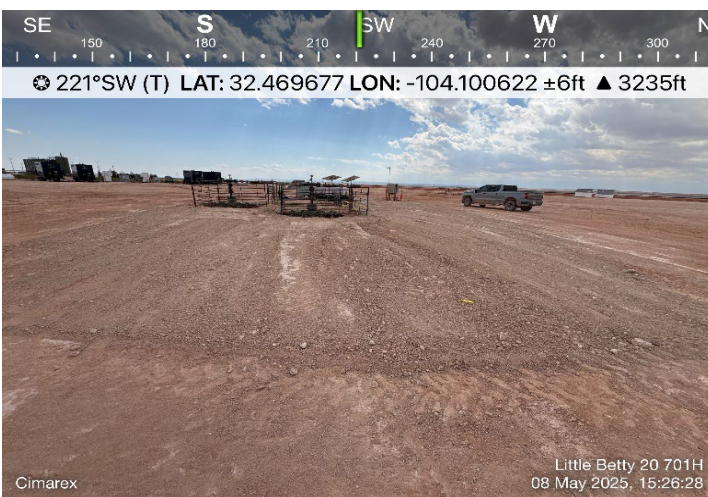
**Photograph No. 18****Facility:** Little Betty 20 701H (04.13.2025)**County:** Eddy County, New Mexico**Description:**

View Southwest, Backfilled area.
