VACUUM ABO UNIT #067

nGRL1033349437

PREPARED BY SAPEC-ECO, LLC.
PREPARED FOR MAVERICK PERMIAN, LLC.

Proposed Sampling and Remediation Work Plan

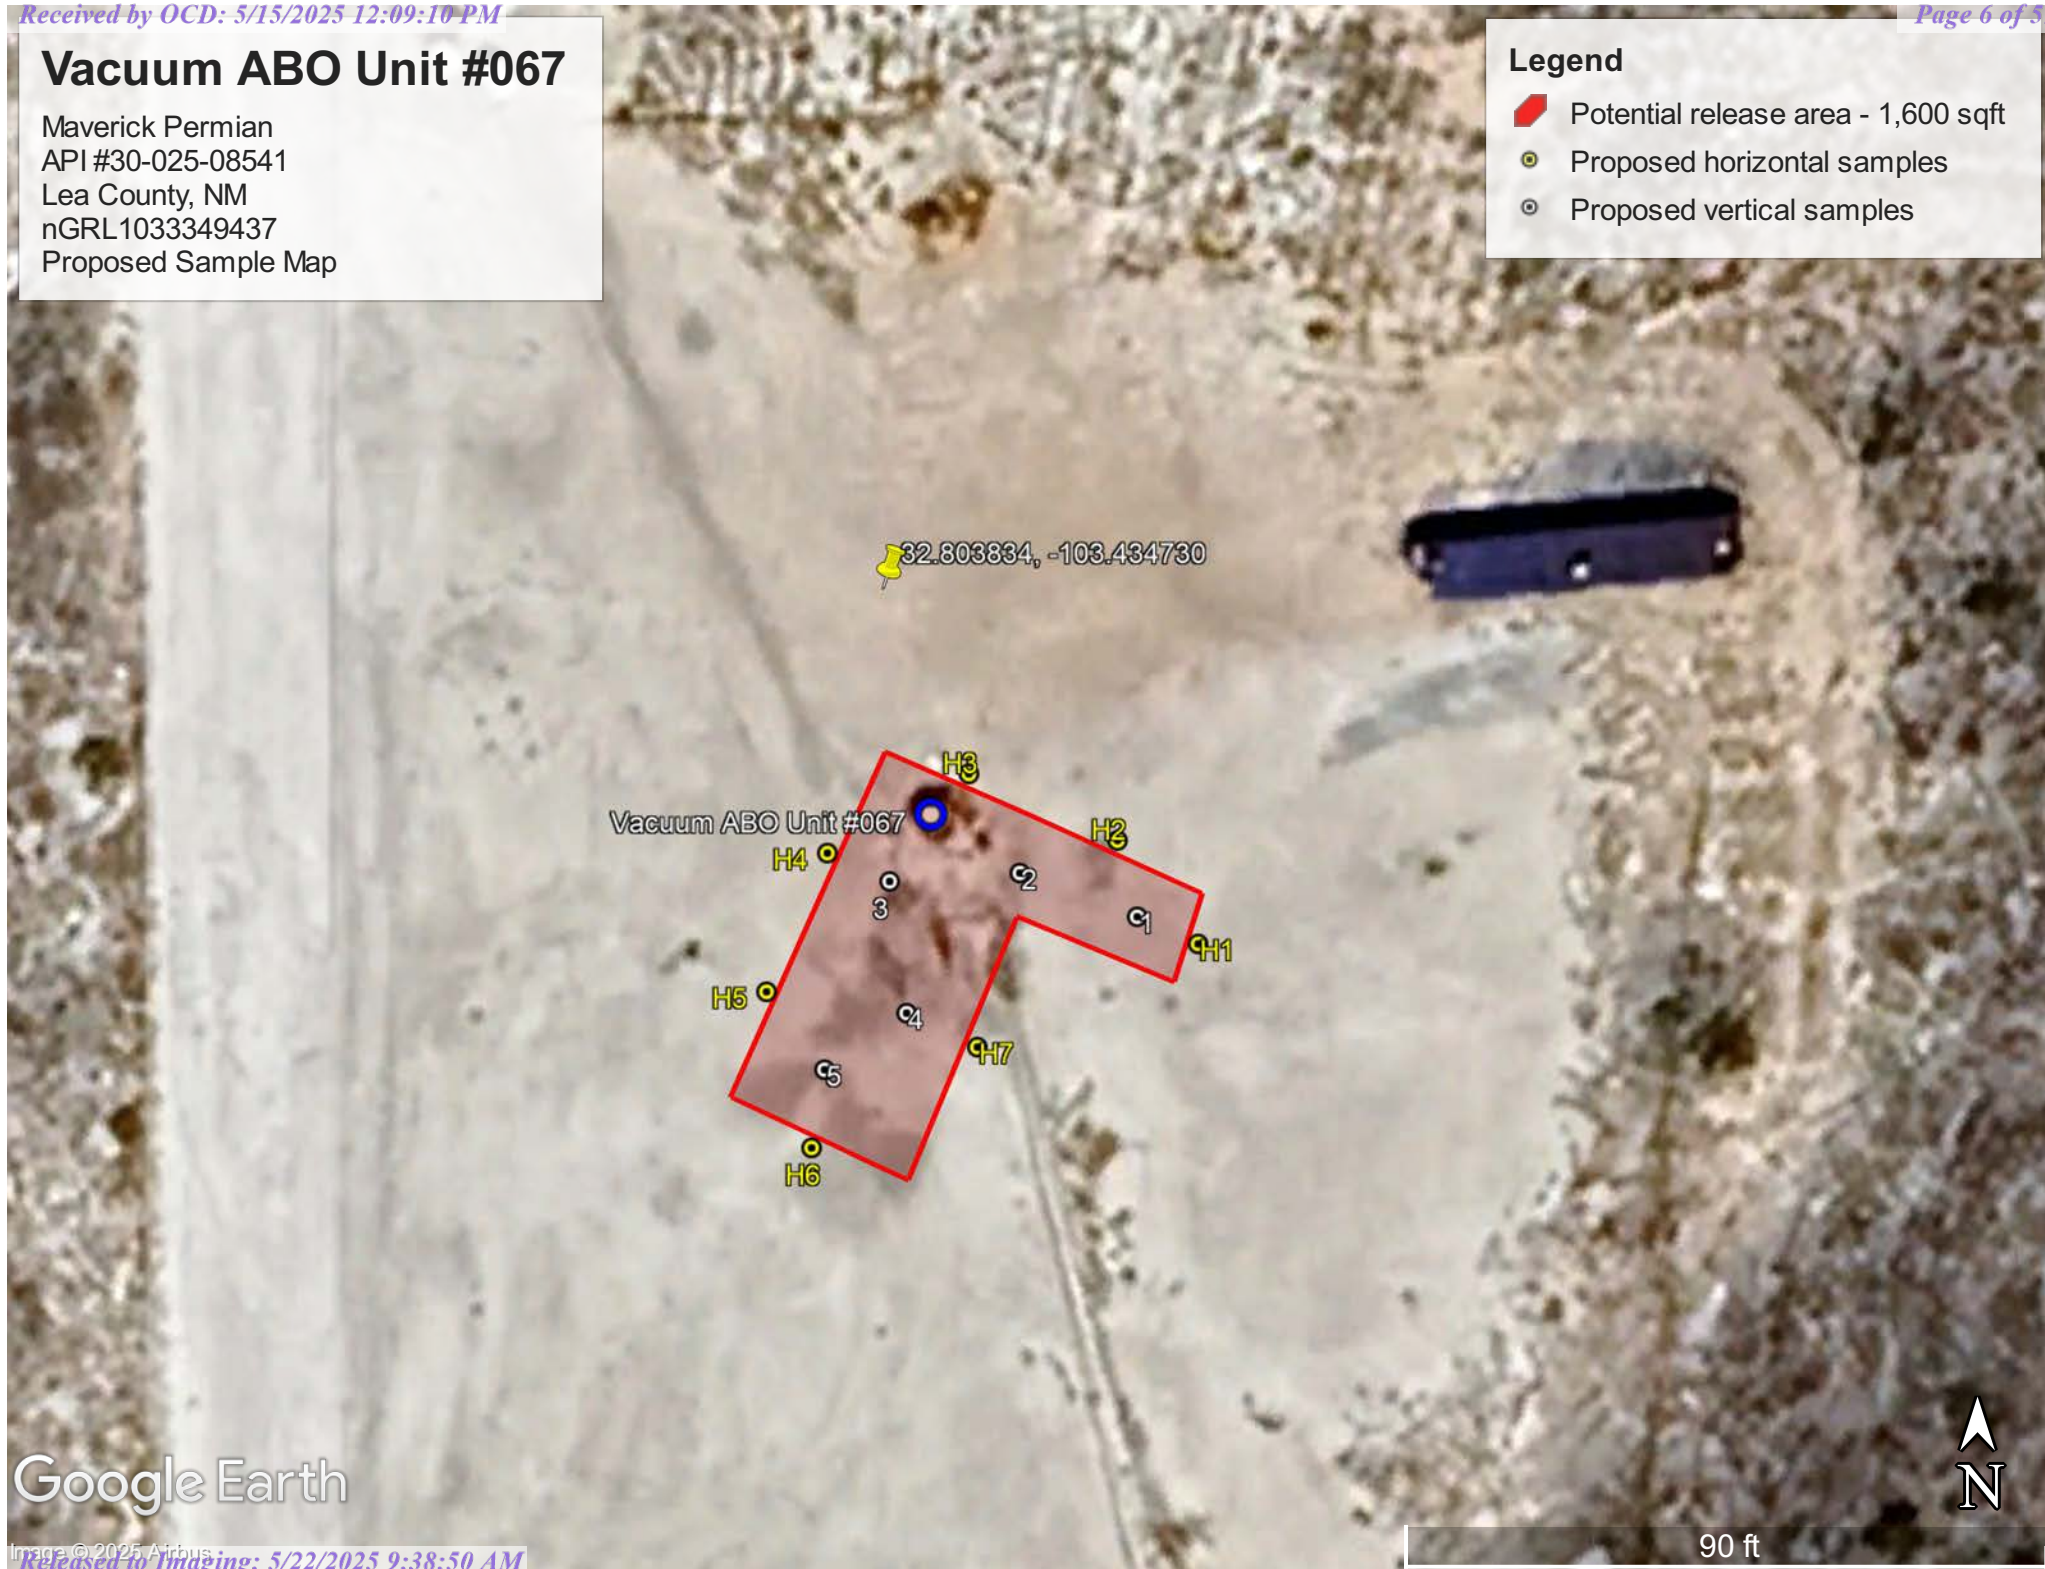
Maverick Permian
API #30-025-08541
Lea County, NM
nGRL1033349437
Proposed Sample Map

- The area of concern measures approximately 1,600 square feet and is solely on the pad surface.
- Collect discrete samples from within and around the edges of the release area to evaluate the presence of contaminants. Twenty-five (25) samples will be collected from 5 different sample points within the release area from depths of surface, 1', 2', 3', and 4' bgs. Thirty-five (35) samples will be collected from 7 different sample points around the edges of the release area from depths of surface, 1', 2', 3', and 4' bgs.

Potential release area - 1,600 sqft
-

Proposed horizontal samples
-

Proposed vertical samples

- A 48-hour sampling notification will be issued to the NMOCD for these sampling events. A variance request is included below for permission to use the delineation samples as confirmations samples depending on the sample results of the soil. A Proposed Sample Map can be found in Figure 1.

- If any samples do not verify delineation, then the "step-out" method will be used for horizontal delineation samples until sample results can confirm delineation. Also, for vertical delineation samples, any samples not verifying delineation will be advanced deeper until sample results can confirm delineation.

- Sample results that are over the regulatory limits of the less than 50-foot to groundwater section of Table 1 will be measured for total area and affected volume then removed via mechanical excavation means. The contaminated soil will be hauled to an NMOCD-approved disposal facility and clean, like material will be brought to the Site for backfilling the excavated area.

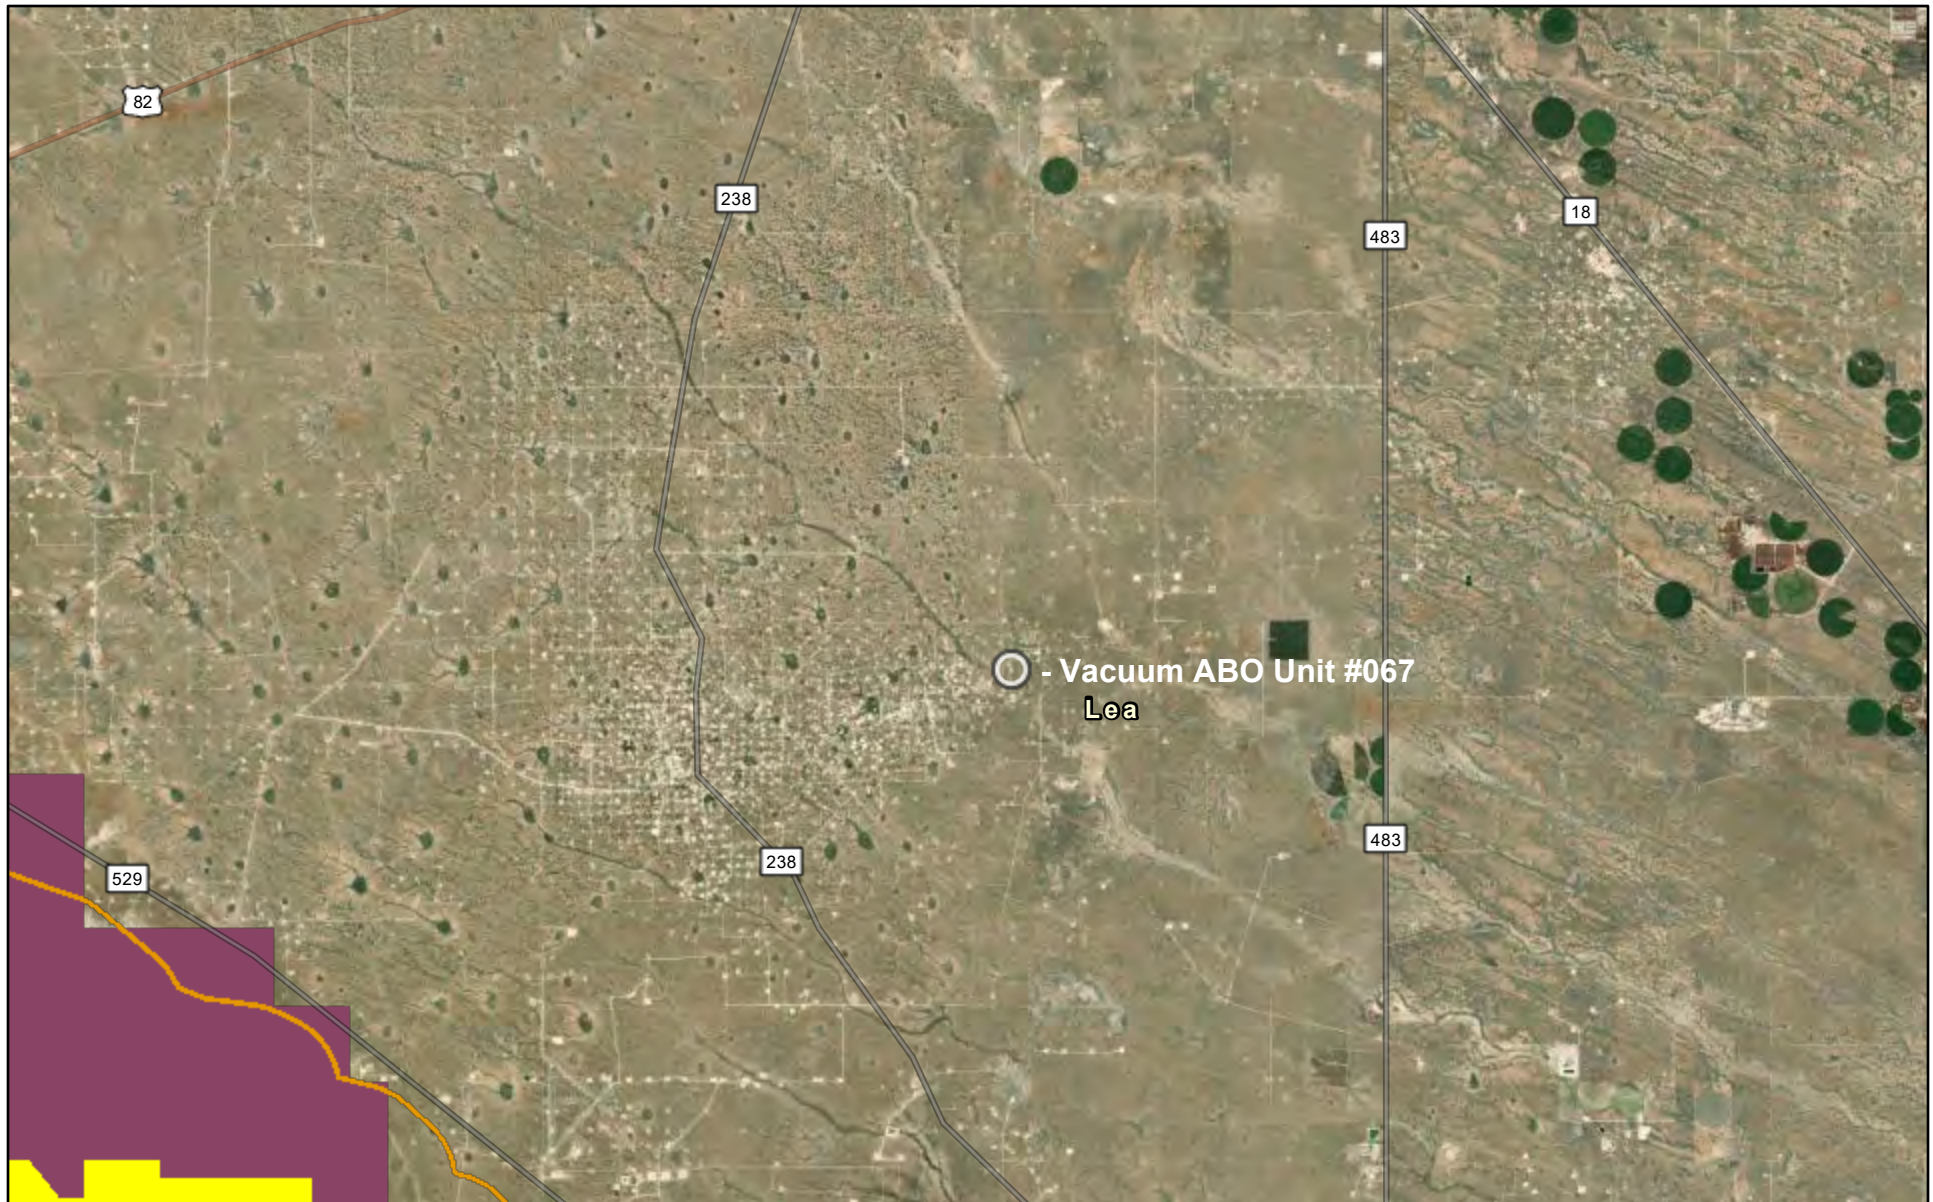
Readily available data were reviewed to determine if the Site lies within biologically sensitive areas. The U.S. Fish and Wildlife Services (USFWS) Information for Planning and Consultation (IPaC) and the New Mexico Department of Game and Fish (NMDGF) Environmental Review Tool (ERT) were queried to determine if sensitive wildlife or plant areas are present at the Site. The Site is not identified to be within biologically sensitive areas where remediation/reclamation would impact sensitive plant habitats. A Special Status Plant/Wildlife Map is included in Figure 2.

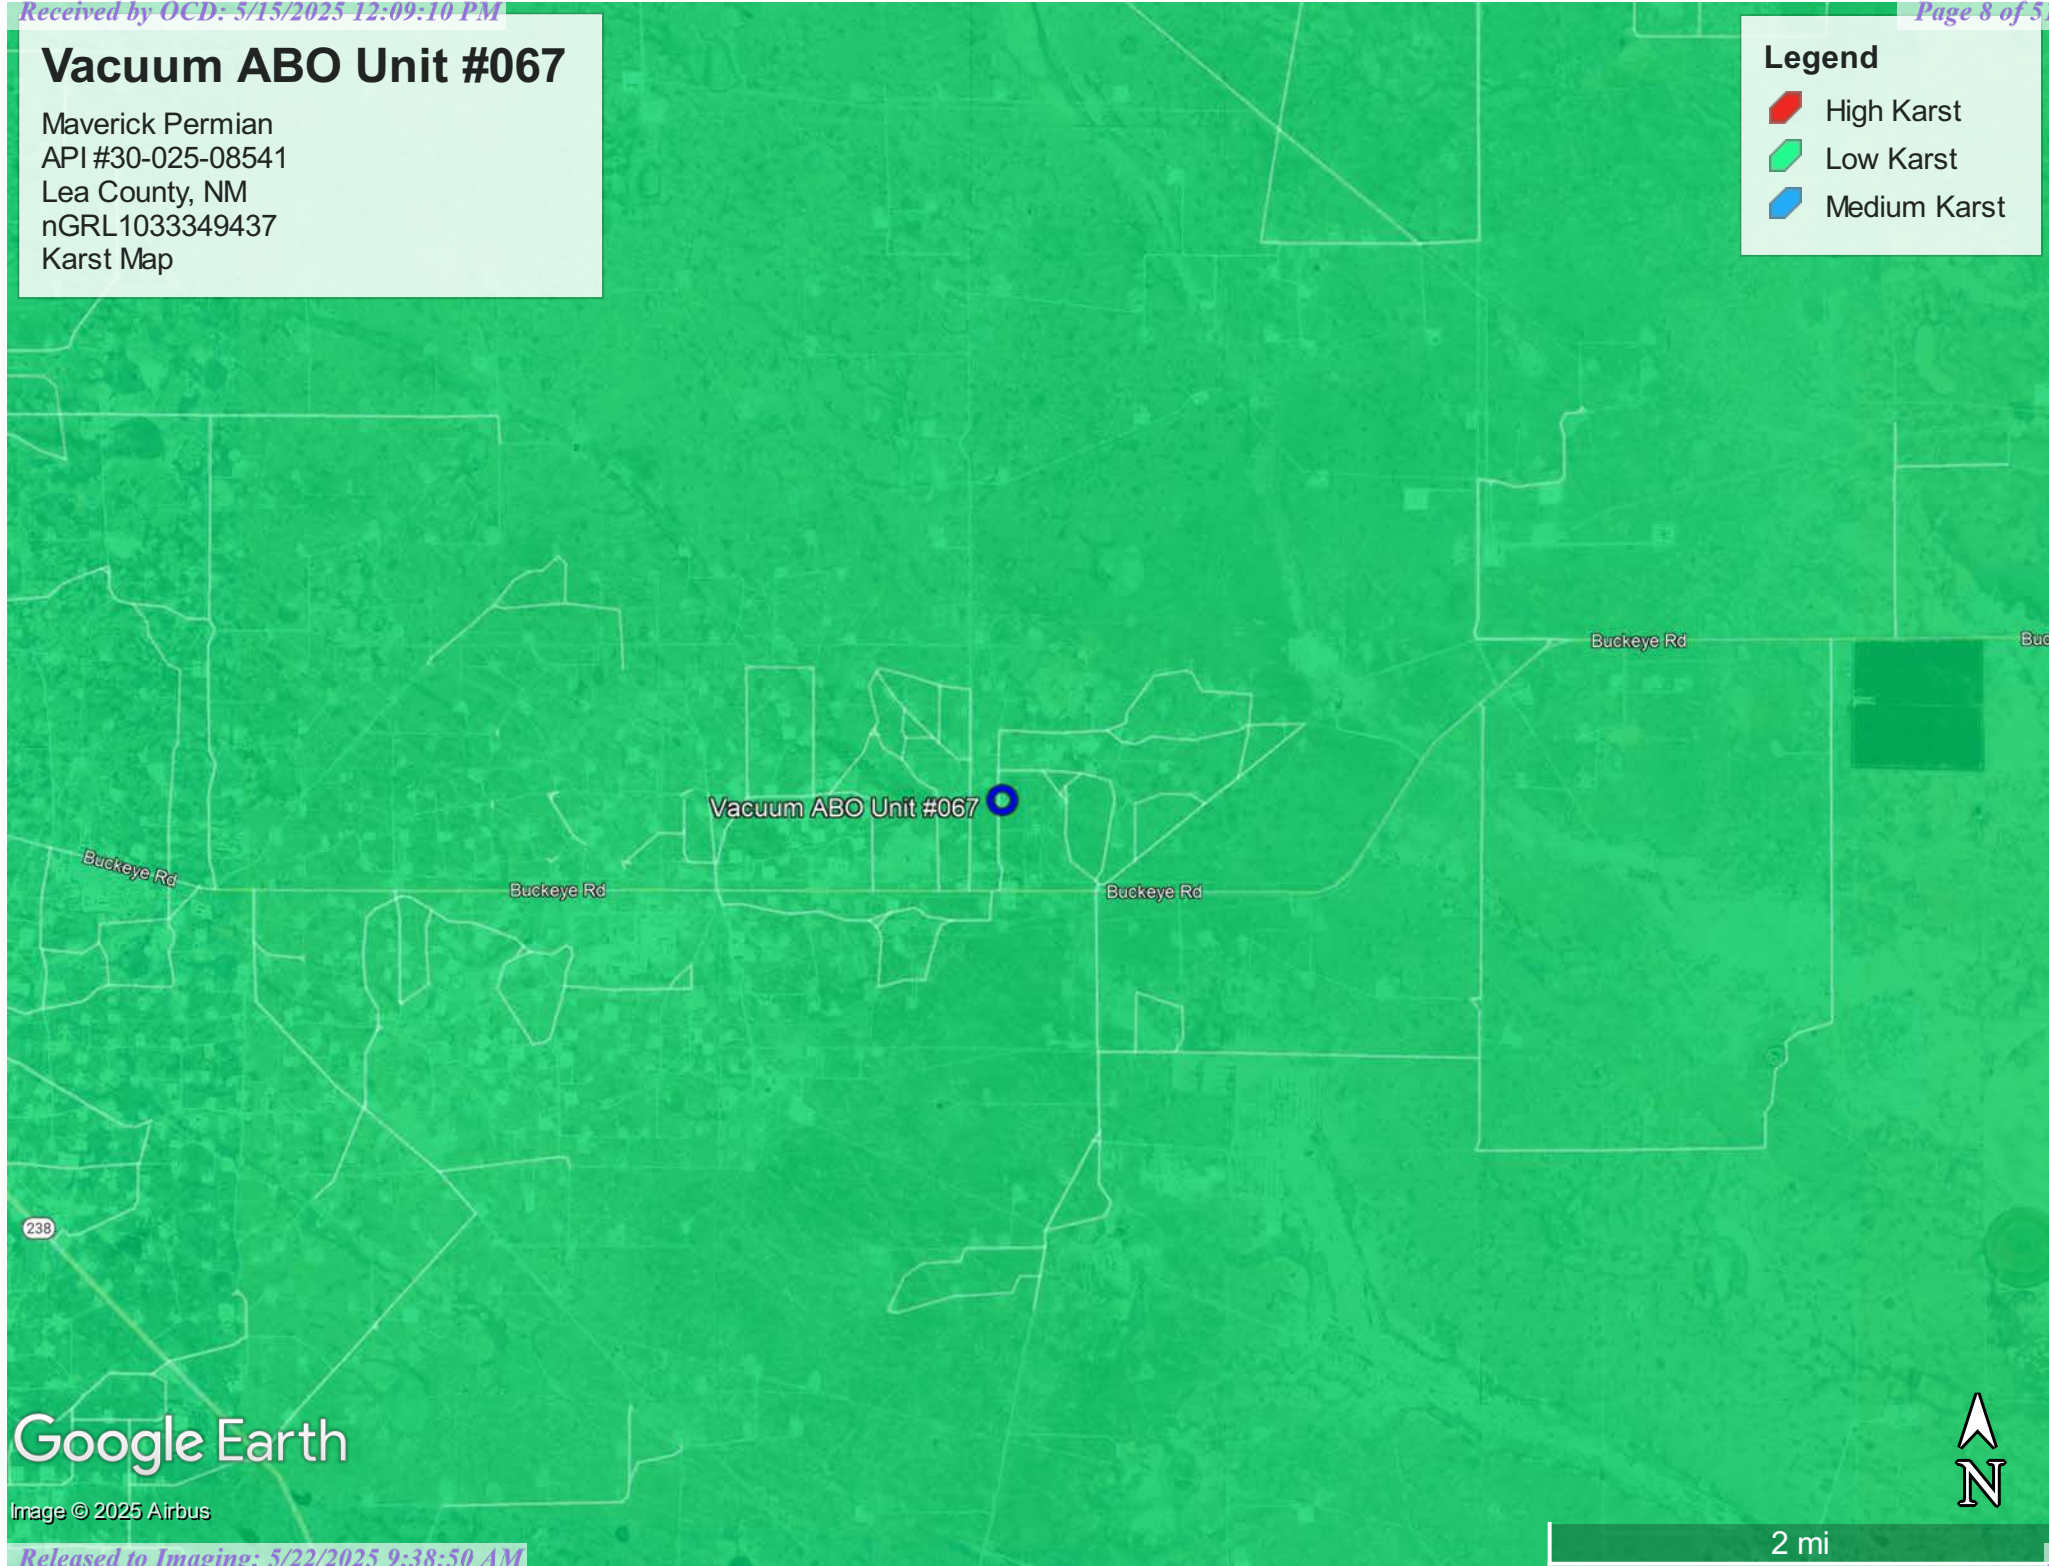
Maverick Permian
API #30-025-08541
Lea County, NM
nGRL1033349437
Karst Map

The Site resides in a low karst zone and is approximately 28.16 miles away from the nearest medium karst zone. Figure 3 refers to the Karst Map.

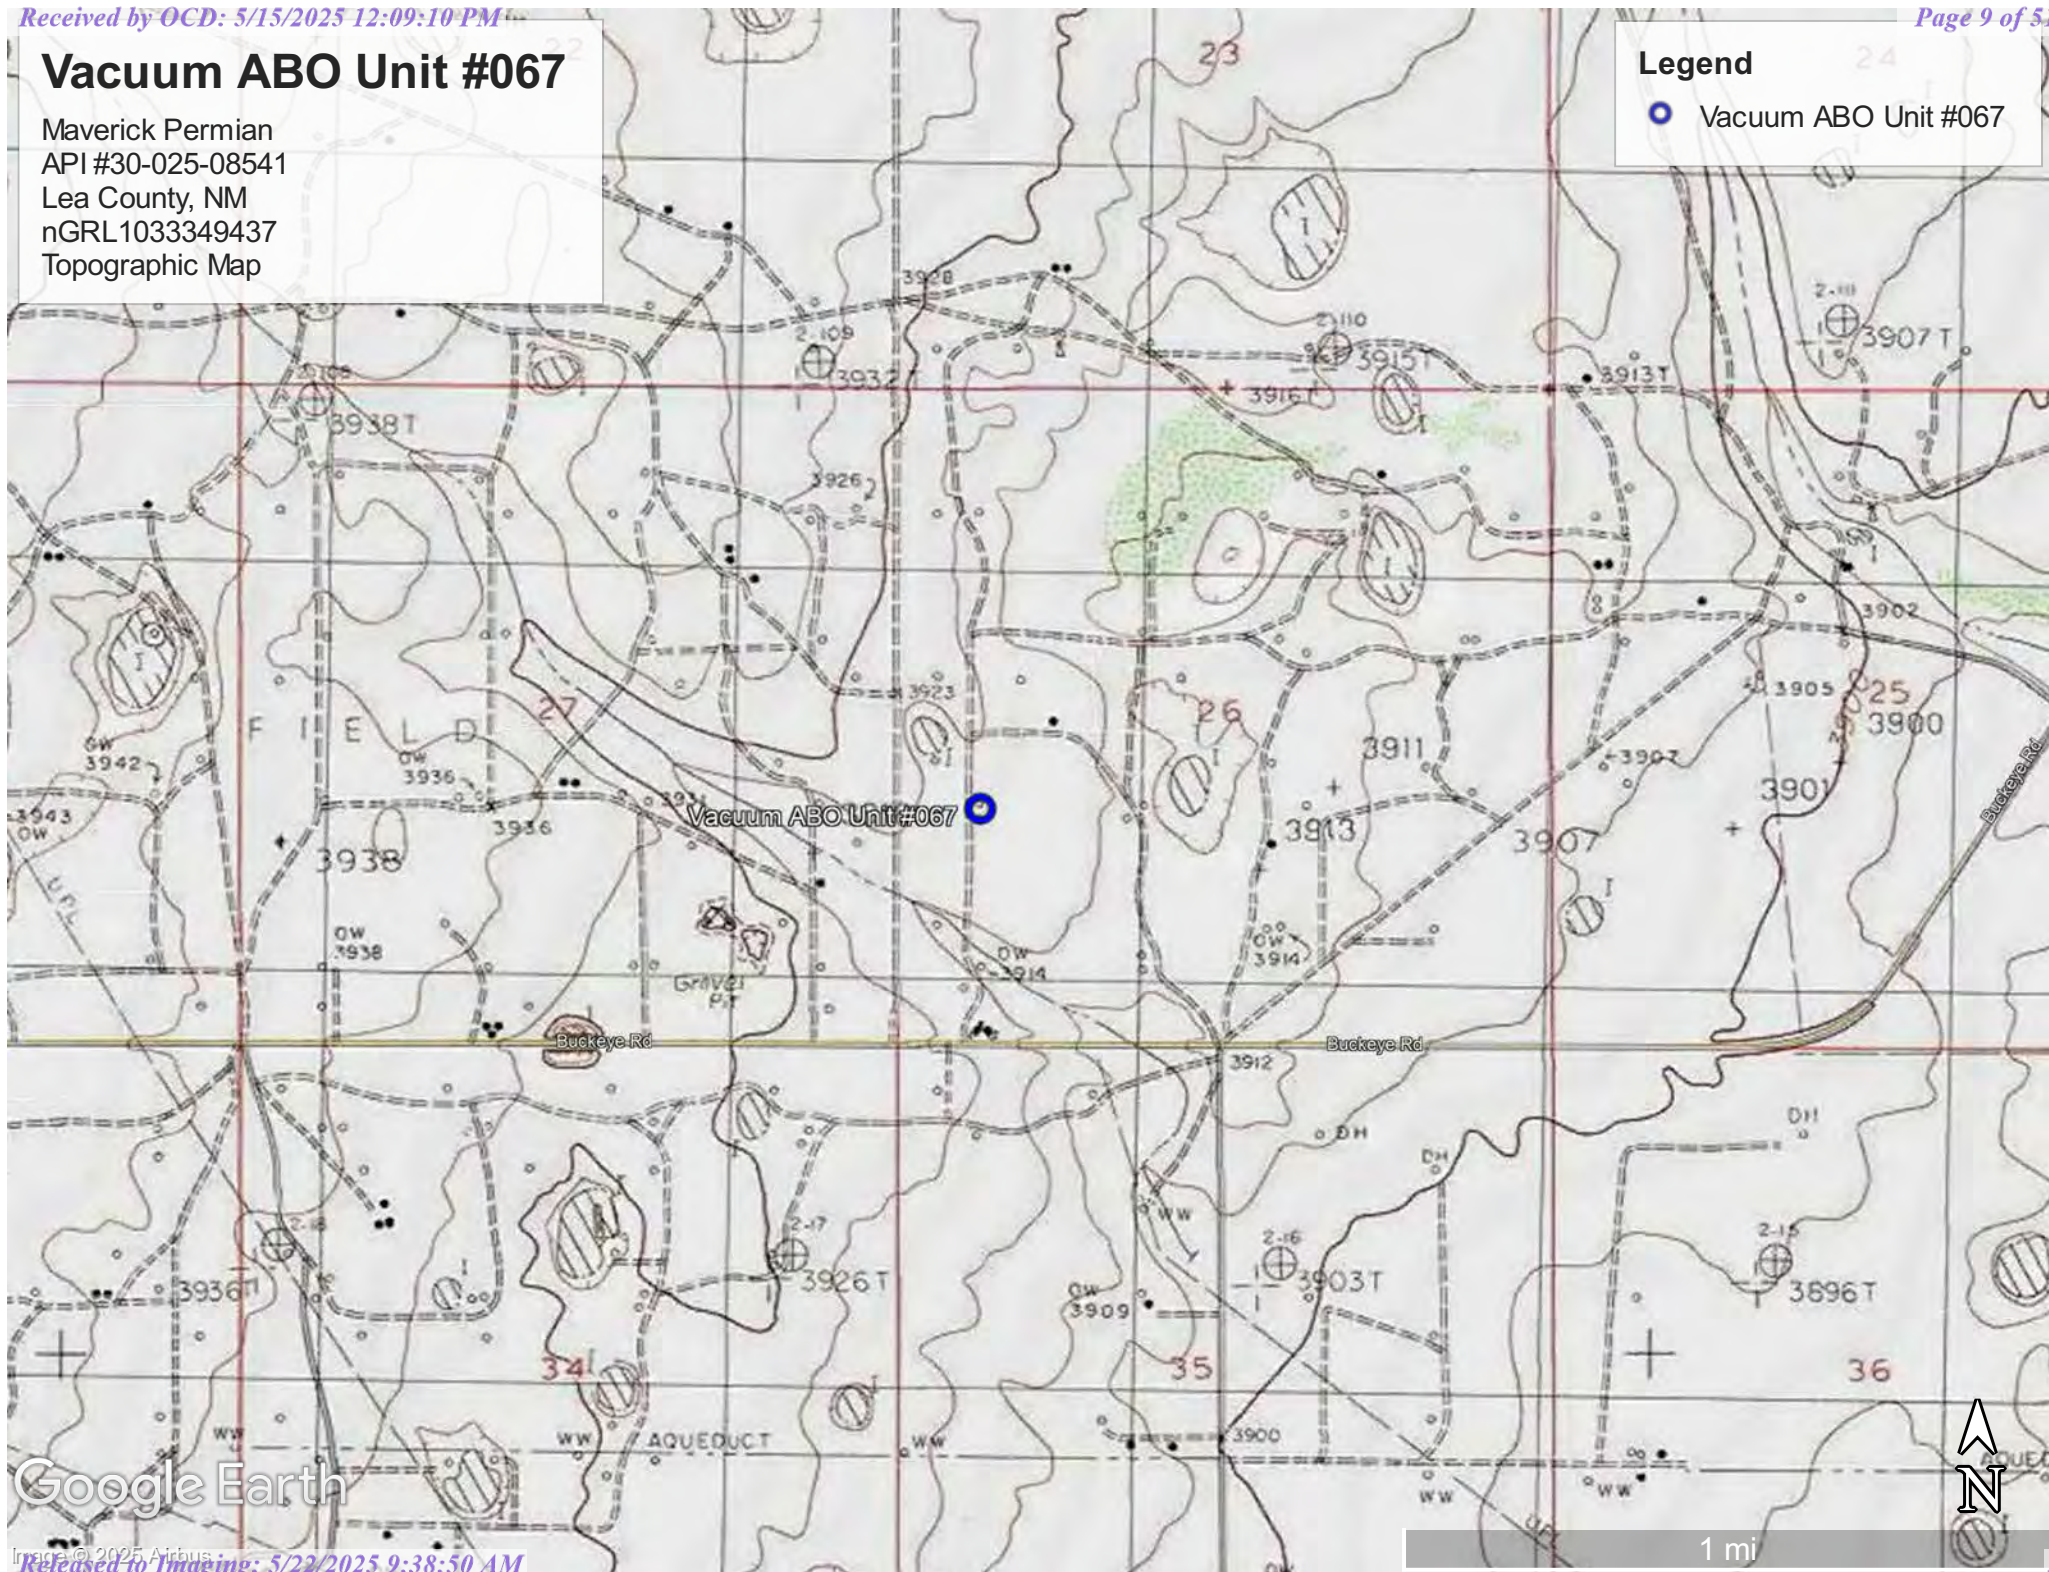
Maverick Permian
API #30-025-08541
Lea County, NM
nGRL1033349437
Topographic Map

The soil type present at the Site is Kimbrough-Lea complex, dry, 0 to 3 percent slopes. The drainage class for this soil type is well drained. Soil type information is according to the United States Department of Agriculture Natural Resources Conservation Service soil survey. The Soil Survey and a Soil Map can be referenced in Appendix C. Reference Figure 4 for a Topographic Map.

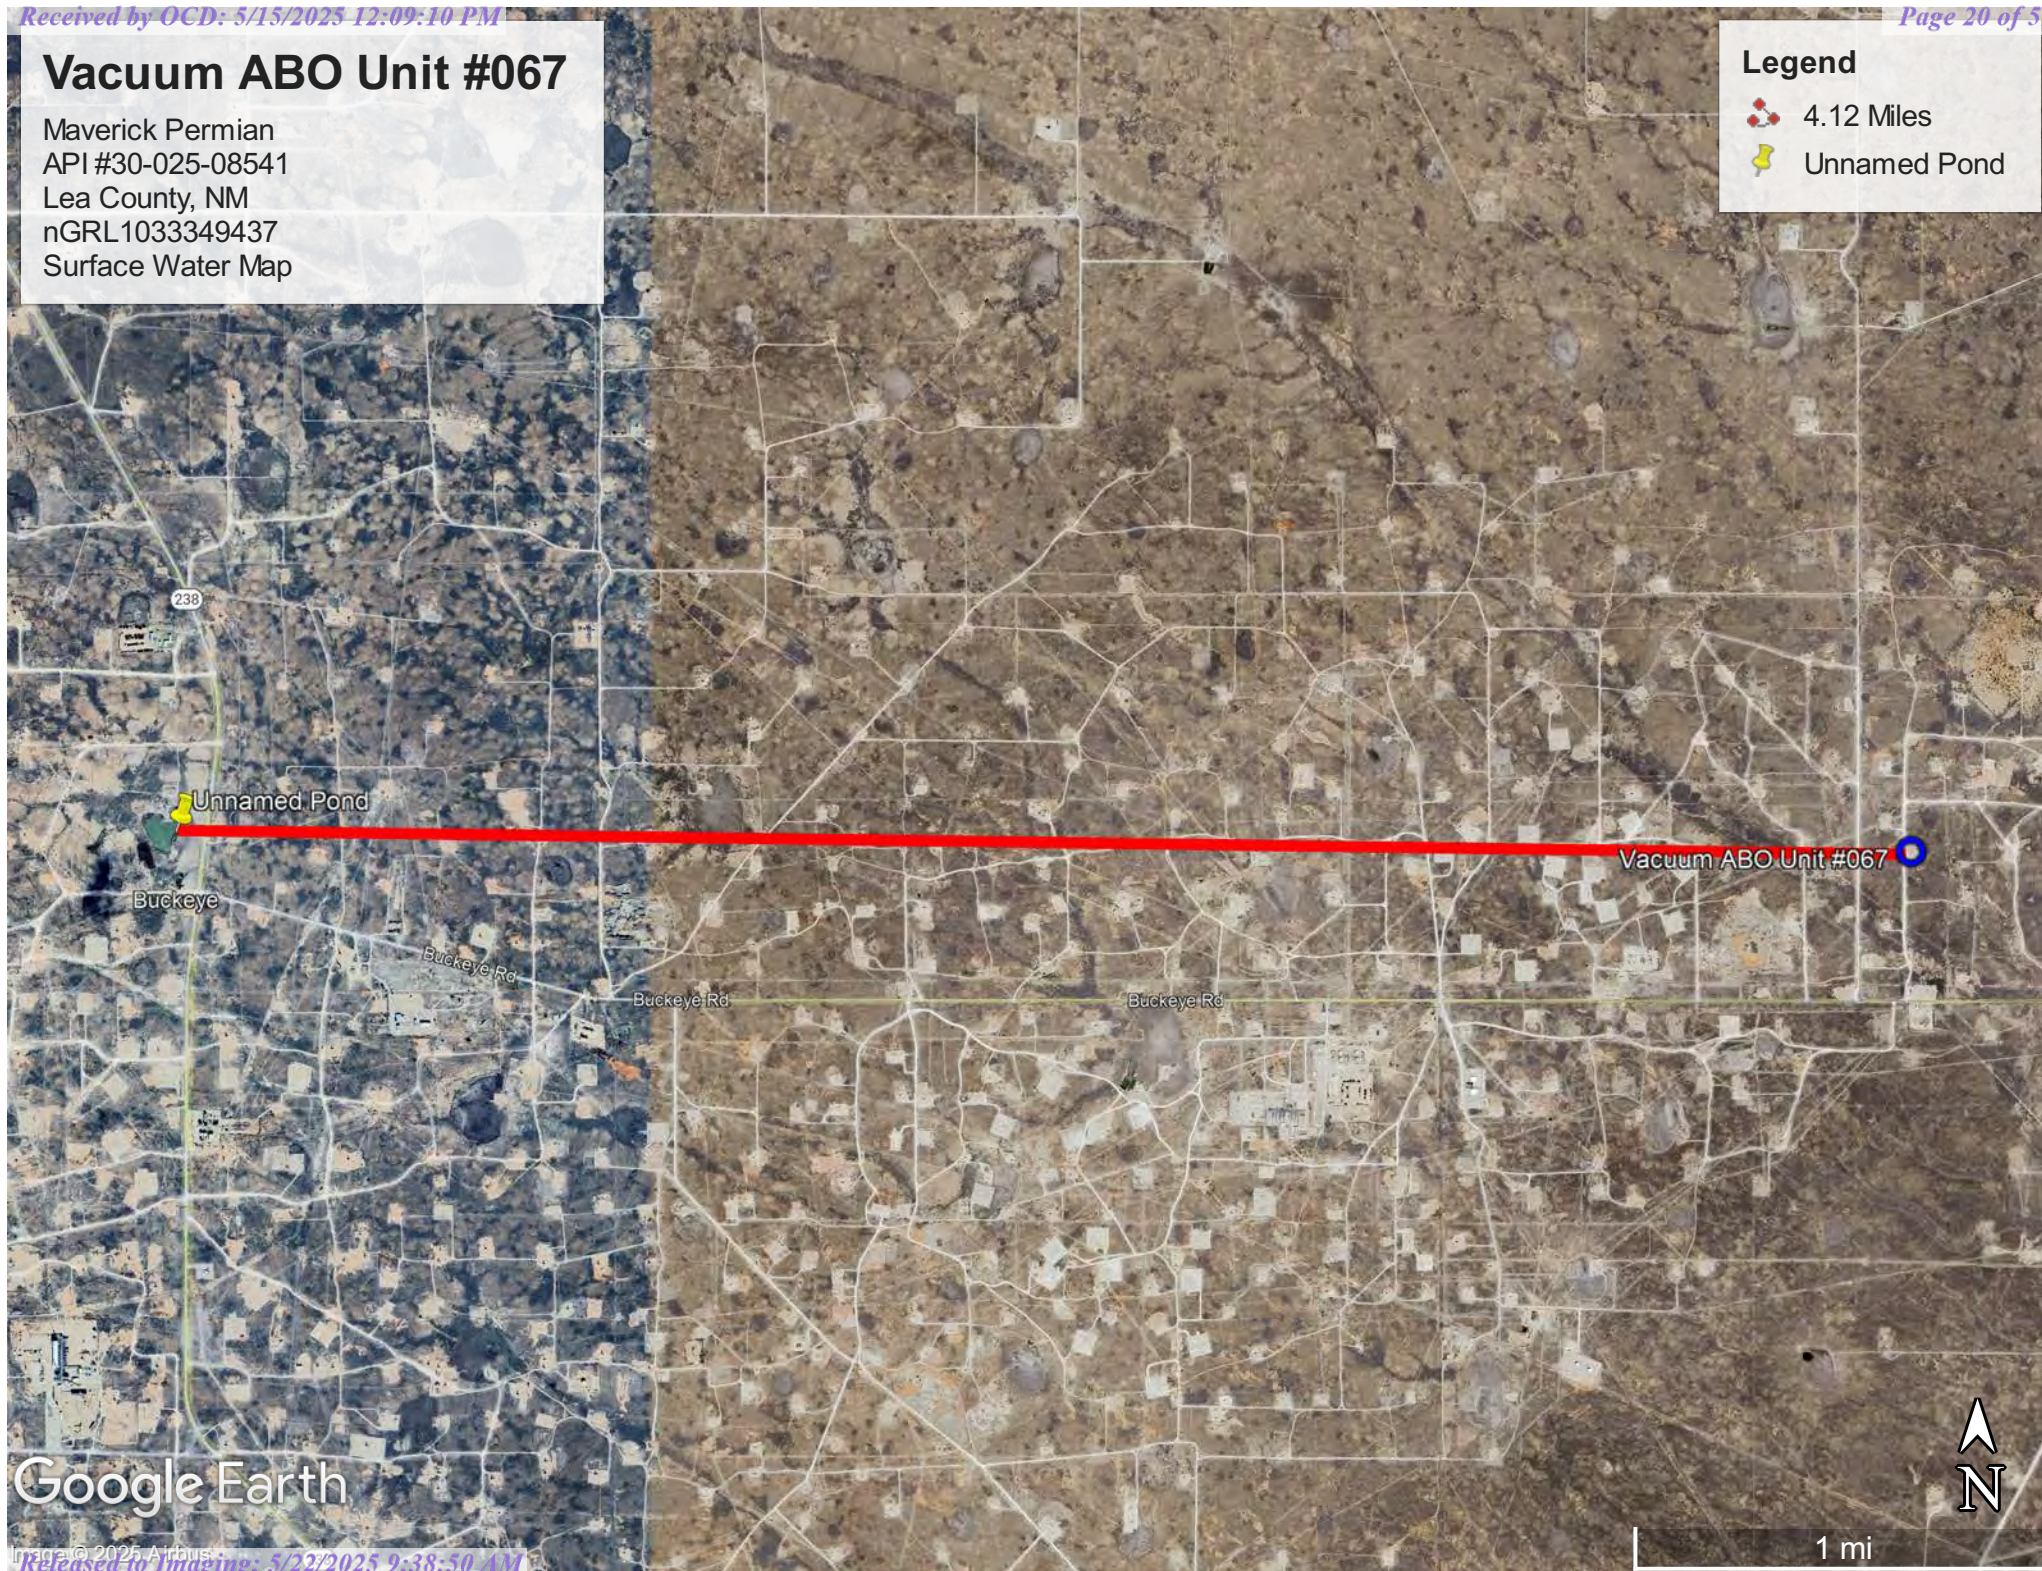
Maverick Permian
API #30-025-08541
Lea County, NM
nGRL1033349437
Surface Water Map

The nearest surface water feature is an Unnamed Pond, and it is located approximately 4.12 miles to the west. The U.S. Fish and Wildlife Service National Wetlands Inventory shows the nearest wetland to be a Riverine approximately 0.16 miles southwest. According to Fema's National Flood Hazard Layer search, the Site is situated in Zone D – Area of Undetermined Flood Hazard and is greater than 5 miles away from the nearest flood hazard zone. See Appendix B for referenced Water Surveys and Water-Related Maps.

- 4.12 Miles
- Unnamed Pond
