**FLOWLINE SUPPLYING REMUDA BASIN SWD**

Incident ID nAPP2213647597

## *Reclamation Report*

**RE: Reclamation Report**  
**Flowline Supplying Remuda Basin SWD**  
**API No. N/A**  
**GPS: Latitude 32.2982665 Longitude -103.9132046**  
**ULSTR – P – 18 – 23S – 30E 200 FSL 327 FEL Eddy County,**  
**NM NMOCD Incident ID nAPP2213647597**

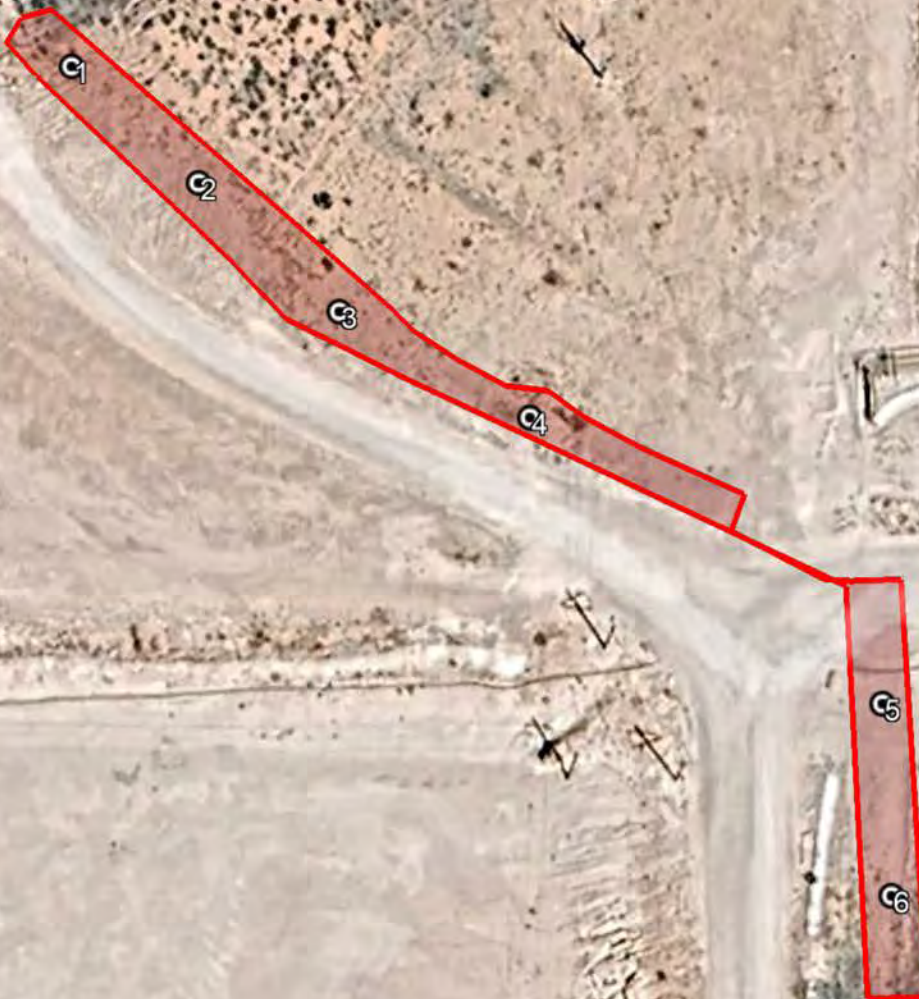
Figure 7- Backfill Sample Map

On May 9, 2025, an analytical report was received and verified that all sample results are under the regulatory limits of the less than 50-foot depth to groundwater section of Table 1, ensuring compliance with 19.15.29.13 NMAC. The laboratory results of this sampling event can be found in the Data Tables included in Figure 1. A corresponding Backfill Sample Map can be referenced in Figure 7. Complete Laboratory Reports are included in Appendix E.

Devon Energy  
Eddy County, NM  
nAPP2213647597  
Backfill Sample Map

Backfill Area - 8,375 sqft
-

Backfill samples

On May 1, 2025, Pima personnel returned to the site to collect samples from backfilled areas. A total of 12 discreet samples were collected from 6 different sample points from depths of surface and 1' bgs. After being collected, the samples were immediately put on ice, jarred, and delivered to Envirotech Labs for official analysis of all constituents listed in Table 1 19.15.29.12 NMAC.

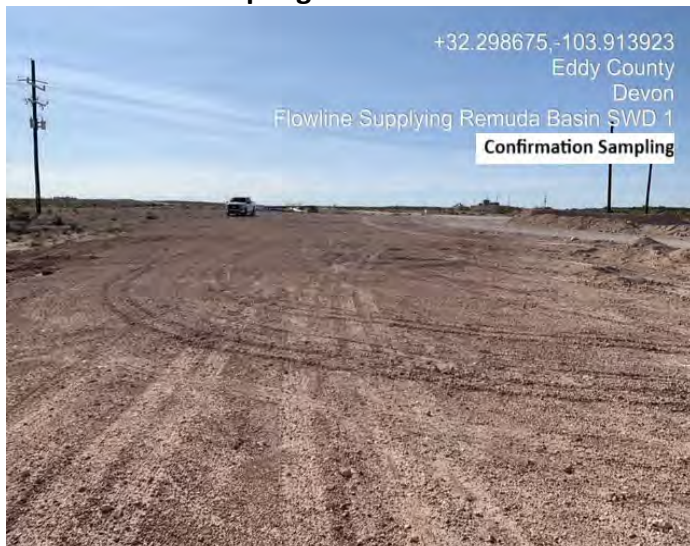
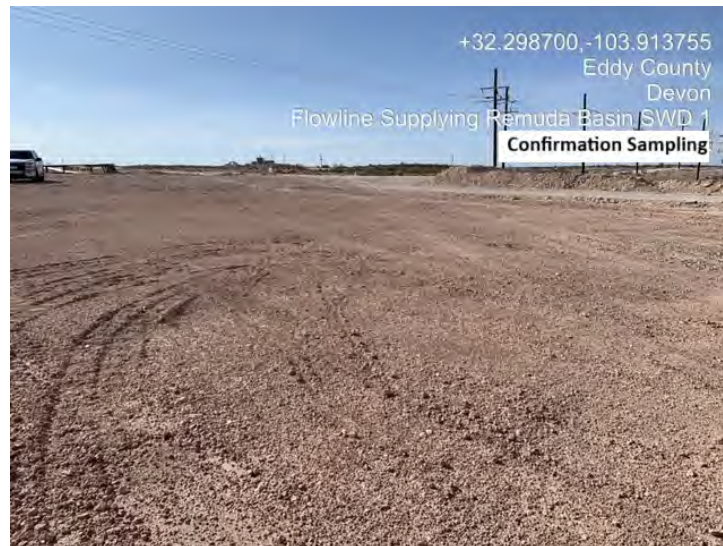
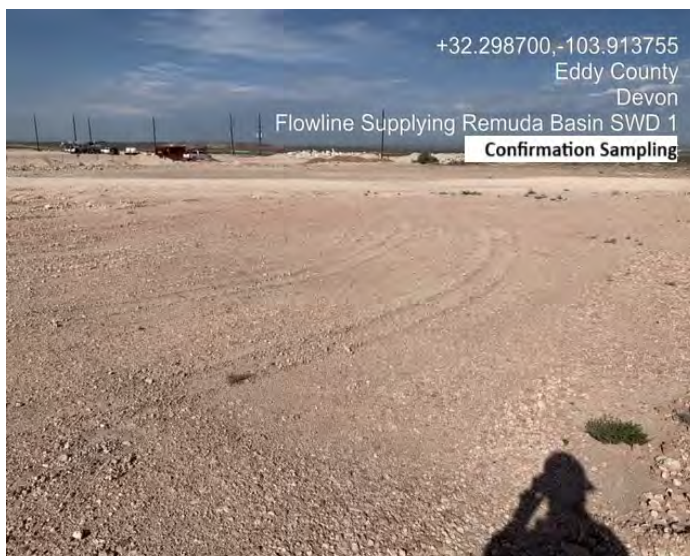
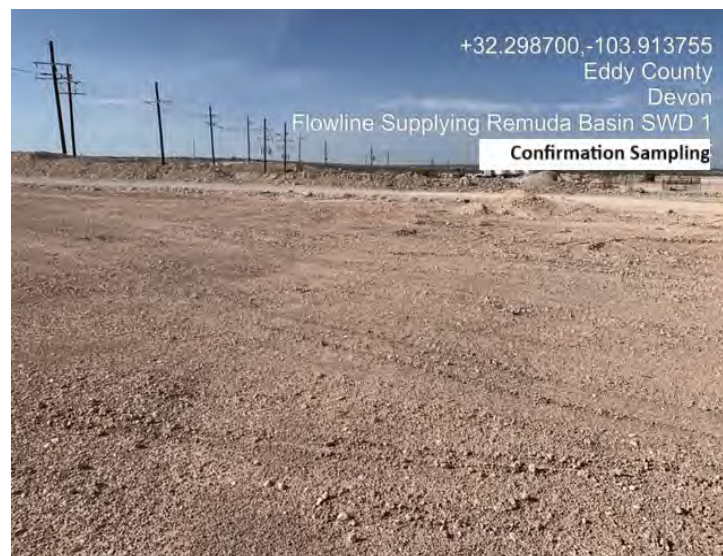
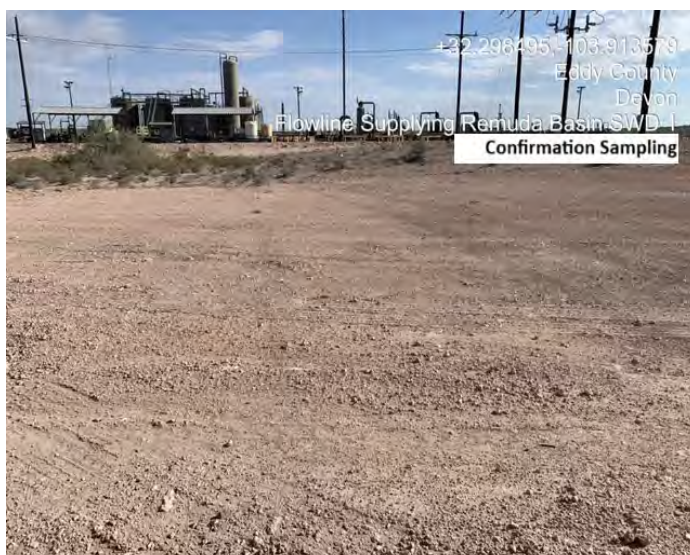
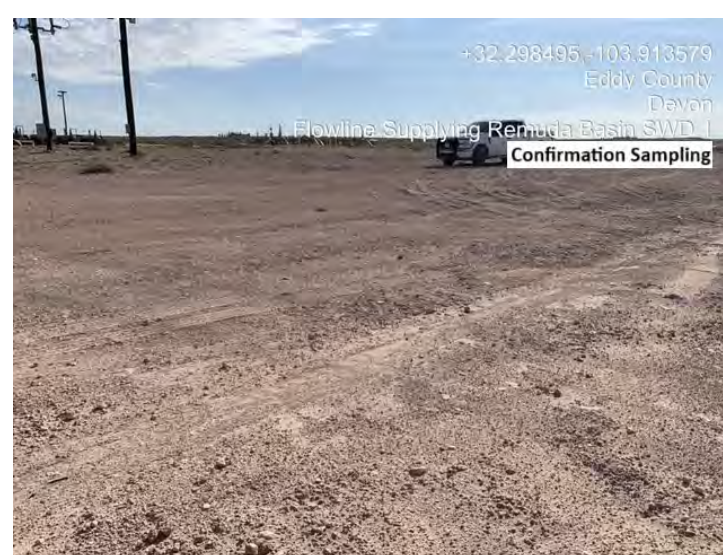
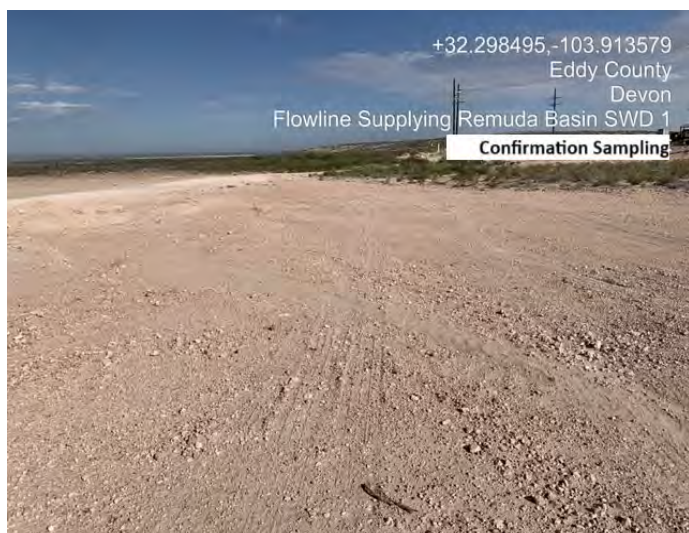
## Confirmation Sampling Event

View from North to South

View from Northeast to Southwest

View from Southeast to Northwest

View from East to West

View from South to North

View from West to East
