RECLAMATION REPORT

PREPARED FOR:
DEVON ENERGY PRODUCTION, LP.

PREPARED BY:
PIMA ENVIRONMENTAL SERVICES, LLC.

RE: Reclamation Report
LOCATION: Cotton Draw Unit 153 CTB
FACILITY ID: fAPP2128034967
GPS (NAD83): 32.166344, -103.764914
INCIDENT LOCATION: B-3-T25S-R31E
COUNTY: Eddy
NMOCD REF. NO. nAPP2316355602

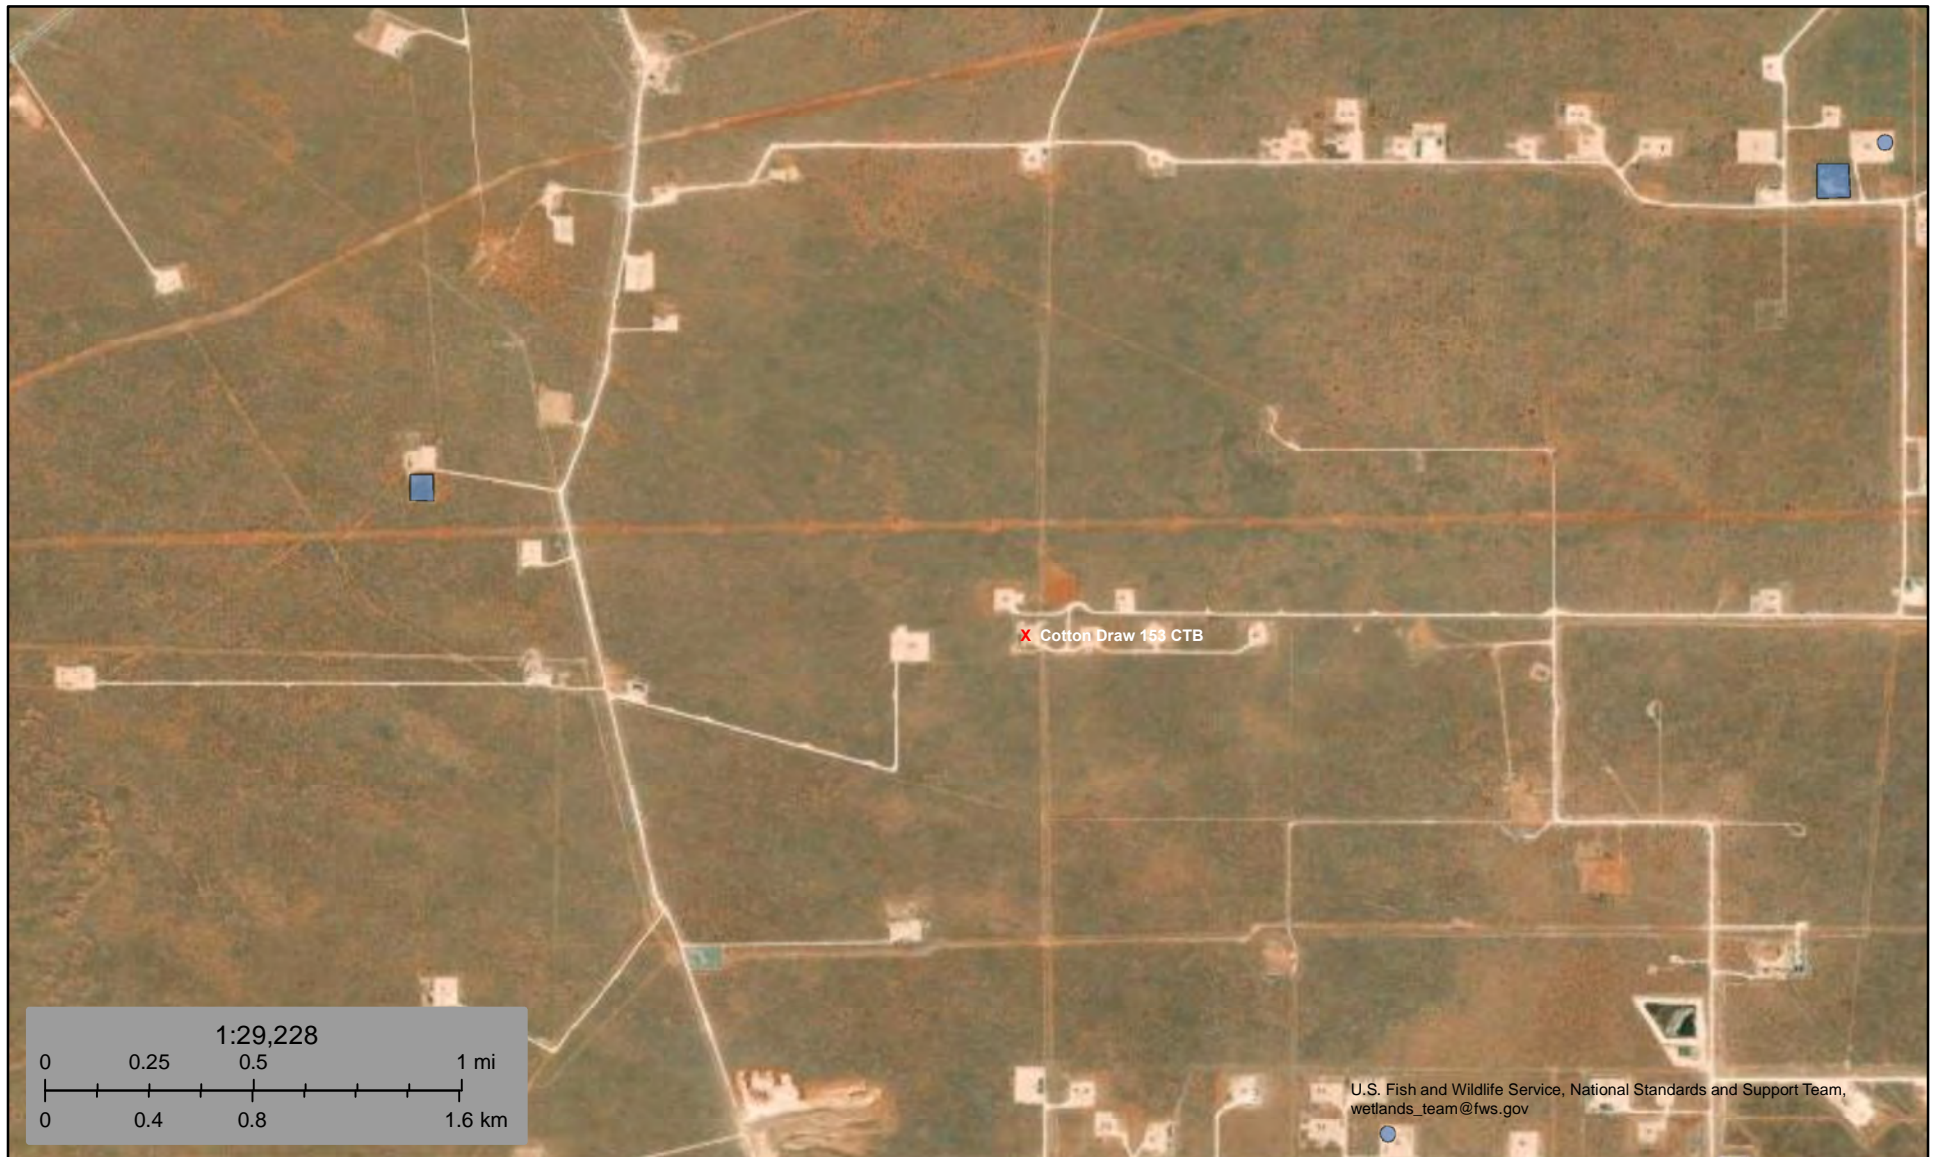
Wetlands Map

According to the U.S. Fish and Wildlife Service National Wetlands Inventory, a Freshwater Pond lies approximately 1.24 miles to the west of the release area. According to a FEMA search for flood hazard information, the Cotton is in Zone X – Area of Minimal Flood Hazard.
