RE: **RDX Federal 21 #022 - Deferral Request Report**

Incident Number: nAPP2506224384

Project No. VP-63

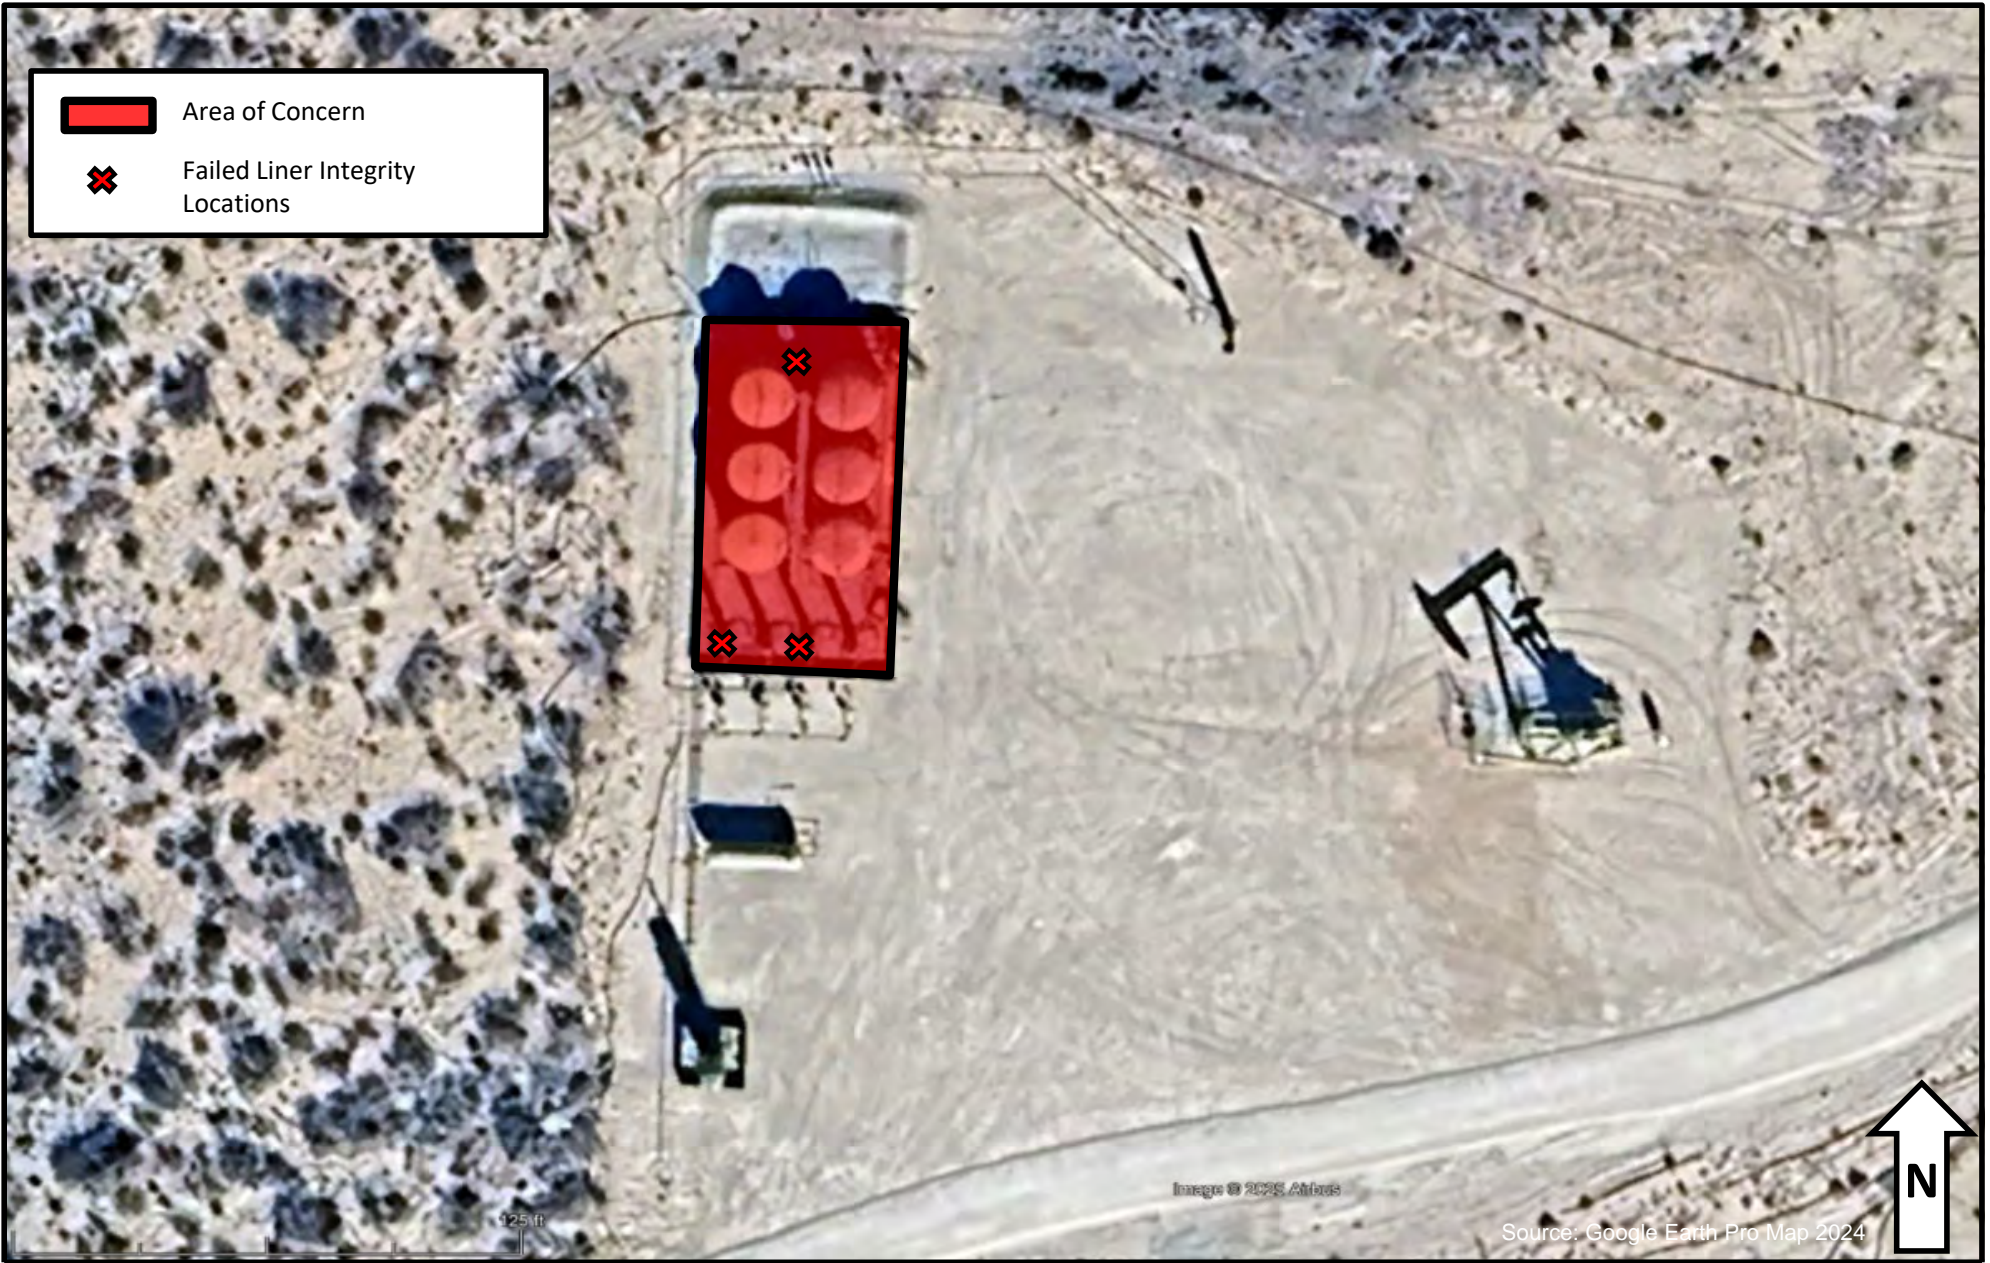
**Figure 2 – Release Extent**

On March 2, 2025, a water transfer pump failed, releasing approximately 67 barrels (bbls) of produced water within a LSC (**Figure 2**). A vacuum truck was immediately dispatched to the Site recovering the 67 bbls of produced water.

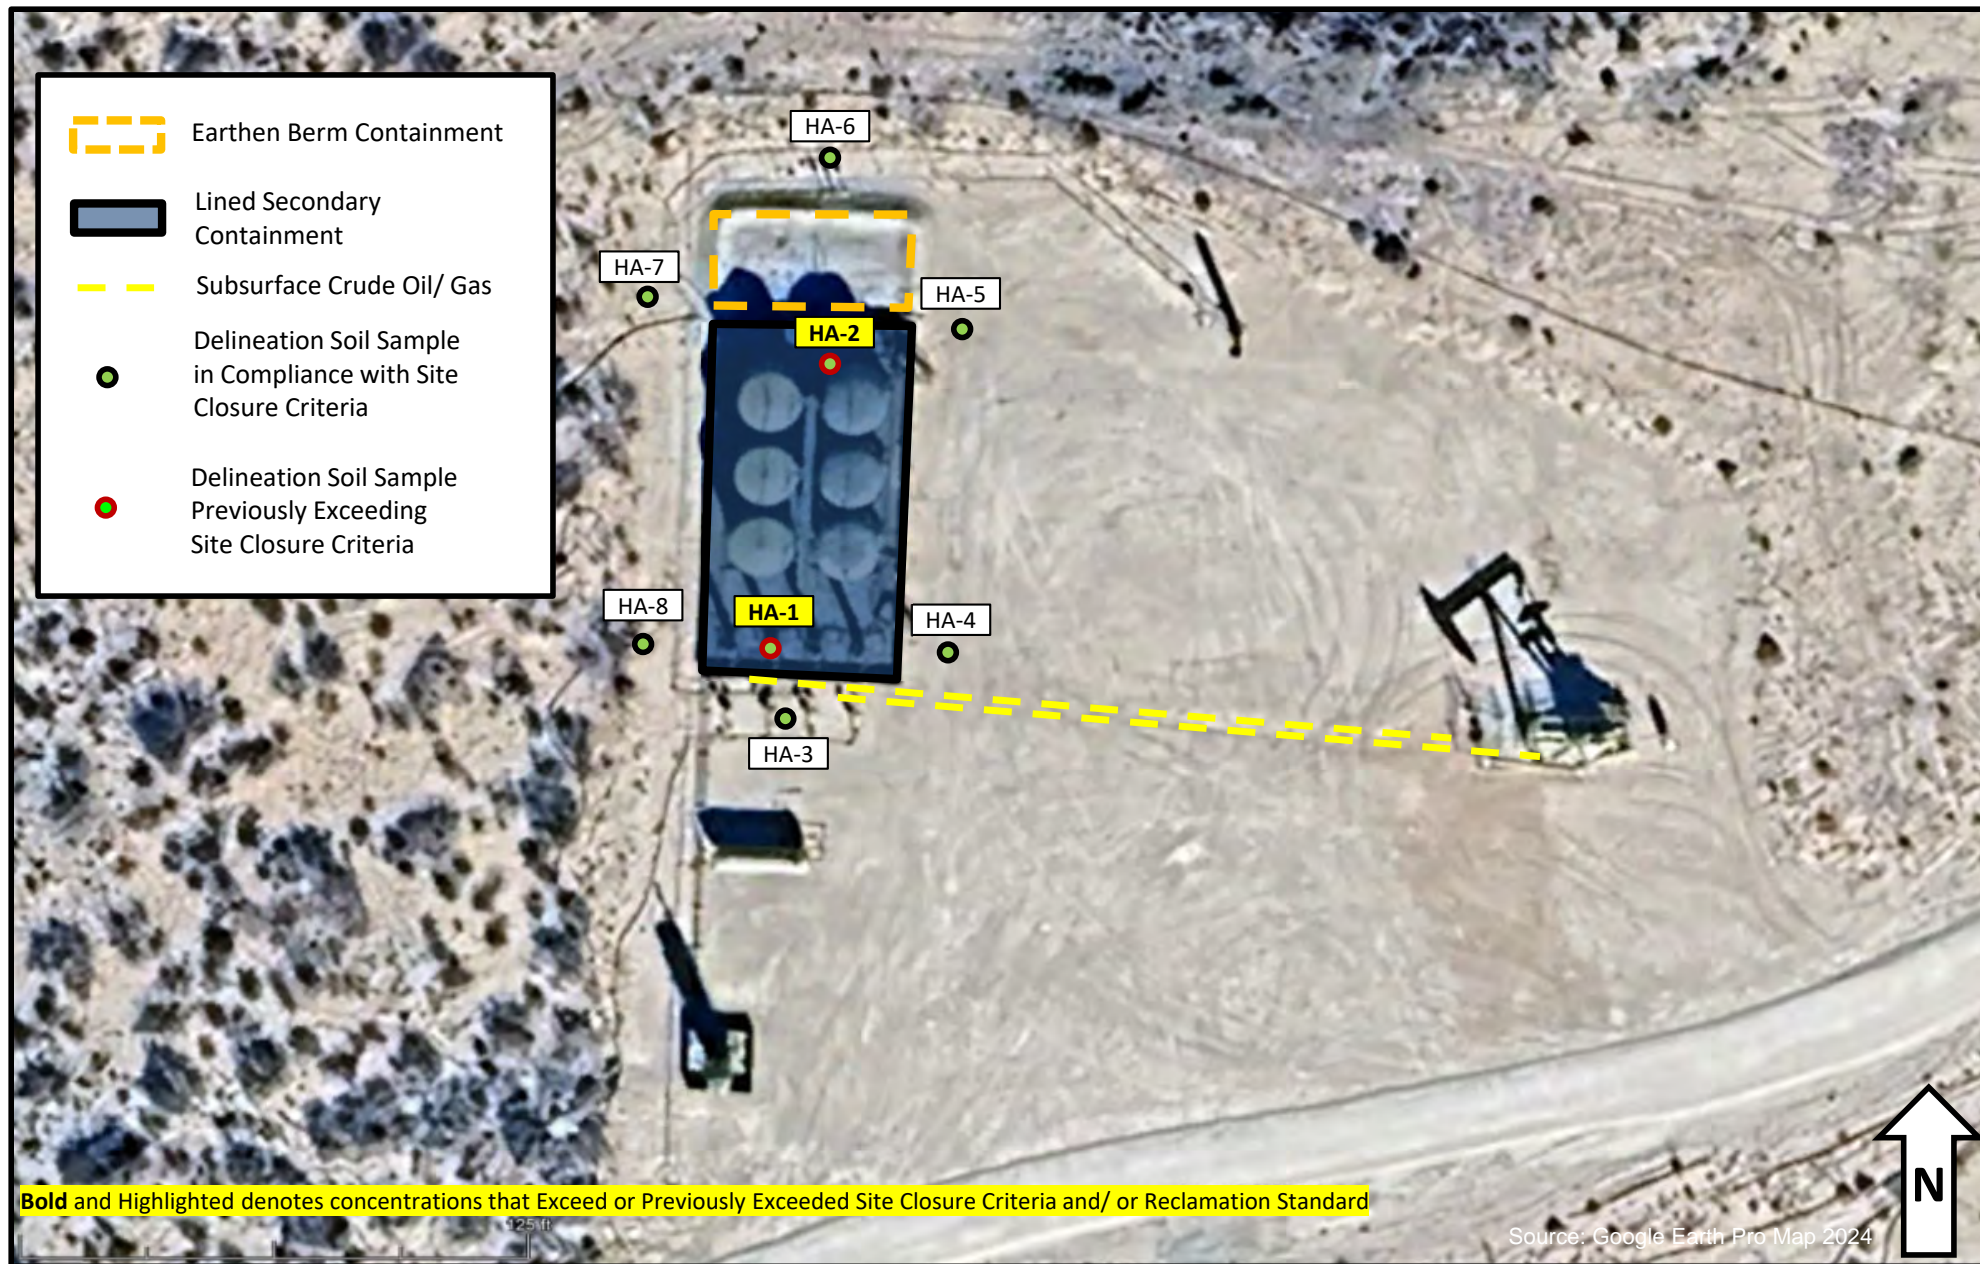
**Figure 5 – Delineation Soil Sample Locations**

Laboratory analytical results for delineation soil samples collected surrounding the AOC (HA-3 through HA-8) were compliant with Site Closure Criteria and/or the reclamation standard defining the horizontal periphery of the AOC.

Laboratory analytical results for delineation soil samples collected within the AOC and directly beneath the LSC (HA-1 and HA-2) indicated Chloride was above the Site Closure Criteria and/or the reclamation standard up to 4 feet bgs. Elevated Chloride concentrations were characterized by concentrations ranging from 1,930 mg/kg to 4,810 mg/kg. Laboratory results are summarized in **Table 1**, included in the attachments. The locations of all delineation soil samples are shown in **Figure 5**.

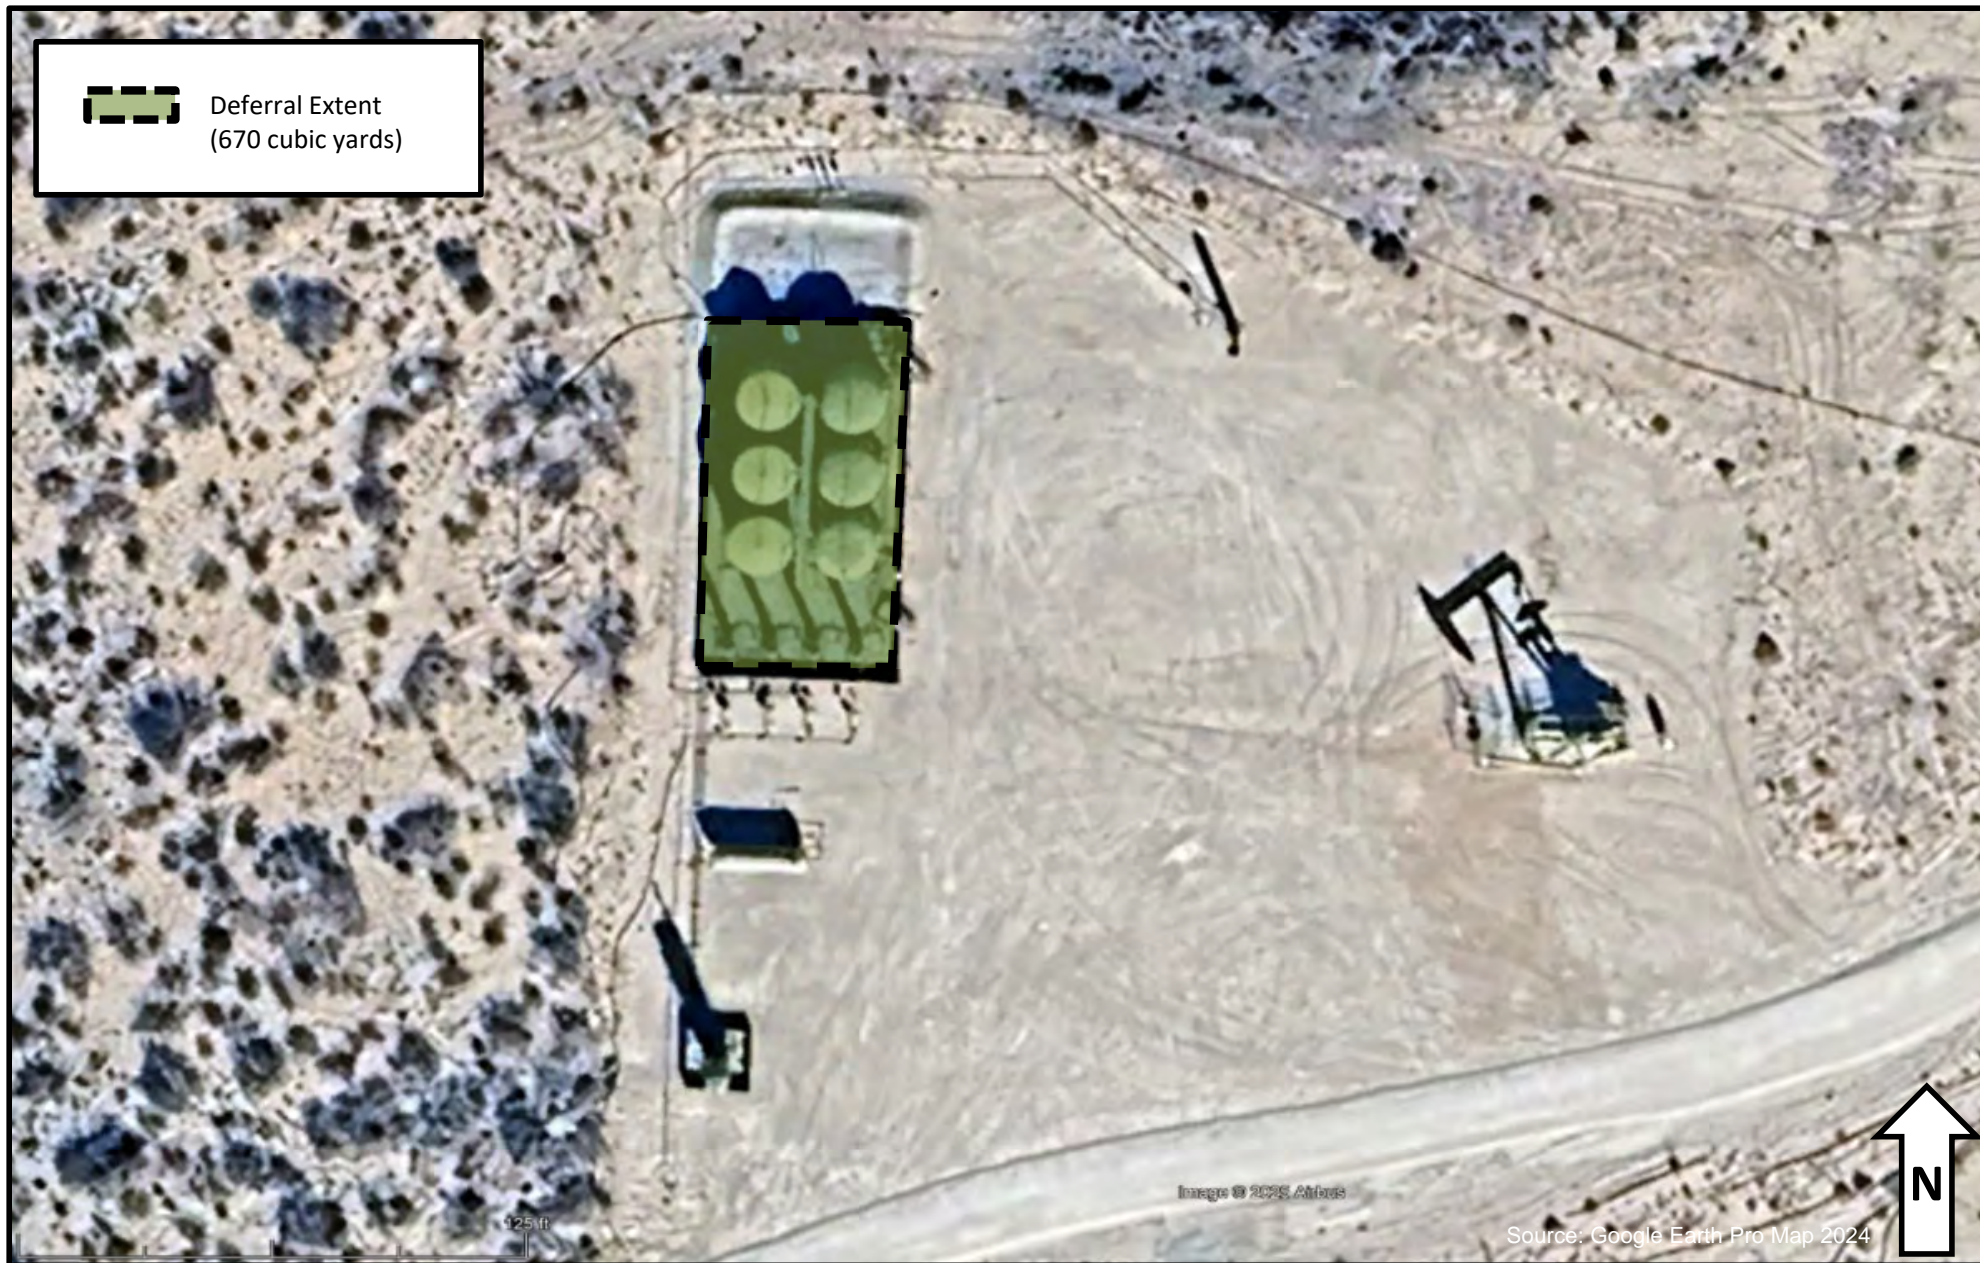
**Figure 6 – Deferral Extent**

Based on laboratory analytical results, residual soil impacts associated with the AOC appear to solely reside below the LSC up to 4 feet bgs (**Figure 6**) based on delineation soil sample locations HA-1 and HA-2. As a result, WPX respectfully requests deferral of up to approximately 670 CY of residual soil impacted beneath the LSC and up to 4 feet bgs until the Site undergoes major facility deconstruction or P&A, whichever comes first.

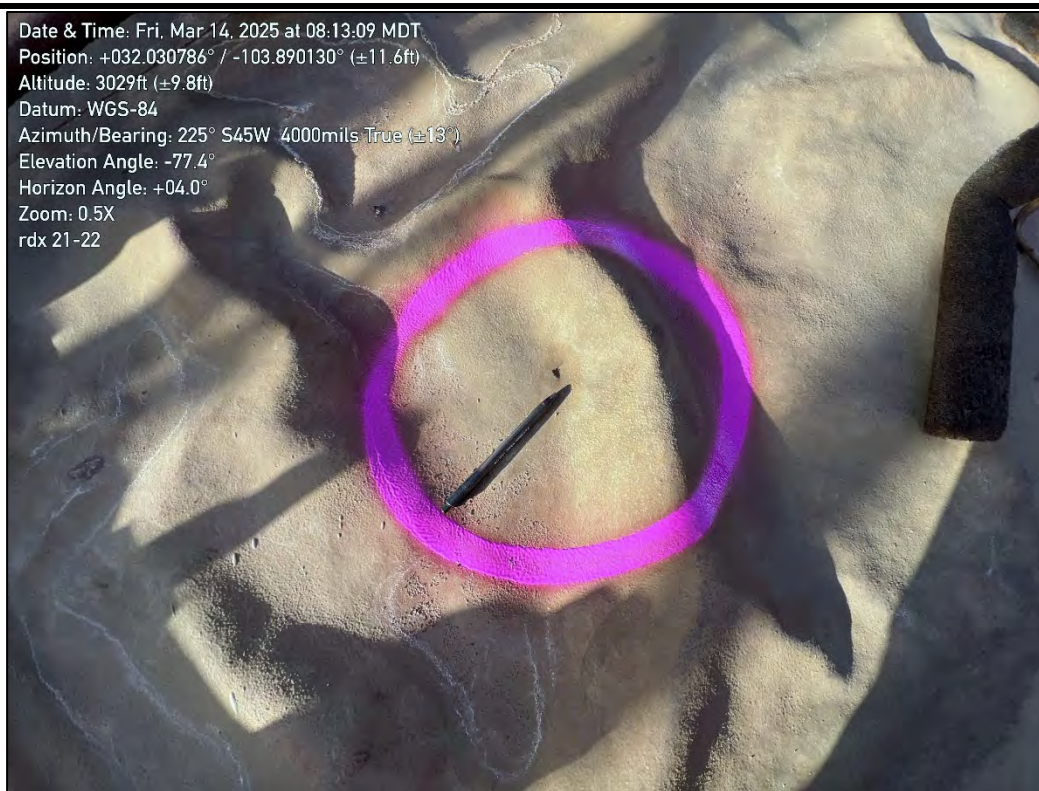
On March 14, 2025, ESRR conducted a thorough visual inspection of the LSC for tears, cracks, cuts, breaks, and other signs of damage, confirming the presence or absence of any evidence for a potential breach to the LSC. The LSC failed inspection and was considered to not be performing as designed due to cuts and tears observed (**Figure 2**). No fluids were observed to have escaped laterally to the pad surface or adjacent native soils. **Photographic Documentation** of liner inspection activities is attached.

PHOTO 16: Southwestern view of failed liner integrity. 3/14/2025

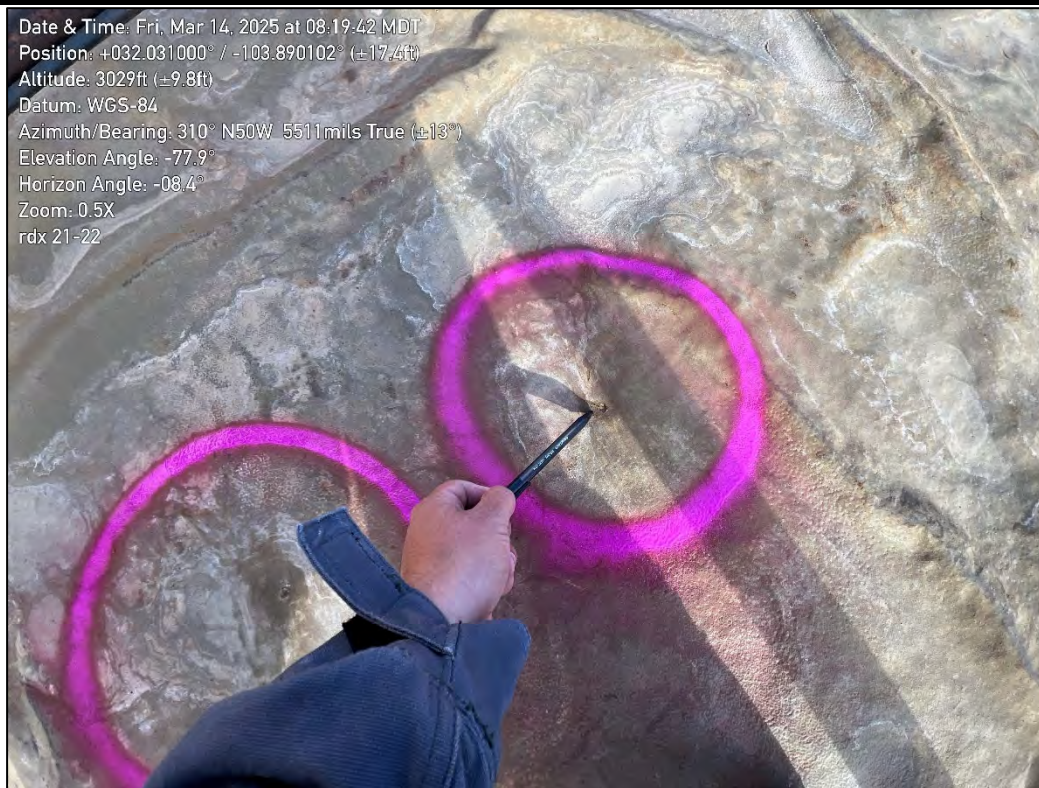
PHOTO 17: Northwestern view of failed liner integrity. 3/14/2025

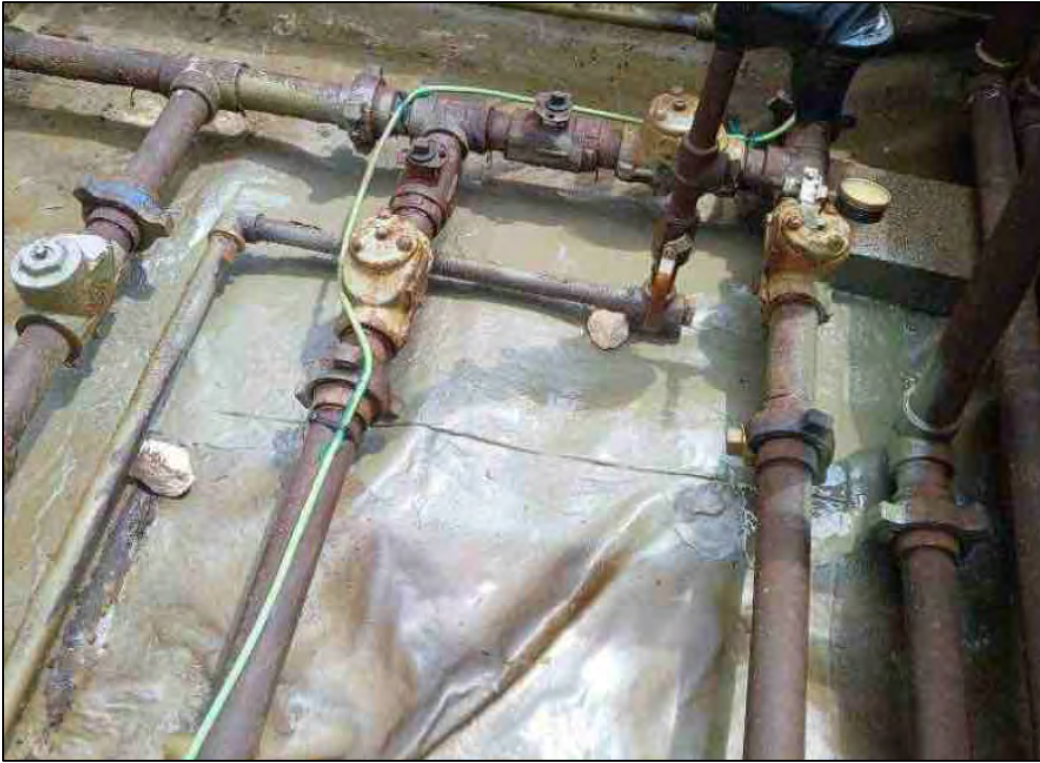
**PHOTO 27:** Southwestern view of liner repair. 5/2/2025

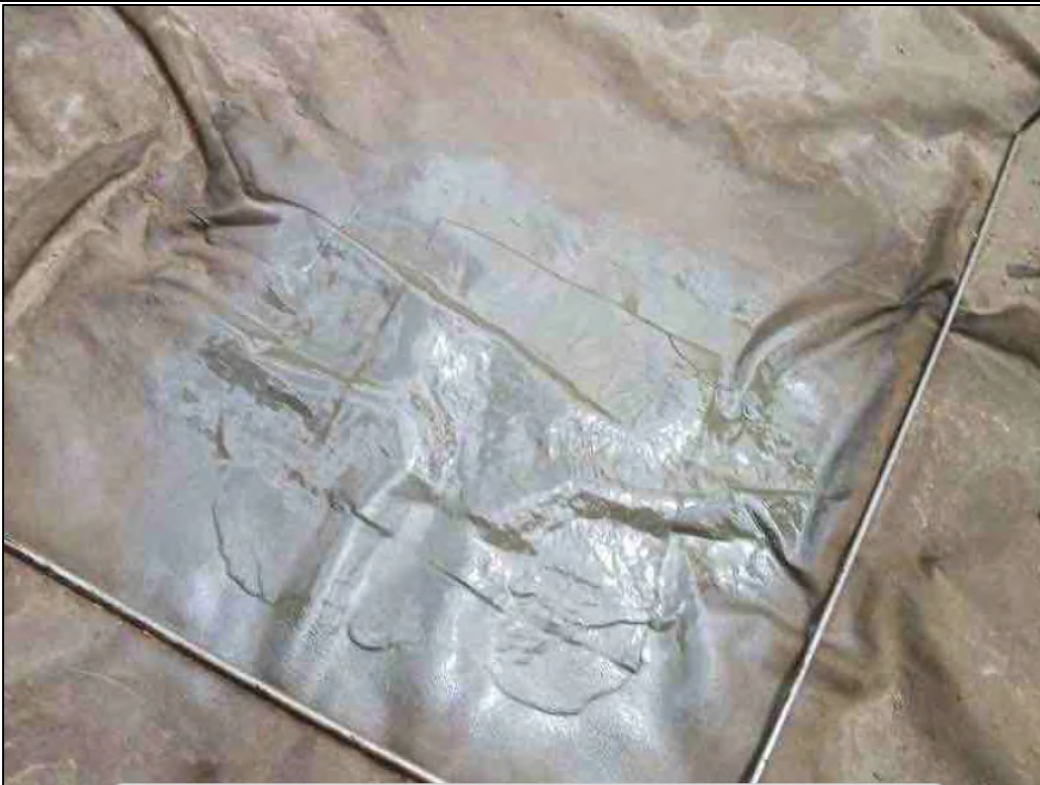
**PHOTO 28:** Southern view of liner repair. 5/2/2025

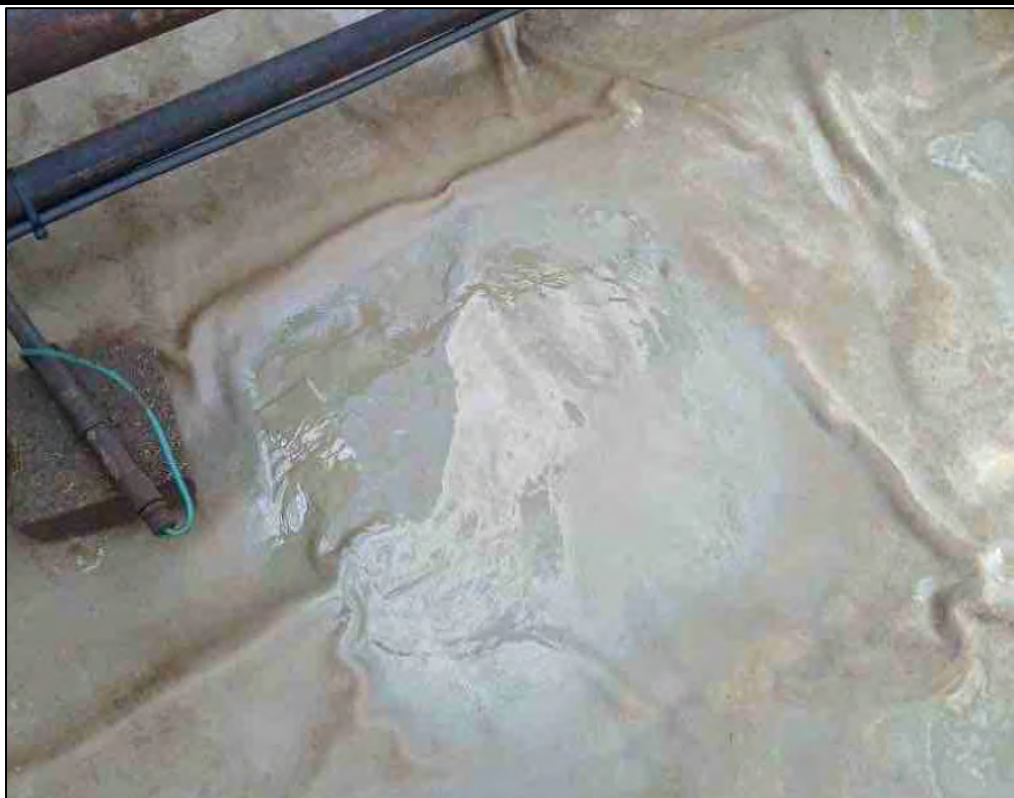
**PHOTO 29:** Western view of liner repair. 5/2/2025
