RE: 2024 Annual Groundwater Report**Rice Operating Company – BD SWD System****BD F-29 (1R426-16) and F-29-1 (1R426-15): UL/F, Sec. 29, T21S, R37E****NMOCD Incident ID: nAPP2109649080, nAPP2109650082**

ROC - BD F-29 (1R426-16) & F-29-1 (1R426-15)**Unit Letter F, Section 29, T21S, R37E**

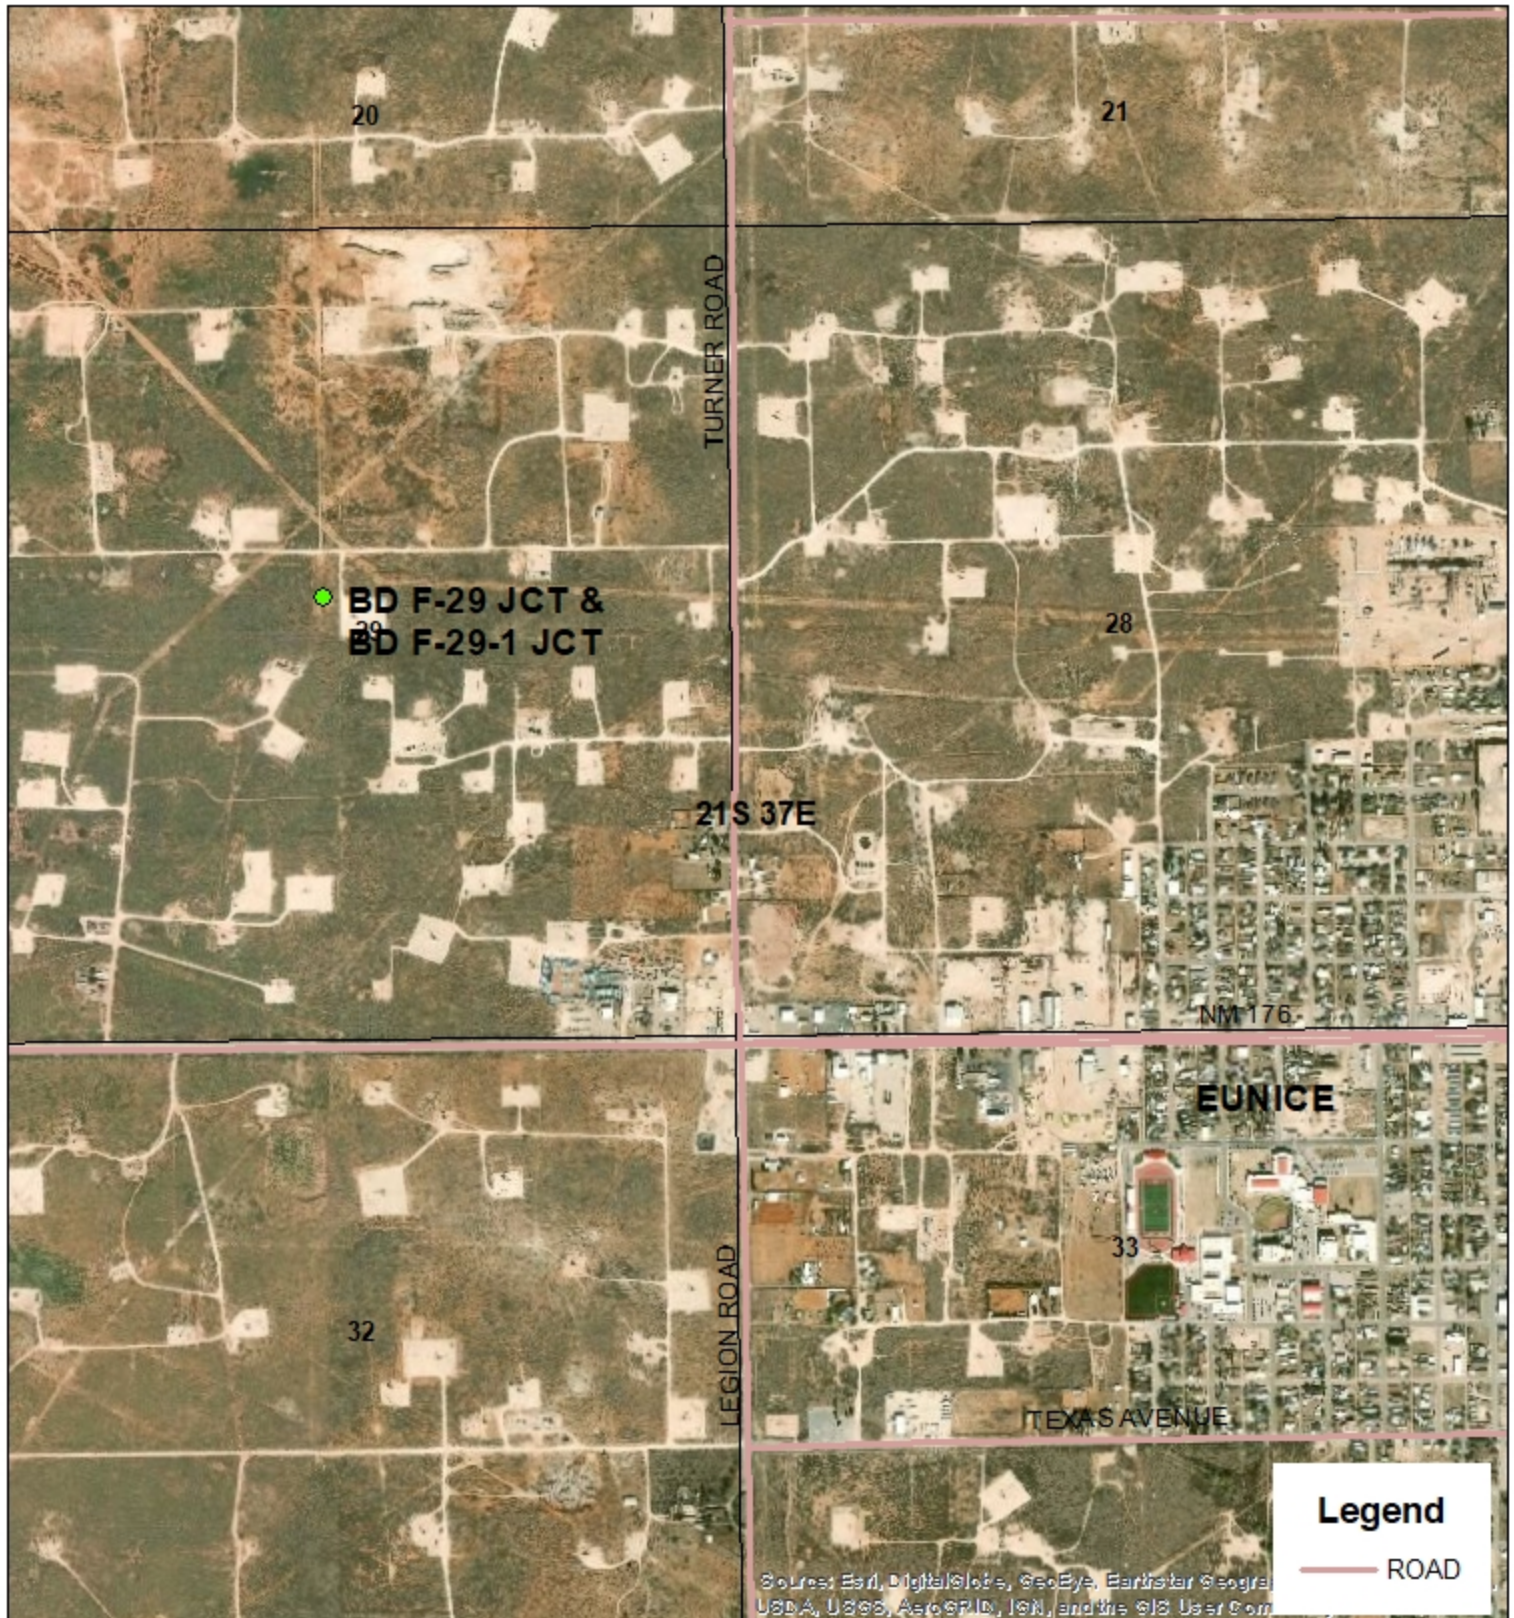
Geographical Location Map

BD F-29 JCT
 1R426-16
BD F-29-1 JCT
 1R426-15
 UL F SECTION 29
 T-21-S R-37-E
 LEA COUNTY, NM

GPS:
 F-29 JCT: 32.450545 -103.185153
 F-29-1 JCT: 32.450619 -103.185157
 NAD 83 STATE PLANE PROJ.
 NM EAST ZONE
 0 1,000 2,000
 Feet
 Drawing date: 1/28/20
 Drafted by: T. Grieco

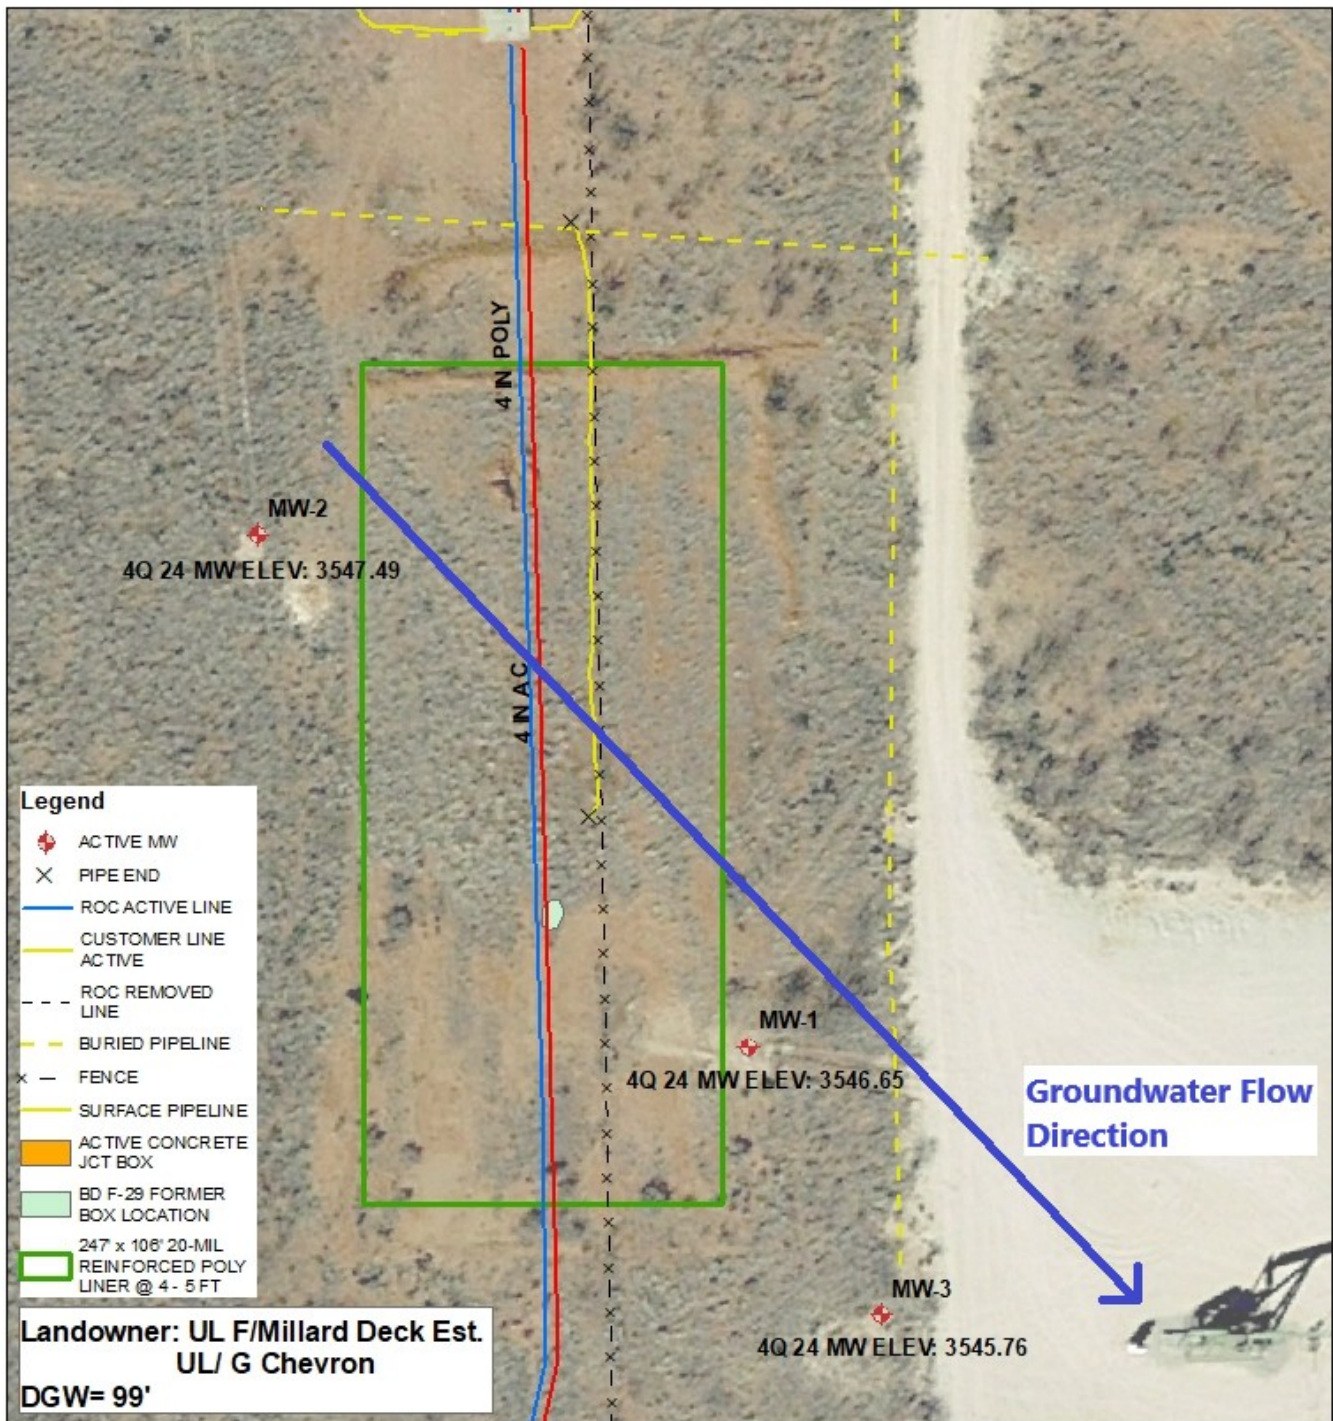
Groundwater Flow Direction

BD
F-29 & F-29-1 JCT
1R426-16 & 1R426-15
UL F & G SECTION 29
T-21-S R-37-E
LEA COUNTY, NM

GPS: 32.450619 -103.185159
NAD83 STATE PLANE PROJECTION
NEW MEXICO EAST ZONE
