Karst Survey

Cave and Karst Resource Inventory Report Remuda Basin Central Tank Battery Eddy County, New Mexico

XTO Energy, Inc
Remuda Basin Battery
Incident Numbers: NMAP1825437863 and NJMW1303140115
Unit F, Sec 19, T 23S, R 30E
Eddy County, New Mexico

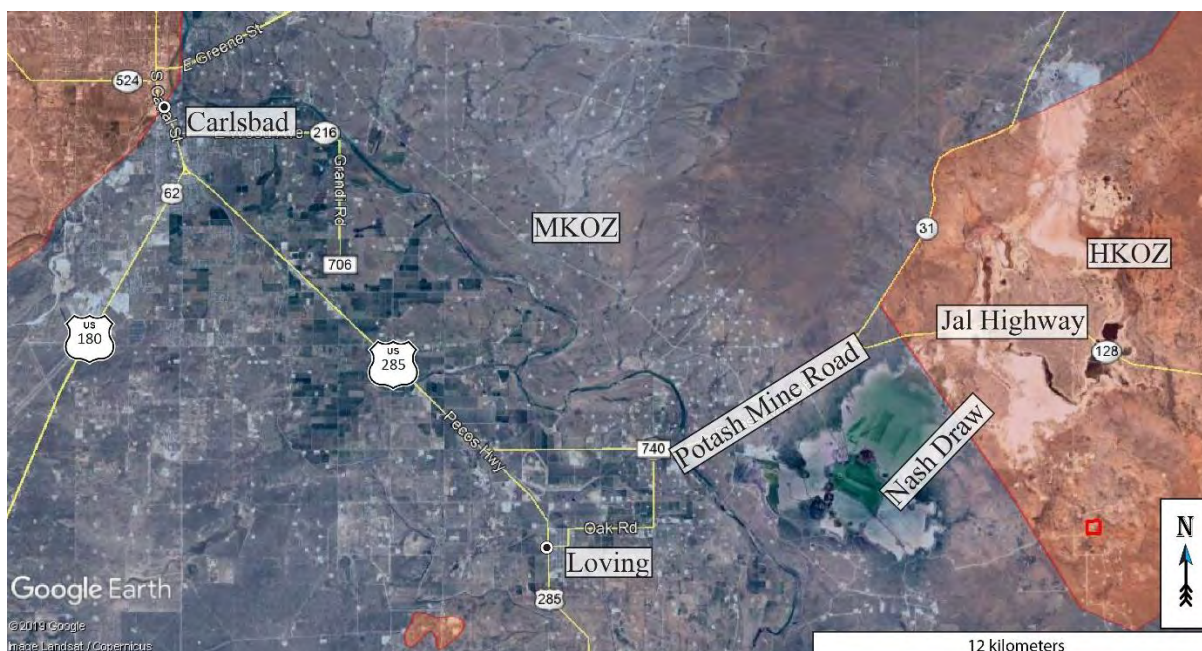
Figure 1: Karst occurrence overview. Red transparent area is a high karst occurrence zone; blue transparent area is a medium karst occurrence zone. Study area is the red outlined area in the lower-right portion of the image. Background image credit: Google Earth. Image date: November 02, 2017. Datum: WGS-84.

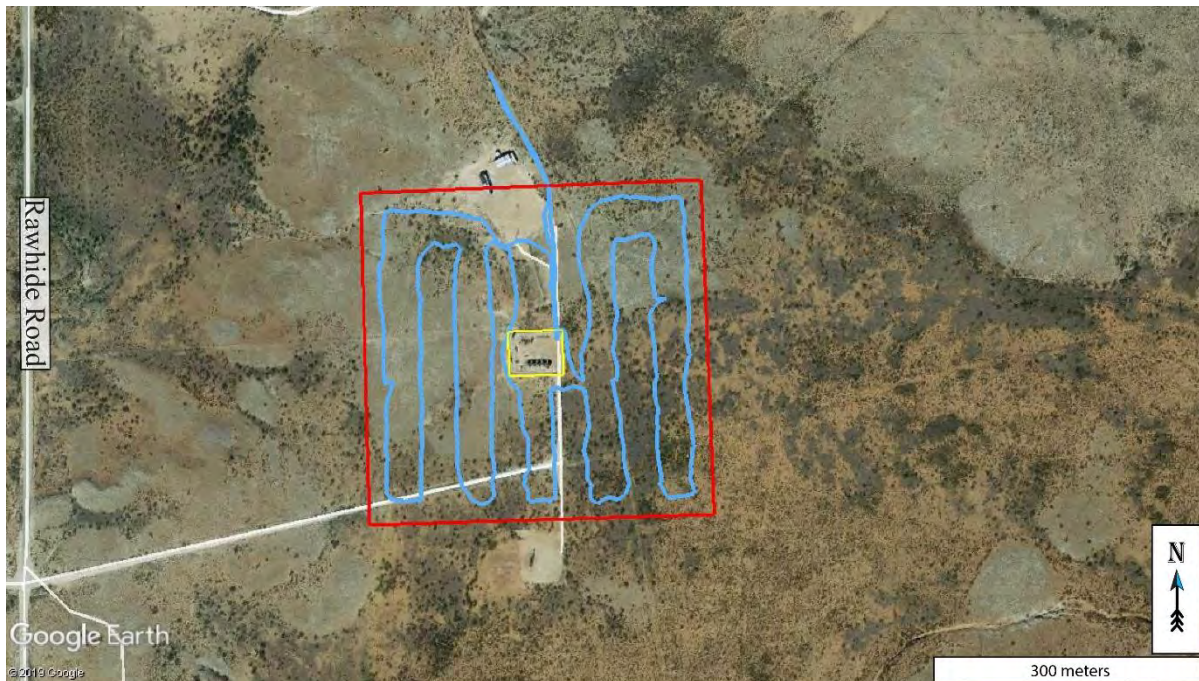
For this survey 10 lines were walked in a raster pattern at 50-meter (165 feet) intervals in the designated area, providing 90 to 100% coverage for features greater than 50 centimeters (20 inches) in diameter (**Table 1**).

The survey was completed by Garrett Jorgensen on January 30, 2020. The total distance walked was 4.5 kilometers (2.8 miles) and the total area covered was 0.2 square kilometers (39.5 acres).

Figure 3: Survey overview. Light blue wavy lines are the actual survey lines walked. Yellow polygon is the pad site. Red polygon is the 200-meter buffer study area. Background image credit: Google Earth. Image date: November 02, 2017. Datum: WGS-84.
