July 2, 2025

**Re: 2025 Q2 Groundwater Monitoring Report  
Historic Dickinson Tank Battery Release  
Unit Letter M, Sec 1, T15S, R37E  
GPS Coodinates: 33.042588°N, -103.158438°W  
Lea County, New Mexico  
NMOCD Release Number: NAUTOFLWP00122 (Formerly 1R-432)**

New Tech Global Environmental, LLC (NTGE) on behalf of Devon Energy (Devon), has prepared this 2025 Q2 Groundwater Monitoring Report for submittal to the New Mexico Oil Conservation Division (NMOCD) in Albuquerque, New Mexico. This report presents the 2025 second (2<sup>nd</sup>) quarter laboratory analysis of groundwater samples collected from three (3) monitor wells (MW-6A, MW-South-A, and MW-North-A) at the former Dickinson Tank Battery (Site) located in Unit Letter M, Section 1, Township 15 South, Range 37 East, in Lea County, New Mexico. The geodetic position is latitude 33.042588° N, longitude -103.158438° W. See Figures 1 and 2 for Site Location and Topographic Maps.

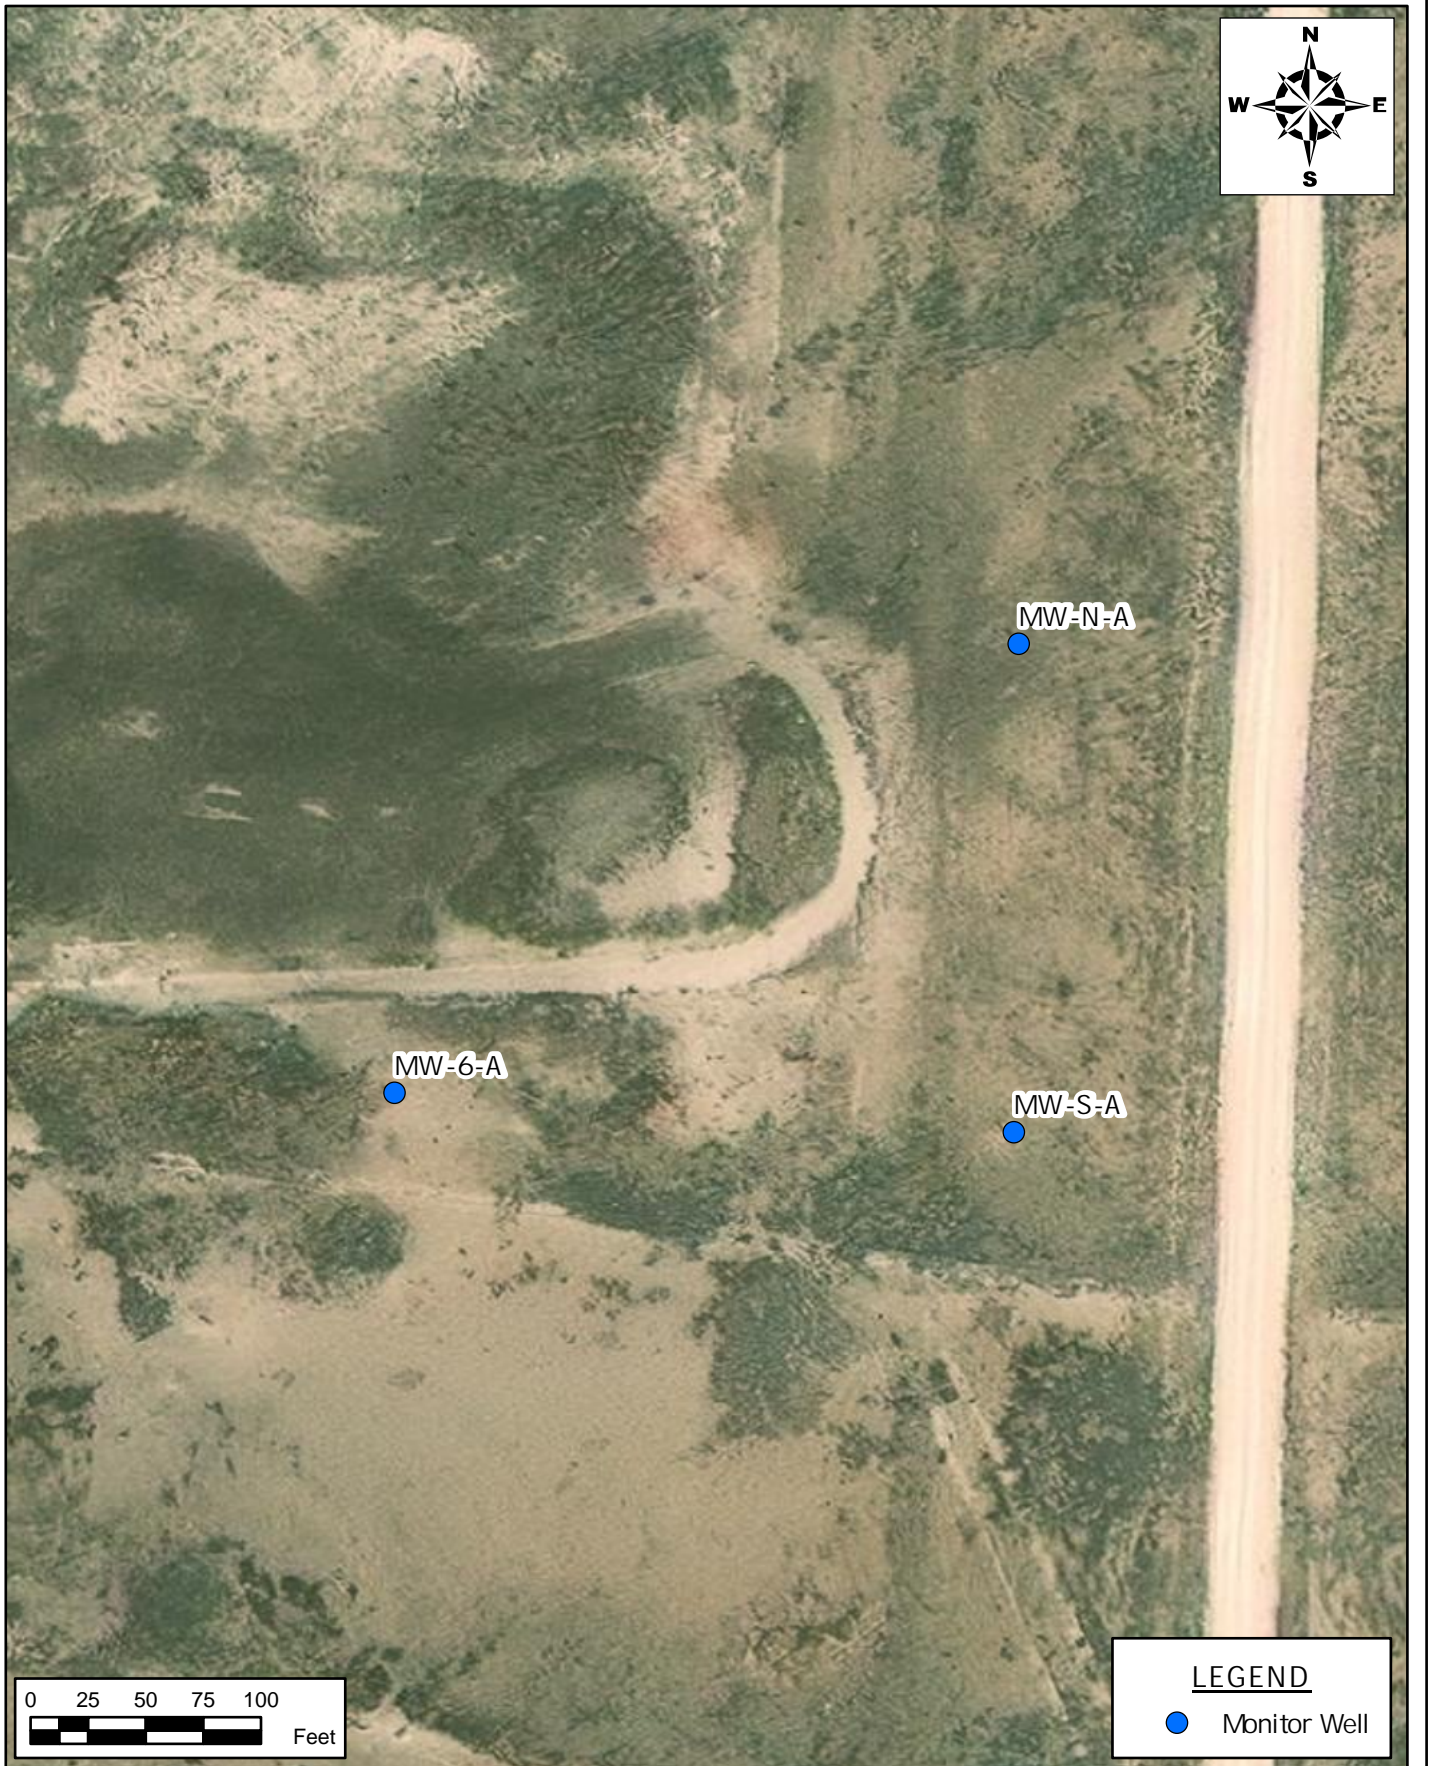
**FIGURE 3**

On May 28, 2025, NTGE was onsite to gauge each of the three (3) monitor wells. See Figure 3 for site monitoring well locations. Utilizing a water level indicator each of the wells were gauged from a mark on the north side of the well casing to depth of encountered groundwater and the bottom of the well. The corrected groundwater depth was then calculated, and a gradient map developed. Figure 4 indicates the groundwater gradient at the site is to the northeast towards monitor well MW-North-A. See Table 1 for gauging data with corrected groundwater elevations.

**MONITOR WELL LOCATION MAP**  
**DEVON ENERGY**  
 DEVON DICKINSON WW  
 LEA COUNTY, NEW MEXICO  
 33.042724, -103.158525

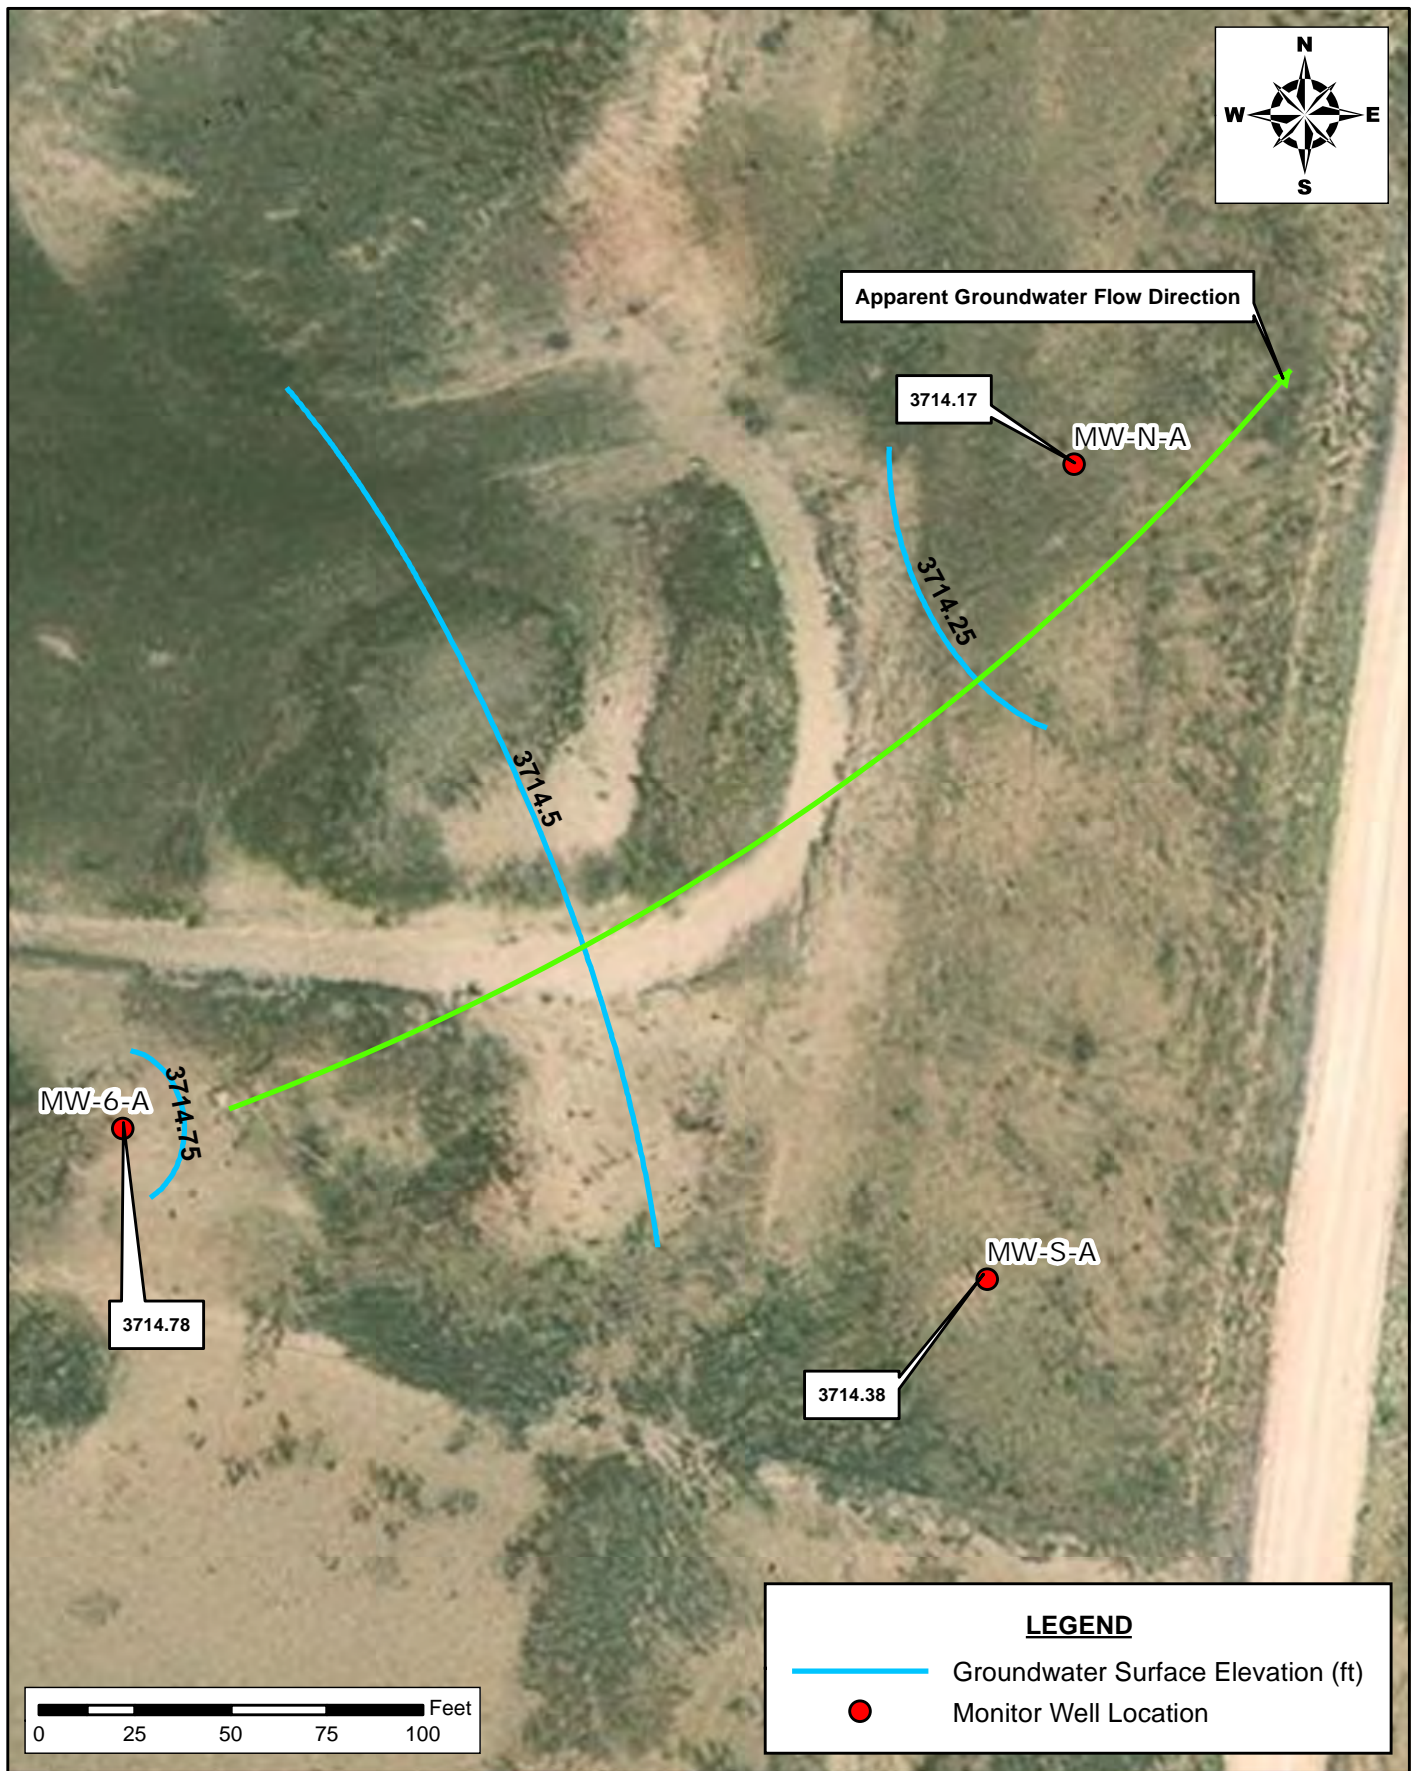
**FIGURE 4**

Based on the current groundwater results, the site gradient appears to be northeast towards monitor well MW-North-A with analytical results below the NMWQCC standards. NTGE suggests the site should remain on quarterly sampling and if the site is below NMWQCC standards for eight (8) consecutive quarters, Devon should pursue closure of the site.

**GROUNDWATER GRADIENT MAP**  
DEVON ENERGY  
DEVON DICKINSON WW  
LEA COUNTY, NEW MEXICO  
32.042724° -103.158525°

1. Base Image: ESRI Maps & Data 2017
2. Map Projection: NAD 1983
3. Contour Intervals = 0.25 ft
4. Elevation in feet
5. Gauged 05/28/2025

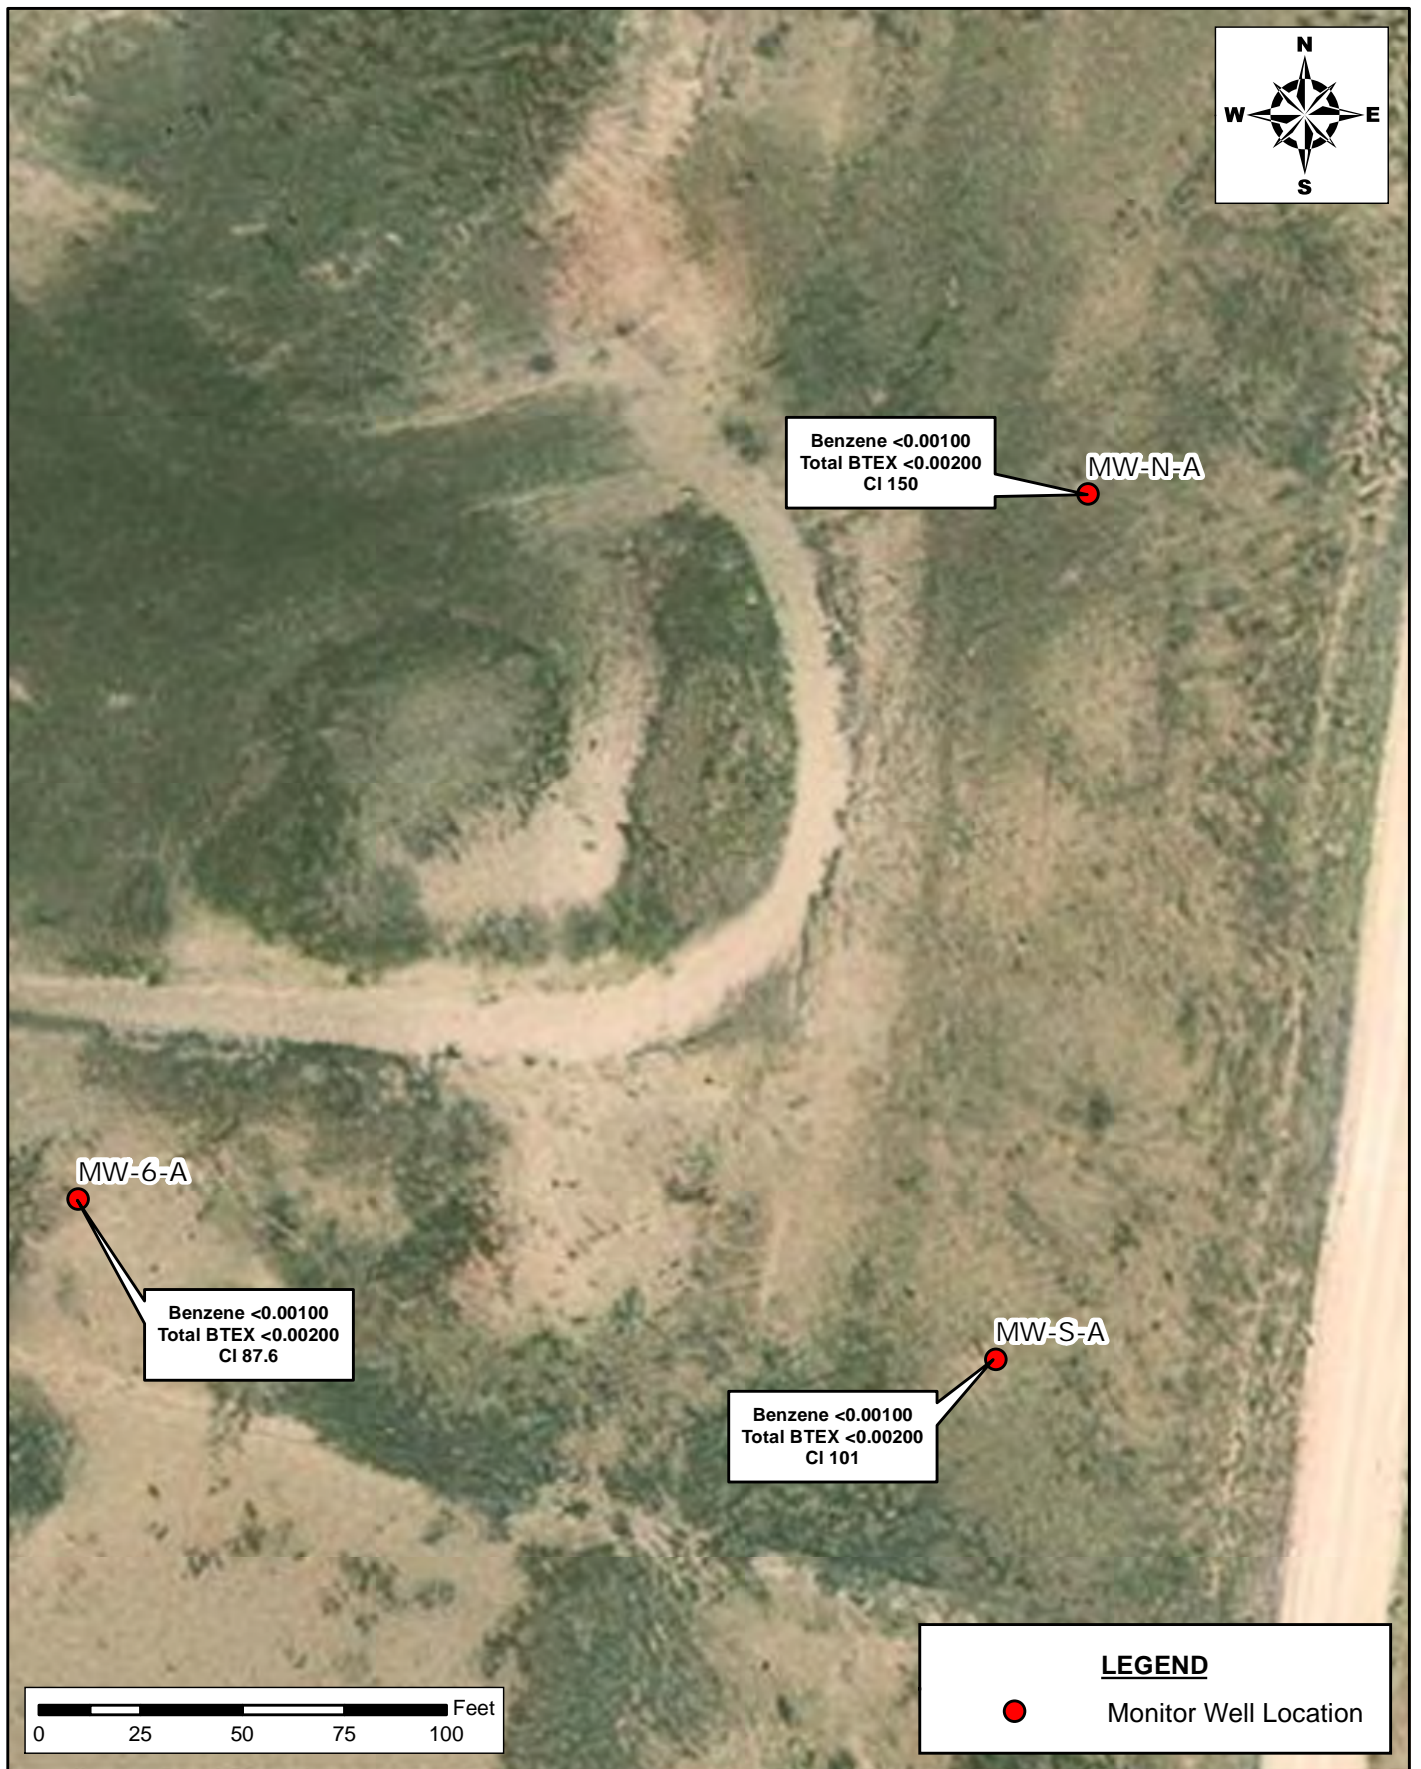
**FIGURE 5**

Analytical results indicated all samples were below the NMWQCC standards for BTEX and chlorides. Chlorides in the groundwater ranged from 87.6 milligrams per Liter (mg/L) in MW-6-A to 150.0 mg/L in MW-North-A. The BTEX concentrations were all below laboratory method detection limits. See Table 2 for groundwater analytical results along with Figure 5 Groundwater Hydrocarbon Concentration Map. See Appendix A for laboratory analytical results.

**GROUNDWATER CONCENTRATION MAP**  
 DEVON ENERGY  
 DEVON DICKINSON WW  
 LEA COUNTY, NEW MEXICO  
 32.042724° -103.158525°

1. Base Image: ESRI Maps & Data 2017
2. Map Projection: NAD 1983
3. Results in mg/L
