Closure Report
Copperhead 31 Federal Com 001H (04.16.24)
Eddy County, New Mexico
Incident ID: nAPP2410932444
Unit H Sec 31 T26S R29E
32.001891°, -104.016572°

Crude Oil Release
Point of Release: Equipment Malfunction
Release Date: 04.16.2024
Volume Released: 132.4491 barrels of Crude Oil
Volume Recovered: 130 barrels of Crude Oil

**Re: Closure Report
Copperhead 31 Federal 001H (04.16.24)
Concho Operating, LLC
Incident # nAPP2410932444
Site Location: Unit H, S31, T26S, R29E
(Lat 32.001891°, Long -104.016572°)
Eddy County, New Mexico**

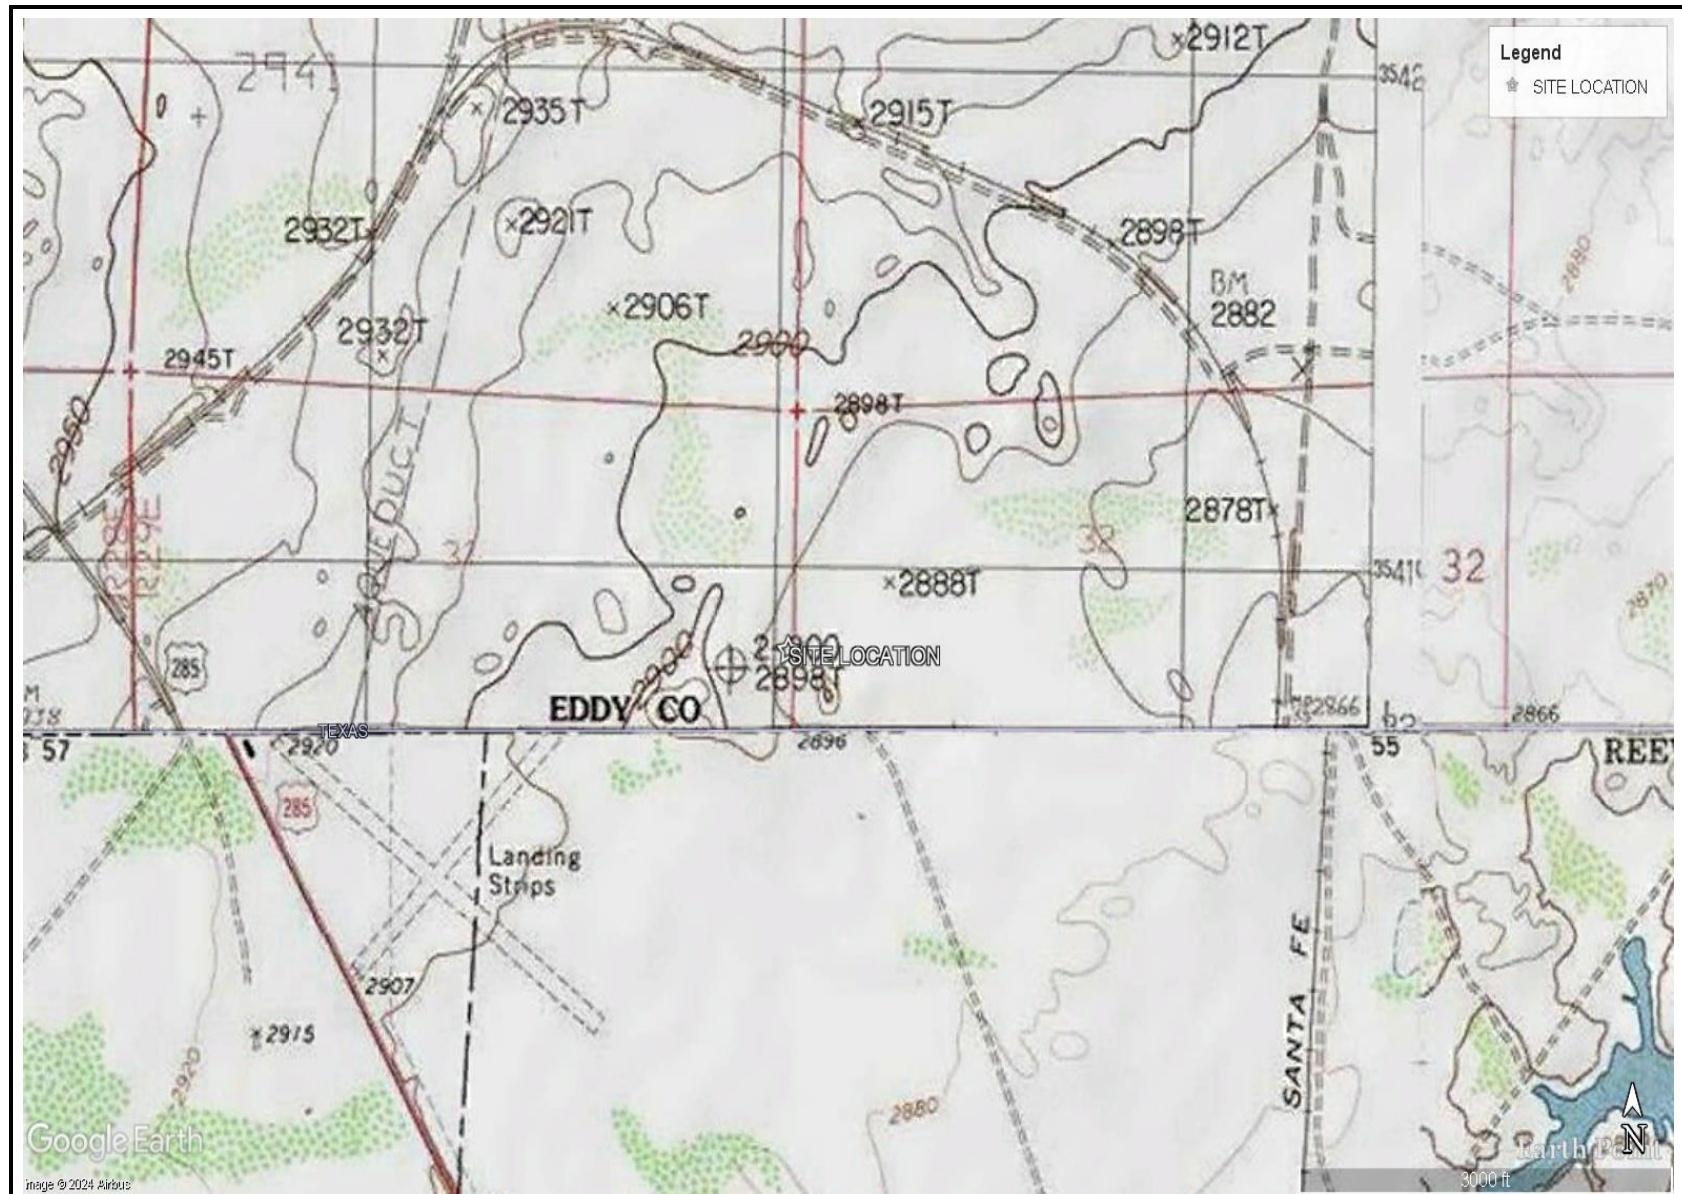
FIGURE 2

TOPOGRAPHIC MAP
COG OPERATING, LLC
COPPERHEAD 31 FED 1H (04.16.24)
EDDY COUNTY, NEW MEXICO
32.001891°, -104.016572°

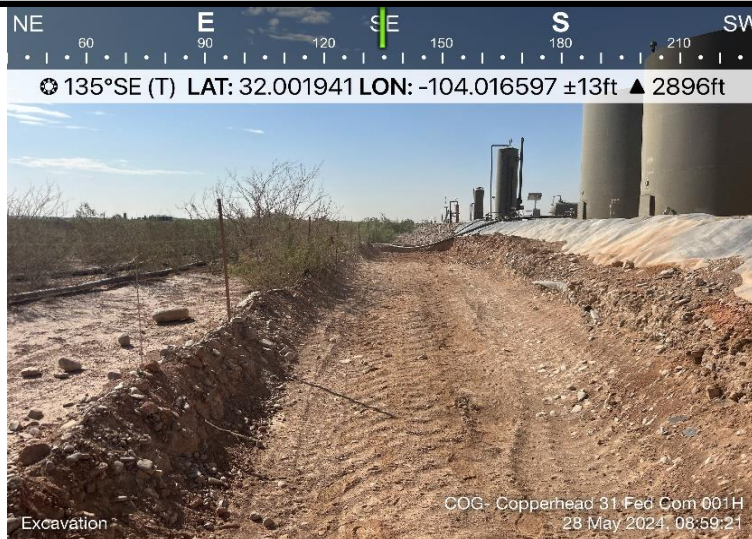
View Southeast, area of Confirmation Samples (1-6).

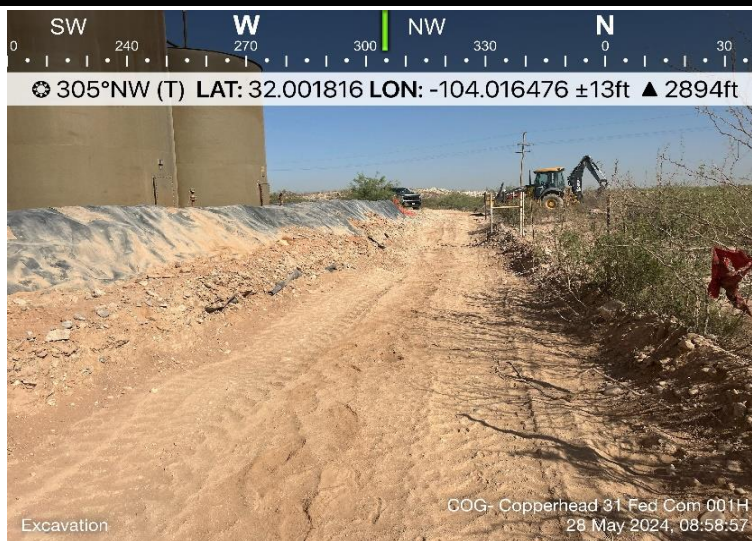
Photograph No. 2

View Northwest, area of Confirmation Samples (5-8).

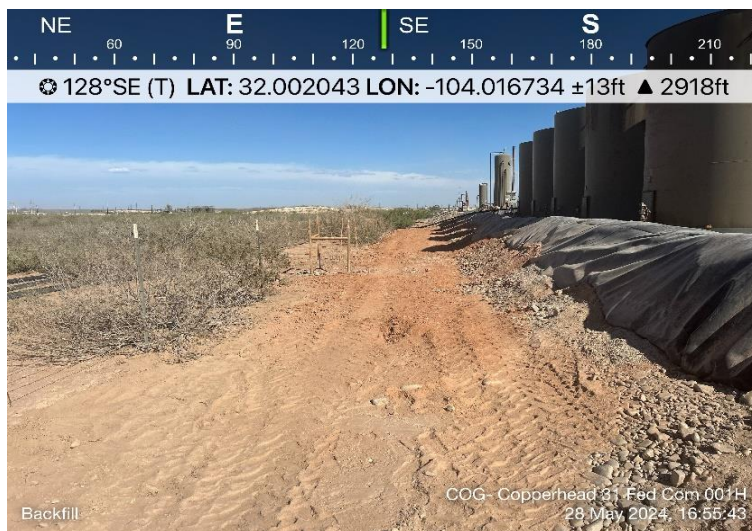
Photograph No. 3

View Southeast after excavation is complete and the area backfilled.

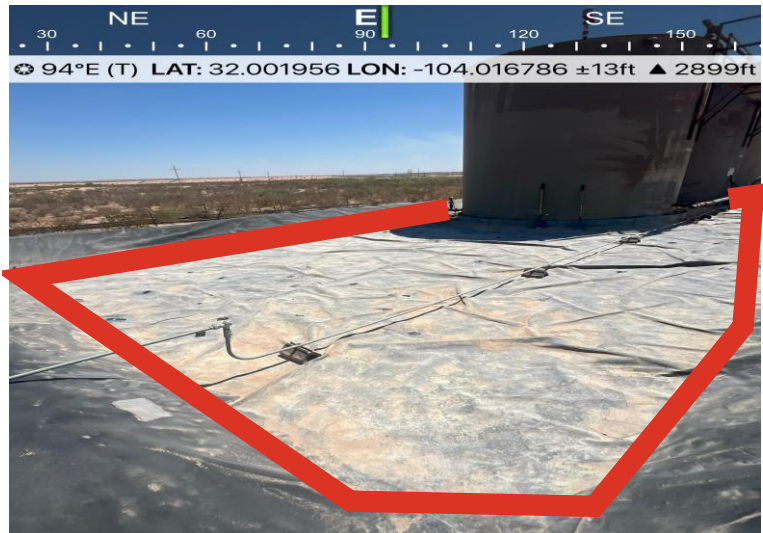
View East, area of liner inspection. (Red outline is the area of the liner inspection).

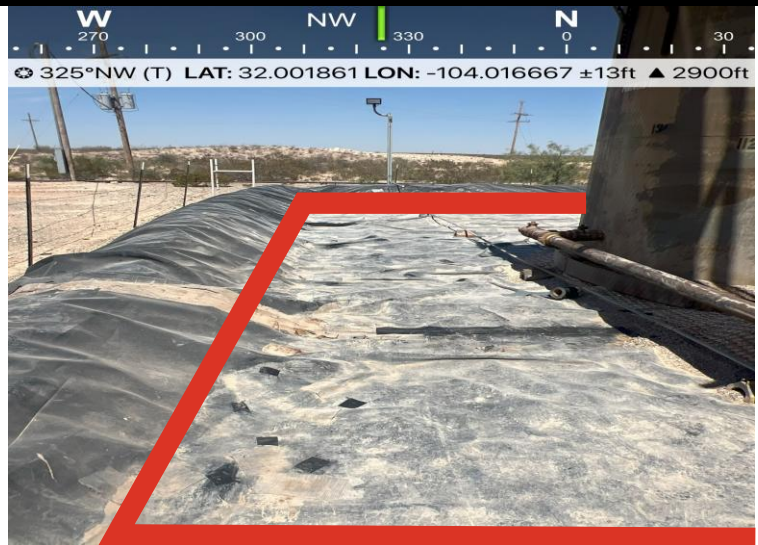
Photograph No. 5

View Northwest, area of liner inspection. (Red outline is the area of the liner inspection).
