ENSOLUM

**Re: Sampling Plan
James Ranch Unit #10 Battery
Incident Numbers NAB1521257588, NAB1535754357, and NAB1904653072
Eddy County, New Mexico**

Ensolum, LLC (Ensolum), on behalf of XTO Energy, Inc. (XTO), presents this *Sampling Plan* proposing confirmation soil sampling activities following the utilization of a solar soil vapor extraction (SVE) system at the James Ranch Unit #10 Battery (Site). The SVE system has been in operation since May 27, 2022, to remediate residual subsurface hydrocarbon impacts to soil at the Site. The following *Sampling Plan* proposes to complete confirmation soil sampling activities via drilling rig.

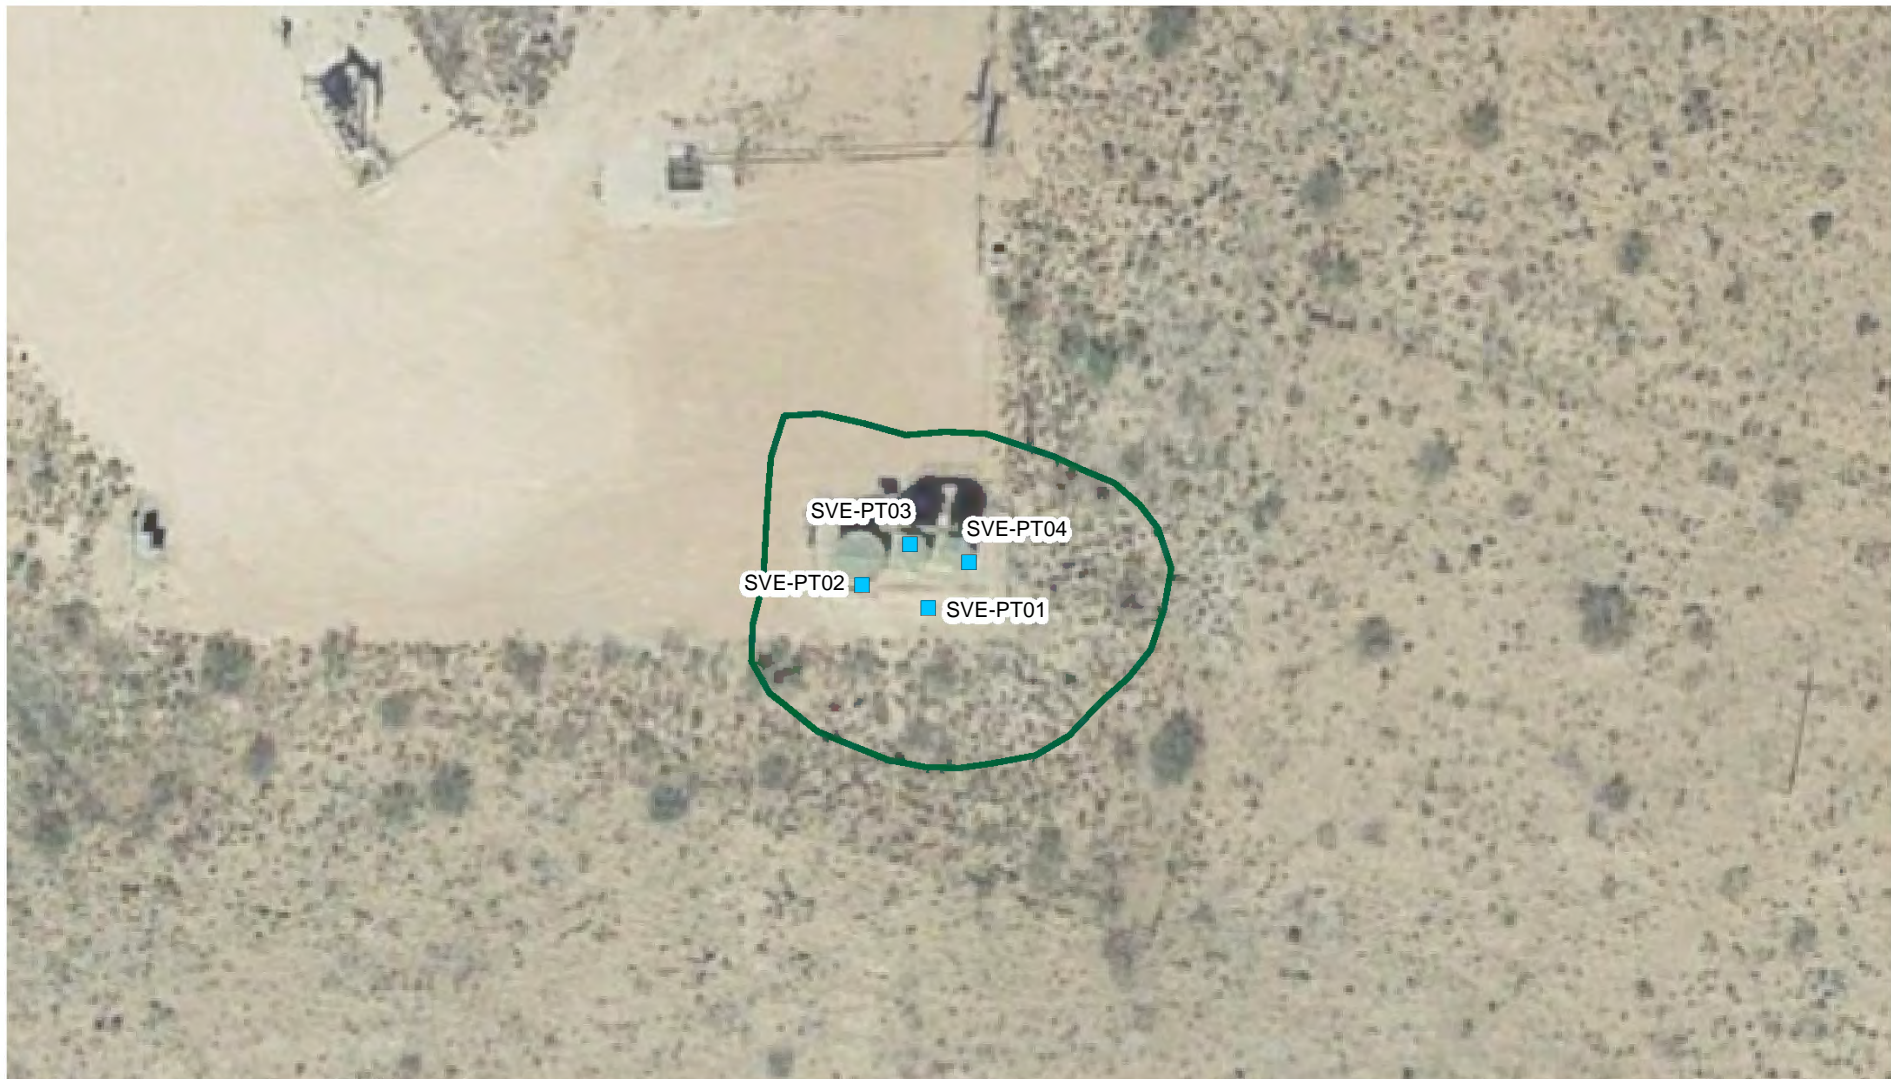
Four SVE wells (SVE-PT-01 through SVE-PT-04) were installed prior to testing in the locations presented on Figure 2. During the advancement of each SVE well, continuous soil sampling was conducted, which included describing the lithology based on the Unified Soil Classification System (USCS) as specified in American Society for Testing and Materials (ASTM) D2488, observations of staining and odors, and field screening of volatile aromatic hydrocarbons and chloride utilizing a calibrated photo-ionization detector (PID) and Hach® chloride QuanTab® test strips, respectively. Soil boring logs were completed at the time of drilling and are provided with the construction diagrams of the SVE wells as Attachment 2.

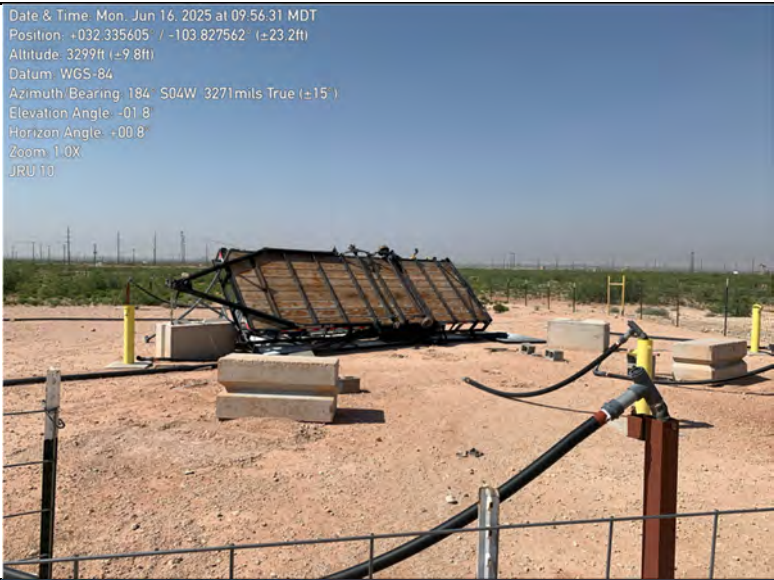
| <p>Photograph 1</p> <p>SVE System Post-Storm June 16, 2025 at 9:56 AM</p> | <p>Date & Time: Mon, Jun 16, 2025 at 09:56:31 MDT Position: +032.335605 / -103.827562 (±23.2ft) Altitude: 3299ft (±9.8ft) Datum: WGS-84 Azimuth/Bearing: 184° S04W 3271mils True (±15°) Elevation Angle: -01.8° Horizon Angle: -00.8° Zoom: 1.0X JRU 10</p> |

On June 16, 2025, an O&M technician was driving by the Site and observed the SVE system disconnected from the anchors and flipped upside down, landing on the faces of the solar panels, likely due to recent high wind events. Upon further inspection, it was determined the existing system would no longer be operational without significant repairs and/or modifications to prevent similar incidents from occurring in the future. The SVE system was removed from the Site for storage at a nearby XTO yard. Photographs of the SVE system post-wind event are provided as Appendix B.

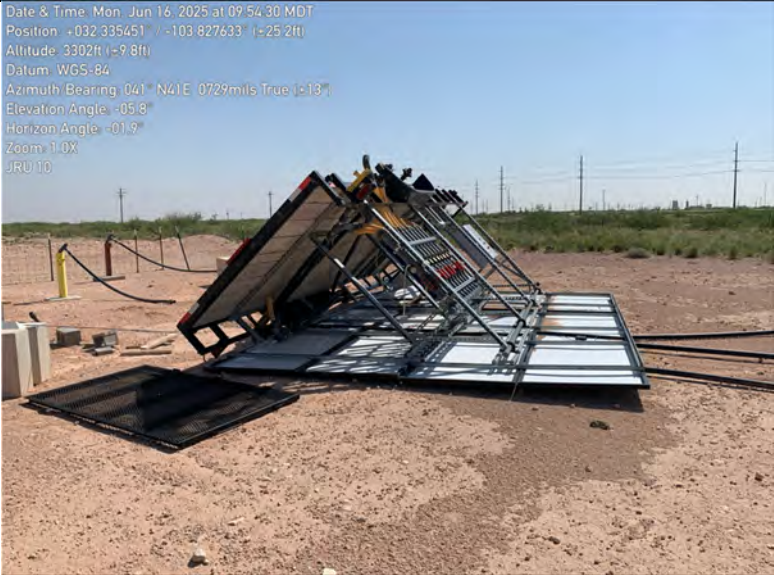
| <p>Photograph 2</p> <p>SVE System Post-Storm June 16, 2025 at 9:54 AM</p> | <p>Date & Time: Mon, Jun 16, 2025 at 09:54:30 MDT Position: +032.335451 / -103.827633 (±25.2ft) Altitude: 3302ft (±9.8ft) Datum: WGS-84 Azimuth/Bearing: 041° N41E 0729mils True (±13°) Elevation Angle: -05.8° Horizon Angle: -01.9° Zoom: 1.0X JRU 10</p> |
