**Re: Stage 2 Abatement Plan (AP) for the Former Reverse Osmosis (RO) Reject Discharge Fields at the HF Sinclair Navajo Refining LLC (HFNSR)  
Quarterly Status Report #4 – April through June 2025  
Incident #nRM2022559242, GW-028**

HF Sinclair Navajo Refining LLC (HFSNR) is submitting this quarterly status report number 4 for the Stage 2 Abatement Plan (AP) for the Former Reverse Osmosis (RO) Reject Discharge Fields (RO Fields) at the HF Sinclair Navajo Refining LLC (HFSNR) Refinery (Refinery) located in Artesia, New Mexico (**Figure 1**). The Oil Conservation Division (OCD) approved the Stage 2 AP on July 11, 2024. The former RO Fields are located within the northern portion of the active Refinery (**Figure 2**).

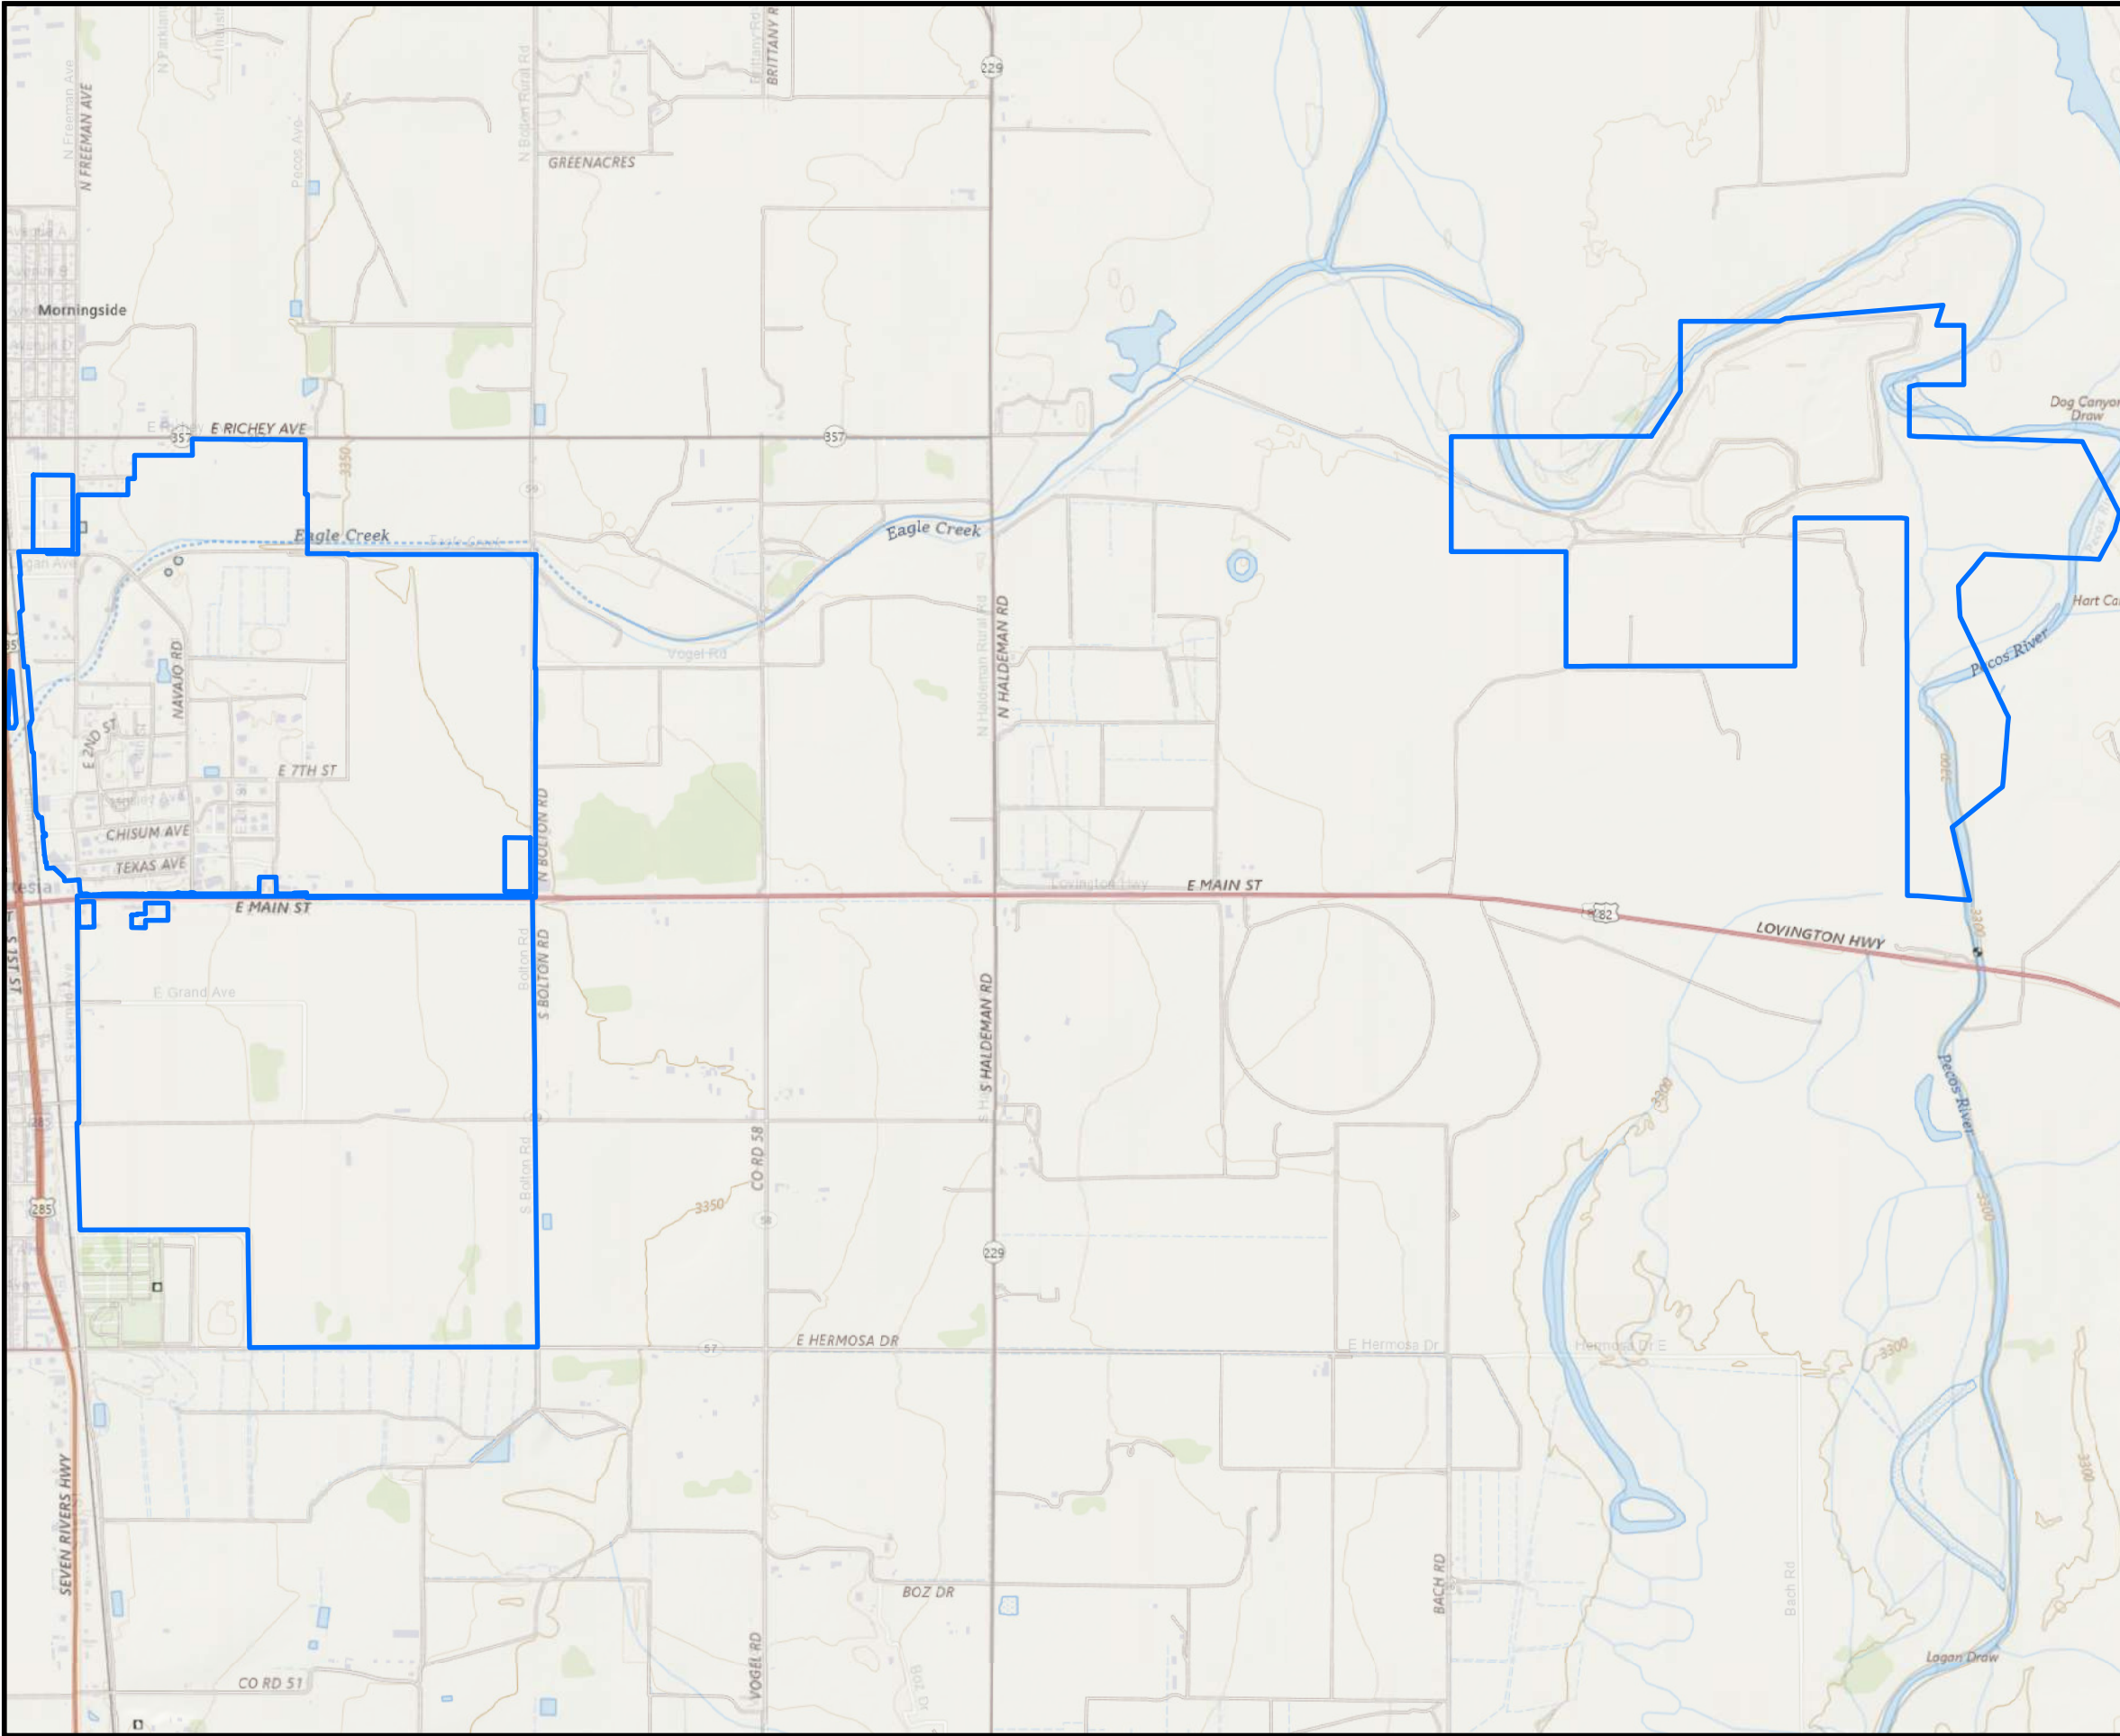
**FIGURE**  
**1**

**SITE LOCATION**  
**HF SINCLAIR NAVAJO REFINING LLC**  
**ARTESIA REFINERY, EDDY COUNTY, NEW MEXICO**

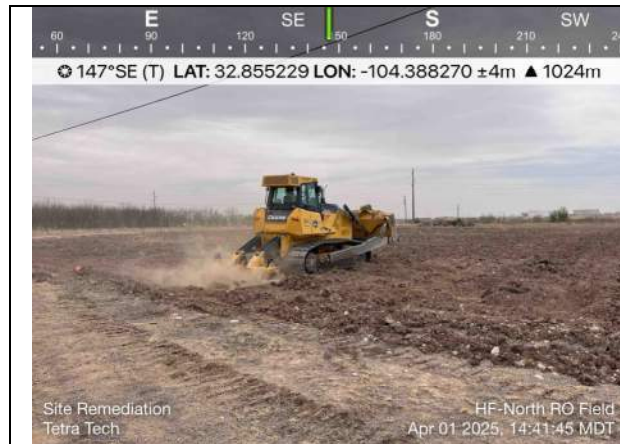
Photo 1: Field preparation in North RO field.

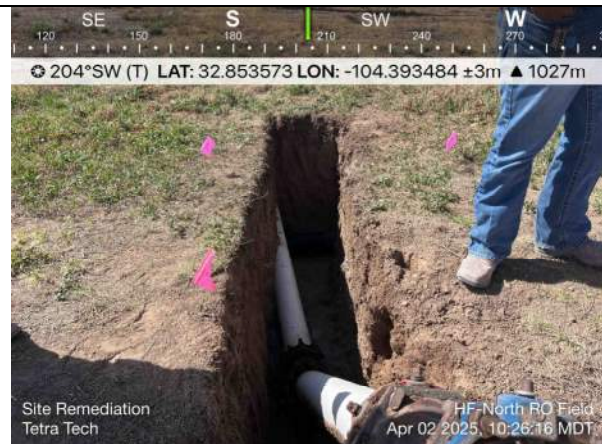
Photo 2: Connection of irrigation distribution piping to source in North RO field.

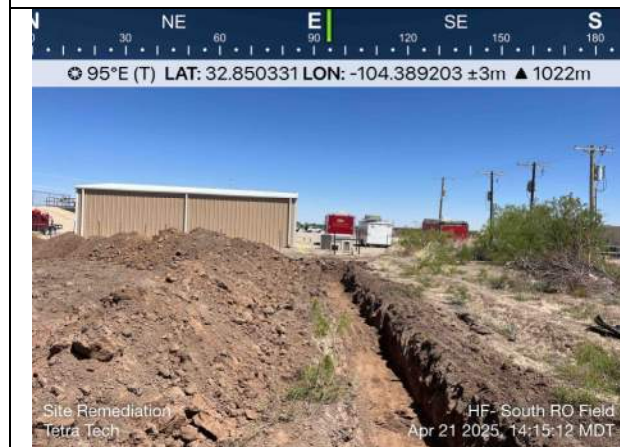
Photo 3: Trench for irrigation distribution piping in South RO field.

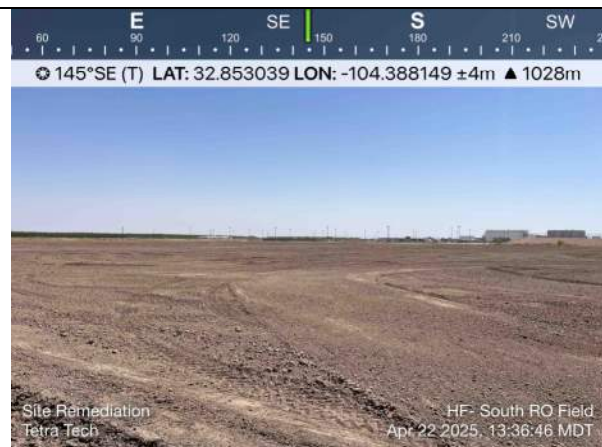
Photo 4: View of South RO field after "floating" of field to prepare for planting.

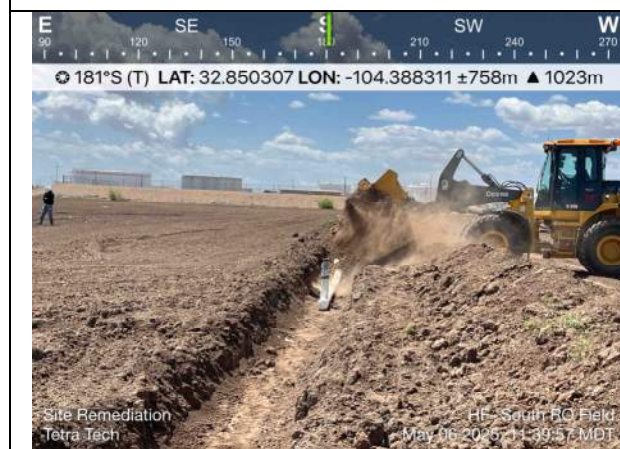
Photo 5: Backfilling irrigation distribution piping trench in South RO field.

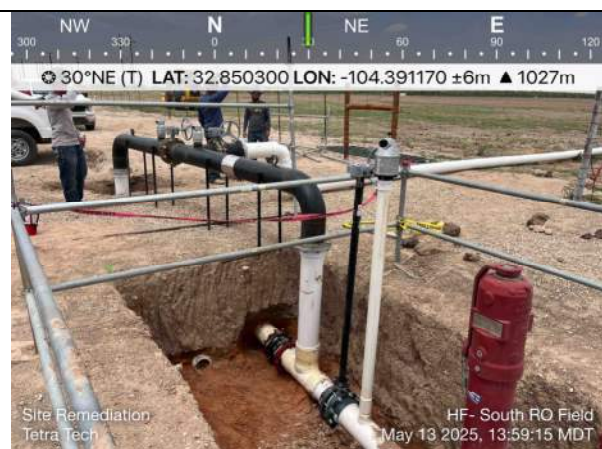
Photo 6: Valve and meter run being constructed west of South RO field.

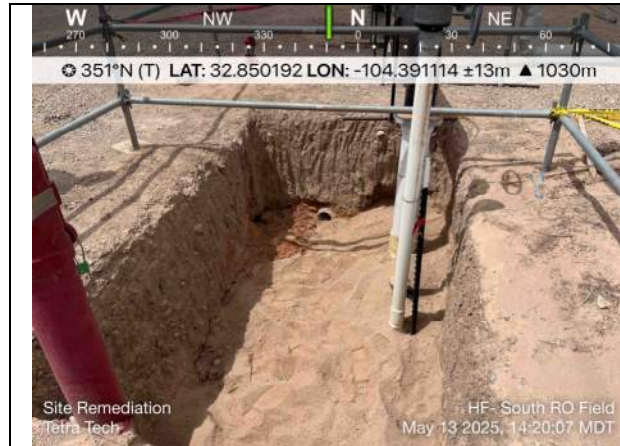
Photo 7: Initial backfill of piping run. Piping in foreground leads to process water tank. Note the firewater system is separate from the irrigation piping.

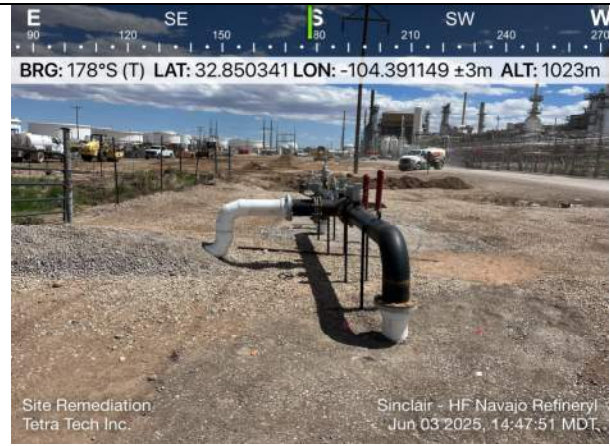
Photo 8: Valve and meter run west of South RO field. Valve and piping to left of photo leads to South RO field; valve and piping in foreground leads to North RO field.

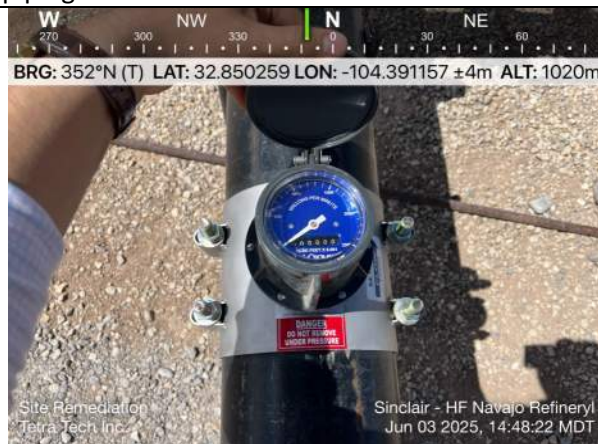
Photo 9: Flowmeter on irrigation piping run.

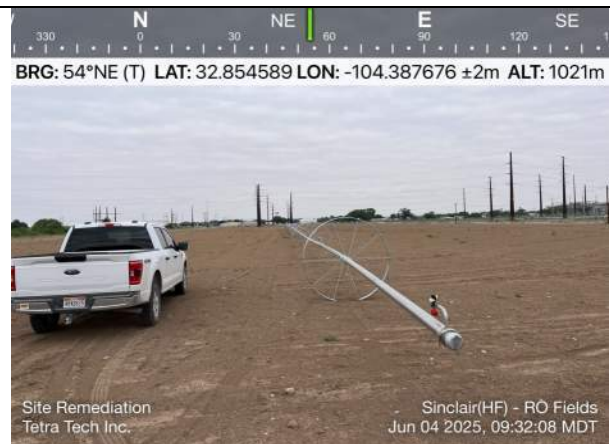
Photo 10: View of one section of irrigation piping in North RO field.

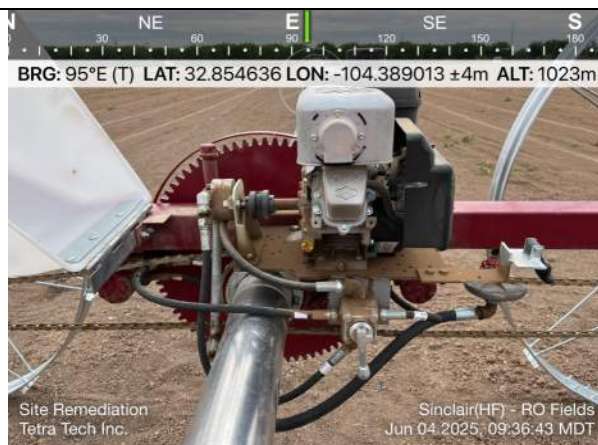
Photo 11: Irrigation system mover (motor and chains).

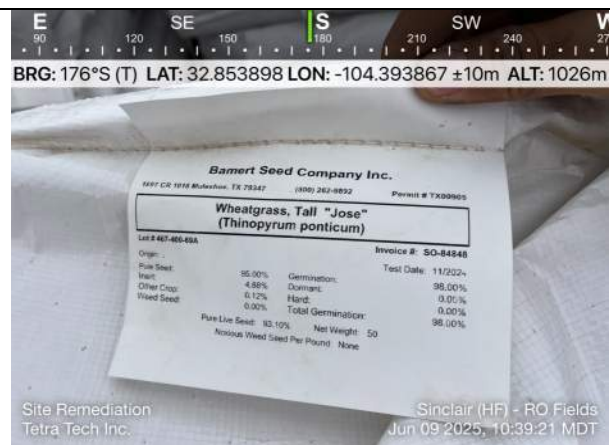
Photo 12: Label on seed used to plant North RO field, east section.
