Environmental Site Remediation Work Plan

NMOCD District:	<u>Artesia</u>	Incident ID:	<u>nAPP2515337712</u>
Landowner:	<u>State</u>	Facility ID:	<u>fAPP2412725430</u>
Client:	<u>EOG Resources, Inc.</u>	Site Location:	<u>Padron 10 State Com CTB AST</u>
Date:	<u>July 15, 2025</u>	Project #:	<u>25A-03091</u>
Client Contact:	<u>Chase Settle</u>	Phone #:	<u>575.703.6537</u>
Vertex PM:	<u>Chance Dixon</u>	Phone #:	<u>575.988.1472</u>

Objective

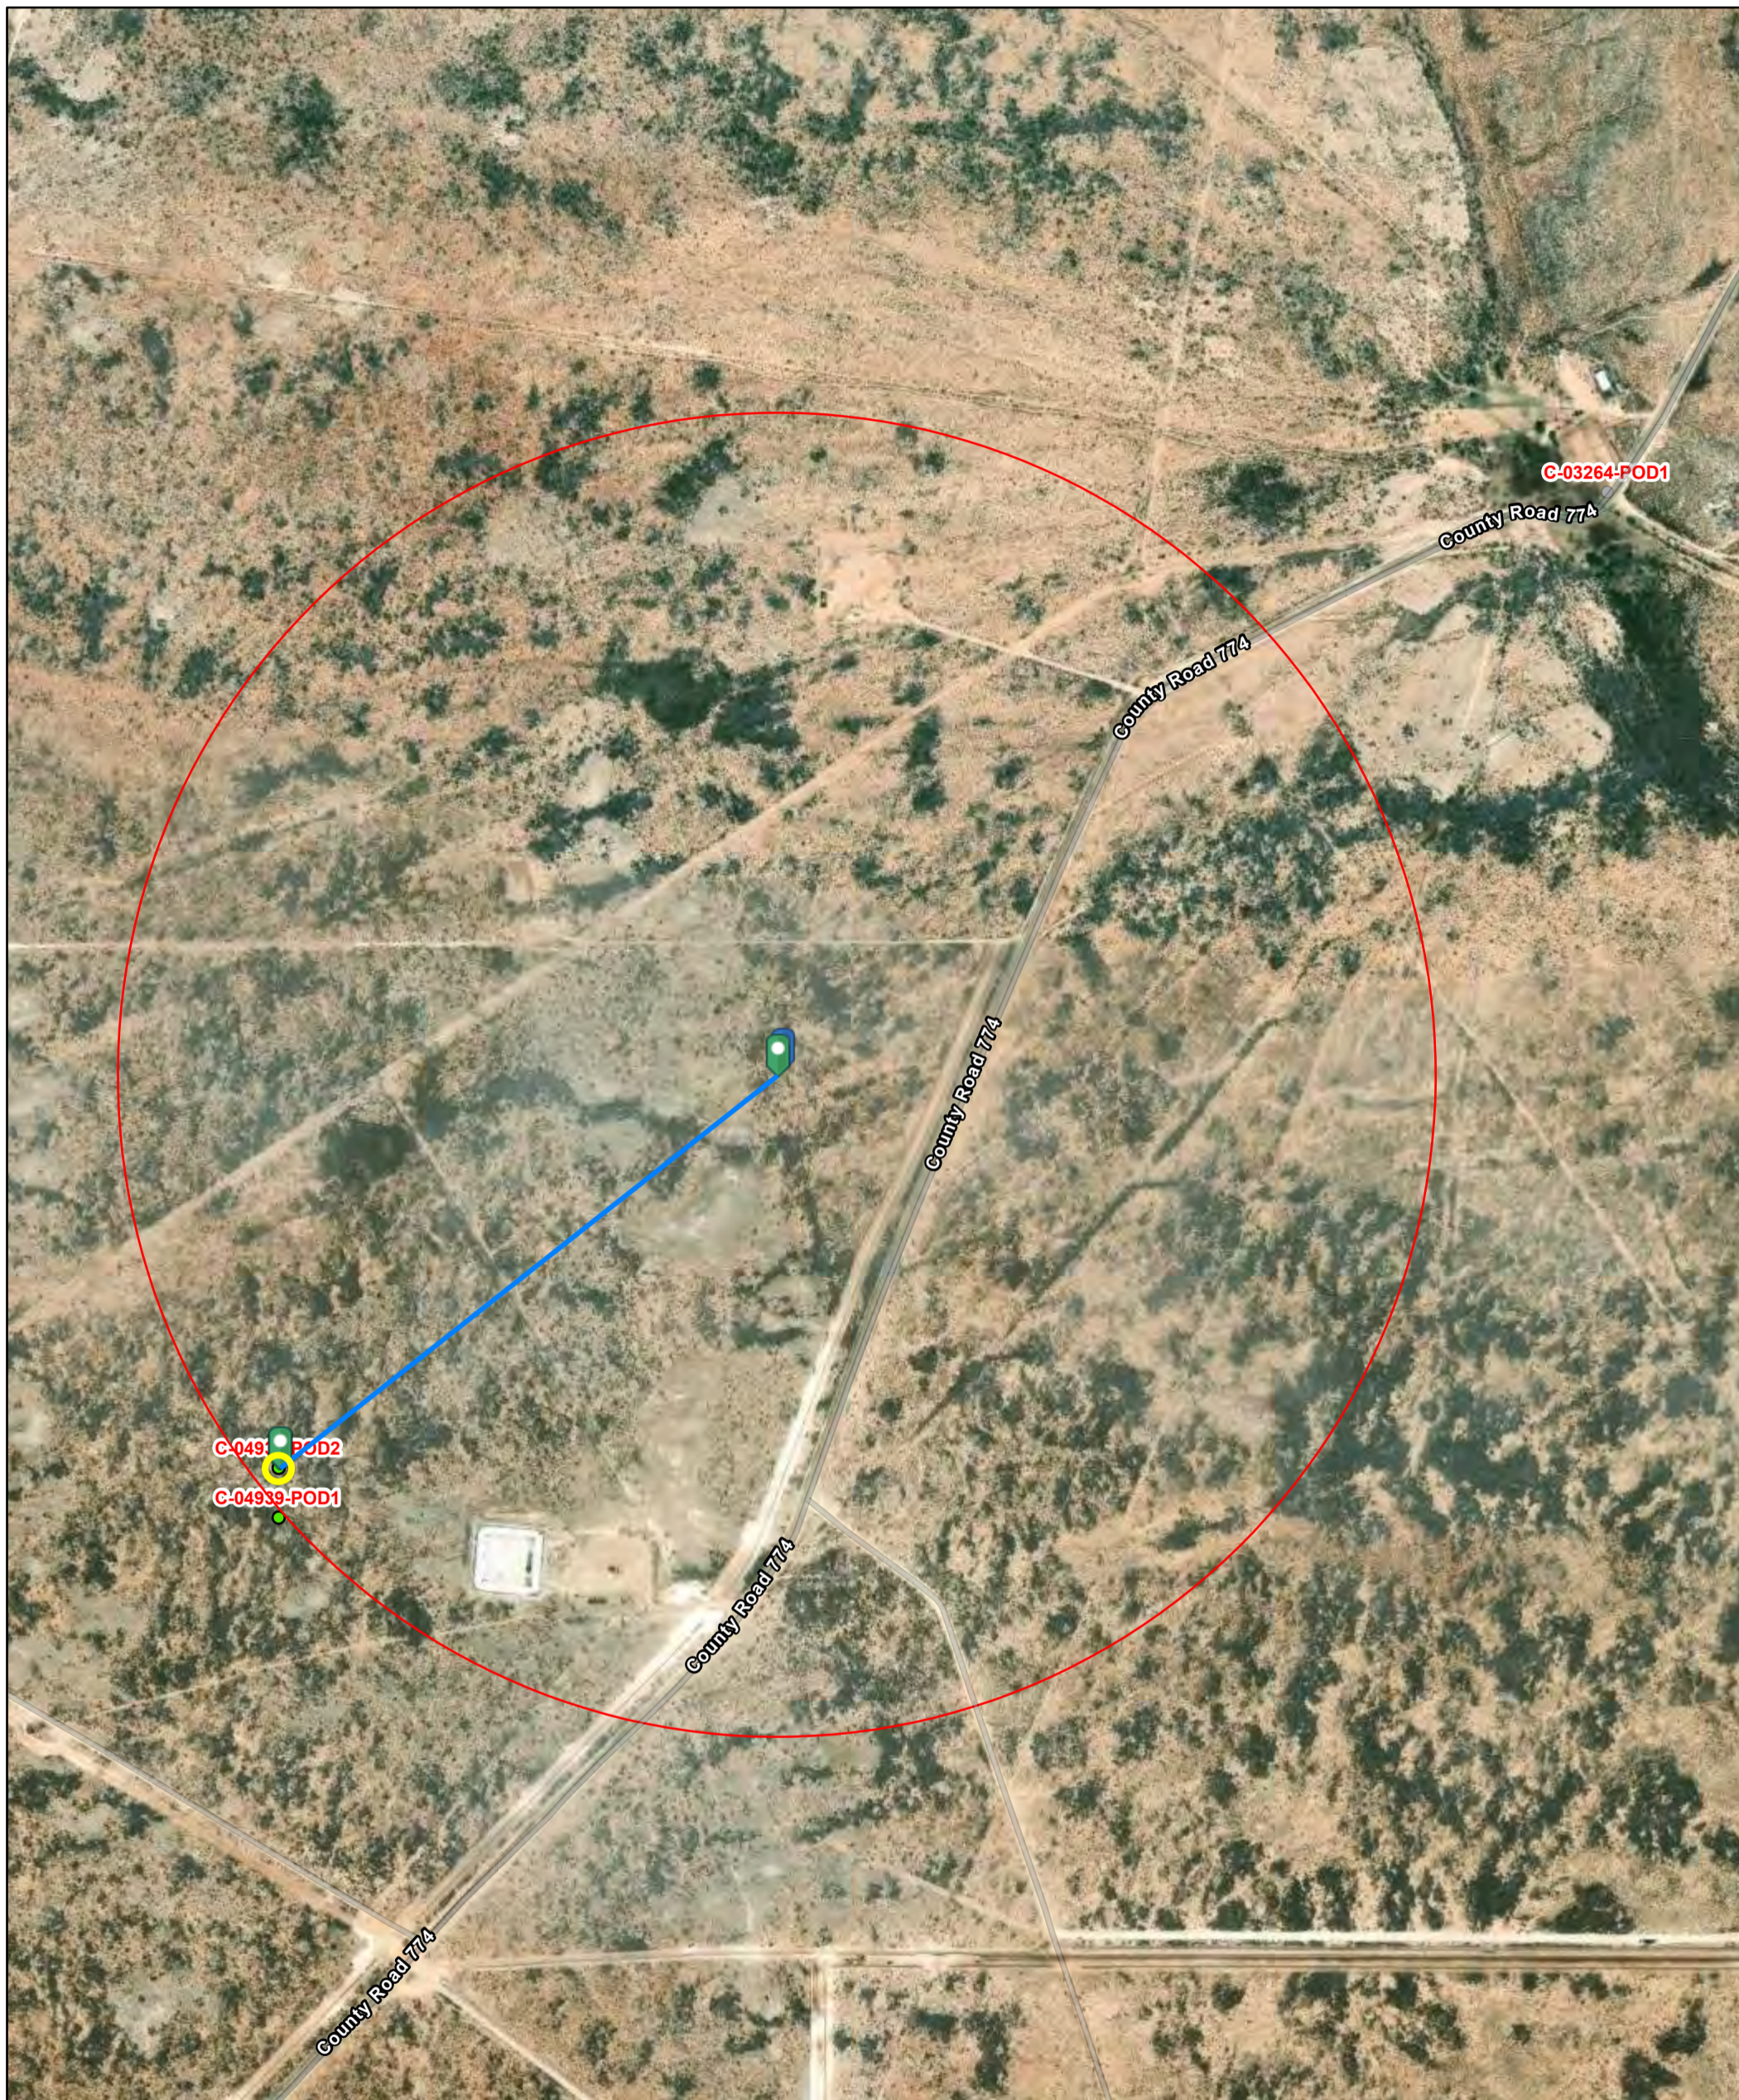
OSE POD Location Map

WR File Number:	C 04939	Subbasin:	CUB	Cross Reference:	
Primary Purpose:	MON MONITORING WELL				
Primary Status:	PMT Permit				
Total Acres:		Subfile:		Header:	
Total Diversion:	0.000	Cause/Case:			
Owner:	EOG RESOURCES	Owner Class:	Owner		
Contact:	CAYDEN SESSIONS

Closure Criteria Determination				
Site Name: Padron 10 State Com CTB AST				
Spill Coordinates: 32.159223, -104.168669		X: 578388.86	Y: 3558387.30	
Site Specific Conditions		Value	Unit	Reference
1	Depth to Groundwater (nearest reference)	>75	feet	1
	Distance between release and nearest DTGW reference	2,534	feet

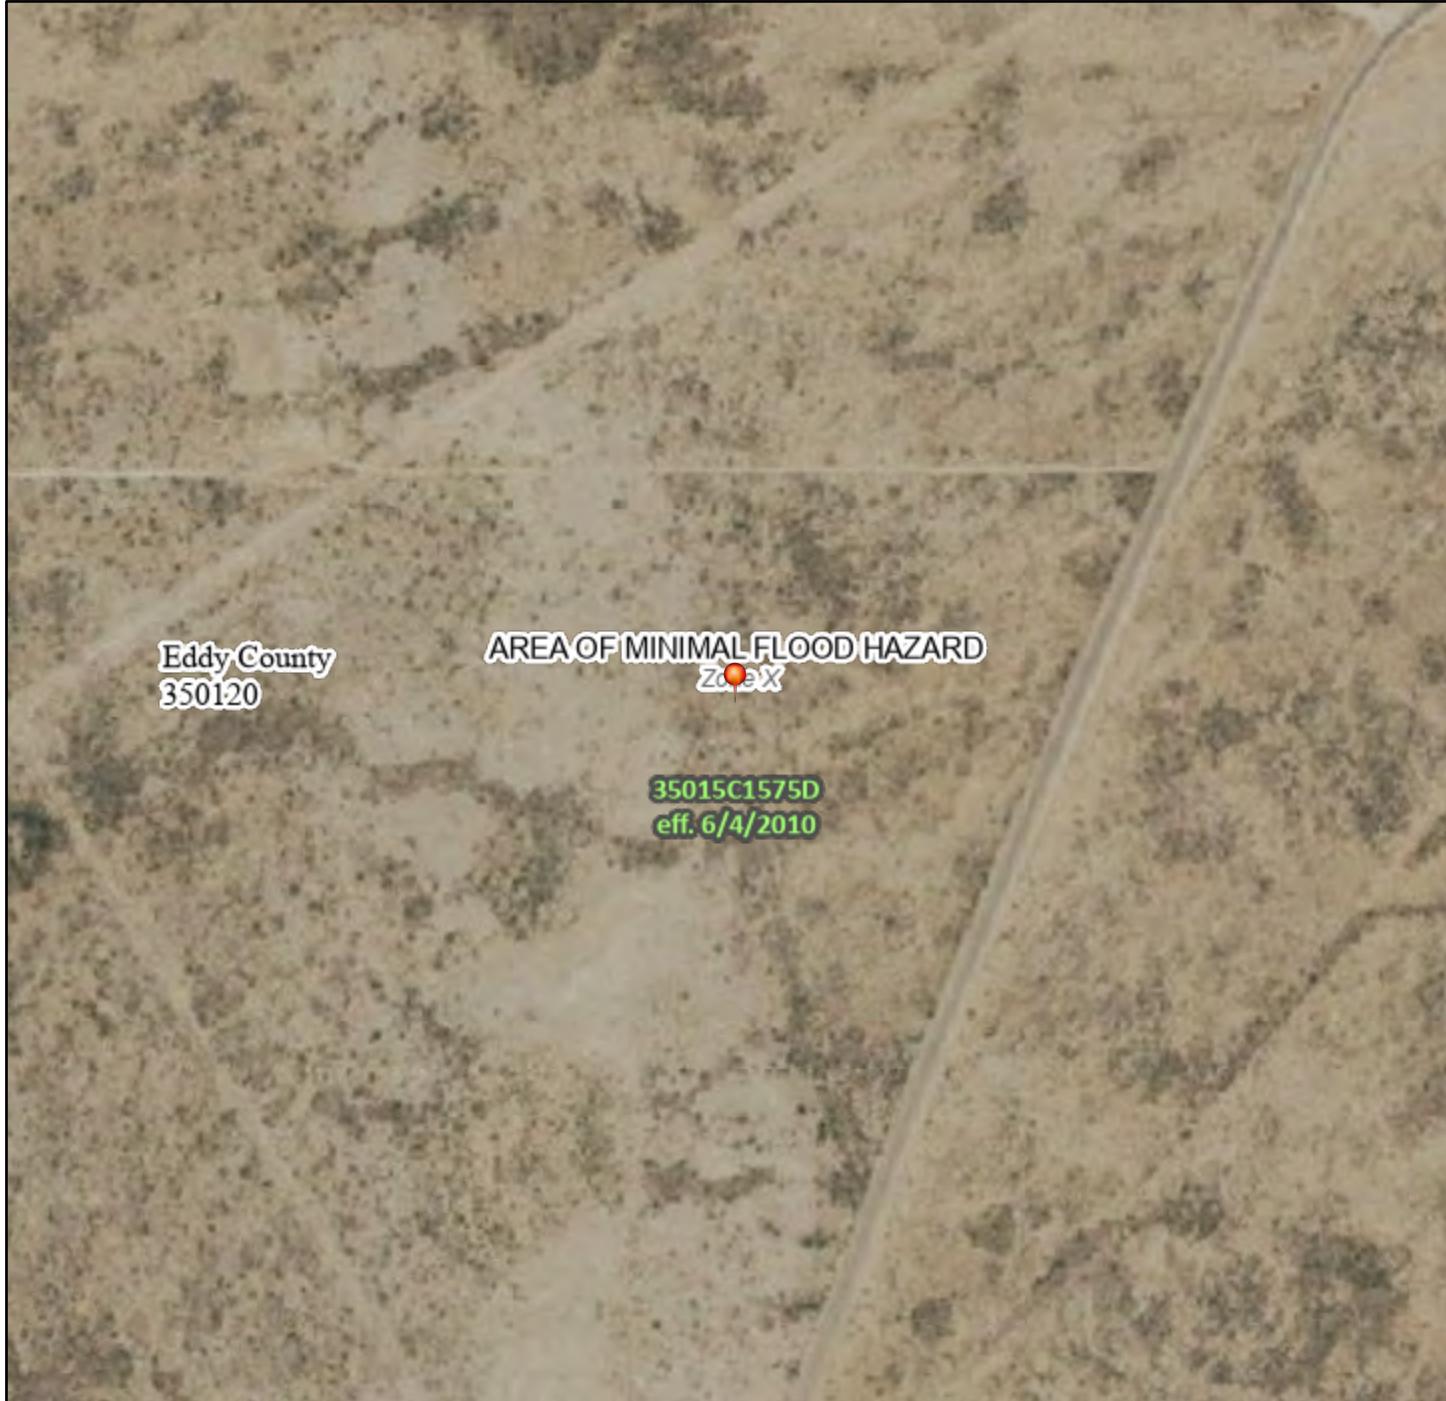
National Flood Hazard Layer FIRMette

The flood hazard information is derived directly from the authoritative NFHL web services provided by FEMA. This map was exported on 6/9/2025 at 4:30 PM and does not reflect changes or amendments subsequent to this date and time. The NFHL and effective information may change or become superseded by new data over time.
