**SITE CHARACTERIZATION, ASSESSMENT,  
& PROPOSED REMEDIATION PLAN**

**OPUNTIA DRAW ATG STATE COM #1  
API # 30-015-30757  
NMSLO LEASE # V-4858  
UNIT M, SECTION 29 TOWNSHIP 23S, RANGE 25E  
EDDY COUNTY, NEW MEXICO  
32.270893, -104.423161**

**EOG RESOURCES, INC.  
MIDLAND DIVISION  
5509 CHAMPIONS DRIVE  
MIDLAND, TEXAS 79706**

**RANGER ENVIRONMENTAL SERVICES, LLC  
P.O. BOX 201179  
AUSTIN, TEXAS 78720**

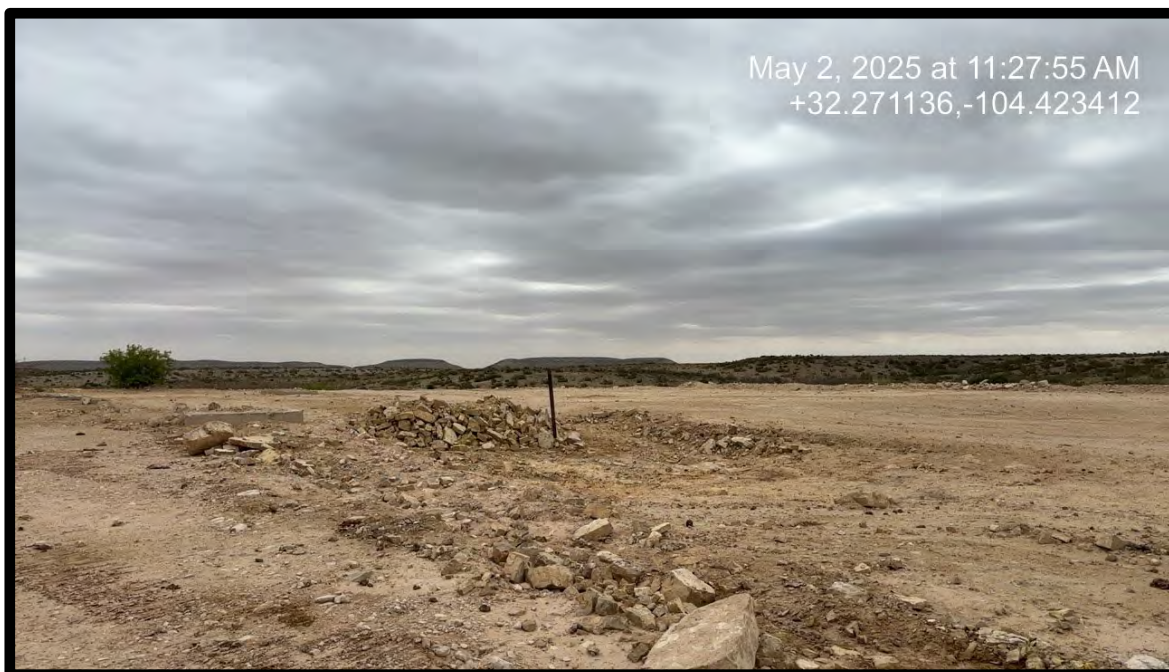
**PHOTOGRAPH NO. 1 – A current view of the Site during the May 2, 2025 Site activities. The view is towards the southeast.**

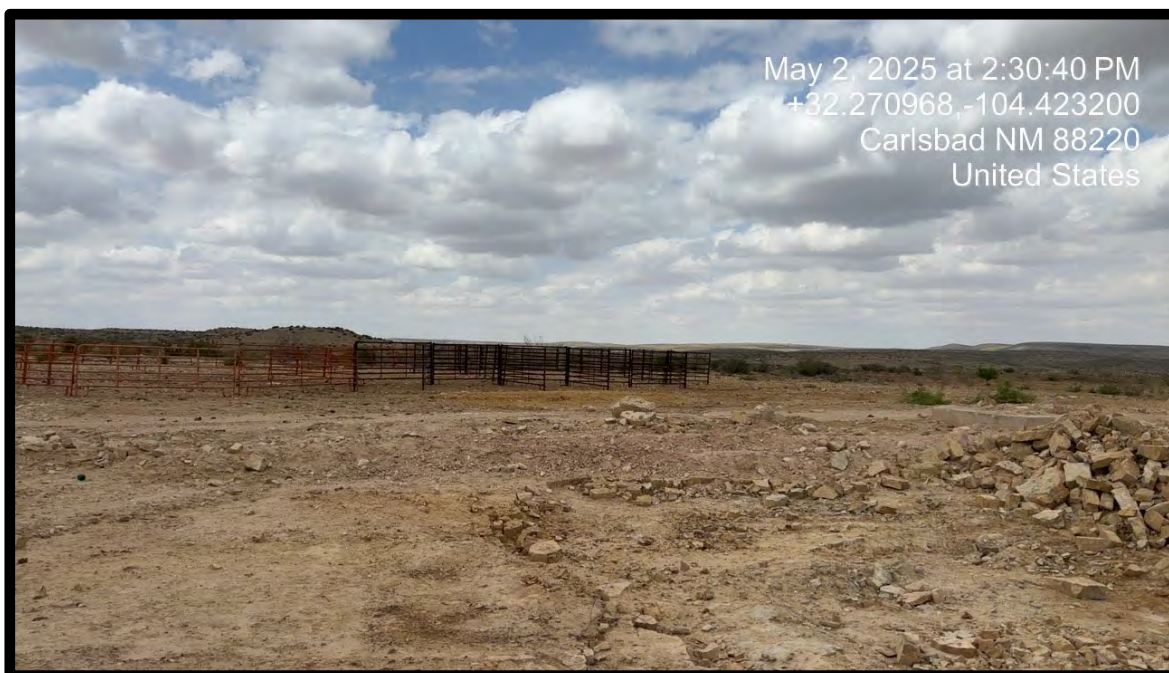
**PHOTOGRAPH NO. 2 – A view of the pit area at the Site. The view is towards the north.**

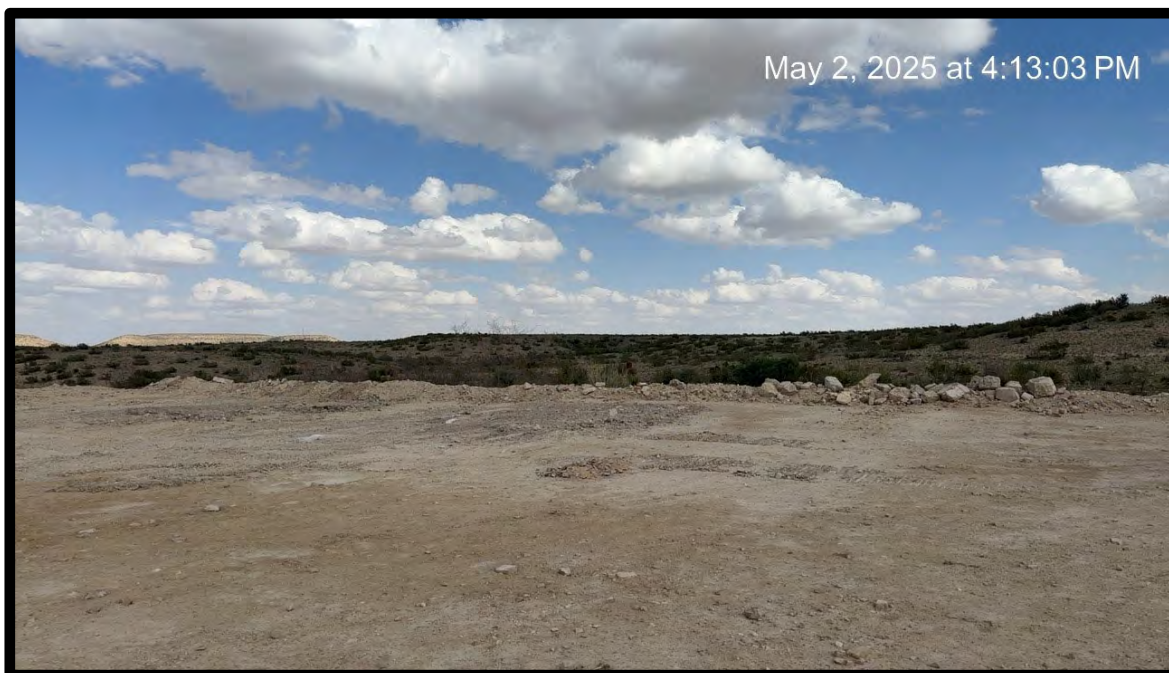
**PHOTOGRAPH NO. 3 – A current view of the former tank battery area. The view is towards the southeast.**

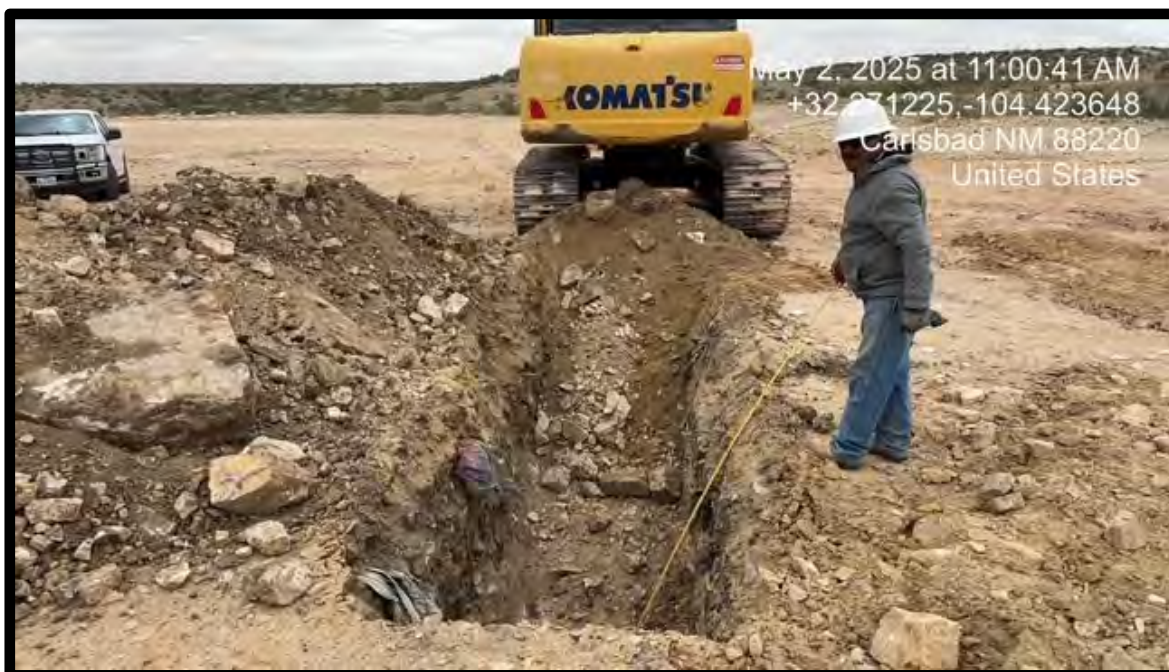
**PHOTOGRAPH NO. 4 – A view during the assessment activities in the former pit area. Plastic liner material associated with the pit can be observed in the photograph.**
