## Amended Remediation Summary & Soil Closure Request

**XTO Energy, Inc.**

**Hat Mesa 32 State 001 Battery 1,2,3**

**NMOCD Reference No. nAPP2422651676**

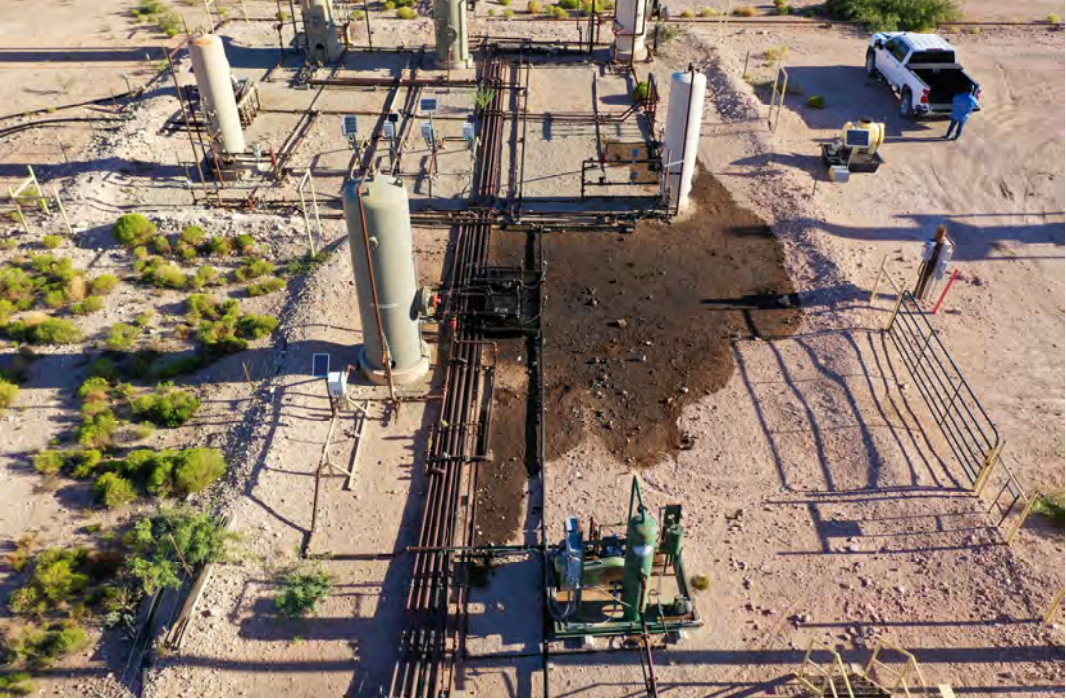
<b>Photo Number:</b> 3

<b>Photo Direction:</b> North	
<b>Coordinates:</b> 32.534872,-103.700794	
<b>Date/Time:</b> 8/15/2024, 9:04 AM	
<b>Photo Description:</b>  Aerial view of the affected area.

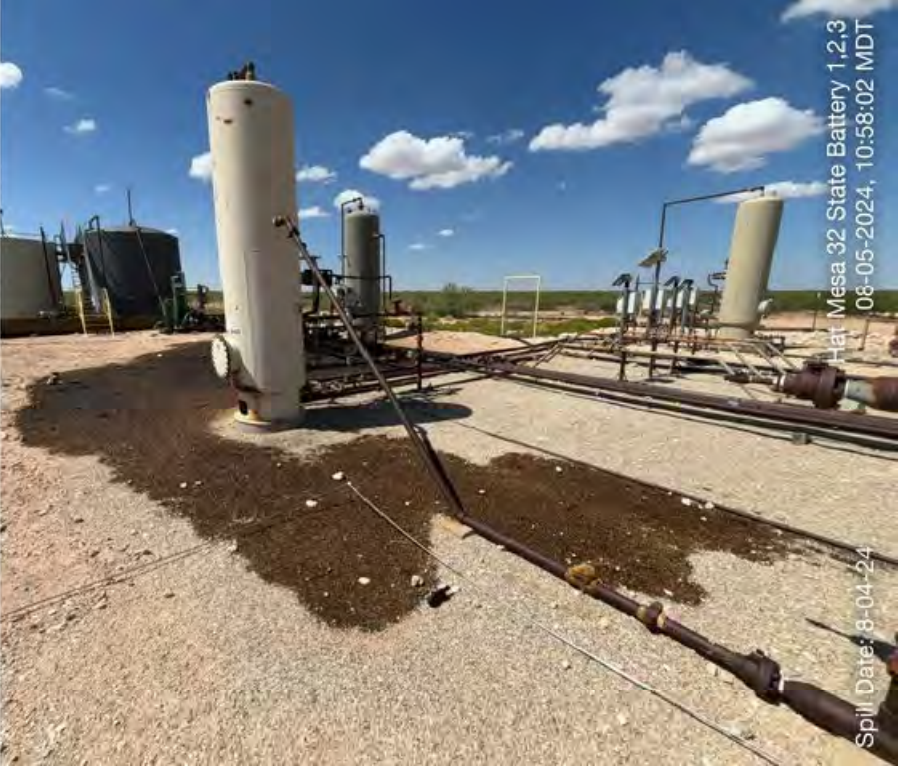
<div>Photo Number:<div>5</div></div>	<div><div><div>W</div><div>270</div><div>240</div><div>210</div><div>180</div><div>S</div></div><div>0222°SW (T) LAT: 32.535109 LON: -103.700689 ±13ft ▲ 3609ft</div><div>

</div><div>Hat Mesa 32 State Battery 1,2,3 08-05-2024, 10:58:02 MDT Spill Date: 8-04-24</div></div>
<div>Photo Direction:<div>Southwest</div></div>	
<div>Photo Description:<div>View of the affected area.</div></div>

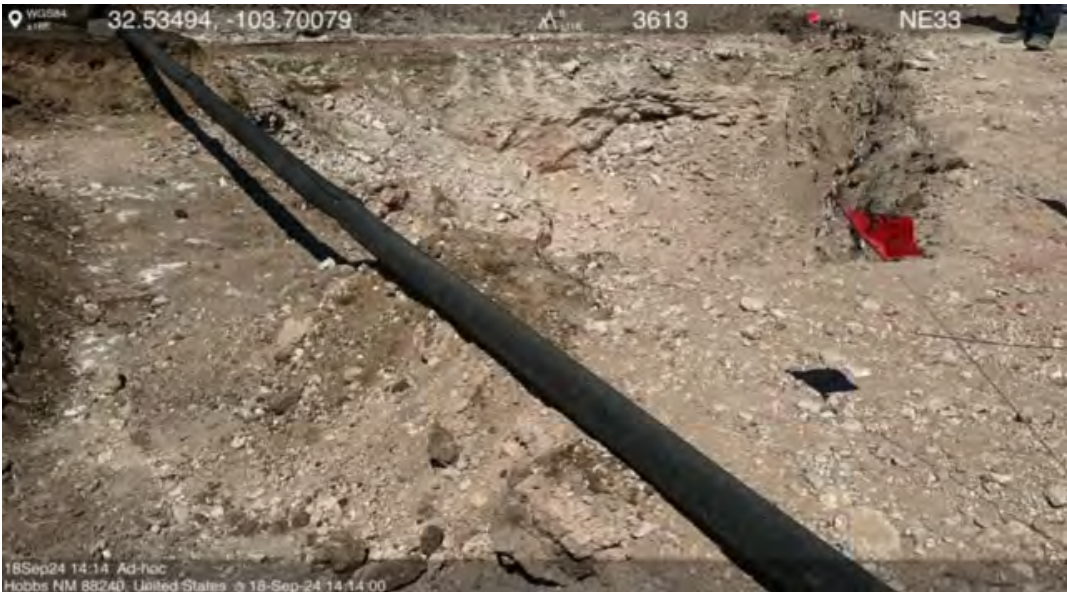
<div>Photo Number: 8</div>

<div>Photo Direction: North-Northeast</div>	
<div>Photo Description:  View of the excavated area.</div>
