**RE: Closure Request  
PLU Big Sinks 3-25-30 Battery  
Remediation Permit Number 2RP-4526 and 2RP-4744  
Eddy County, New Mexico**

LT Environmental, Inc. (LTE), on behalf of XTO Energy, Inc. (XTO), is pleased to present the following letter report detailing the soil sampling and excavation activities at the PLU Big Sinks 3-25-30 Battery (Site) in Unit Letter O, Section 3, Township 25 South, Range 30 East, in Eddy County, New Mexico (Figure 1). The purpose of the soil sampling and excavation activities was to assess impacts to soil after two separate events caused the release of crude oil and of produced water on the well pad and the surrounding pasture.

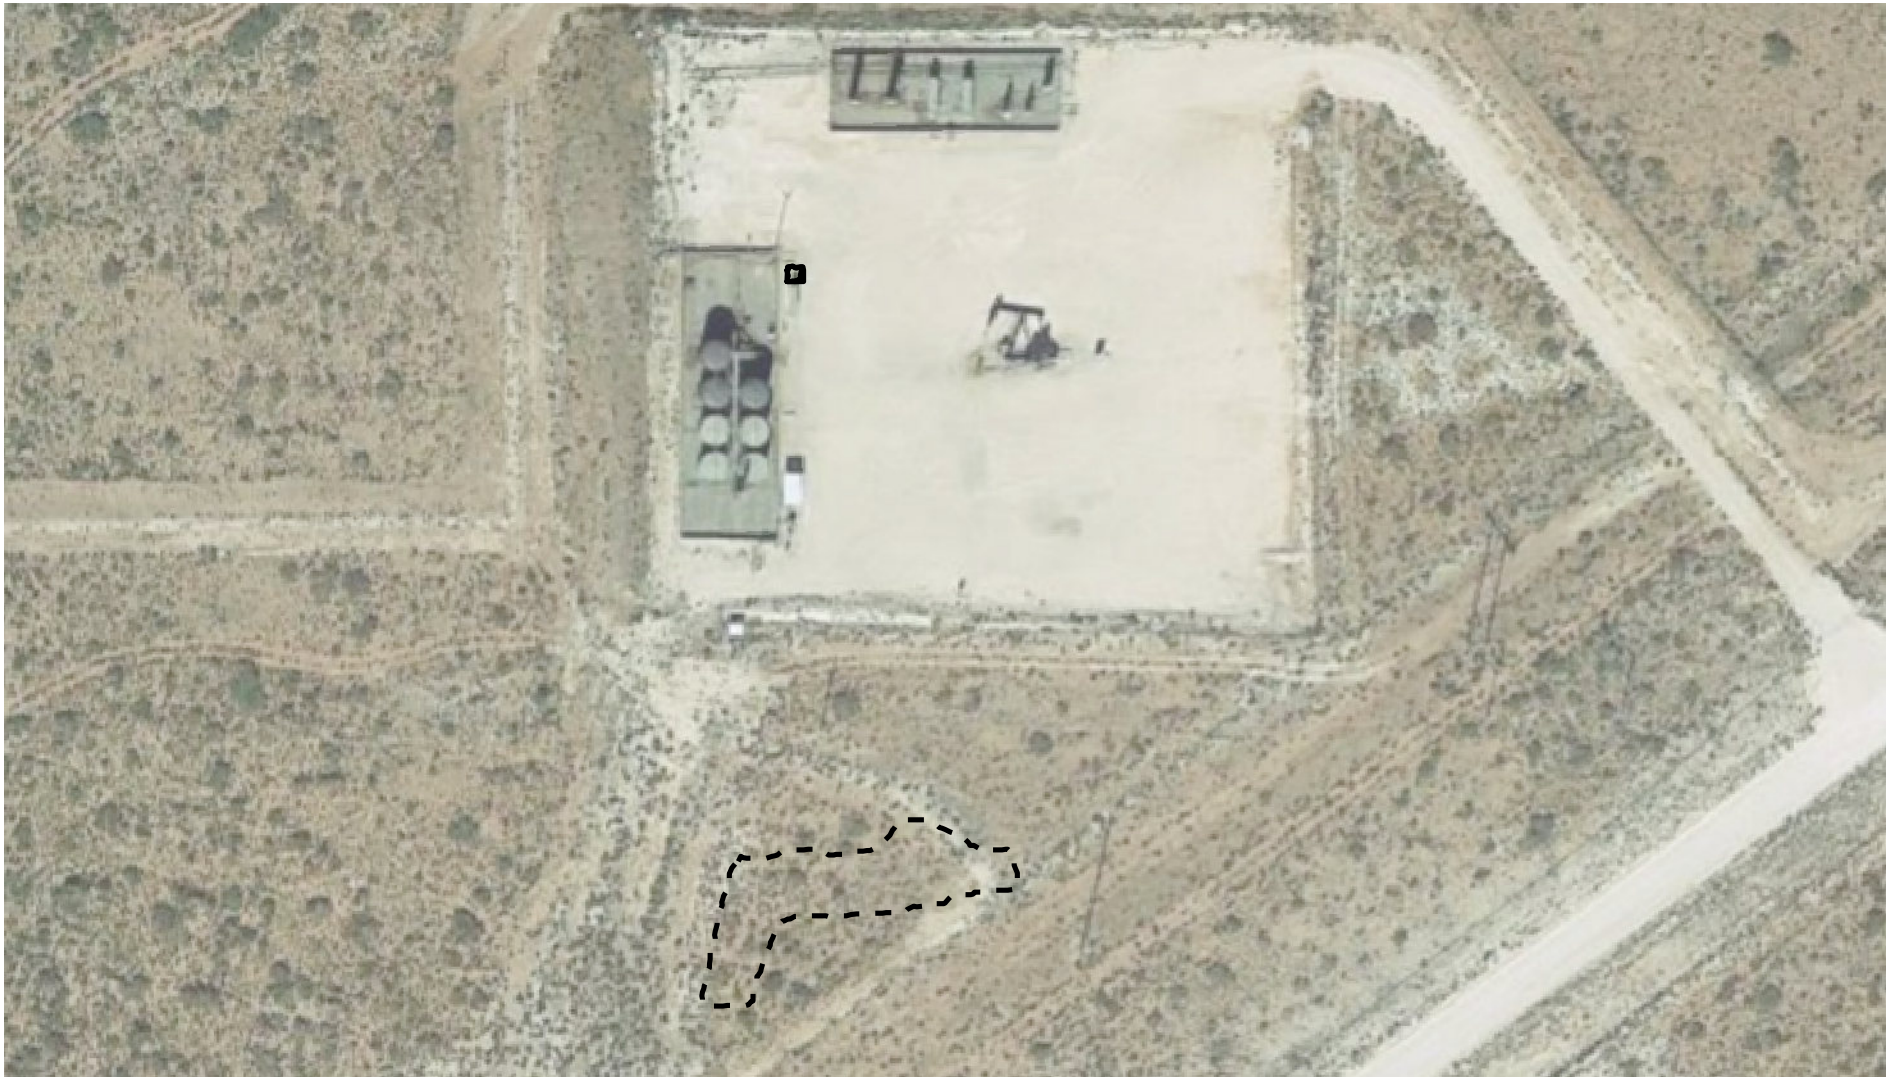
**FIGURE 3**  
**SITE MAP**  
PLU BIG SINKS 3-25-30 BATTERY  
UNIT 0 SEC 3 T25S R30E  
EDDY COUNTY, NEW MEXICO  
**XTO ENERGY, INC.**

During June and July 2018, LTE personnel returned to the Site to oversee excavation of impacted soil. Excavation activities commenced on June 12 and concluded on July 17, 2018. To delineate hydrocarbon and chloride impacts to soil and direct excavation activities, LTE screened soil samples using a PID and Hach® chloride QuanTab® test strips. The final excavation extents are depicted on Figure 3.

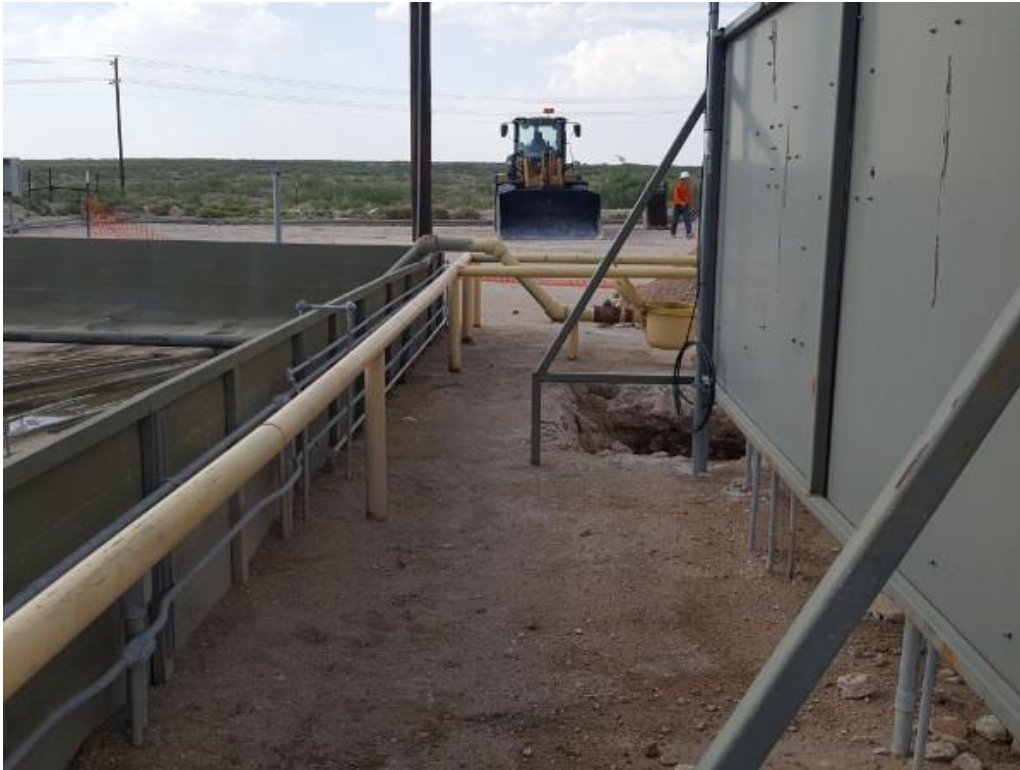
**Photograph 1:** View north west of equipment and excavation.

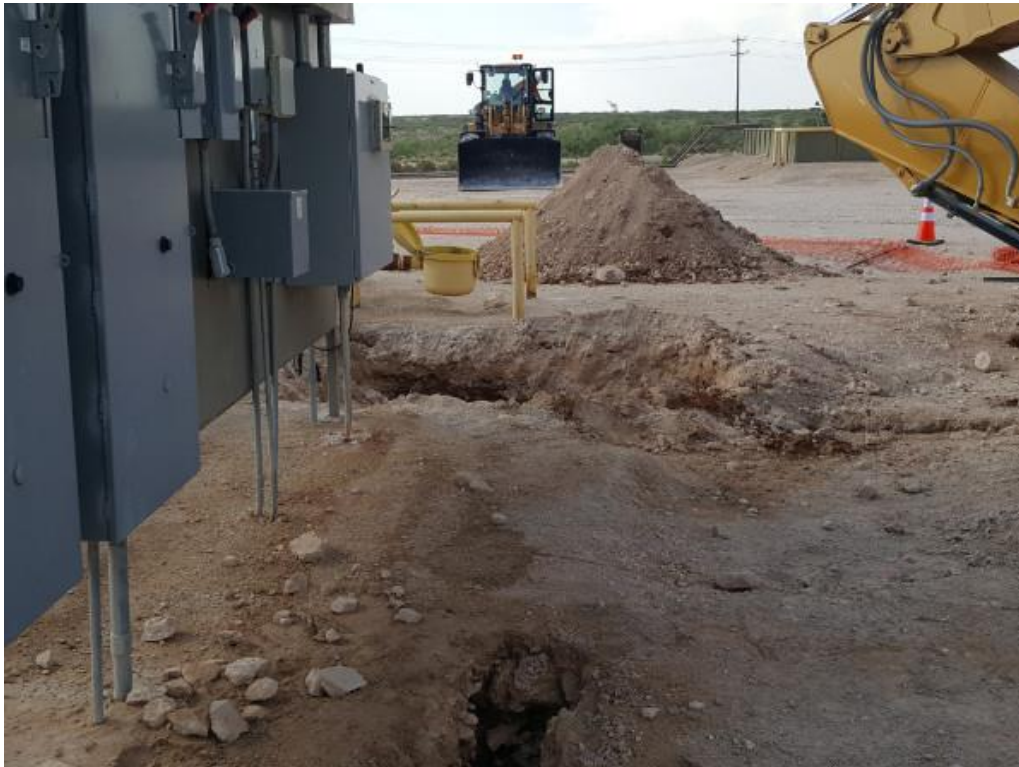
**Photograph 2:** View north east of excavation.

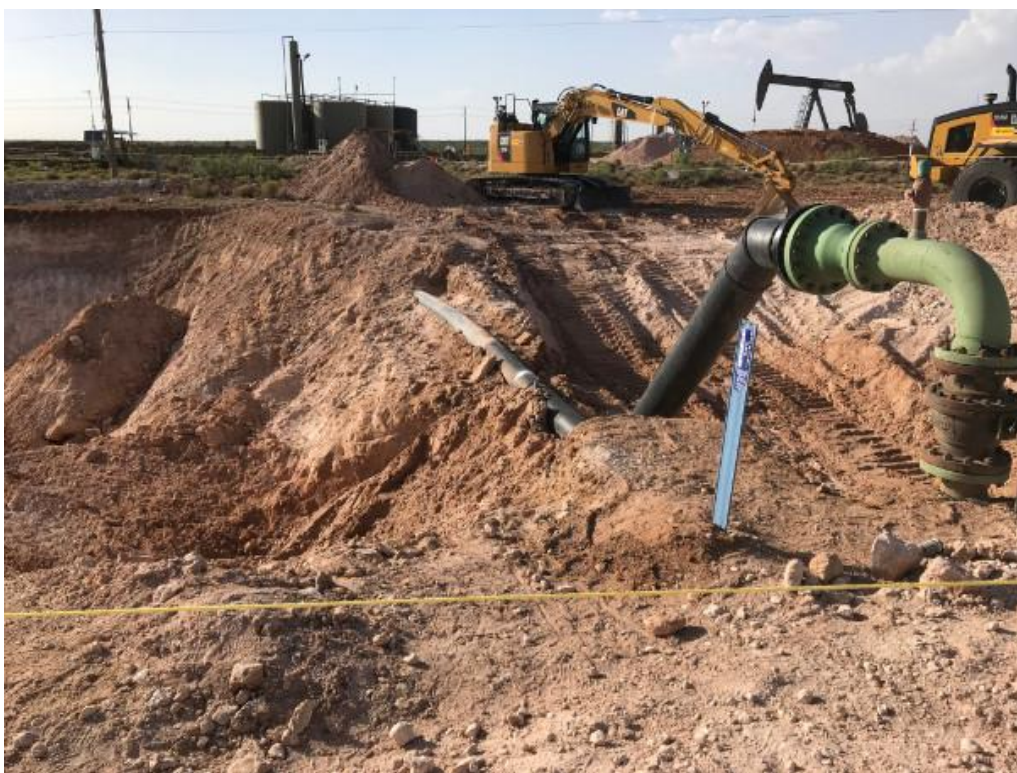
**Photograph 1:** View north of excavation.

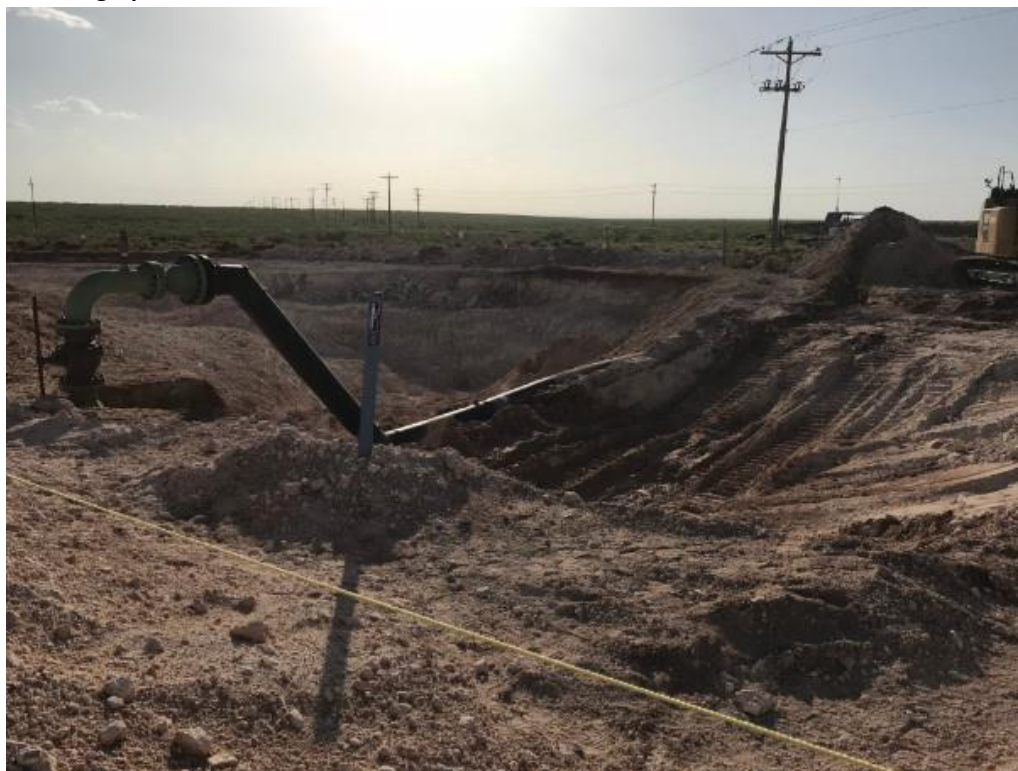
**Photograph 2:** View northwest of excavation.
