**Re: Closure Request  
PLU 431H  
Incident Number nAPP2516451693  
Eddy County, New Mexico**

Ensolum, LLC (Ensolum), on behalf of XTO Energy, Inc. (XTO), has prepared this *Closure Request* to document assessment, excavation, and soil sampling activities at the PLU 431H (Site). The purpose of the assessment and sampling activities was to assess for the presence or absence of impacts to soil following a pipeline failure resulting in the release of crude oil and produced water on a lease road. Based on field observations, field screening activities, and soil sample laboratory analytical results, XTO is submitting this *Closure Request*, describing assessment, excavation, and soil sampling activities that have occurred and requesting no further action for Incident Number nAPP2516451693.

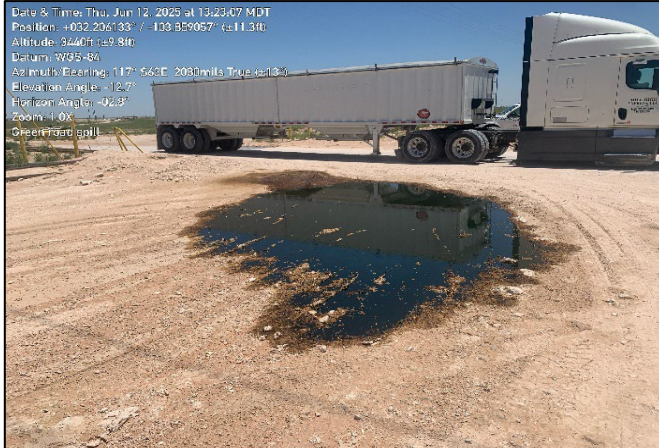
Photograph: 1 Date: 6/12/2025  
 Description: Pooling in release footprint  
 View: Southeast

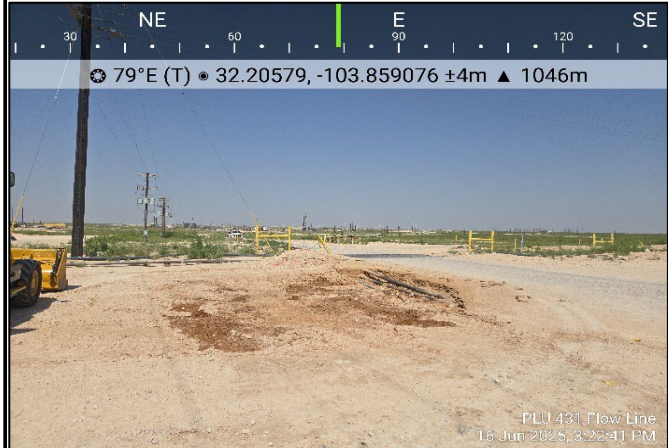
Photograph: 2 Date: 6/16/2025  
 Description: Excavation activities; near FS02  
 View: East

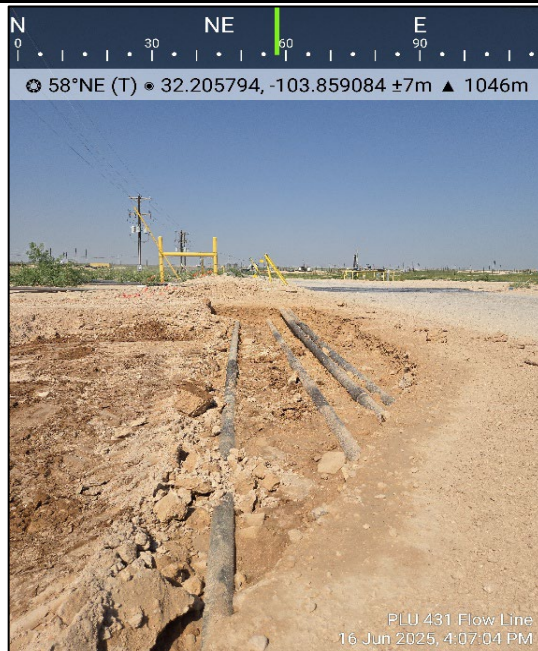
Photograph: 3 Date: 6/16/2025  
 Description: Excavation activities; near FS01  
 View: Northeast
