## Remediation Summary & Soil Closure Request

**XTO Energy, Inc.**

**PLU 26 Brushy Draw CVB**

**NMOCD Reference No. nAPP2406161820**

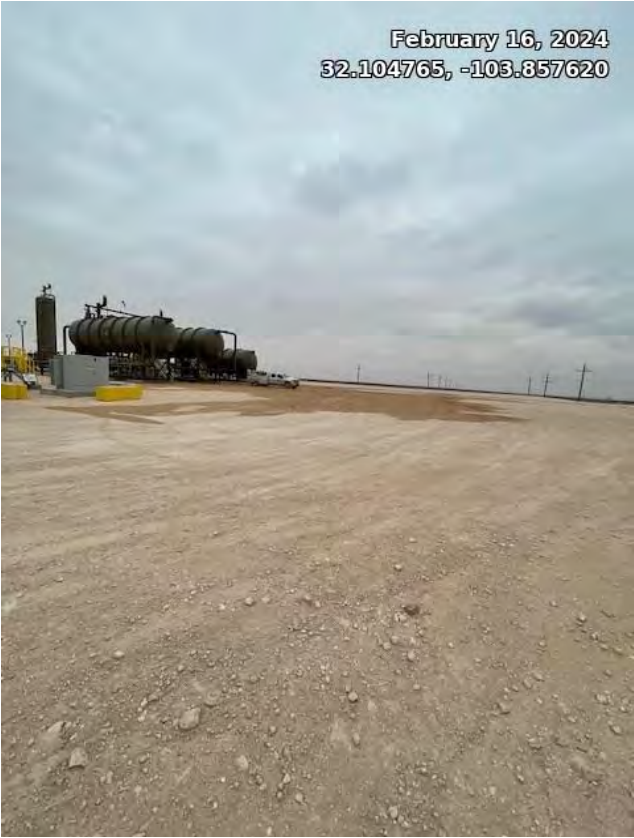
| <b>Photo Number:</b><br>1 | |

| <b>Photo Direction:</b><br>Southeast | |
| <b>Photo Description:</b><br><br>View of the affected area. | |

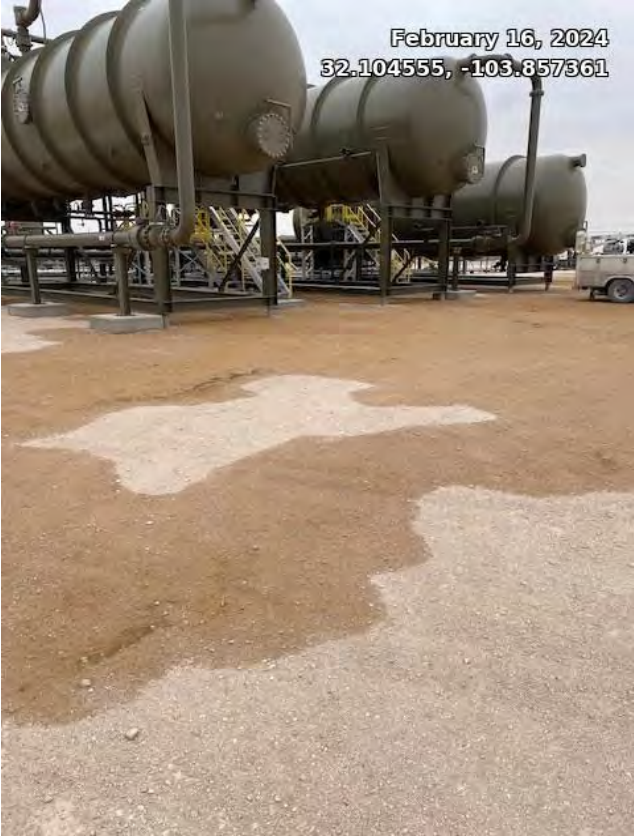
| <b>Photo Number:</b><br>2 | |

| <b>Photo Direction:</b><br>Southeast | |
| <b>Photo Description:</b><br><br>View of the affected area. | |

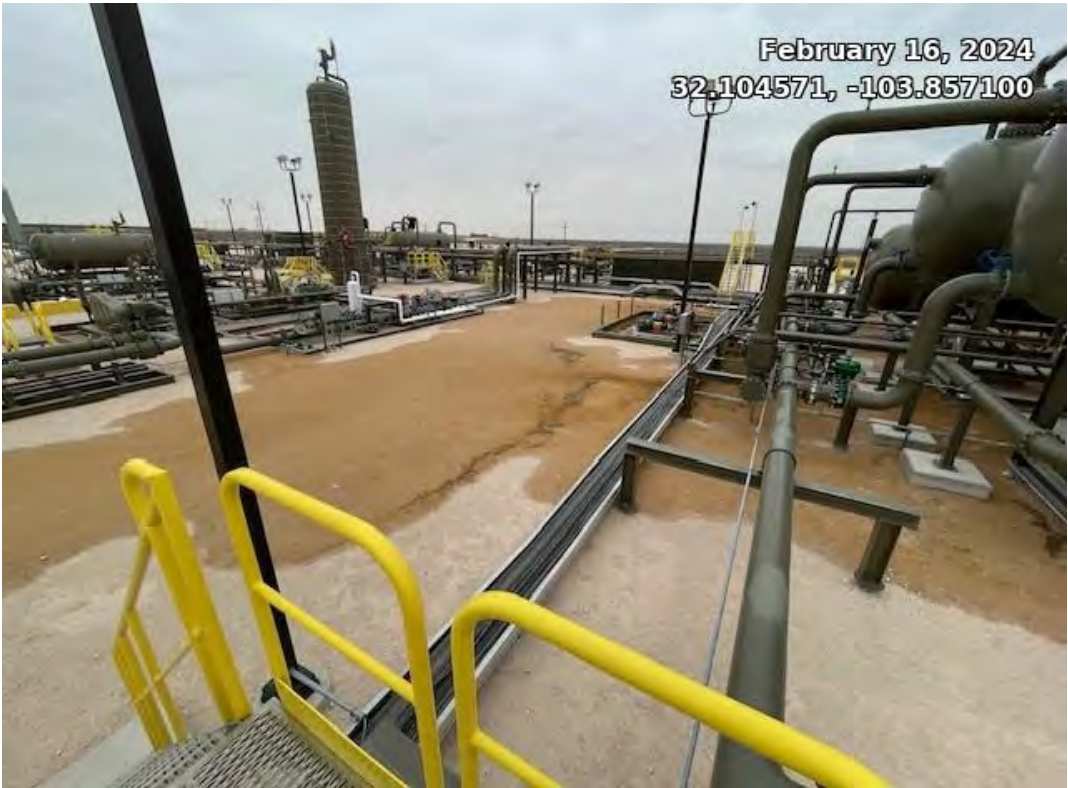
| <b>Photo Number:</b><br>3 | |

| <b>Photo Direction:</b><br>South-Southeast | |
| <b>Photo Description:</b><br><br>View of the affected area. | |

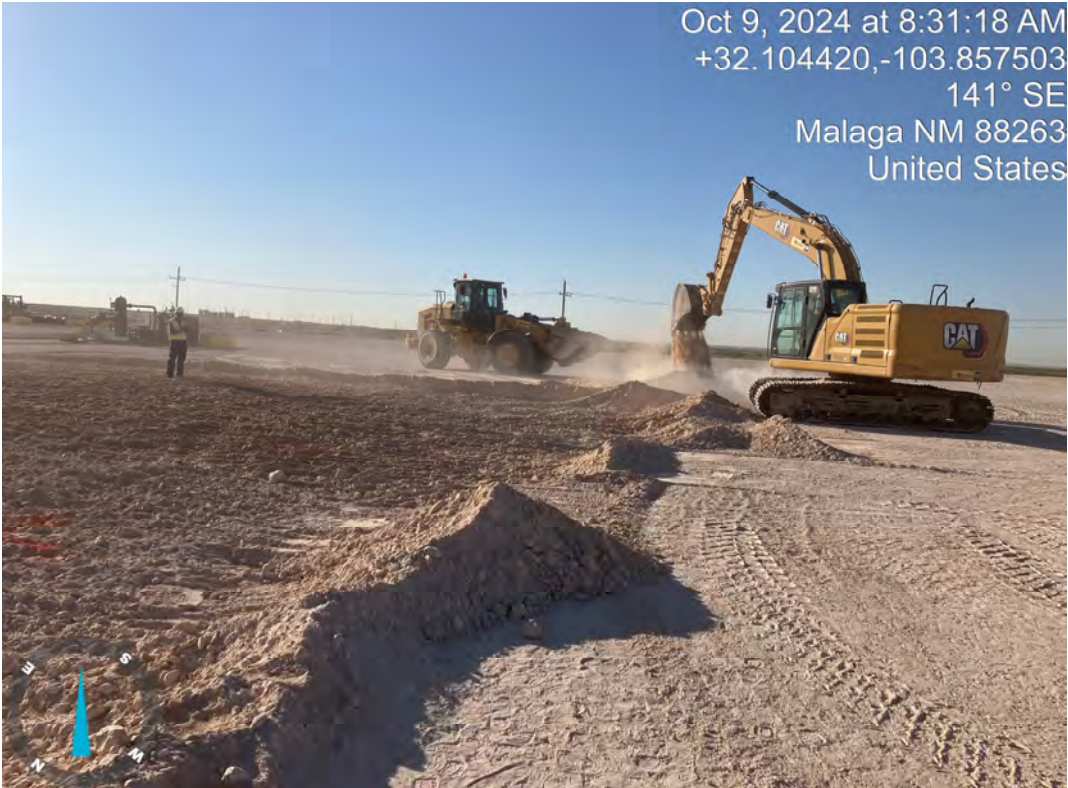
| <b>Photo Number:</b><br>4 | |

| <b>Photo Direction:</b><br>Southeast | |
| <b>Photo Description:</b><br><br>View of the excavated area. | |

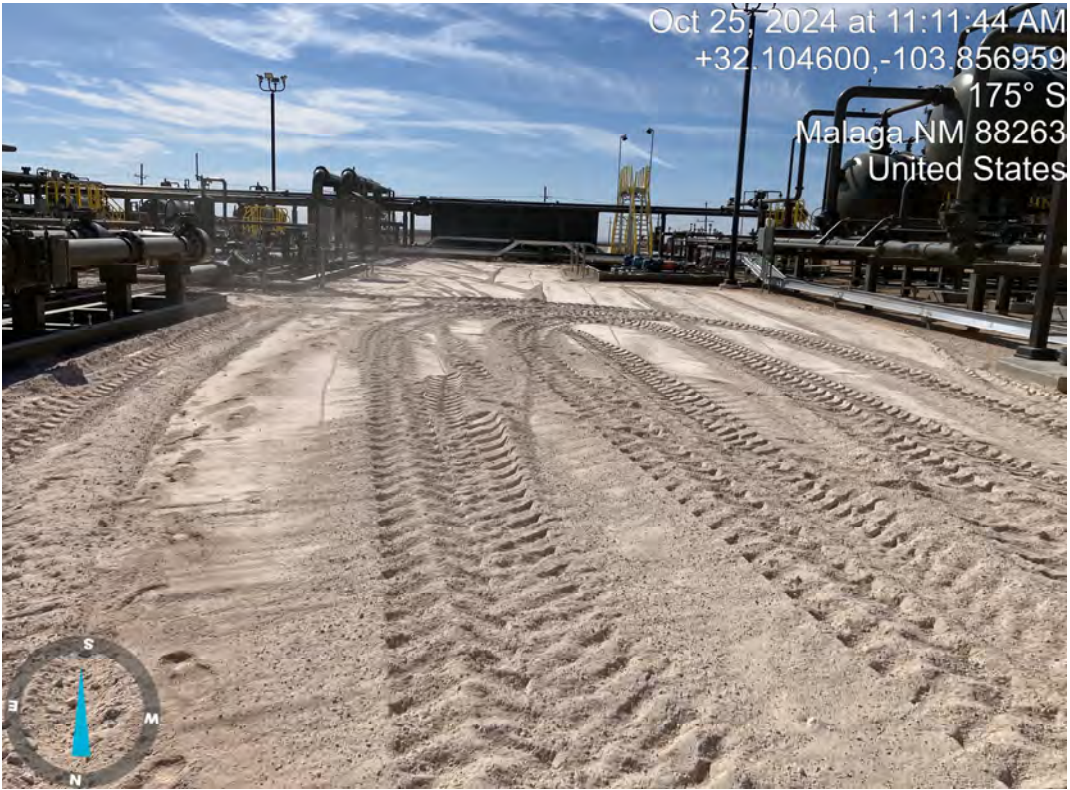
| <b>Photo Number:</b><br>9 | <p>Oct 25, 2024 at 11:11:44 AM<br/>+32.104600,-103.856959<br/>175° S<br/>Malaga NM 88263<br/>United States</p> |

| <b>Photo Direction:</b><br>South | |
| <b>Photo Description:</b><br><br>View of the remediated area following backfill and regrading. | |

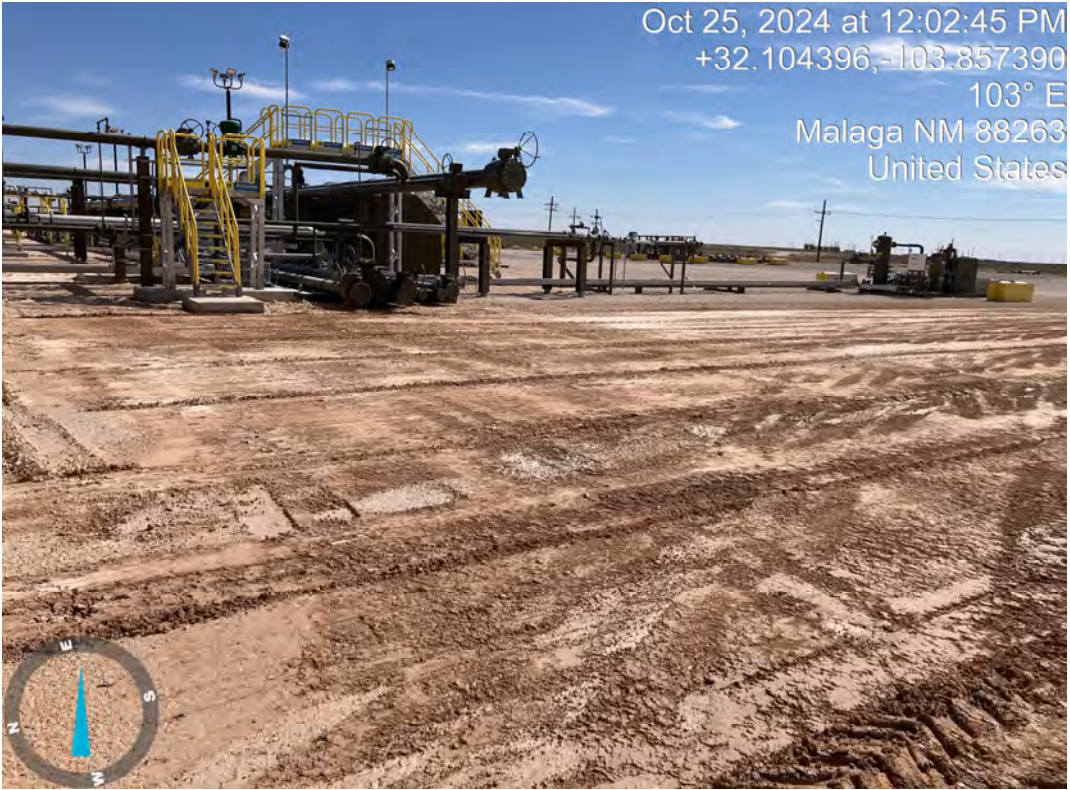
| <b>Photo Number:</b><br>10 | <p>Oct 25, 2024 at 12:02:45 PM<br/>+32.104396,-103.857390<br/>103° E<br/>Malaga NM 88263<br/>United States</p> |

| <b>Photo Direction:</b><br>East-Southeast | |
| <b>Photo Description:</b><br><br>View of the remediated area following backfill and regrading. | |
