## Release Assessment and Closure

Adeline ALN Federal CTB

Vertex File Number: 25A-04460

EOG Resources, Inc.

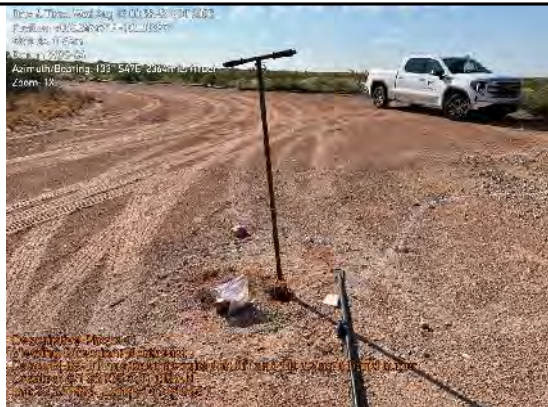
## Viewing Direction: Southeast

BH25-01 has been acquired at 0ft and 1ft using a hand auger

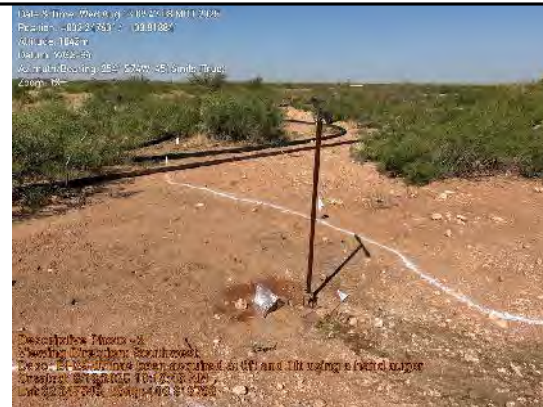
## Viewing Direction: Southwest

BH25-07 has been acquired at 0ft and 1ft using a hand auger

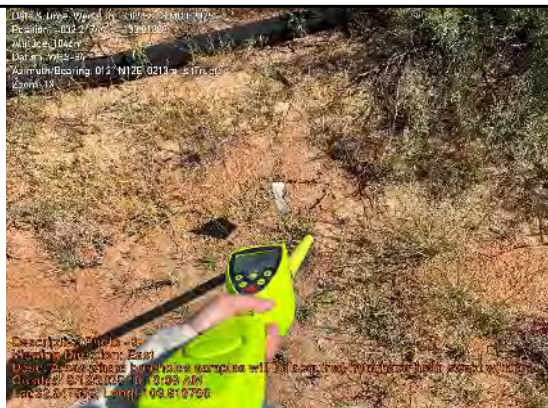
## Viewing Direction: Northeast

Areas where boreholes samples will be acquired from have been swept with a line locator

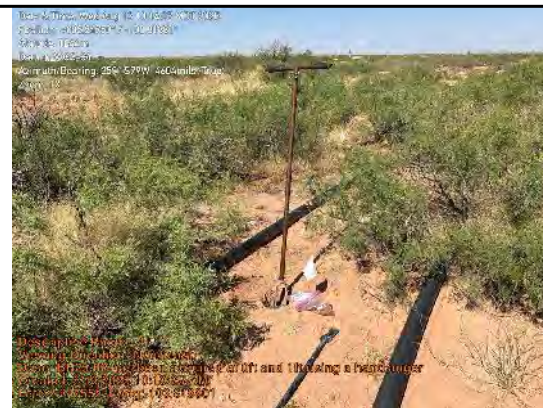
## Viewing Direction: Southwest

BH25-02 has been acquired at 0ft and 1ft using a hand auger

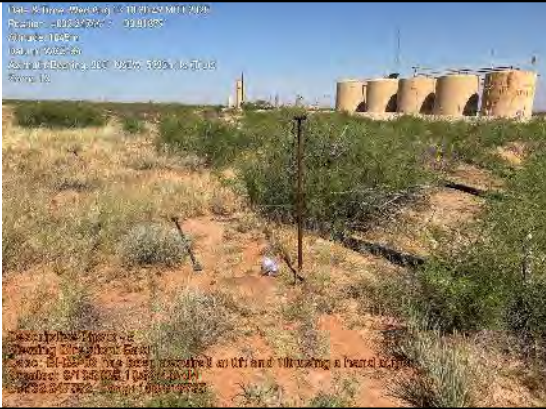
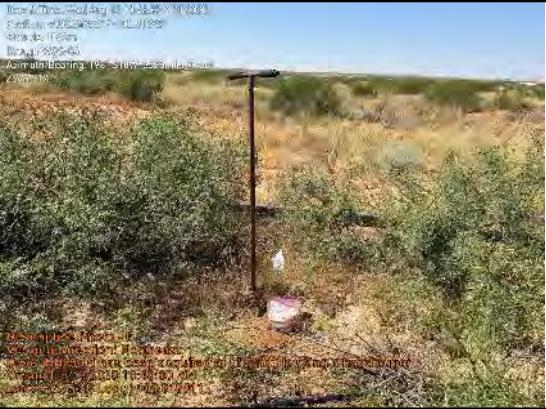
| <p><b>Viewing Direction: Northwest</b></p> <p> <b>Description Photo - 3</b><br/> Viewing Direction: Northwest<br/> Date: 09-13-2025<br/> Time: 11:45:44<br/> Location: 32° 54' 00" N, 109° 54' 00" W<br/> Elevation: 3250 ft<br/> Description: BH25-03 has been acquired at 0ft and 1ft using a hand auger </p> | <p><b>Viewing Direction: Southwest</b></p> <p> <b>Description Photo - 4</b><br/> Viewing Direction: Southwest<br/> Date: 09-13-2025<br/> Time: 11:45:44<br/> Location: 32° 54' 00" N, 109° 54' 00" W<br/> Elevation: 3250 ft<br/> Description: BH25-04 has been acquired at 0ft and 1ft using a hand auger </p> |

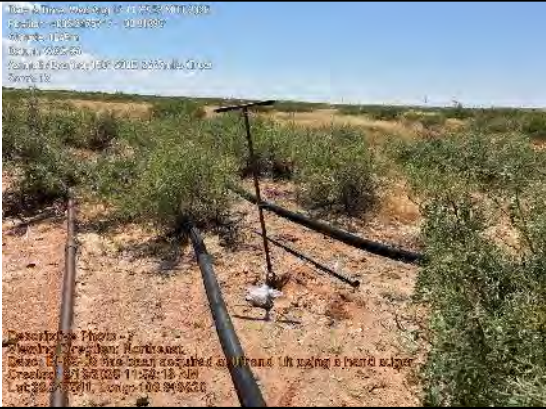
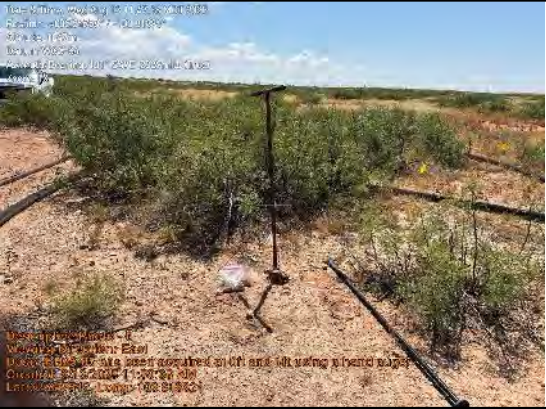
| <p><b>Viewing Direction: Southeast</b></p> <p> <b>Description Photo - 7</b><br/> Viewing Direction: Southeast<br/> Date: 09-13-2025<br/> Time: 11:45:44<br/> Location: 32° 54' 00" N, 109° 54' 00" W<br/> Elevation: 3250 ft<br/> Description: BH25-08 has been acquired at 0ft and 1ft using a hand auger </p> | <p><b>Viewing Direction: Southeast</b></p> <p> <b>Description Photo - 8</b><br/> Viewing Direction: Southeast<br/> Date: 09-13-2025<br/> Time: 11:45:44<br/> Location: 32° 54' 00" N, 109° 54' 00" W<br/> Elevation: 3250 ft<br/> Description: BH25-05 has been acquired at 0ft and 1ft using a hand auger </p> |

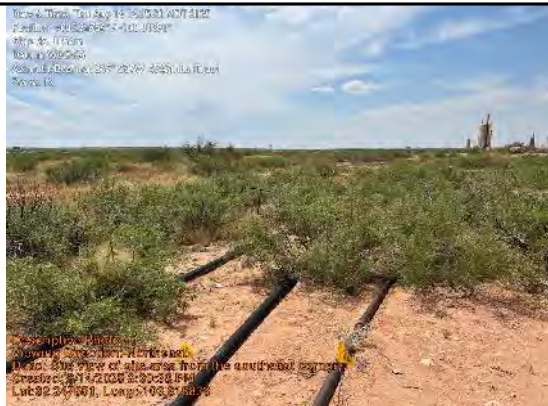
## Viewing Direction: Southwest

Site view of the East end of the release

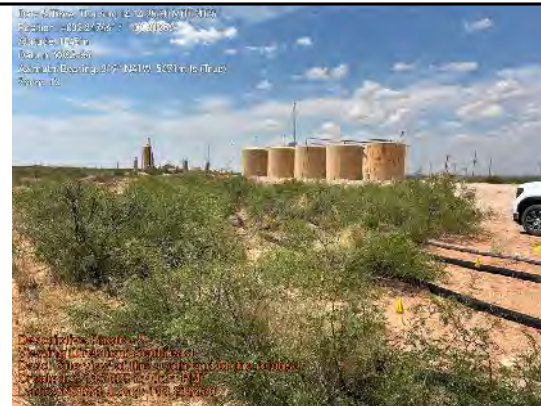
## Viewing Direction: Northwest

Site view of site area from the southeast corner. BH25-06 is where auger is at in this image.

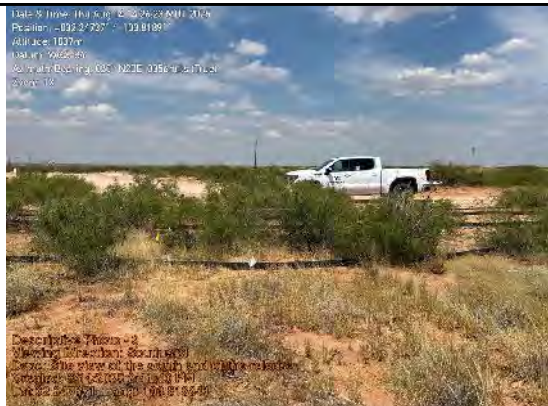
## Viewing Direction: Northeast

Site view of the south end of the release

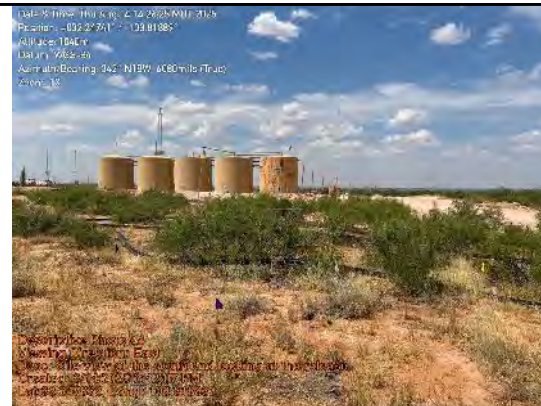
## Viewing Direction: East

Site view of the south end looking at the release

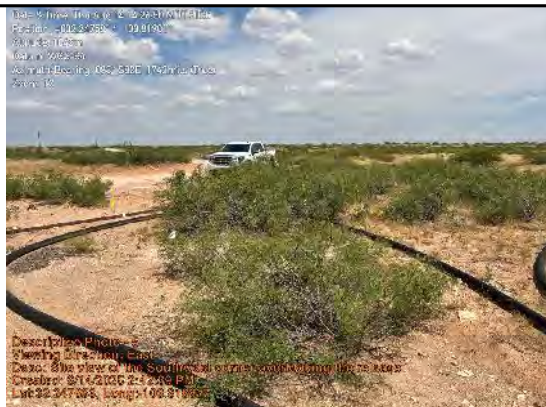
### Viewing Direction: Southeast

Site view of the Southwest corner overlooking the release

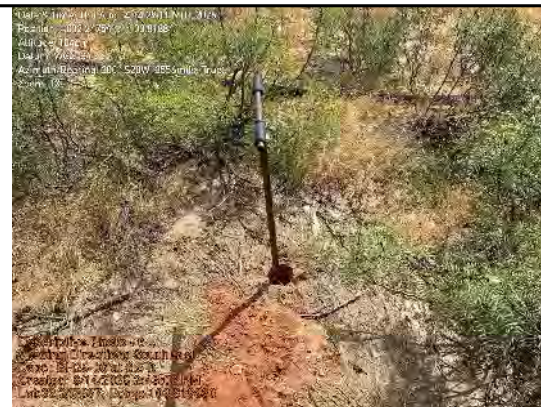
### Viewing Direction: West

BH25-06 at 2.5 ft

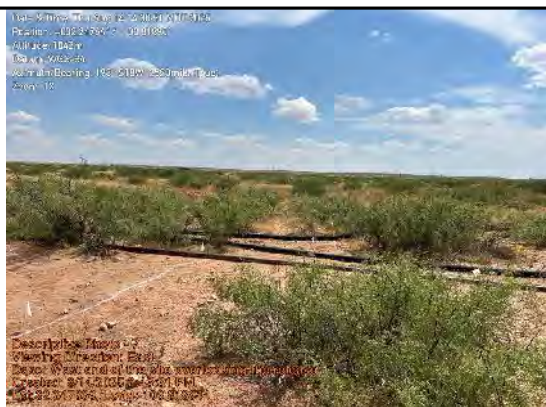
### Viewing Direction: Southwest

West end of the site overlooking the release

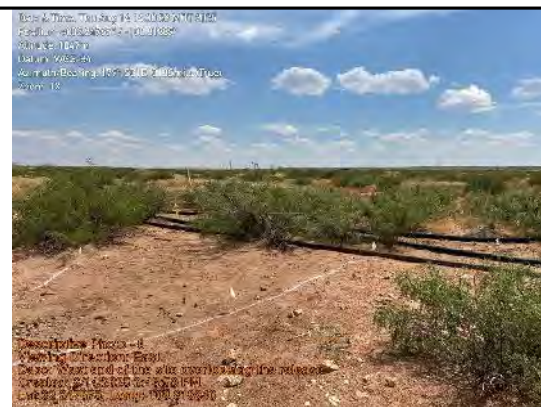
### Viewing Direction: Southeast

West end of the site overlooking the release

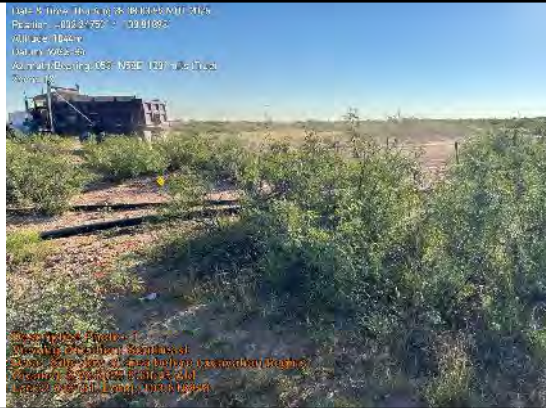
## Viewing Direction: Northeast

Site view of area before excavation begins from the Southwest corner.

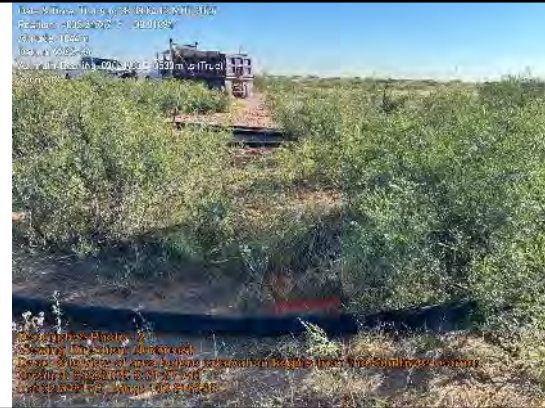
## Viewing Direction: Northeast

Site view of area before excavation begins from the South end.

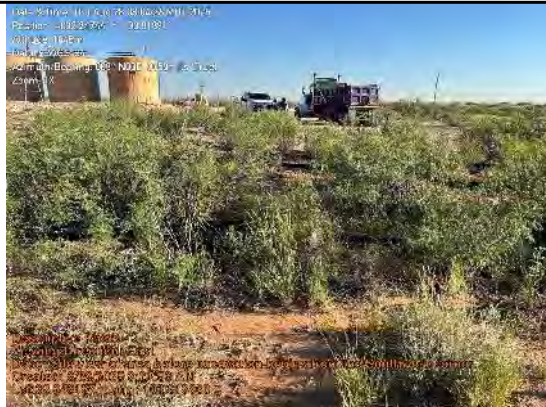
## Viewing Direction: Northeast

Site view of area before excavation begins from the Southeast corner looking west

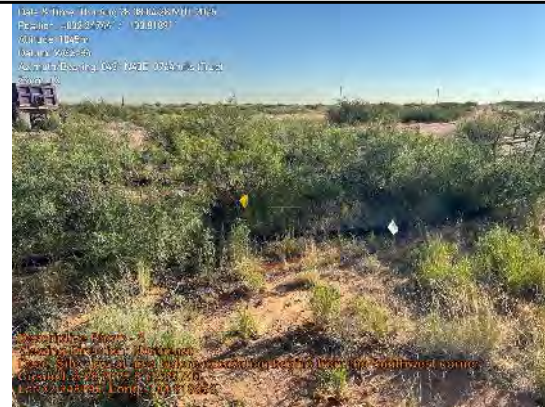
## Viewing Direction: Northeast

Site view of area before excavation begins from the Southeast corner looking East.

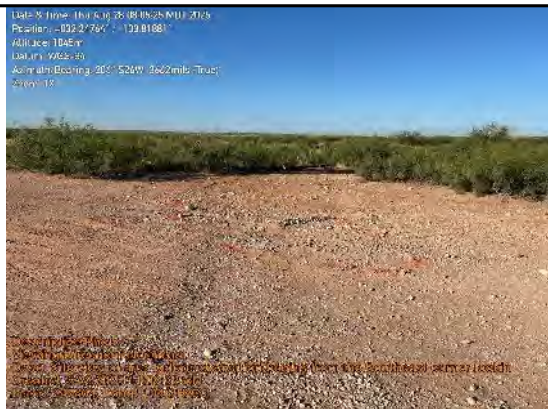
### Viewing Direction: Southwest

Site view of area before excavation north end looking towards the south.

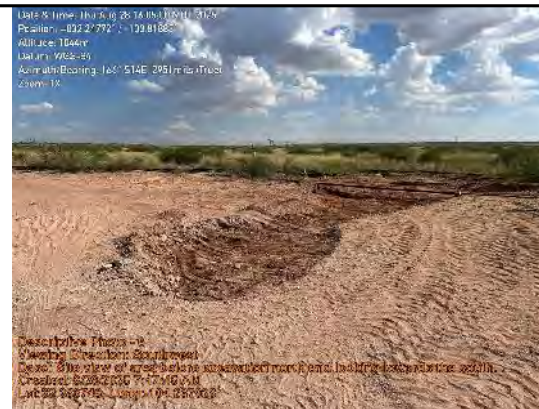
### Viewing Direction: Southeast

Site view of excavation area. Image taken from the North end where spill went into the road. Excavation at 0.5ft in this area.

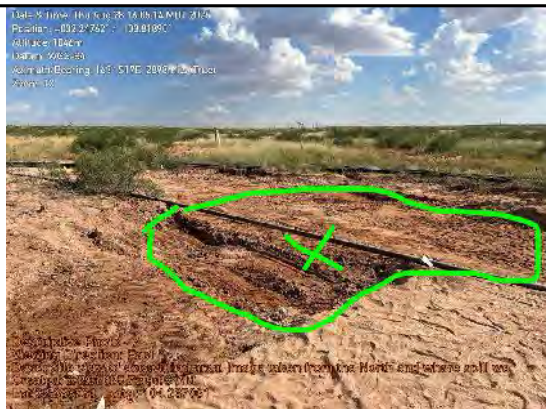
### Viewing Direction: Southeast

Site view of excavation area. Image taken from the North end where spill went into the road looking towards the Southeast. Excavation at 0.5ft and 1.25ft. Excavation at 1.25ft is circled in green and marked with a green "X" in the middle, while surrounding area is at 0.5ft.

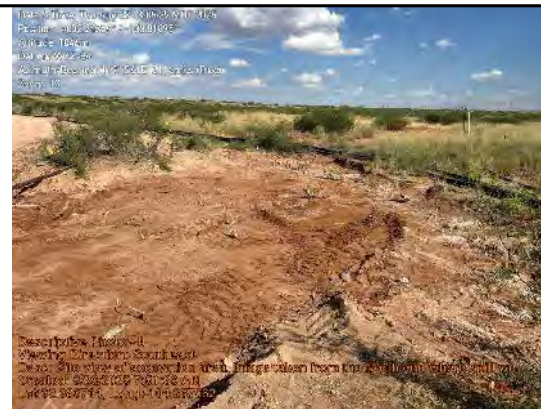
### Viewing Direction: Southeast

Site view of excavation area. Image taken from the North end where spill went into the road looking towards the Southeast corner where excavation is at 0.5ft.

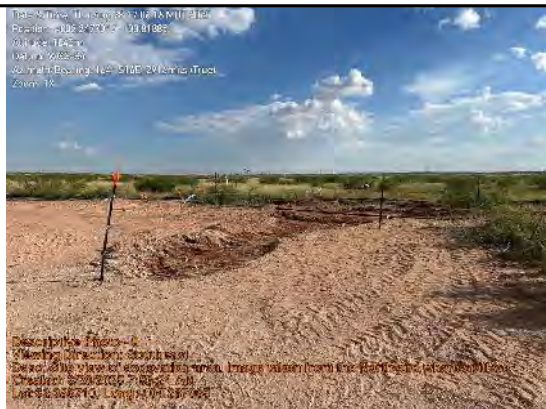
### Viewing Direction: Southeast

Site view of excavation area. Image taken from the North end where spill went into the road looking towards the Southeast. Excavation at 0.5ft and 1.25ft. Area has been surrounded by fencing.

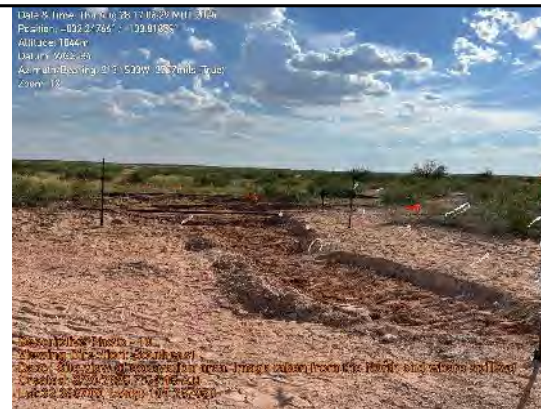
### Viewing Direction: Southwest

Site view of excavation area. Image taken from the North end where spill went into the road looking towards the Southwest. Excavation at 0.5ft and 1.25ft. Area has been surrounded by fencing.

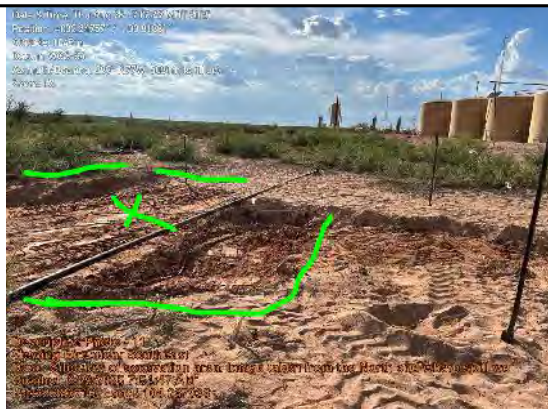
### Viewing Direction: Northwest

Site view of excavation area. Image taken from the North end where spill went into the road looking towards the Southeast. Excavation at 0.5ft and 1.25ft. Area has been surrounded by fencing. Excavation at 1.25ft is circled in green and marked with a green "X" in the middle, while surrounding area is at 0.5ft.

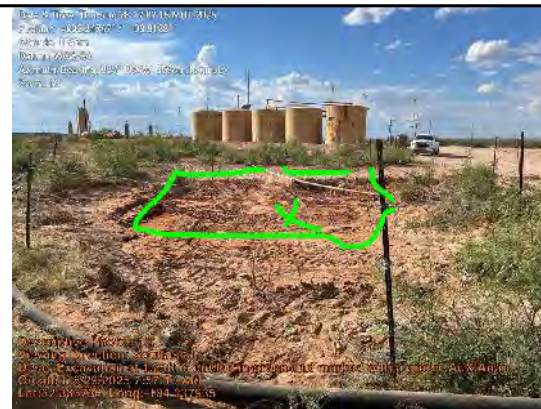
### Viewing Direction: Northwest

Site view of excavation area. Image taken from the East end looking towards the Northwest. Excavation at 0.5ft and 1.25ft. Area has been surrounded by fencing. Excavation at 1.25ft is circled in green and marked with a green "X" in the middle, while surrounding area is at 0.5ft.

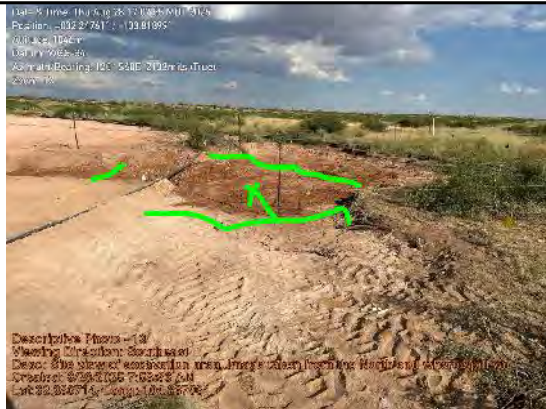
### Viewing Direction: Southeast

Site view of excavation area. Image taken from the east end looking towards the southwest. Excavation at 0.5ft and 1.25ft. Area has been surrounded by fencing. Excavation at 1.25ft is circled in green and marked with a green "X" in the middle, while surrounding area is at 0.5ft.

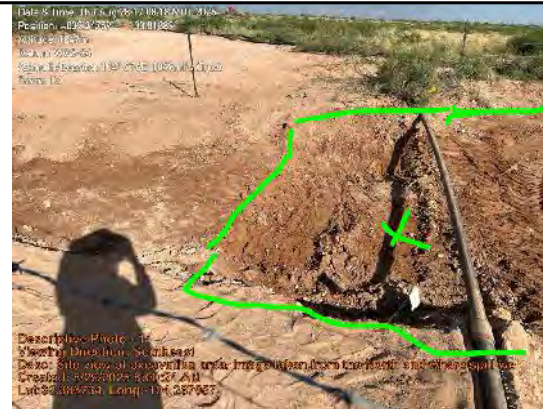
### Viewing Direction: Southeast

Image to show the change in topography in the excavation. Material present makes it difficult to see the change. Area marked in X is at 1.25ft. Area not marked is at 0.5ft

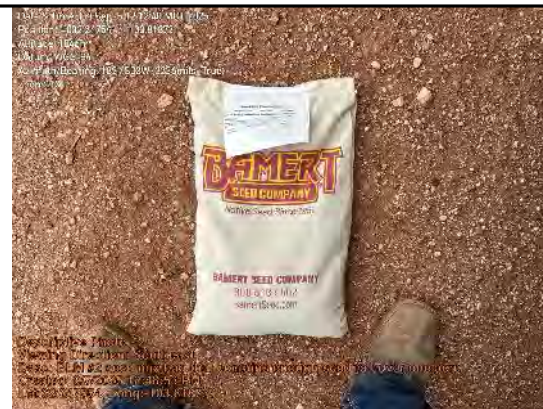
## Viewing Direction: Southeast

BLM #2 seed mix bag that contains enough seed to cover one acre

a 1lb bag. BLM seed mix #2 was obtained and administered by Vertex personnel for the site and applied by hand broadcasting at approximately 8 PLS/acre, double the recommended rate of 4 PLS/acre. The area was first prepared by loosening and leveling the soil with a rake, followed by evenly scattering the seed, and using the back of the rake to gently work in the seeds into the top 1/8 inch of the soil. This approach was selected to ensure greater coverage and improve the likelihood of successful revegetation. Photograph documentation of the excavation area after backfilling and seeding was completed is included in Appendix B.

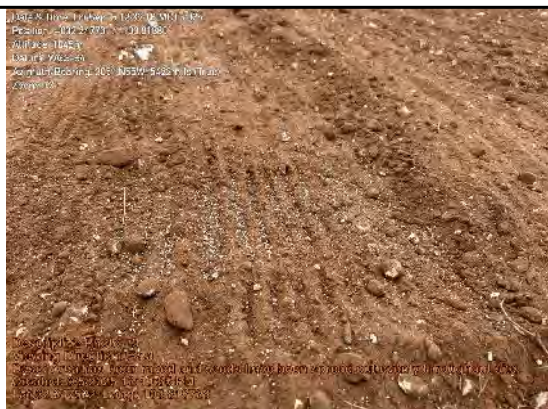
## Viewing Direction: Northwest

Area has been raked and seeds have been spread out evenly throughout site. Close up view of seeds

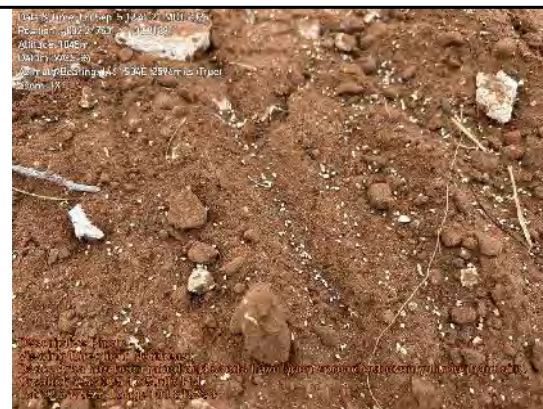
## Viewing Direction: Southeast

Area has been raked and seeds have been spread out evenly throughout site. Close up view of seeds

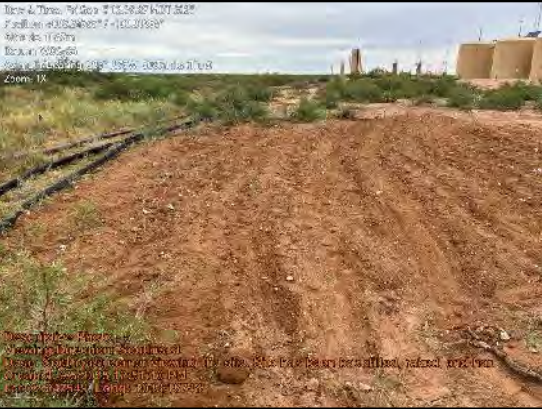
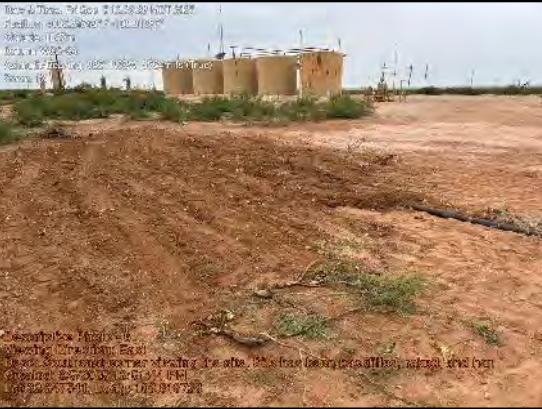
| <p><b>Viewing Direction: Northwest</b></p> <p>View 4: Time: 9/15/2025 4:25:22 PM<br/>Position: 33.025468° N, 102.01838° W<br/>Altitude: 1160m<br/>Date: 9/15/2025<br/>Time: 16:25:22<br/>Scale: 1:1000000<br/>Description: View 4: Southeast end viewing the site towards the west. Site has been backfilled, raked, and hand seeded.</p> <p>Southeast end viewing the site towards the west. Site has been backfilled, raked, and hand seeded.</p> | <p><b>Viewing Direction: Northwest</b></p> <p>View 4: Time: 9/15/2025 4:25:22 PM<br/>Position: 33.025468° N, 102.01838° W<br/>Altitude: 1160m<br/>Date: 9/15/2025<br/>Time: 16:25:22<br/>Scale: 1:1000000<br/>Description: View 4: Southeast corner viewing the site towards the north corner. Site has been backfilled, raked, and hand seeded.</p> <p>Southeast corner viewing the site towards the north corner. Site has been backfilled, raked, and hand seeded.</p> |

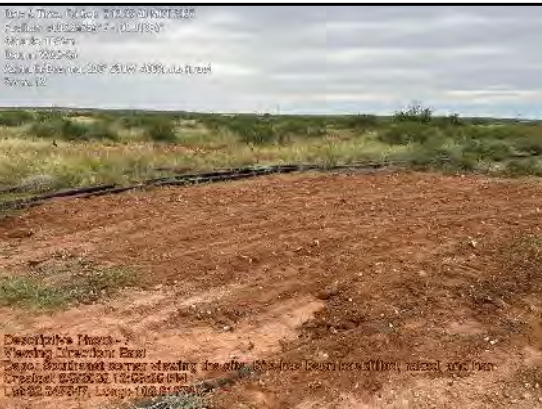
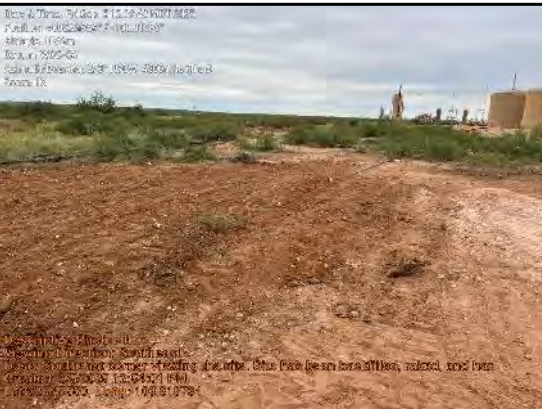
| <p><b>Viewing Direction: Southwest</b></p> <p>View 4: Time: 9/15/2025 4:25:22 PM<br/>Position: 33.025468° N, 102.01838° W<br/>Altitude: 1160m<br/>Date: 9/15/2025<br/>Time: 16:25:22<br/>Scale: 1:1000000<br/>Description: View 4: Northeast corner viewing the site towards the south end. Site has been backfilled, raked, and hand seeded.</p> <p>Northeast corner viewing the site towards the south end. Site has been backfilled, raked, and hand seeded.</p> | <p><b>Viewing Direction: Northwest</b></p> <p>View 4: Time: 9/15/2025 4:25:22 PM<br/>Position: 33.025468° N, 102.01838° W<br/>Altitude: 1160m<br/>Date: 9/15/2025<br/>Time: 16:25:22<br/>Scale: 1:1000000<br/>Description: View 4: Northeast corner viewing the site towards the southwest corner. Site has been backfilled, raked, and hand seeded.</p> <p>Northeast corner viewing the site towards the southwest corner. Site has been backfilled, raked, and hand seeded.</p> |

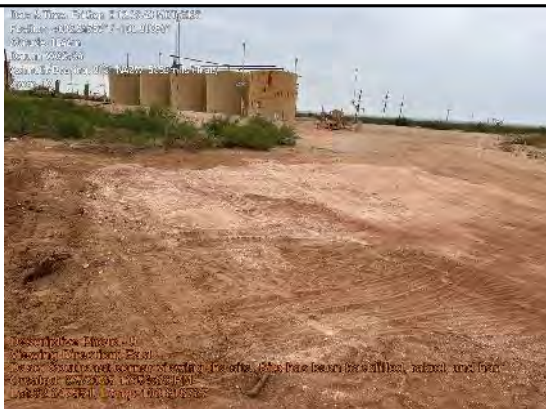
### Viewing Direction: Northwest

Southeast corner viewing the site towards the north corner. Image shows area where road has been backfilled. Road was backfilled with caliche and no topsoil. Site has been backfilled, raked, and hand seeded.

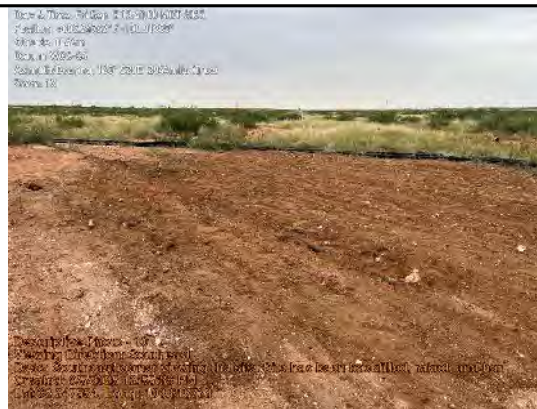
### Viewing Direction: Southeast

Northwest corner viewing the site towards the southeast end. Site has been backfilled, raked, and hand seeded.

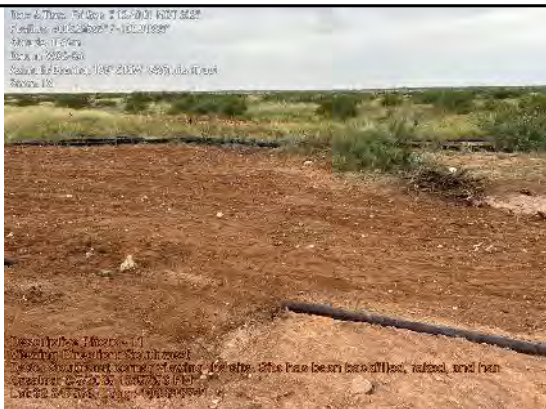
### Viewing Direction: Southwest

Northwest corner viewing the southwest corner. Site has been backfilled, raked, and hand seeded.

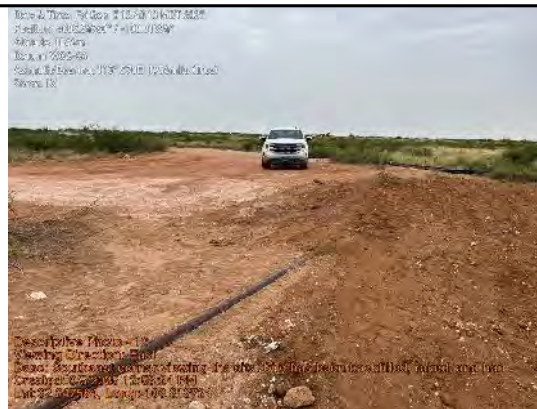
### Viewing Direction: Southeast

Northwest corner viewing the site towards the northeast corner towards the road. Site has been backfilled, raked, and hand seeded.

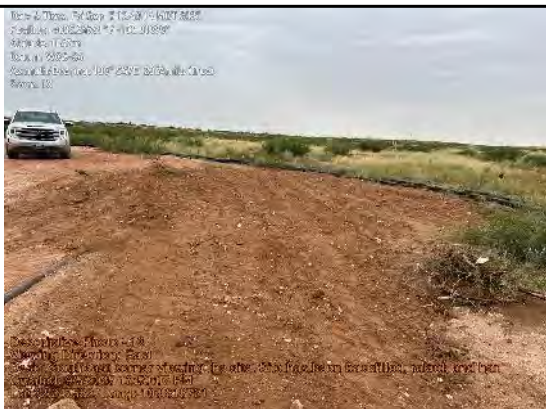
### Viewing Direction: Southeast

West end viewing the east end. Site has been backfilled, raked, and hand seeded.

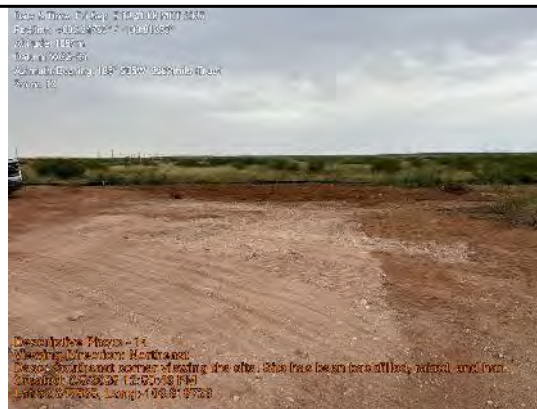
### Viewing Direction: Southwest

North corner viewing the site towards the south. Site has been backfilled, raked, and hand seeded.
