Amended Remediation Summary & Soil Closure Request

Mewbourne Oil Company Mad Dog 35 CN St. Com #1H Battery

Lea County, New Mexico

NMOCD Reference No. nAPP2400929341

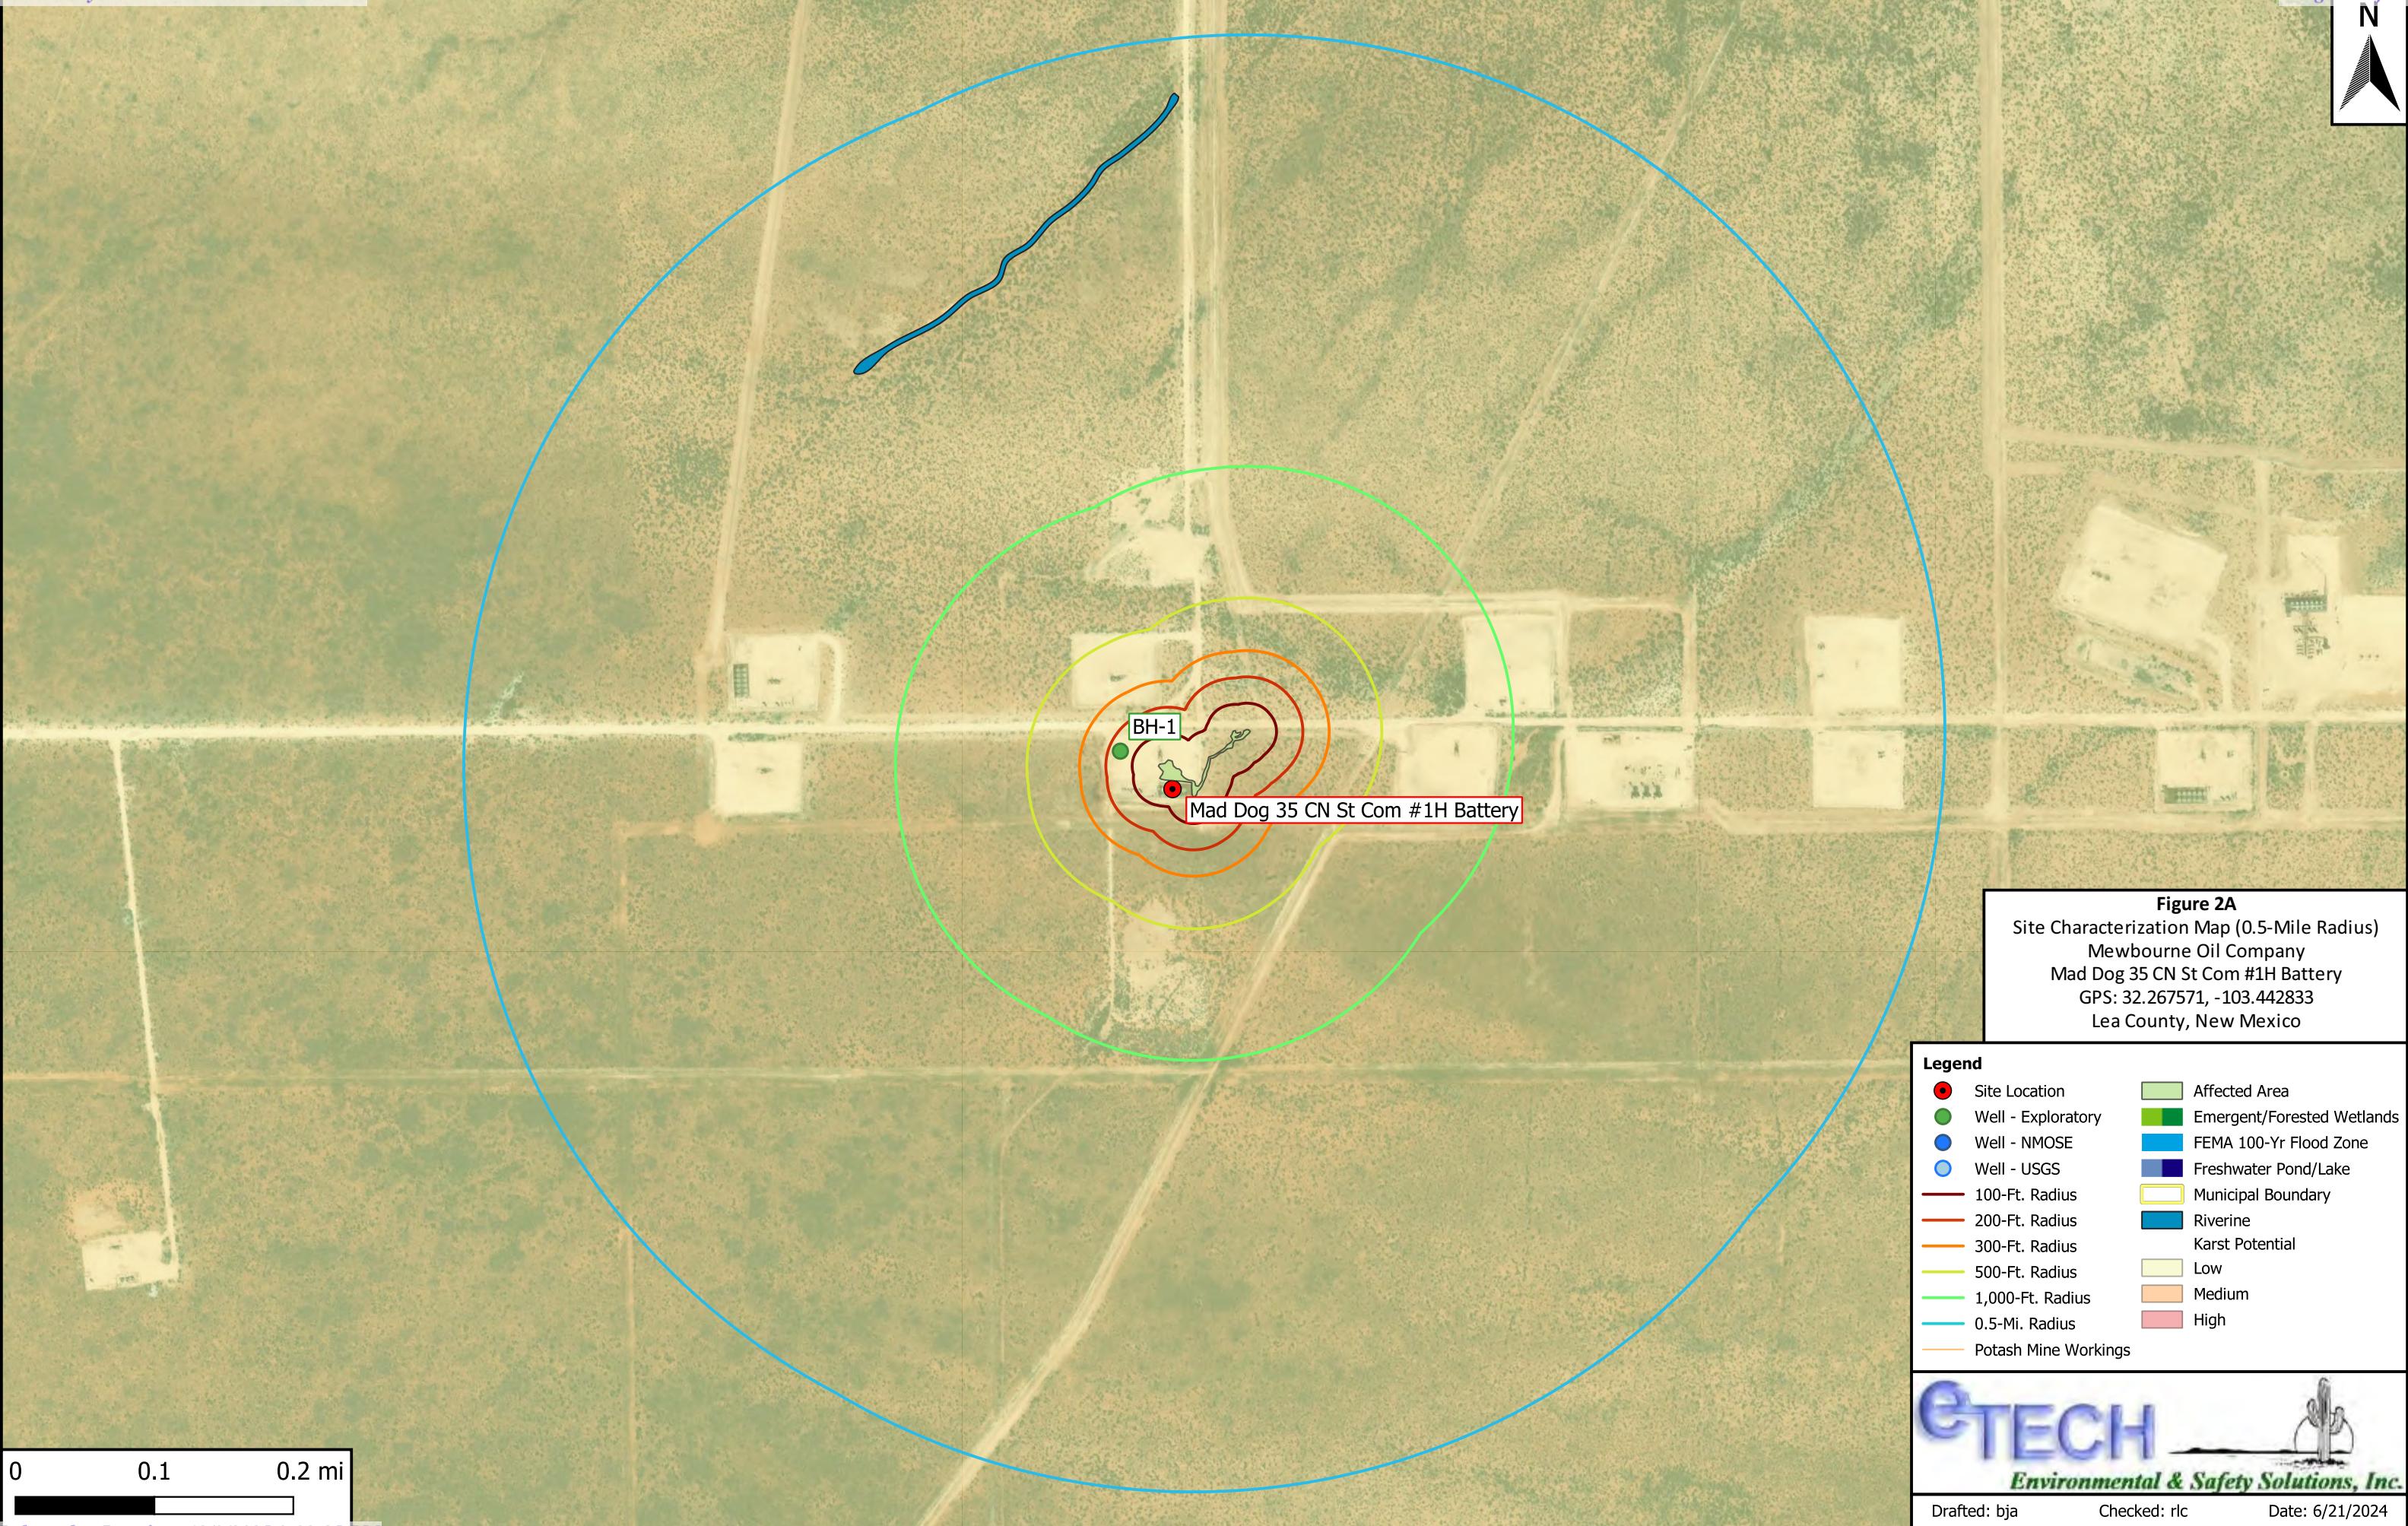
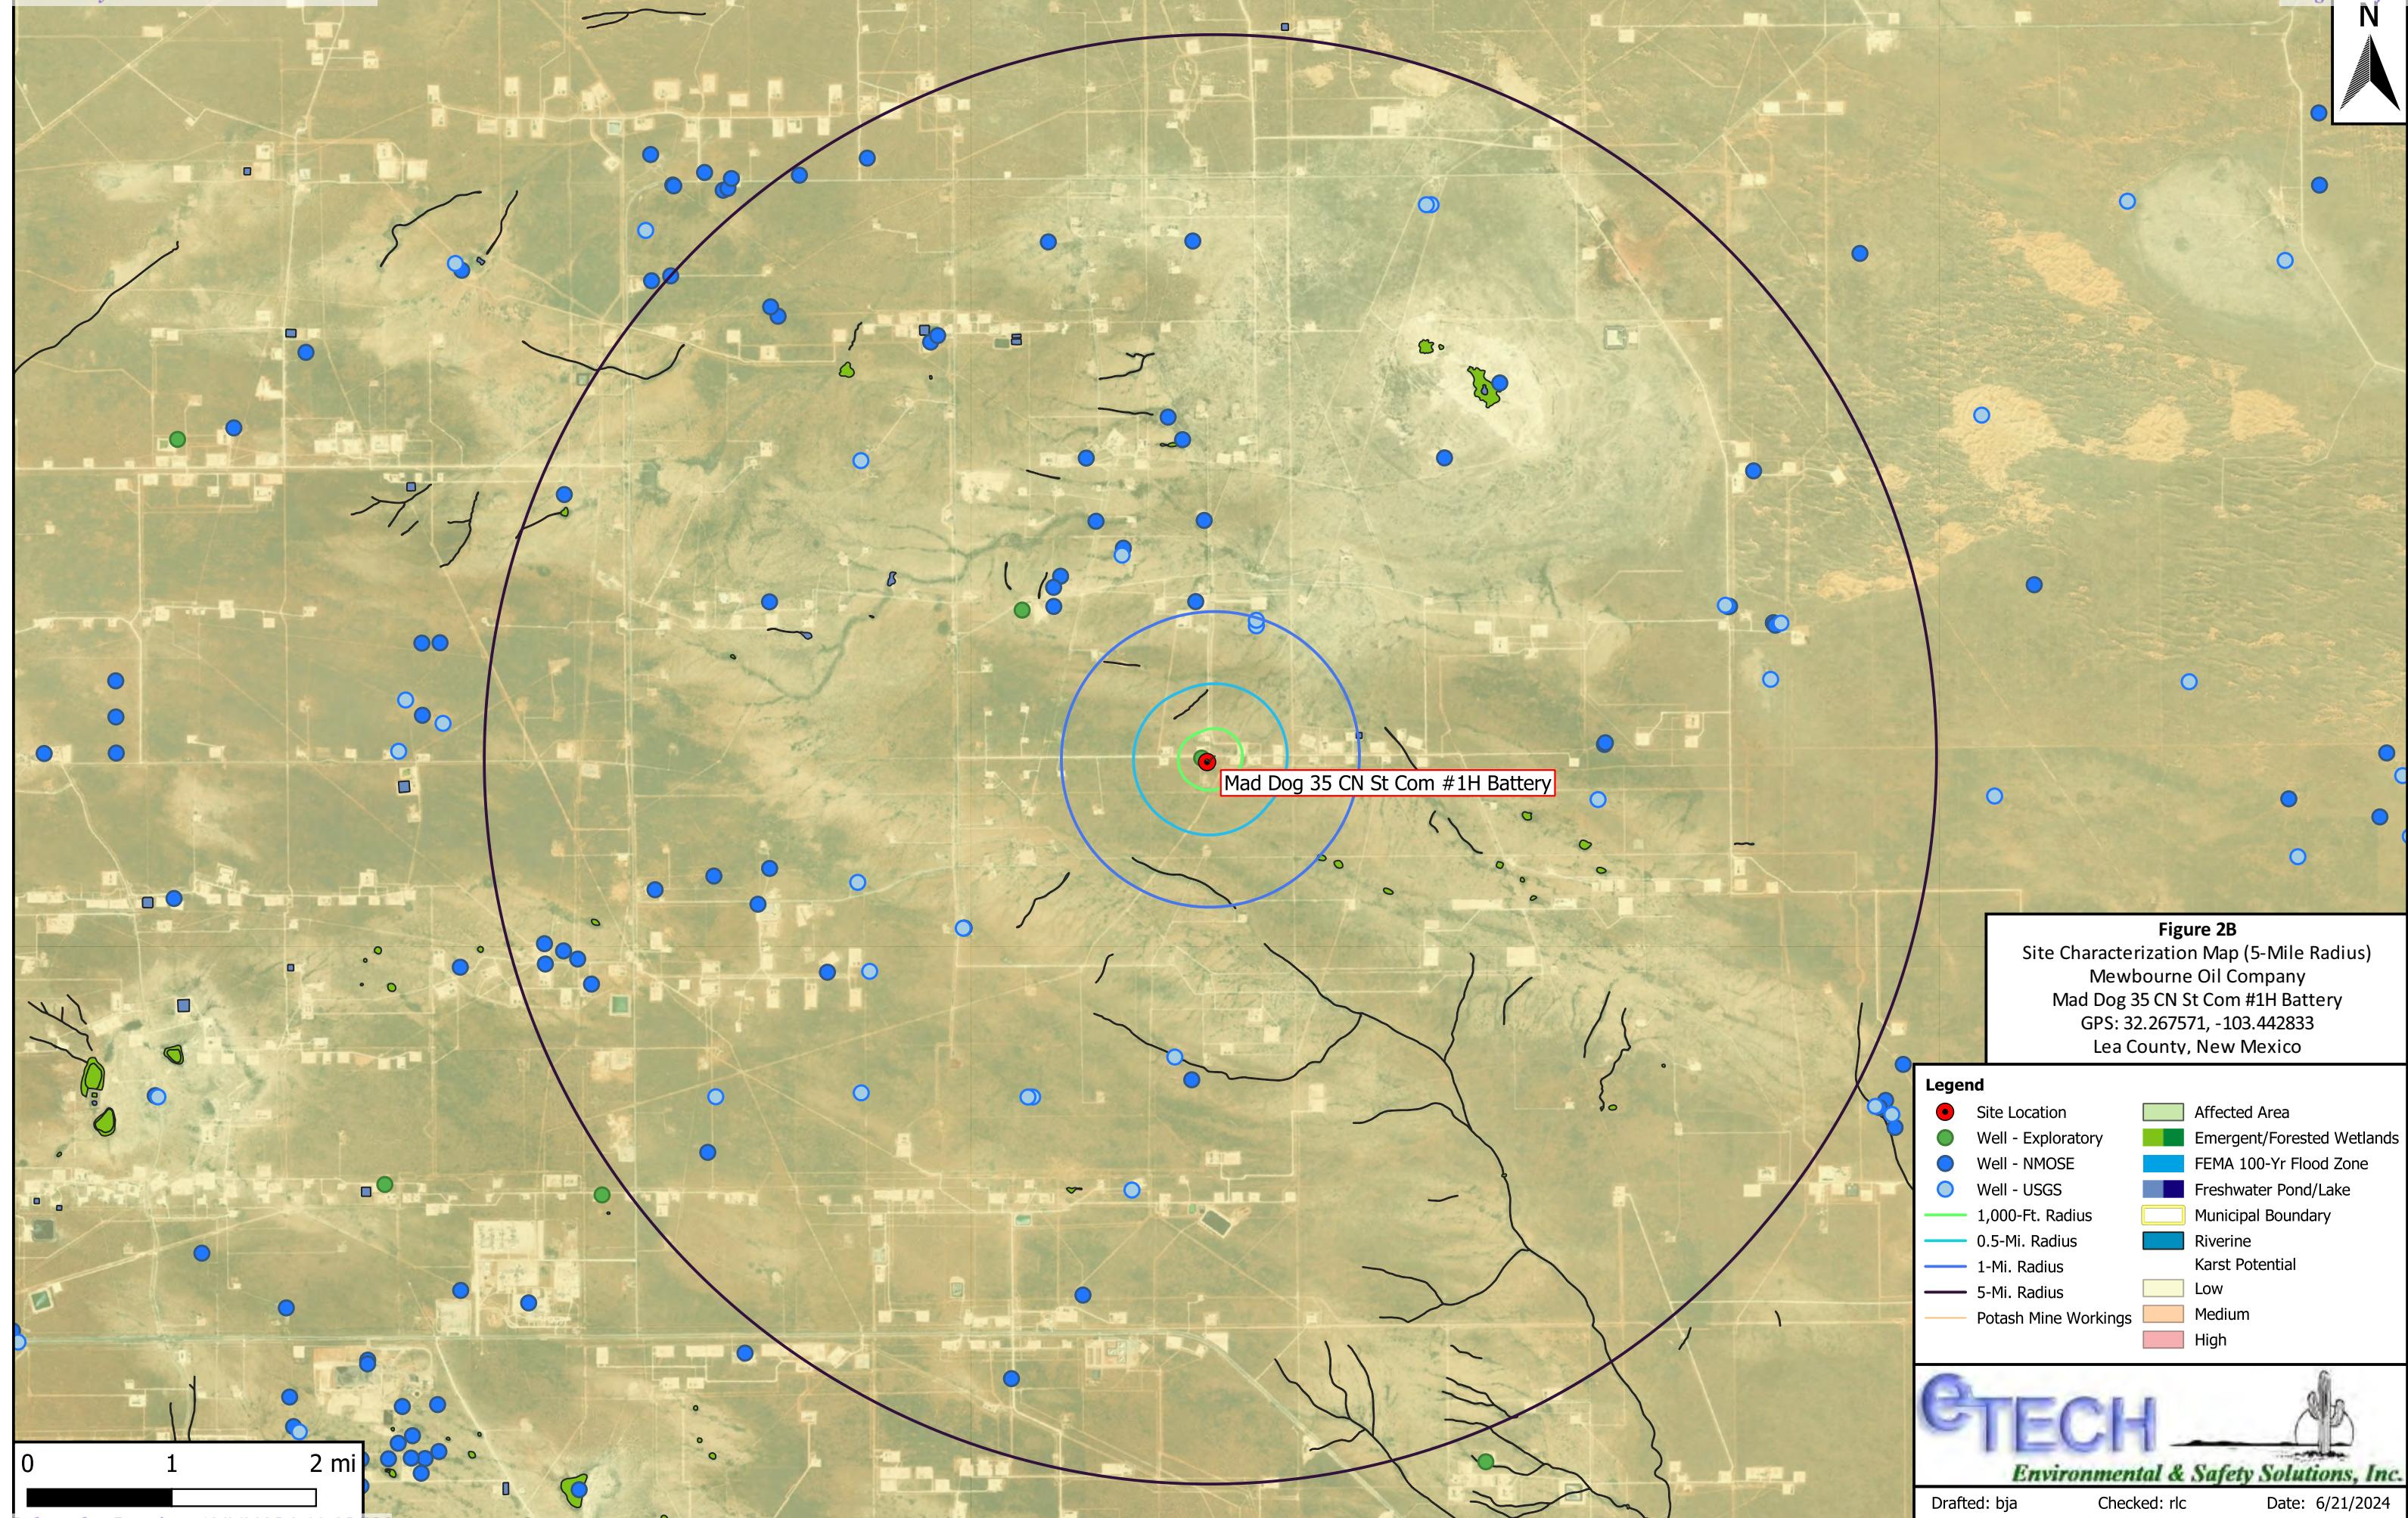
Figures 2A & 2B

Probable groundwater depth was determined using data generated by numeric models based on available water well data and published information. In addition, on June 18, 2024, an investigative soil boring (BH-1) was drilled in the northwest corner of the Mad Dog 35 production pad in order to determine if shallow groundwater is present in the area. Soil boring BH-1 was advanced to a total depth of approximately 105 feet bgs and left open for over 72 hours. No indications of inflow or accumulation of water were noted during the advancement of the borehole or a subsequent gauging event. In addition, a groundwater gauging event conducted on June 21, 2024, prior to plugging and abandonment (P&A), confirmed that the borehole was dry. The location of soil boring BH-1 is depicted in Figures 2A, 2B, and 4. A drilling log is provided in Appendix A.

Site Characterization Maps

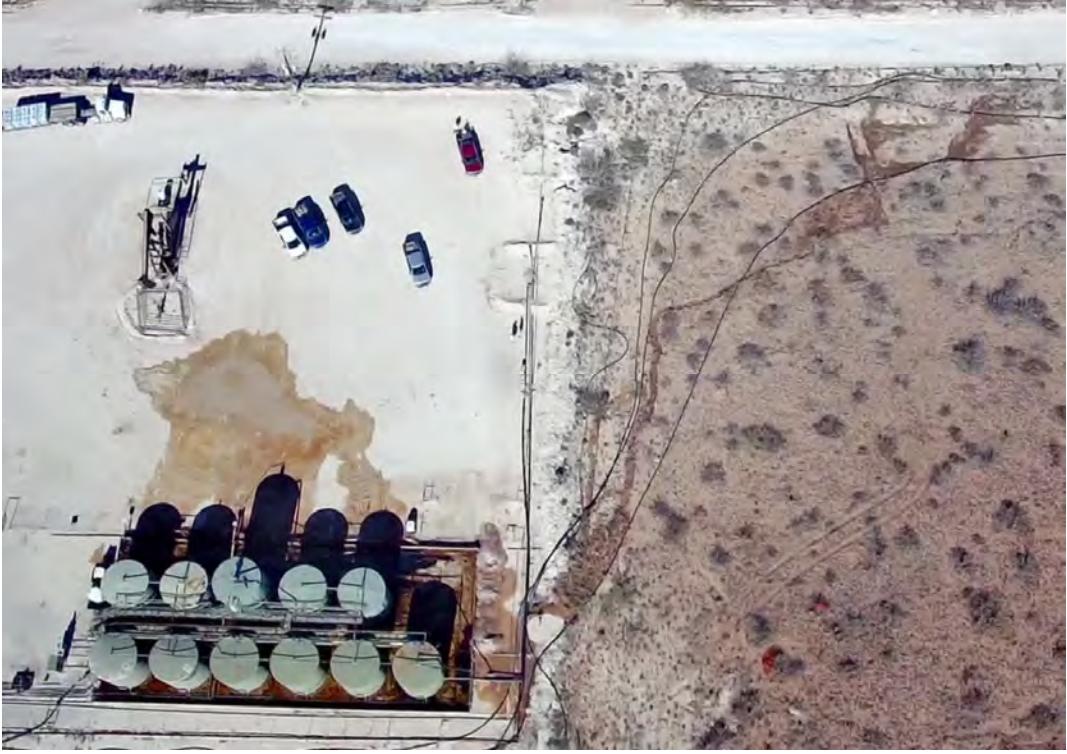
Photo Number: 1	
Photo Direction: Overhead/Bird's Eye	
Photo Description: Aerial view of the affected area. December 27, 2023 32.267843,-103.442535

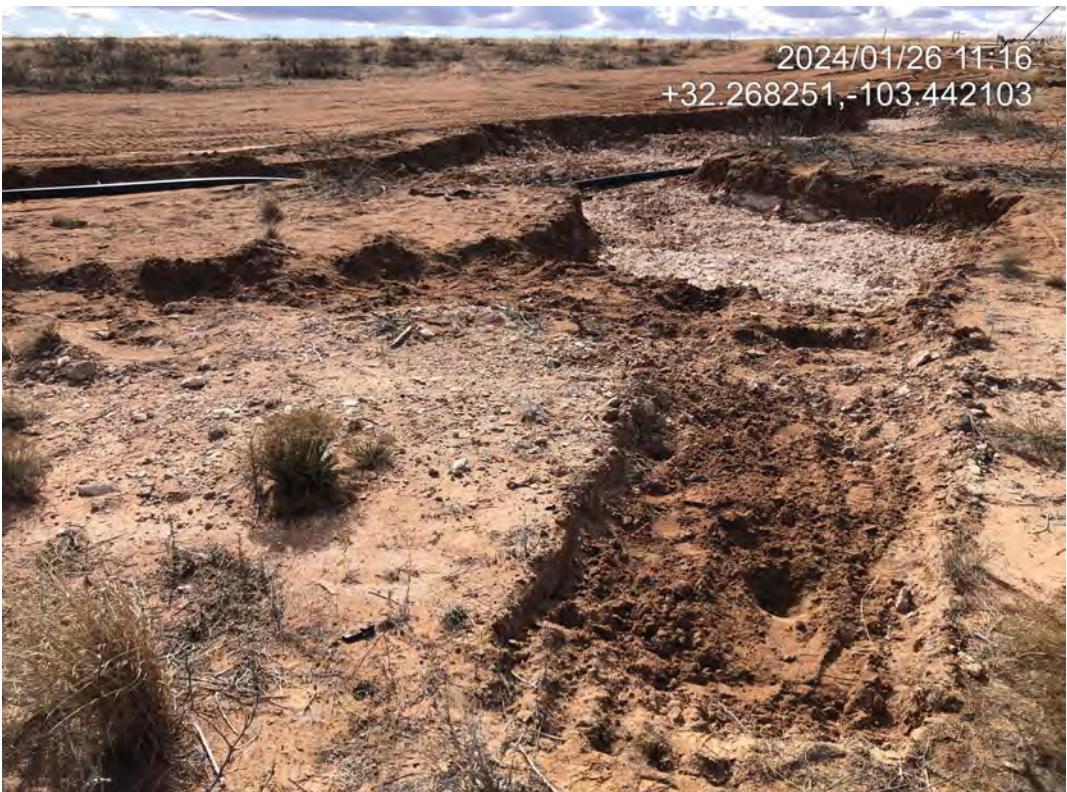
Photo Number: 2	
Photo Direction: South-Southwest	
Photo Description: View of the excavated area.

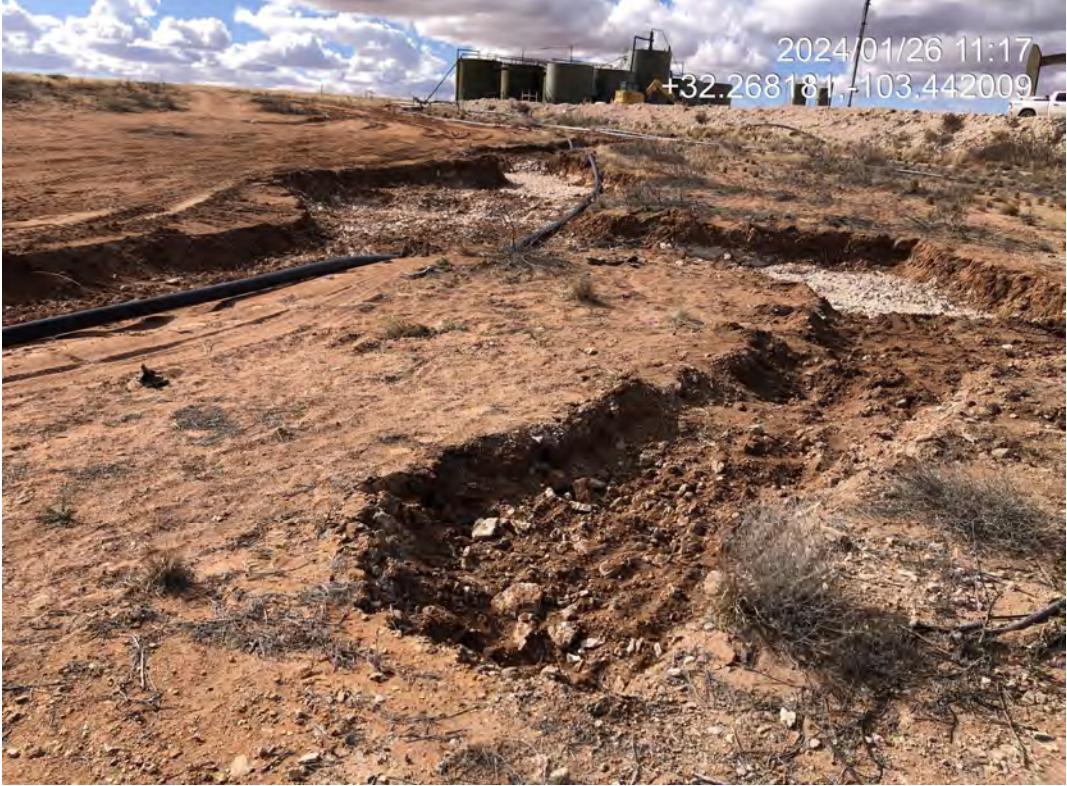
Photo Number: 3

2024/01/26 11:17 +32.268181,-103.442009
Photo Description: View of the excavated area.

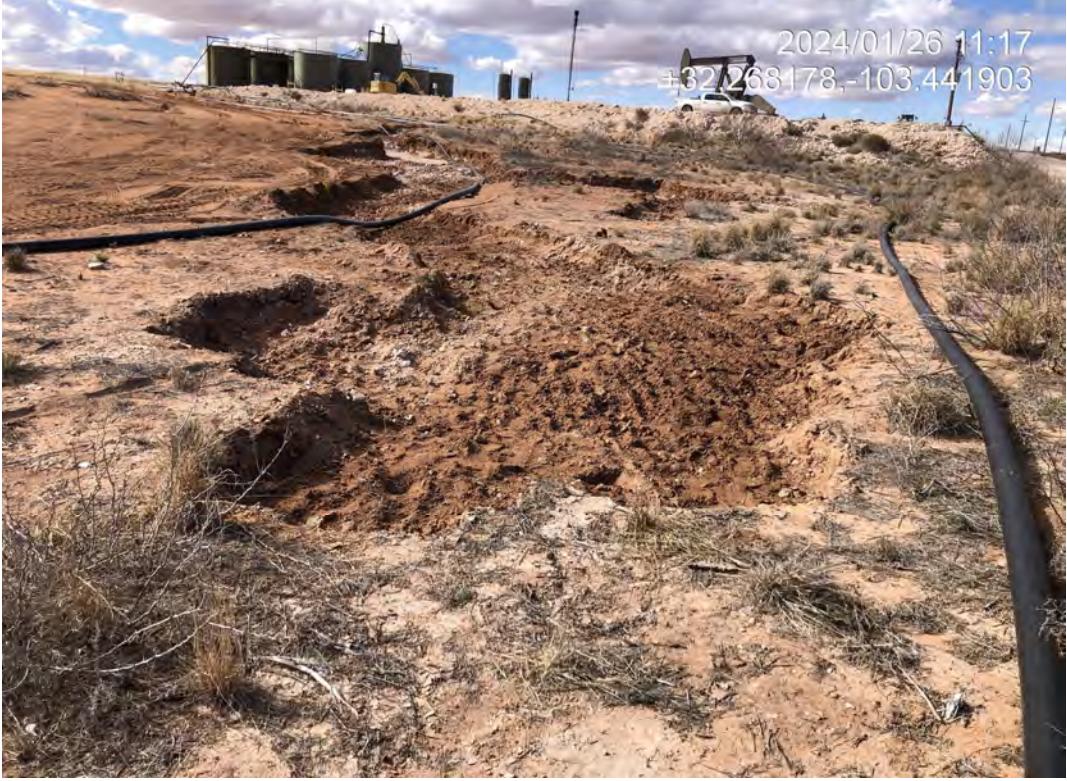
Photo Number: 4

2024/01/26 11:17 +32.268178,-103.441903
Photo Description: View of the excavated area.

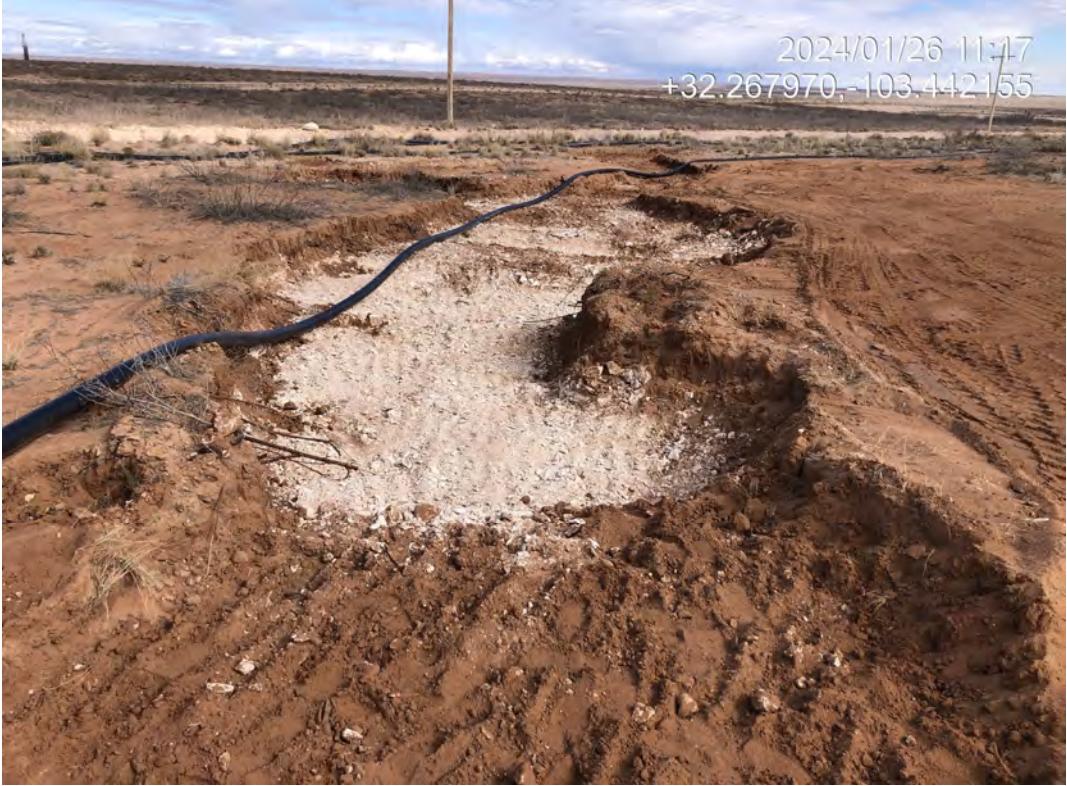
Photo Number: 5

<p>2024/01/26 11:17 +32.267970,-103.442155</p>
Photo Description: View of the excavated area.

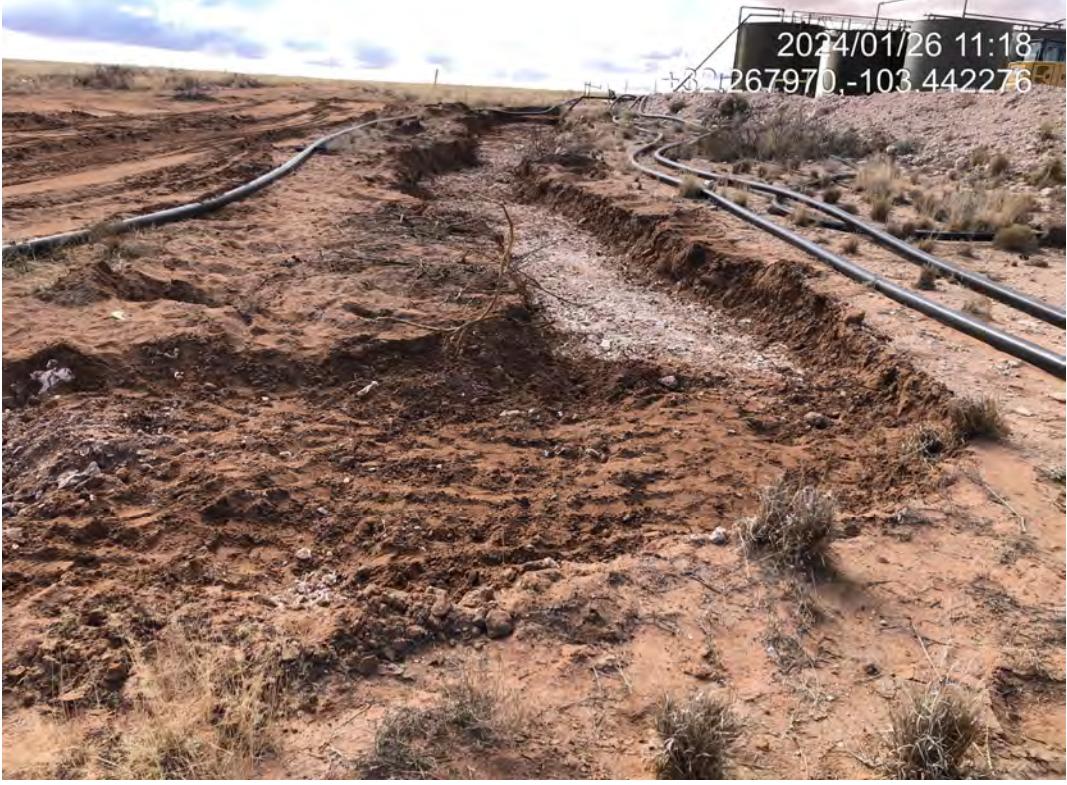
Photo Number: 6

<p>2024/01/26 11:18 +32.267970,-103.442276</p>
Photo Description: View of the excavated area.

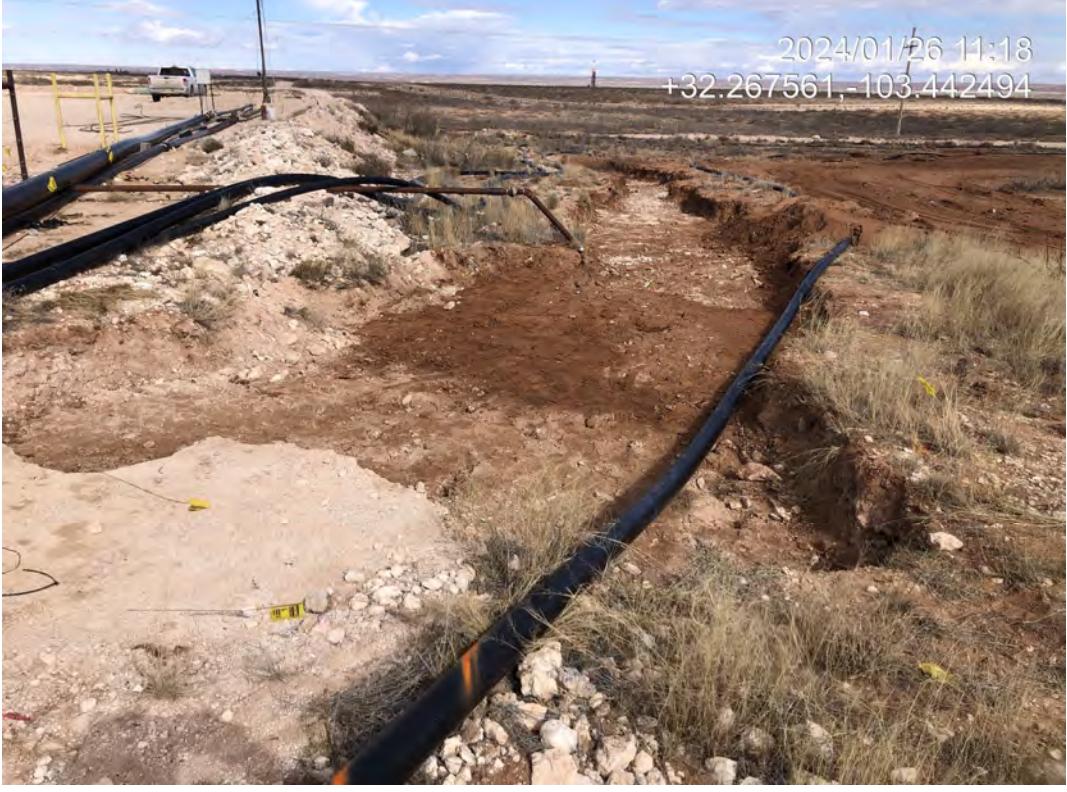
Photo Number: 7

<p>2024/01/26 11:18 +32.267561, -103.442494</p>
Photo Description: View of the excavated area.

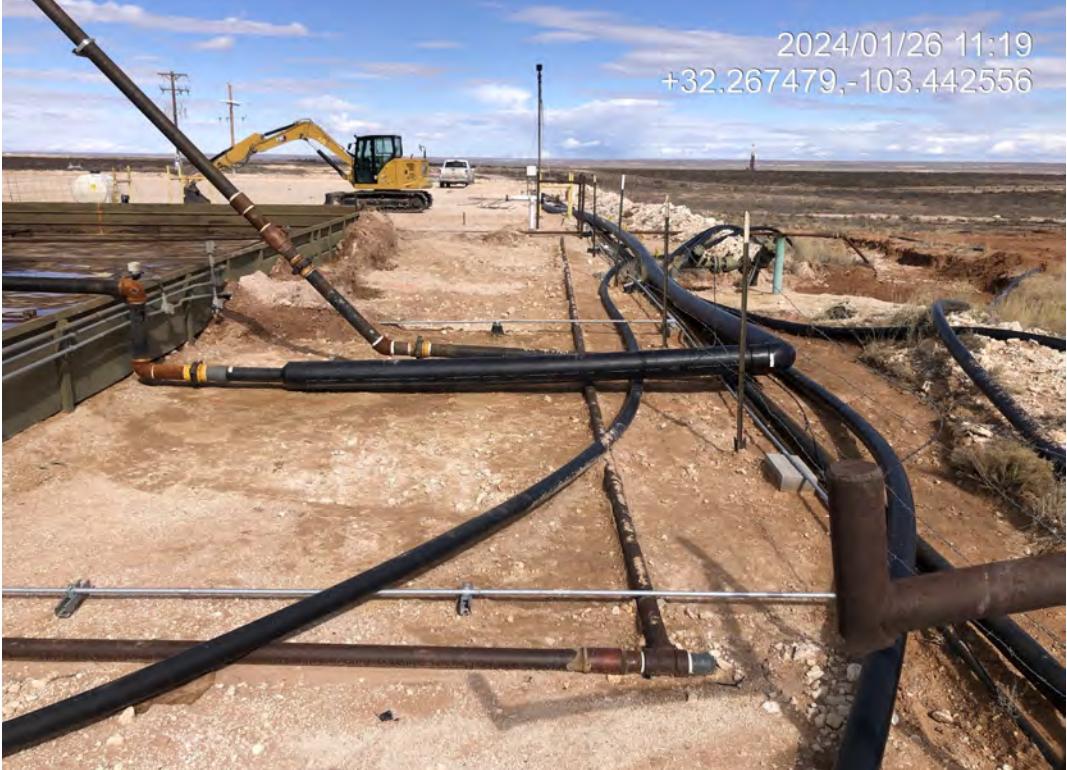
Photo Number: 8

<p>2024/01/26 11:19 +32.267479, -103.442556</p>
Photo Description: View of the excavated area.

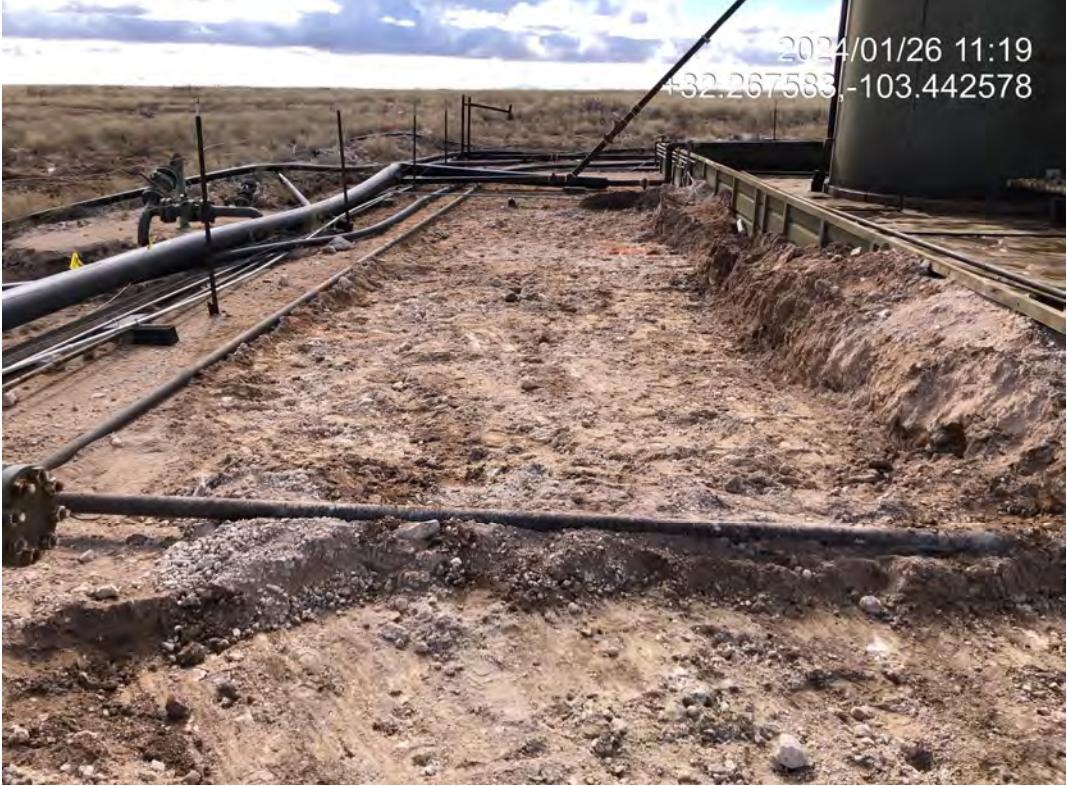
Photo Number: 9

2024/01/26 11:19 +32.267583,-103.442578
Photo Direction: South	
Photo Description: View of the excavated area.

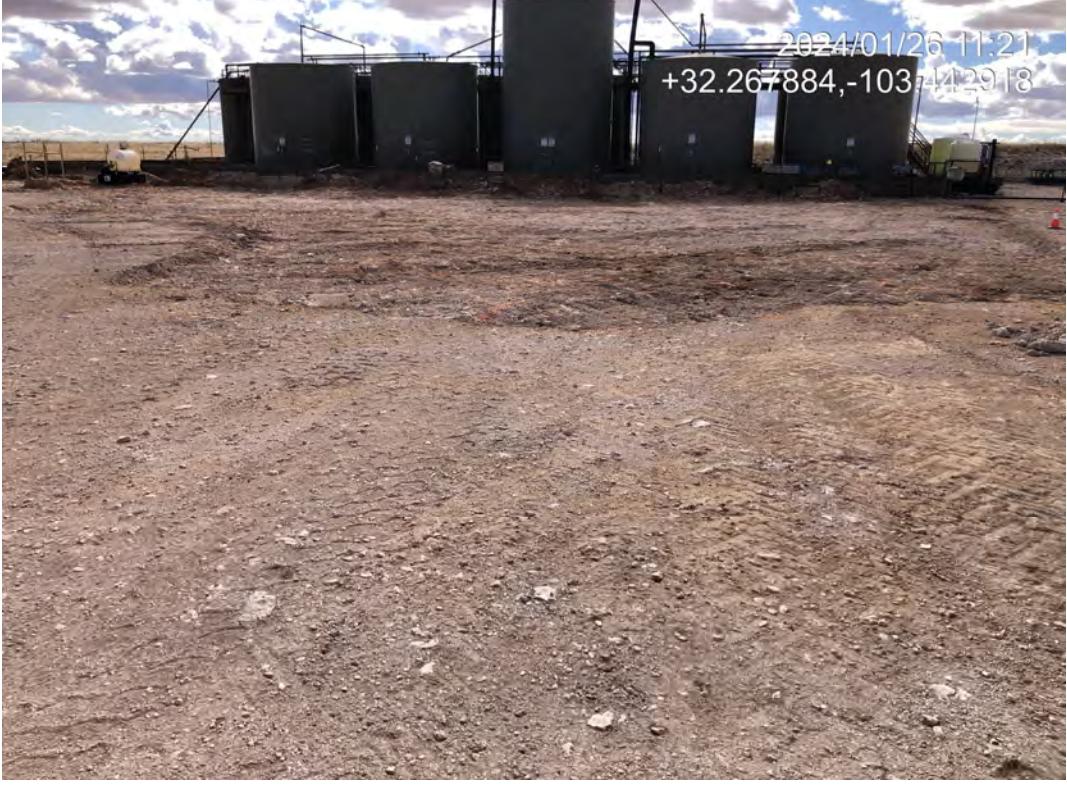
Photo Number: 10

2024/01/26 11:21 +32.267884,-103.442918
Photo Direction: South	
Photo Description: View of the excavated area.

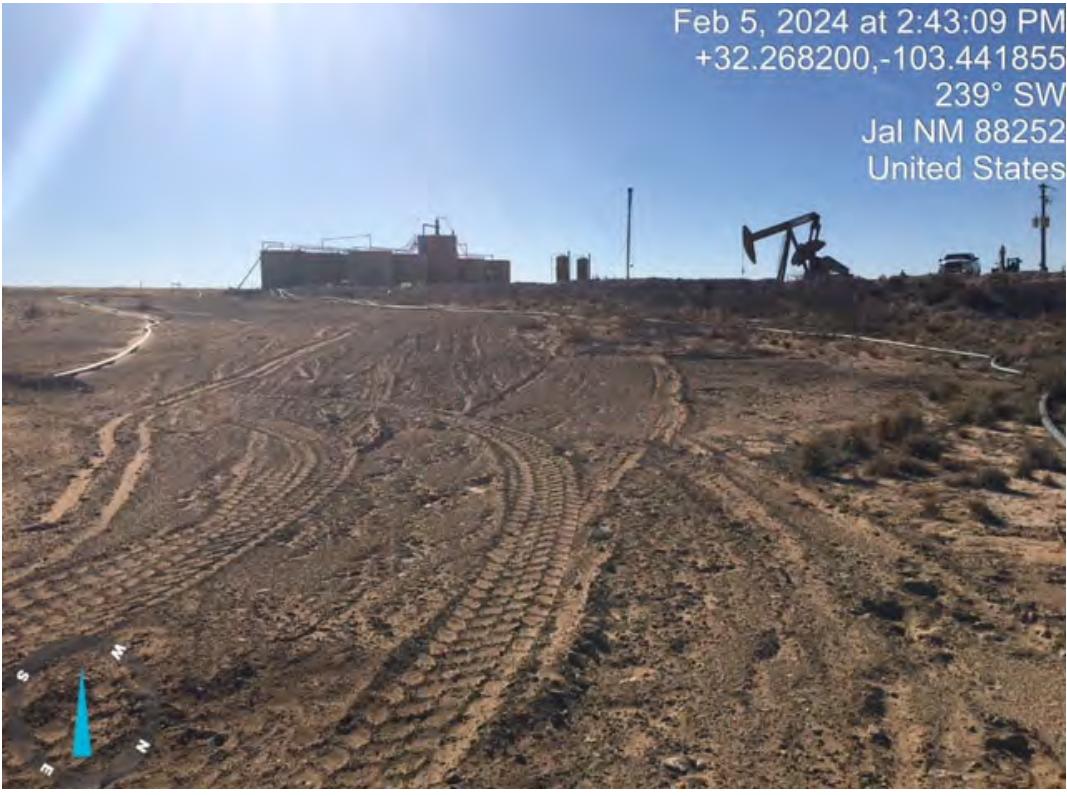
Photo Number: 11

Feb 5, 2024 at 2:43:09 PM +32.268200,-103.441855 239° SW Jal NM 88252 United States
Photo Description: View of the remediated area after backfill and regrading.

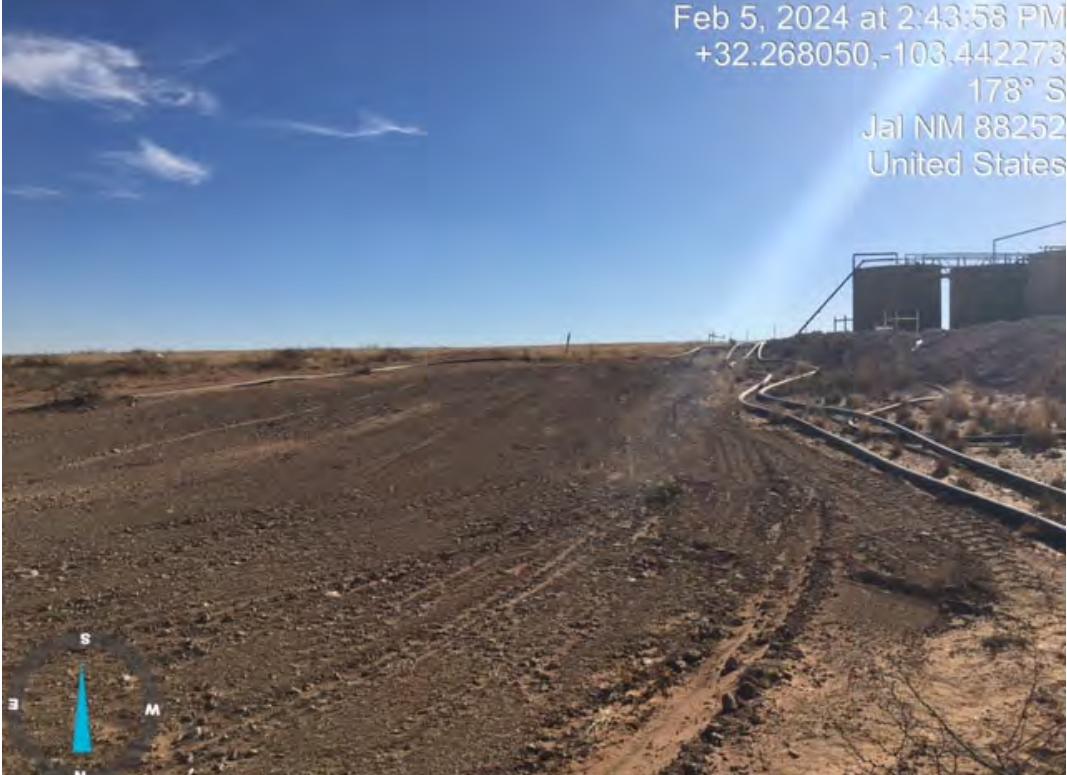
Photo Number: 12

Feb 5, 2024 at 2:43:58 PM +32.268050,-103.442273 178° S Jal NM 88252 United States
Photo Description: View of the remediated area after backfill and regrading.

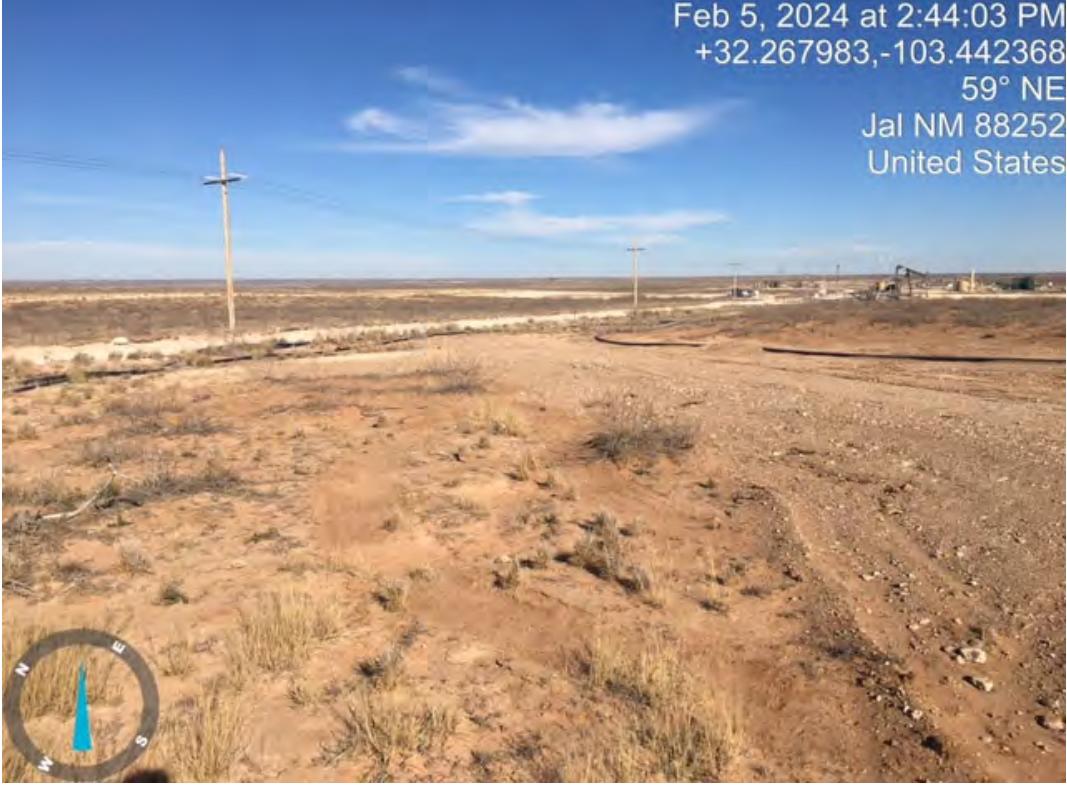
Photo Number: 13

Feb 5, 2024 at 2:44:03 PM +32.267983,-103.442368 59° NE Jal NM 88252 United States
Photo Description: View of the remediated area after backfill and regrading.

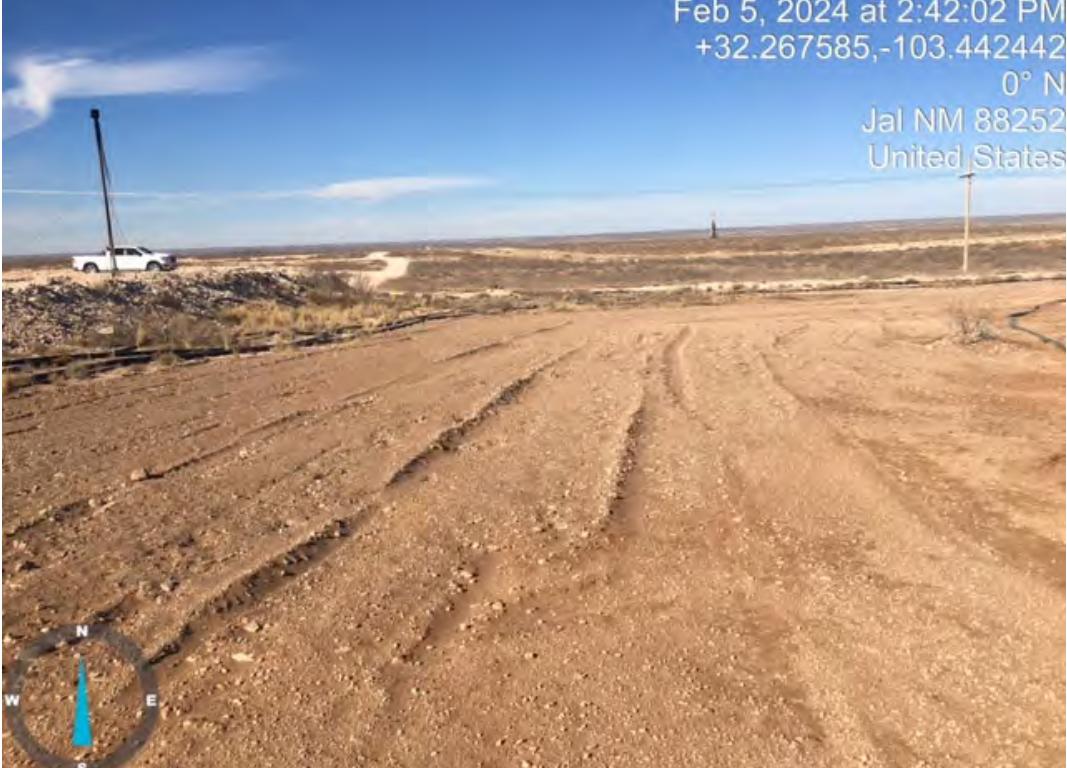
Photo Number: 14

Feb 5, 2024 at 2:42:02 PM +32.267585,-103.442442 0° N Jal NM 88252 United States
Photo Description: View of the remediated area after backfill and regrading.

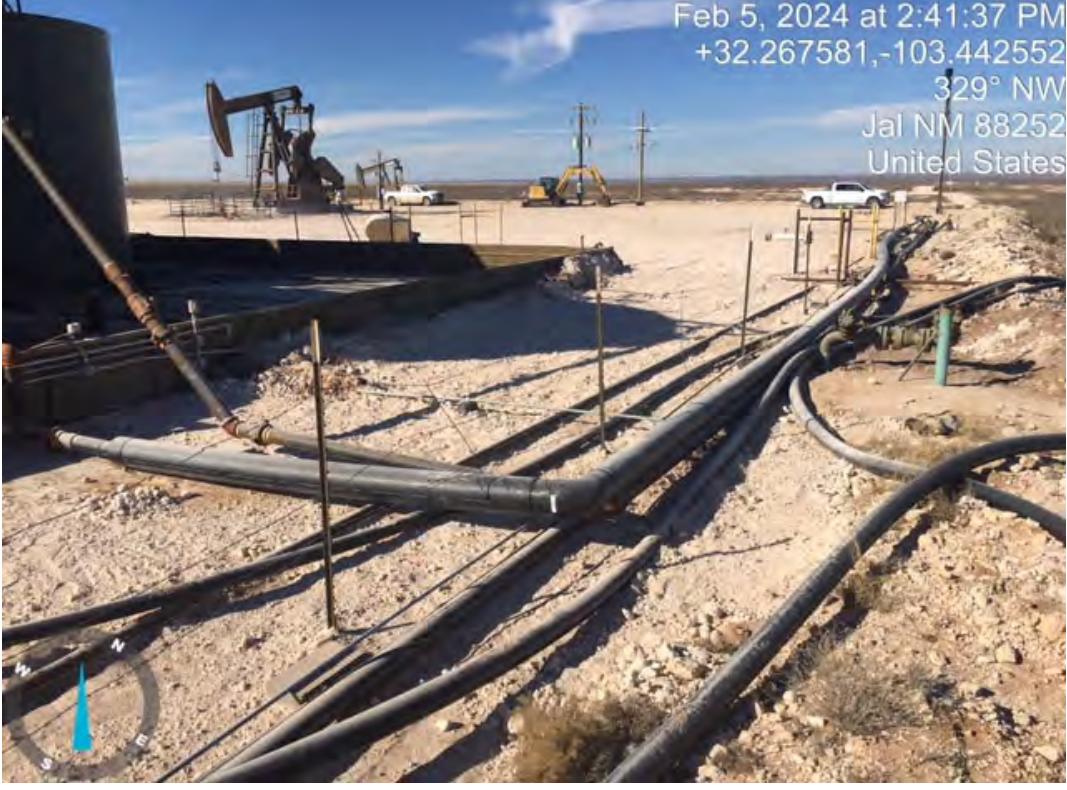
Photo Number: 15

<p>Feb 5, 2024 at 2:41:37 PM +32.267581,-103.442552 329° NW Jal NM 88252 United States</p>
Photo Description: View of the remediated area after backfill and regrading.

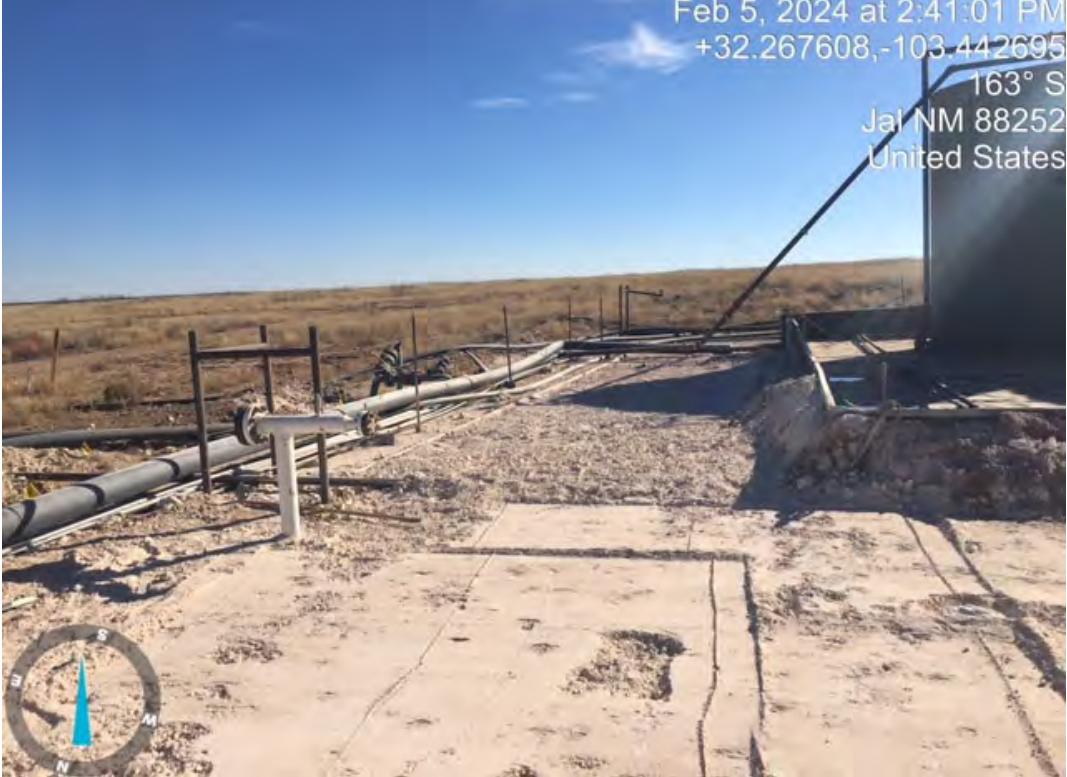
Photo Number: 16

<p>Feb 5, 2024 at 2:41:01 PM +32.267608,-103.442695 163° S Jal NM 88252 United States</p>
Photo Description: View of the remediated area after backfill and regrading.

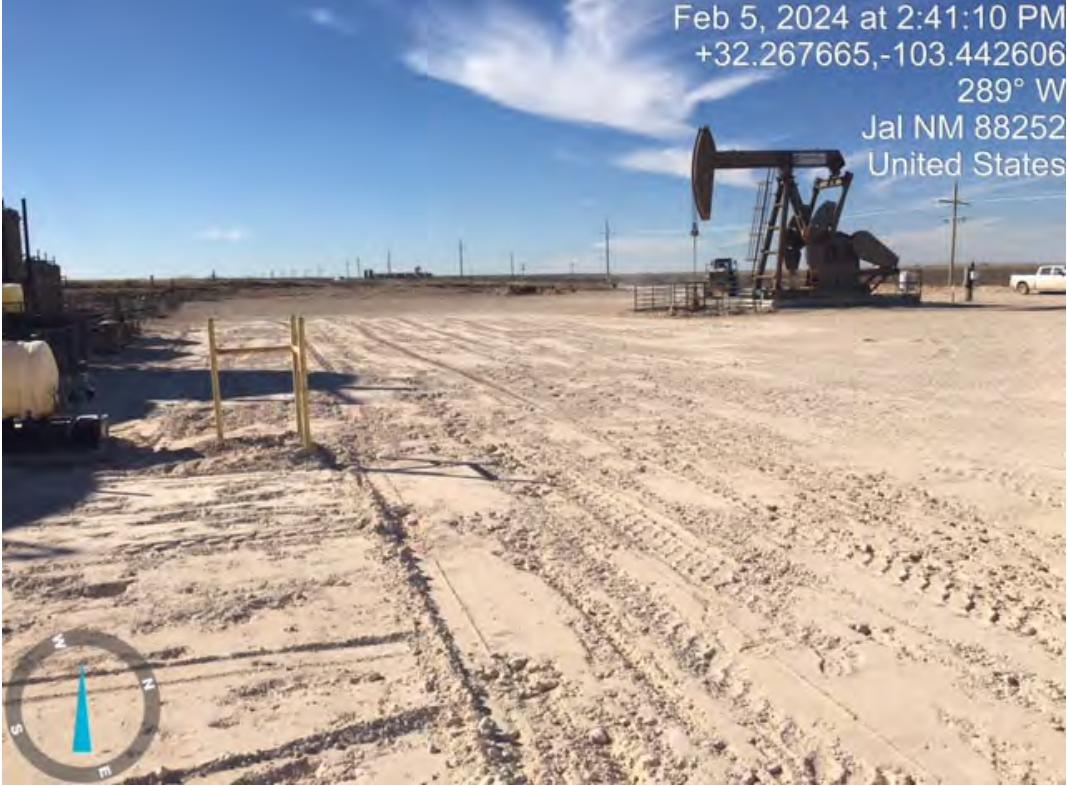
Photo Number: 17

<p>Feb 5, 2024 at 2:41:10 PM +32.267665,-103.442606 289° W Jal NM 88252 United States</p>
Photo Description: View of the remediated area after backfill and regrading.
