Amended Remediation Summary & Soil Closure Request

Mewbourne Oil Company Mad Dog 35 CN St. Com #1H Battery

Lea County, New Mexico

NMOCD Reference No. nAPP2400929341

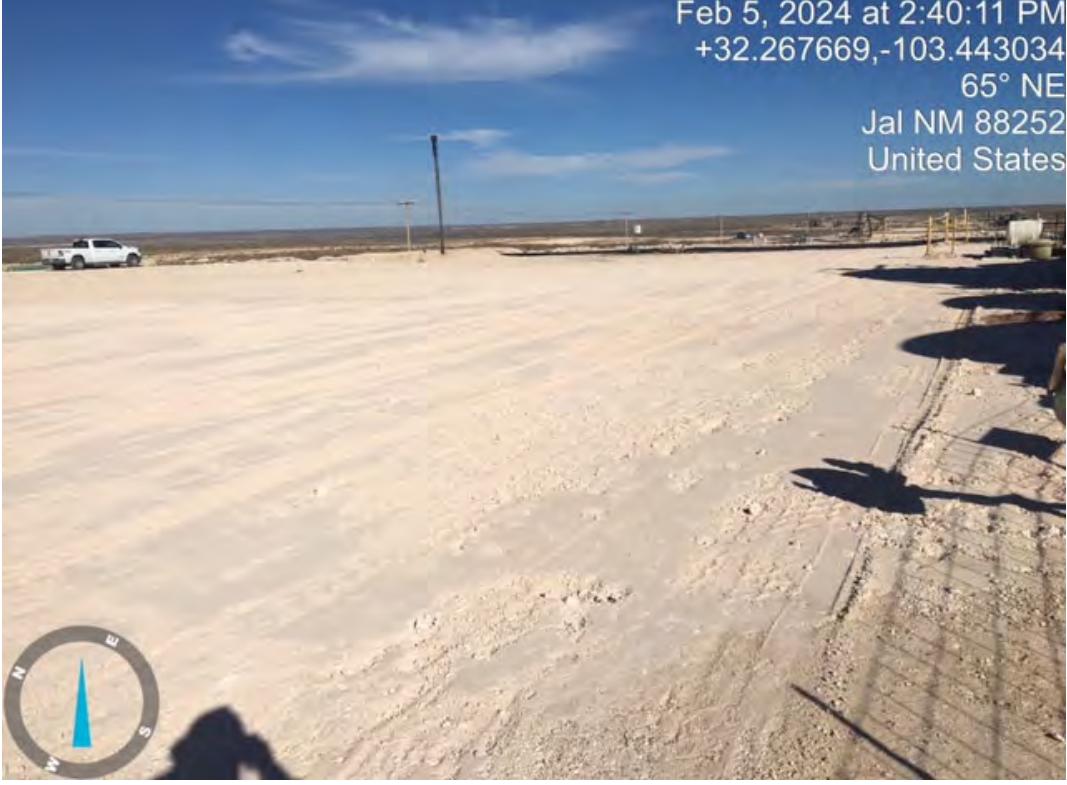
Photo Number: 18

<p>Feb 5, 2024 at 2:40:11 PM +32.267669,-103.443034 65° NE Jal NM 88252 United States</p>
Photo Description: View of the remediated area after backfill and regrading.

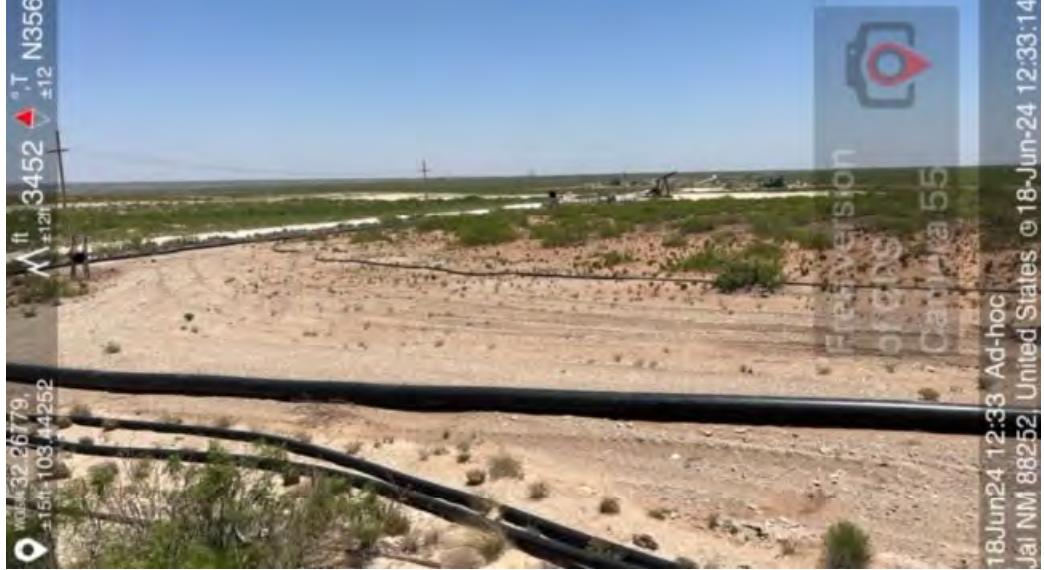
Photo Number: 19	Photo Direction: North	Photo Description: View of the reclaimed area prior to seeding event.

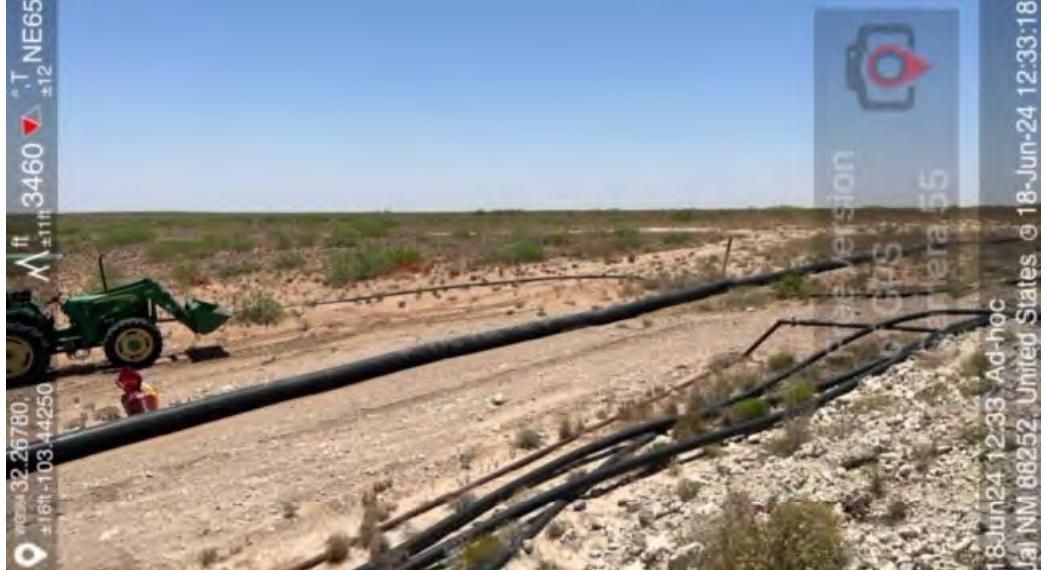
Photo Number: 20	Photo Direction: East-Northeast	Photo Description: View of the reclaimed area prior to seeding event.

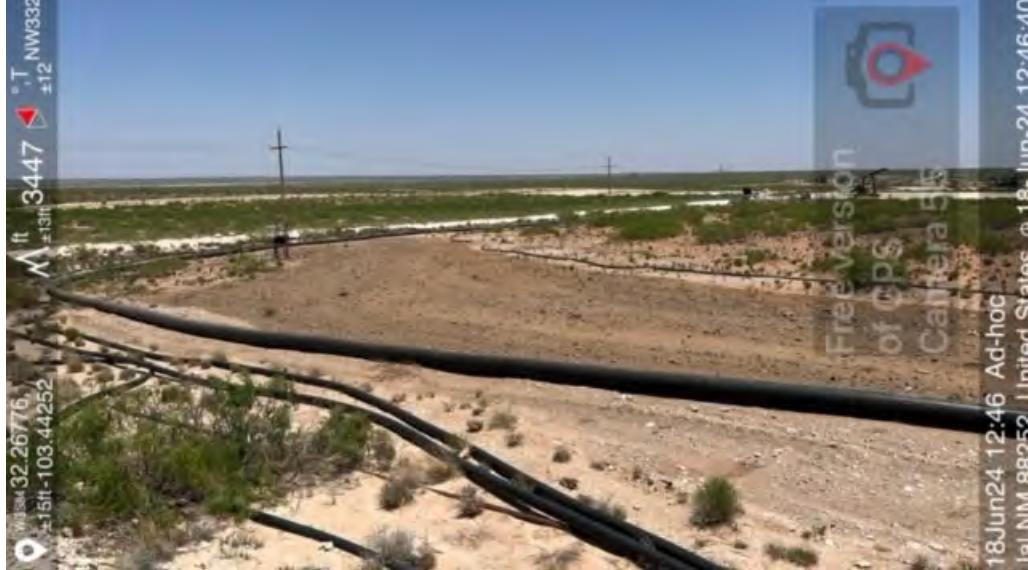
Photo Number: 21	Photo Direction: North-Northwest	Photo Description: View of the reclaimed area following seeding event.

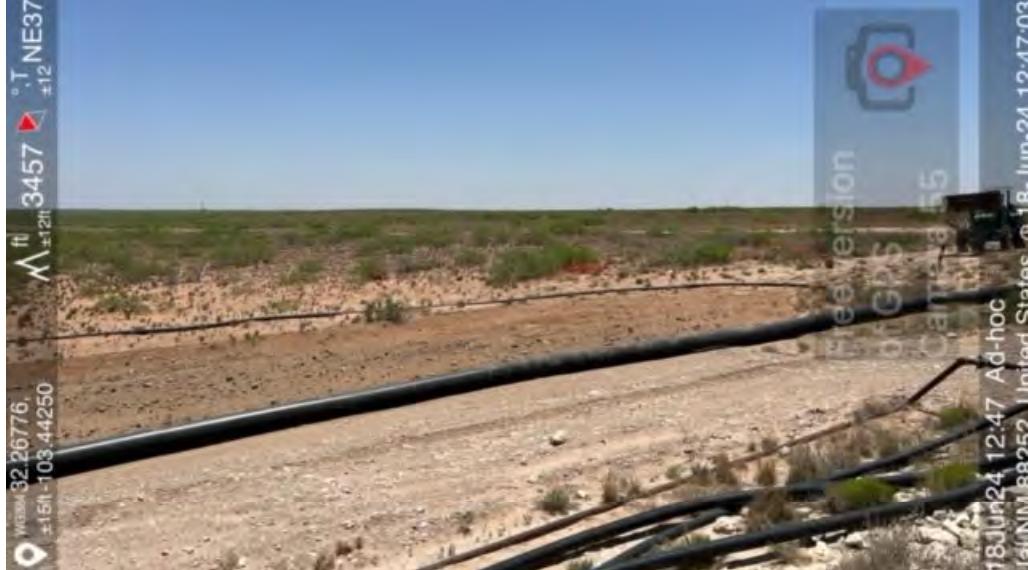
Photo Number: 22	Photo Direction: Northeast	Photo Description: View of the reclaimed area following seeding event.
