# TROJAN HORSE COMPRESSOR STATION

## Closure Request

**NMOCD Incident No. nAPP2509740971**

Re: Closure Request  
Trojan Horse Compressor Station  
UL "I", Section 18, Township 24 South, Range 27 East  
Eddy County, New Mexico  
NMOCD Incident No. nAPP2509740971  
Tasman Project No. 9036

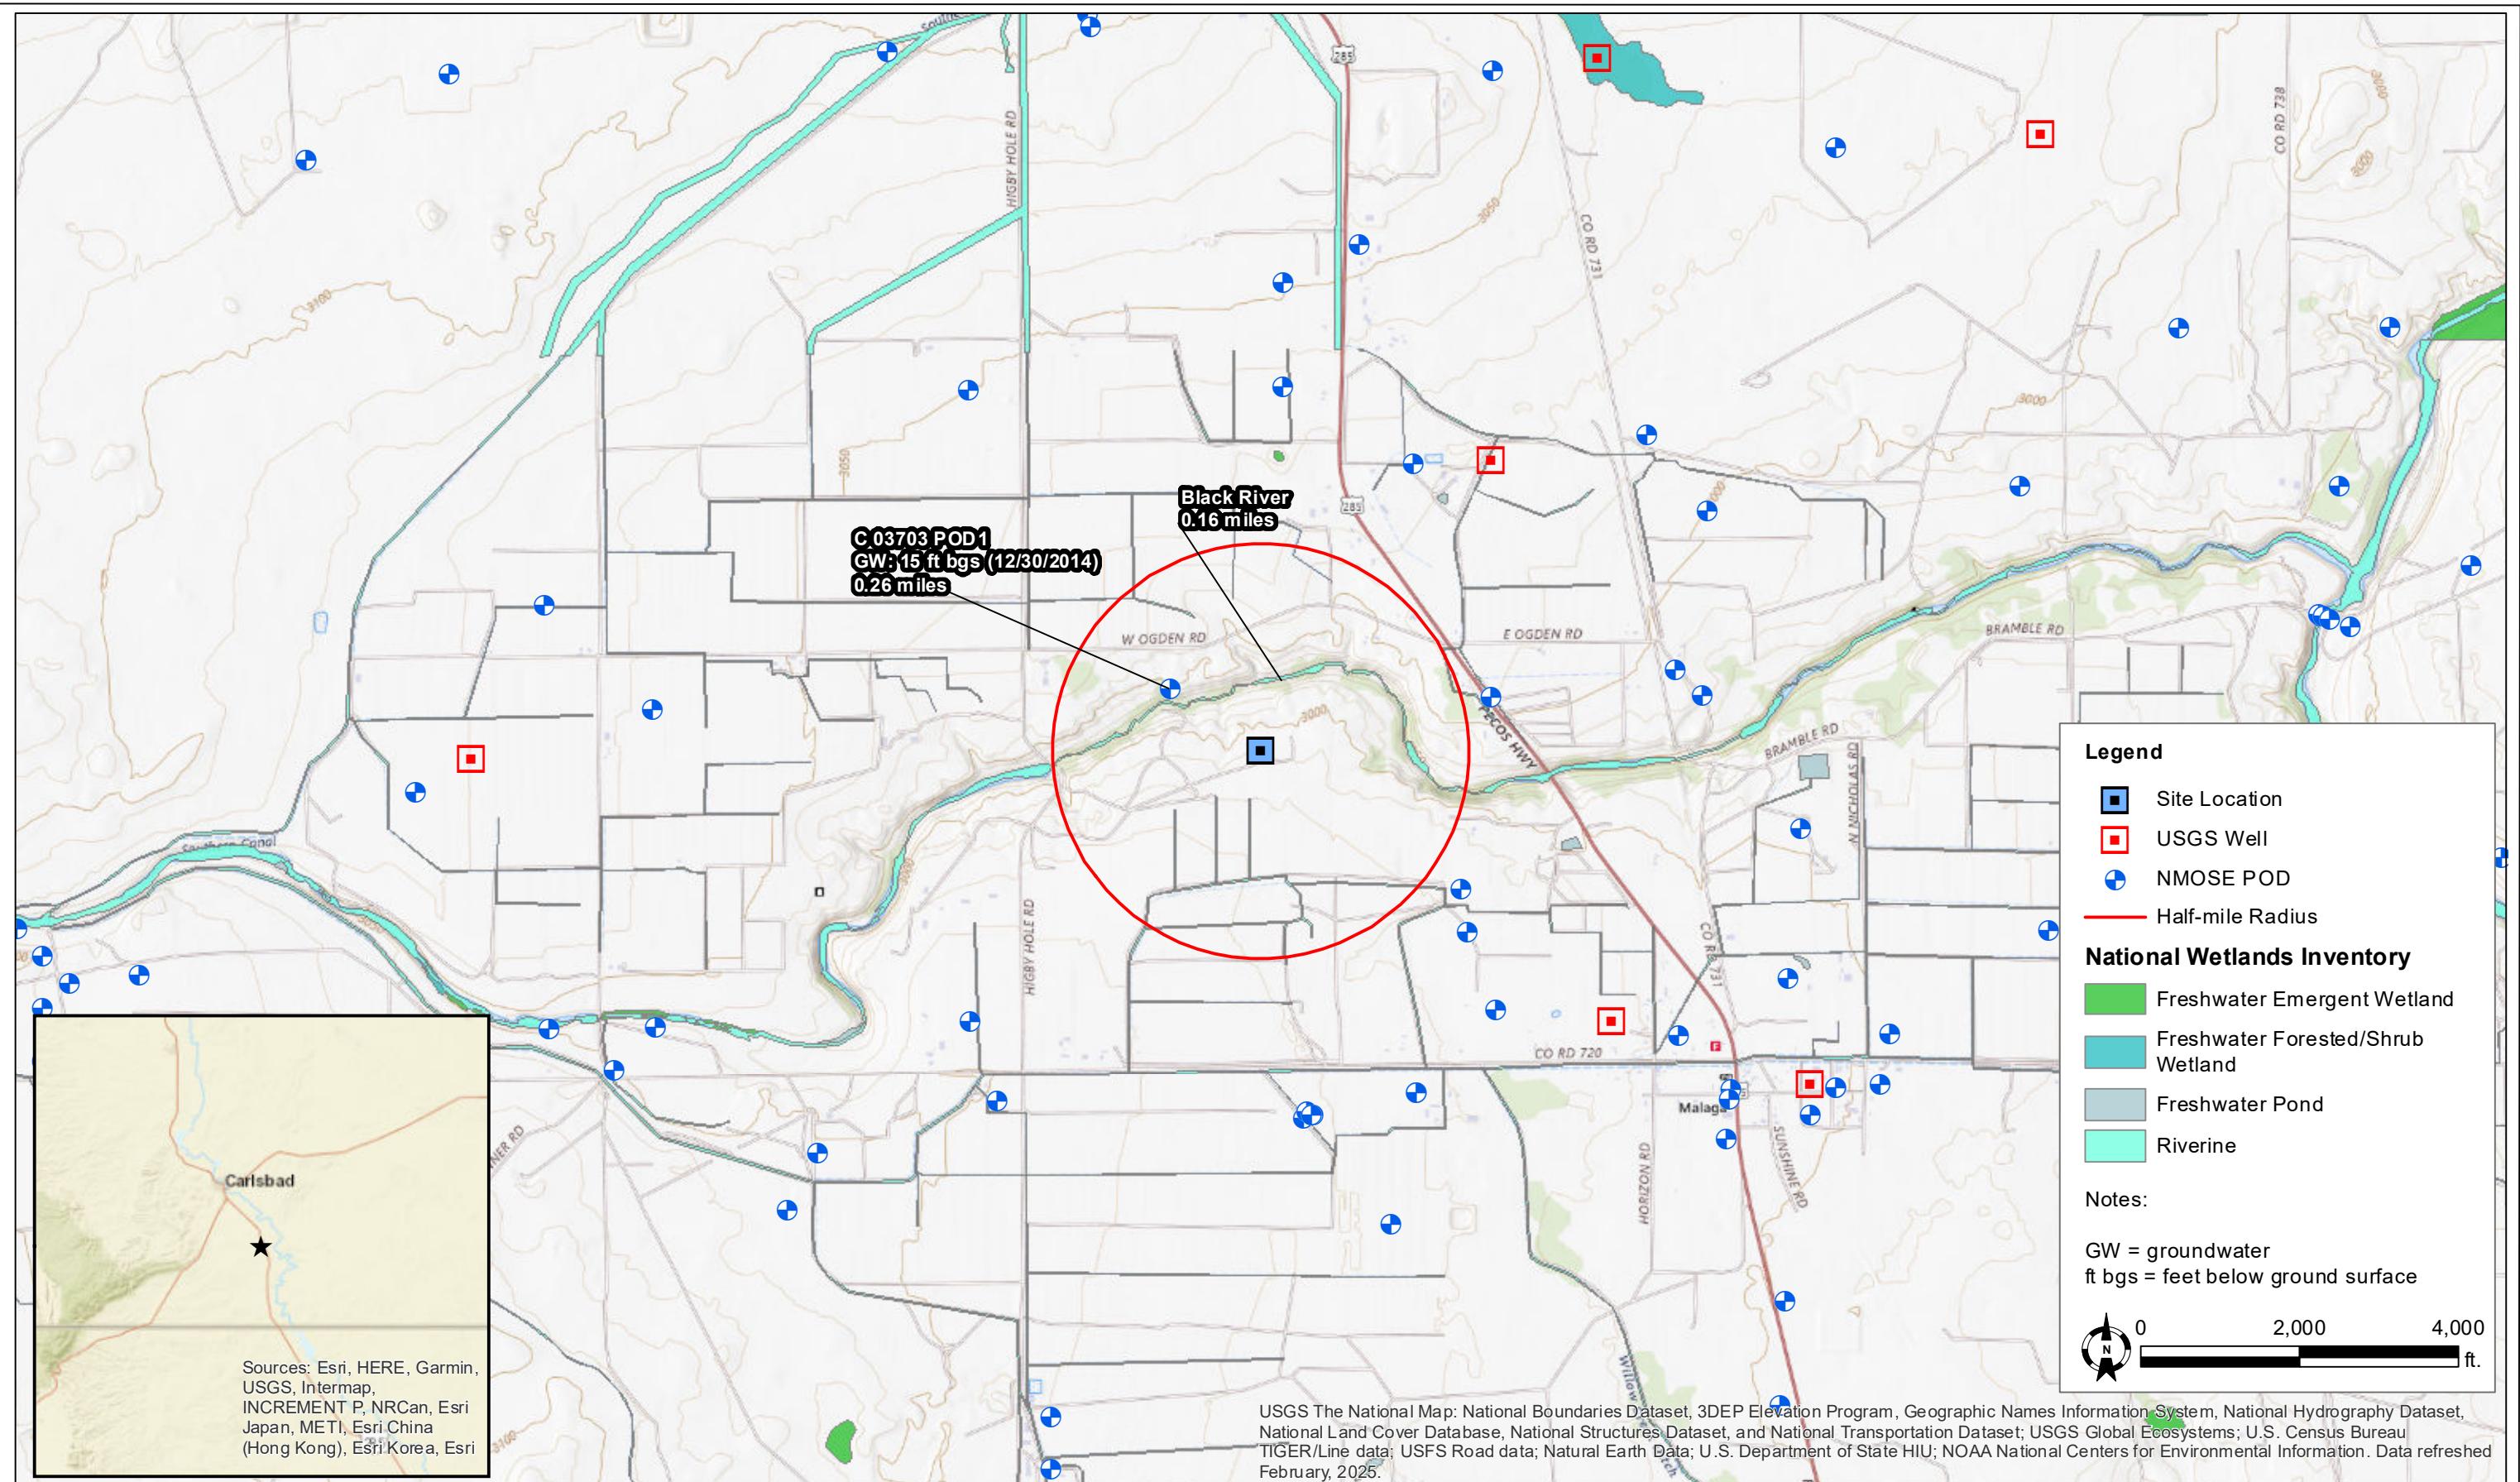
The Site Location & Groundwater Map included as Figure 1 illustrates the location of the registered water wells within the vicinity of the site, and a summary of depth to groundwater

The nearest potable water well is assumed to be C-03703 POD 1, located 0.28 miles from the site. Tasman did not visually confirm the presence of the well. The location of C-03703 POD 1 is shown on the attached Figure 1.

Tasman reviewed aerial imagery and the National Wetland Inventory Map, published by the U.S. Fish and Wildlife Service, for wetlands and surface water in the vicinity of the site. Both the nearest wetland and nearest significant surface water was identified as the Black River, located 0.16 miles from the site. The location of the Black River in relation to the site is shown on Figure 1.

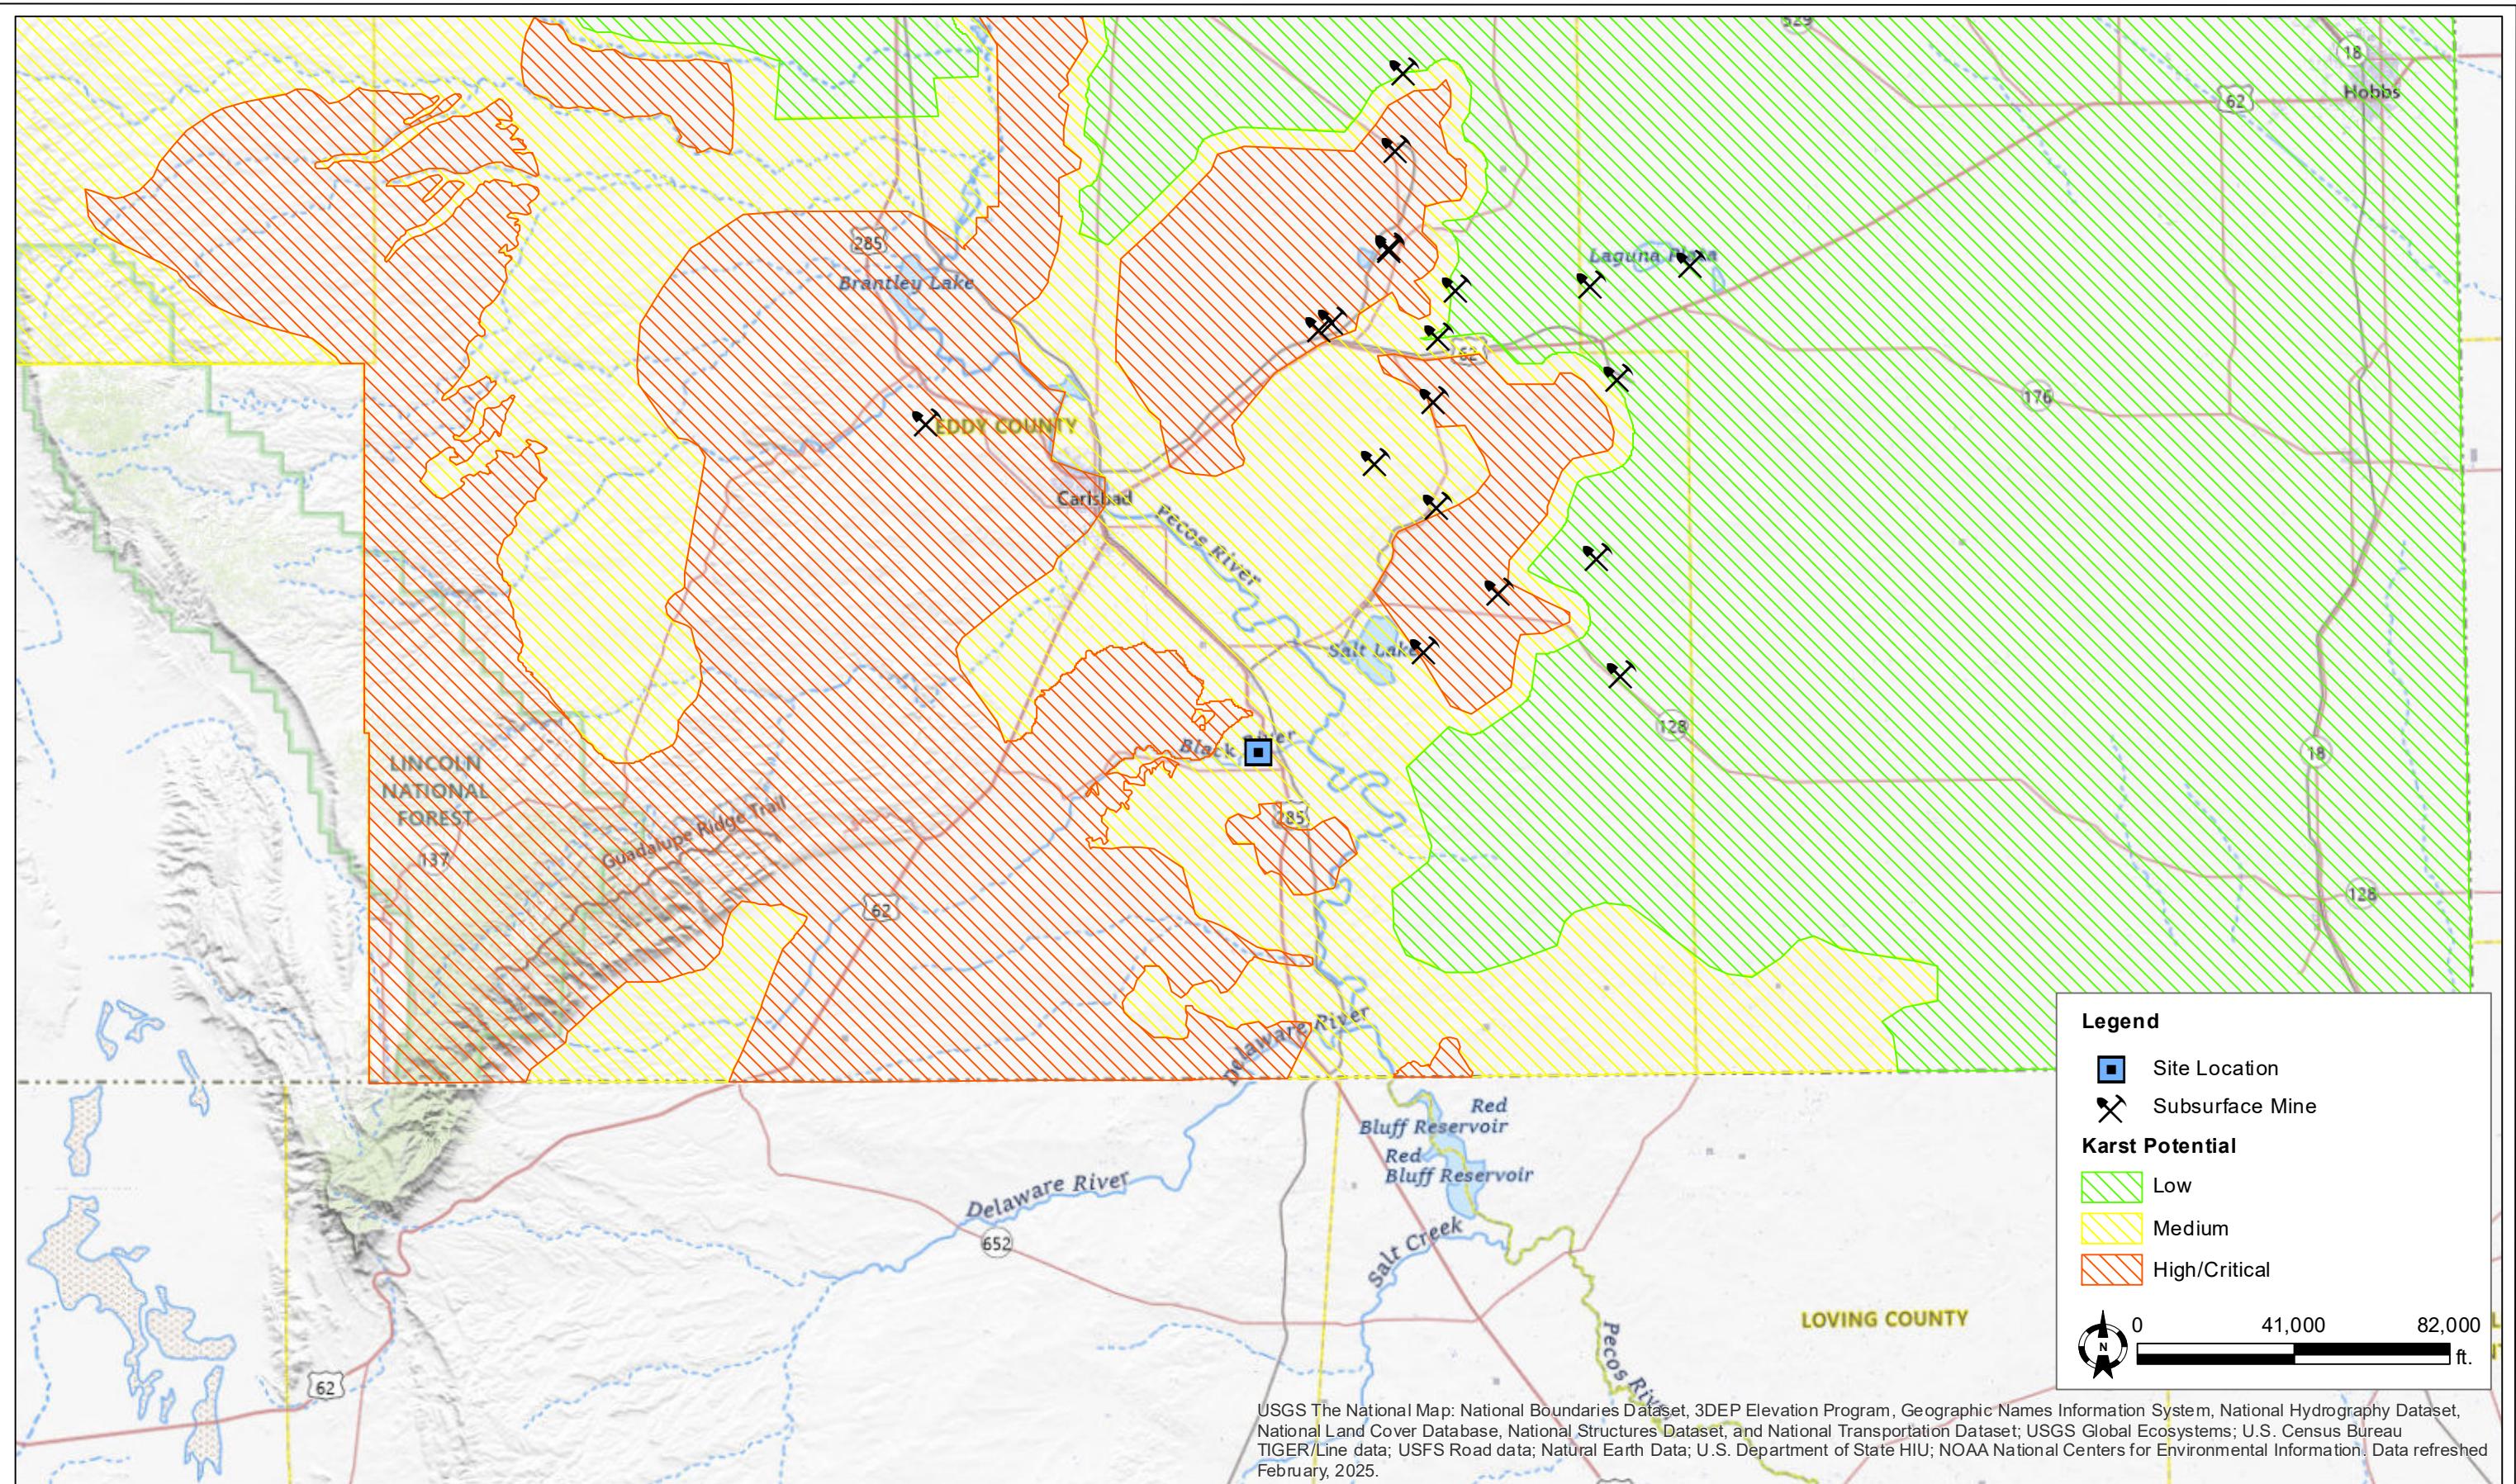
Figure  
2

Tasman utilized the publicly available karst potential map published by the Bureau of Land Management (BLM) Carlsbad Field Office (CFO) to determine the potential for encountering karst formations beneath the site. Review of the BLM CFO karst potential map indicates that the site is located in an area of medium potential to encounter karstic features.

Tasman utilized the USGS Mineral Resources database to determine that there are no subsurface mines beneath or in the vicinity of the site.

Areas of high/critical karst and subsurface mine locations are illustrated on Figure 2.

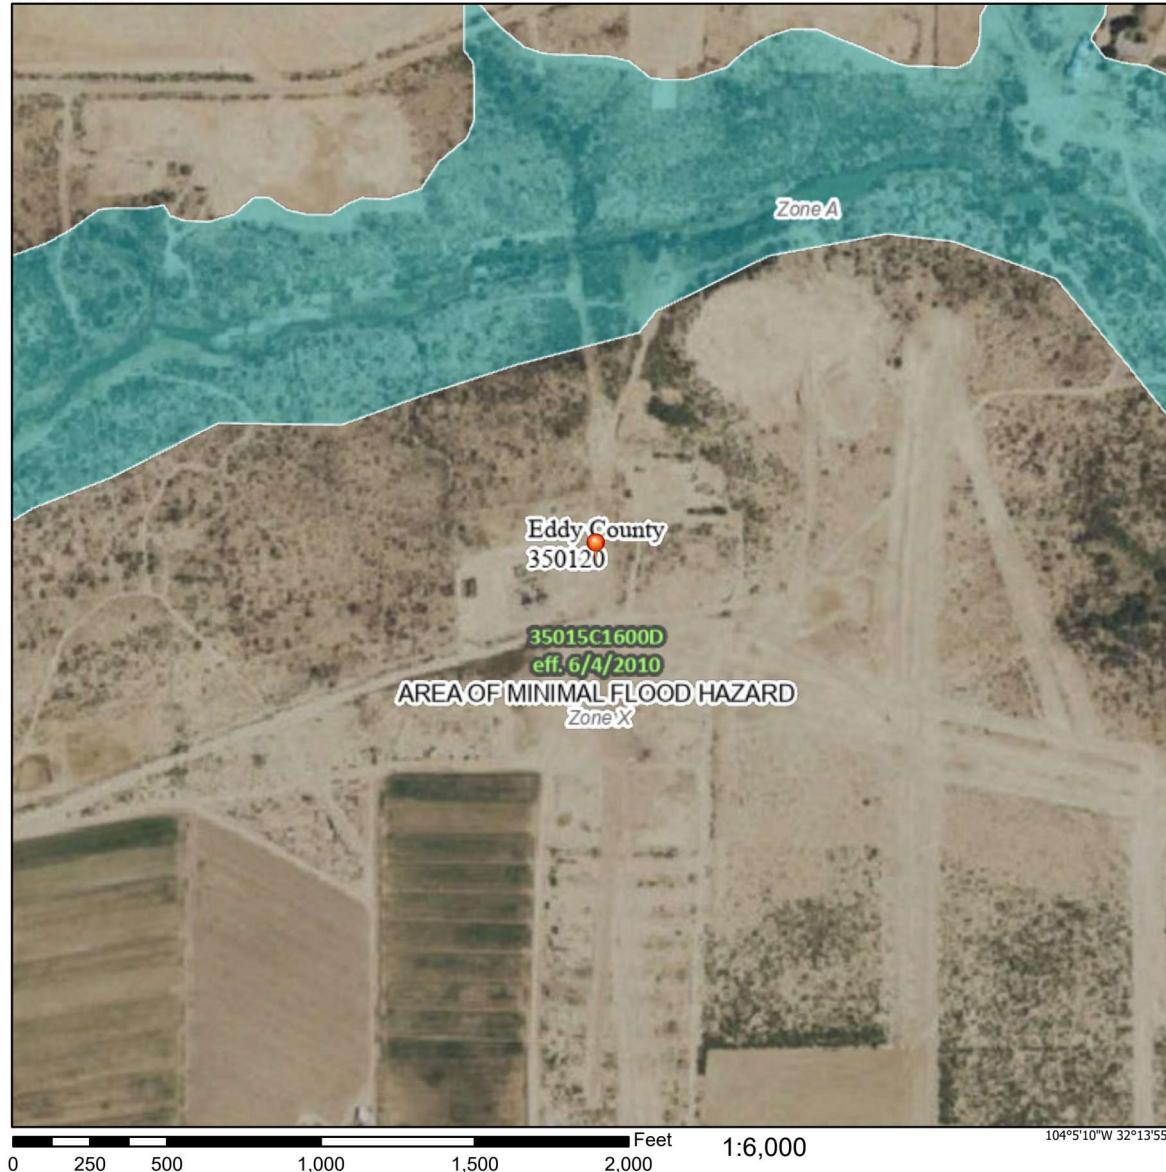
Figure 3

Review of flood map data published by the Federal Emergency Management Agency (FEMA) indicates the site is not located within a 100-year floodplain. A copy of the FEMA FIRMap can be found attached as Figure 3.

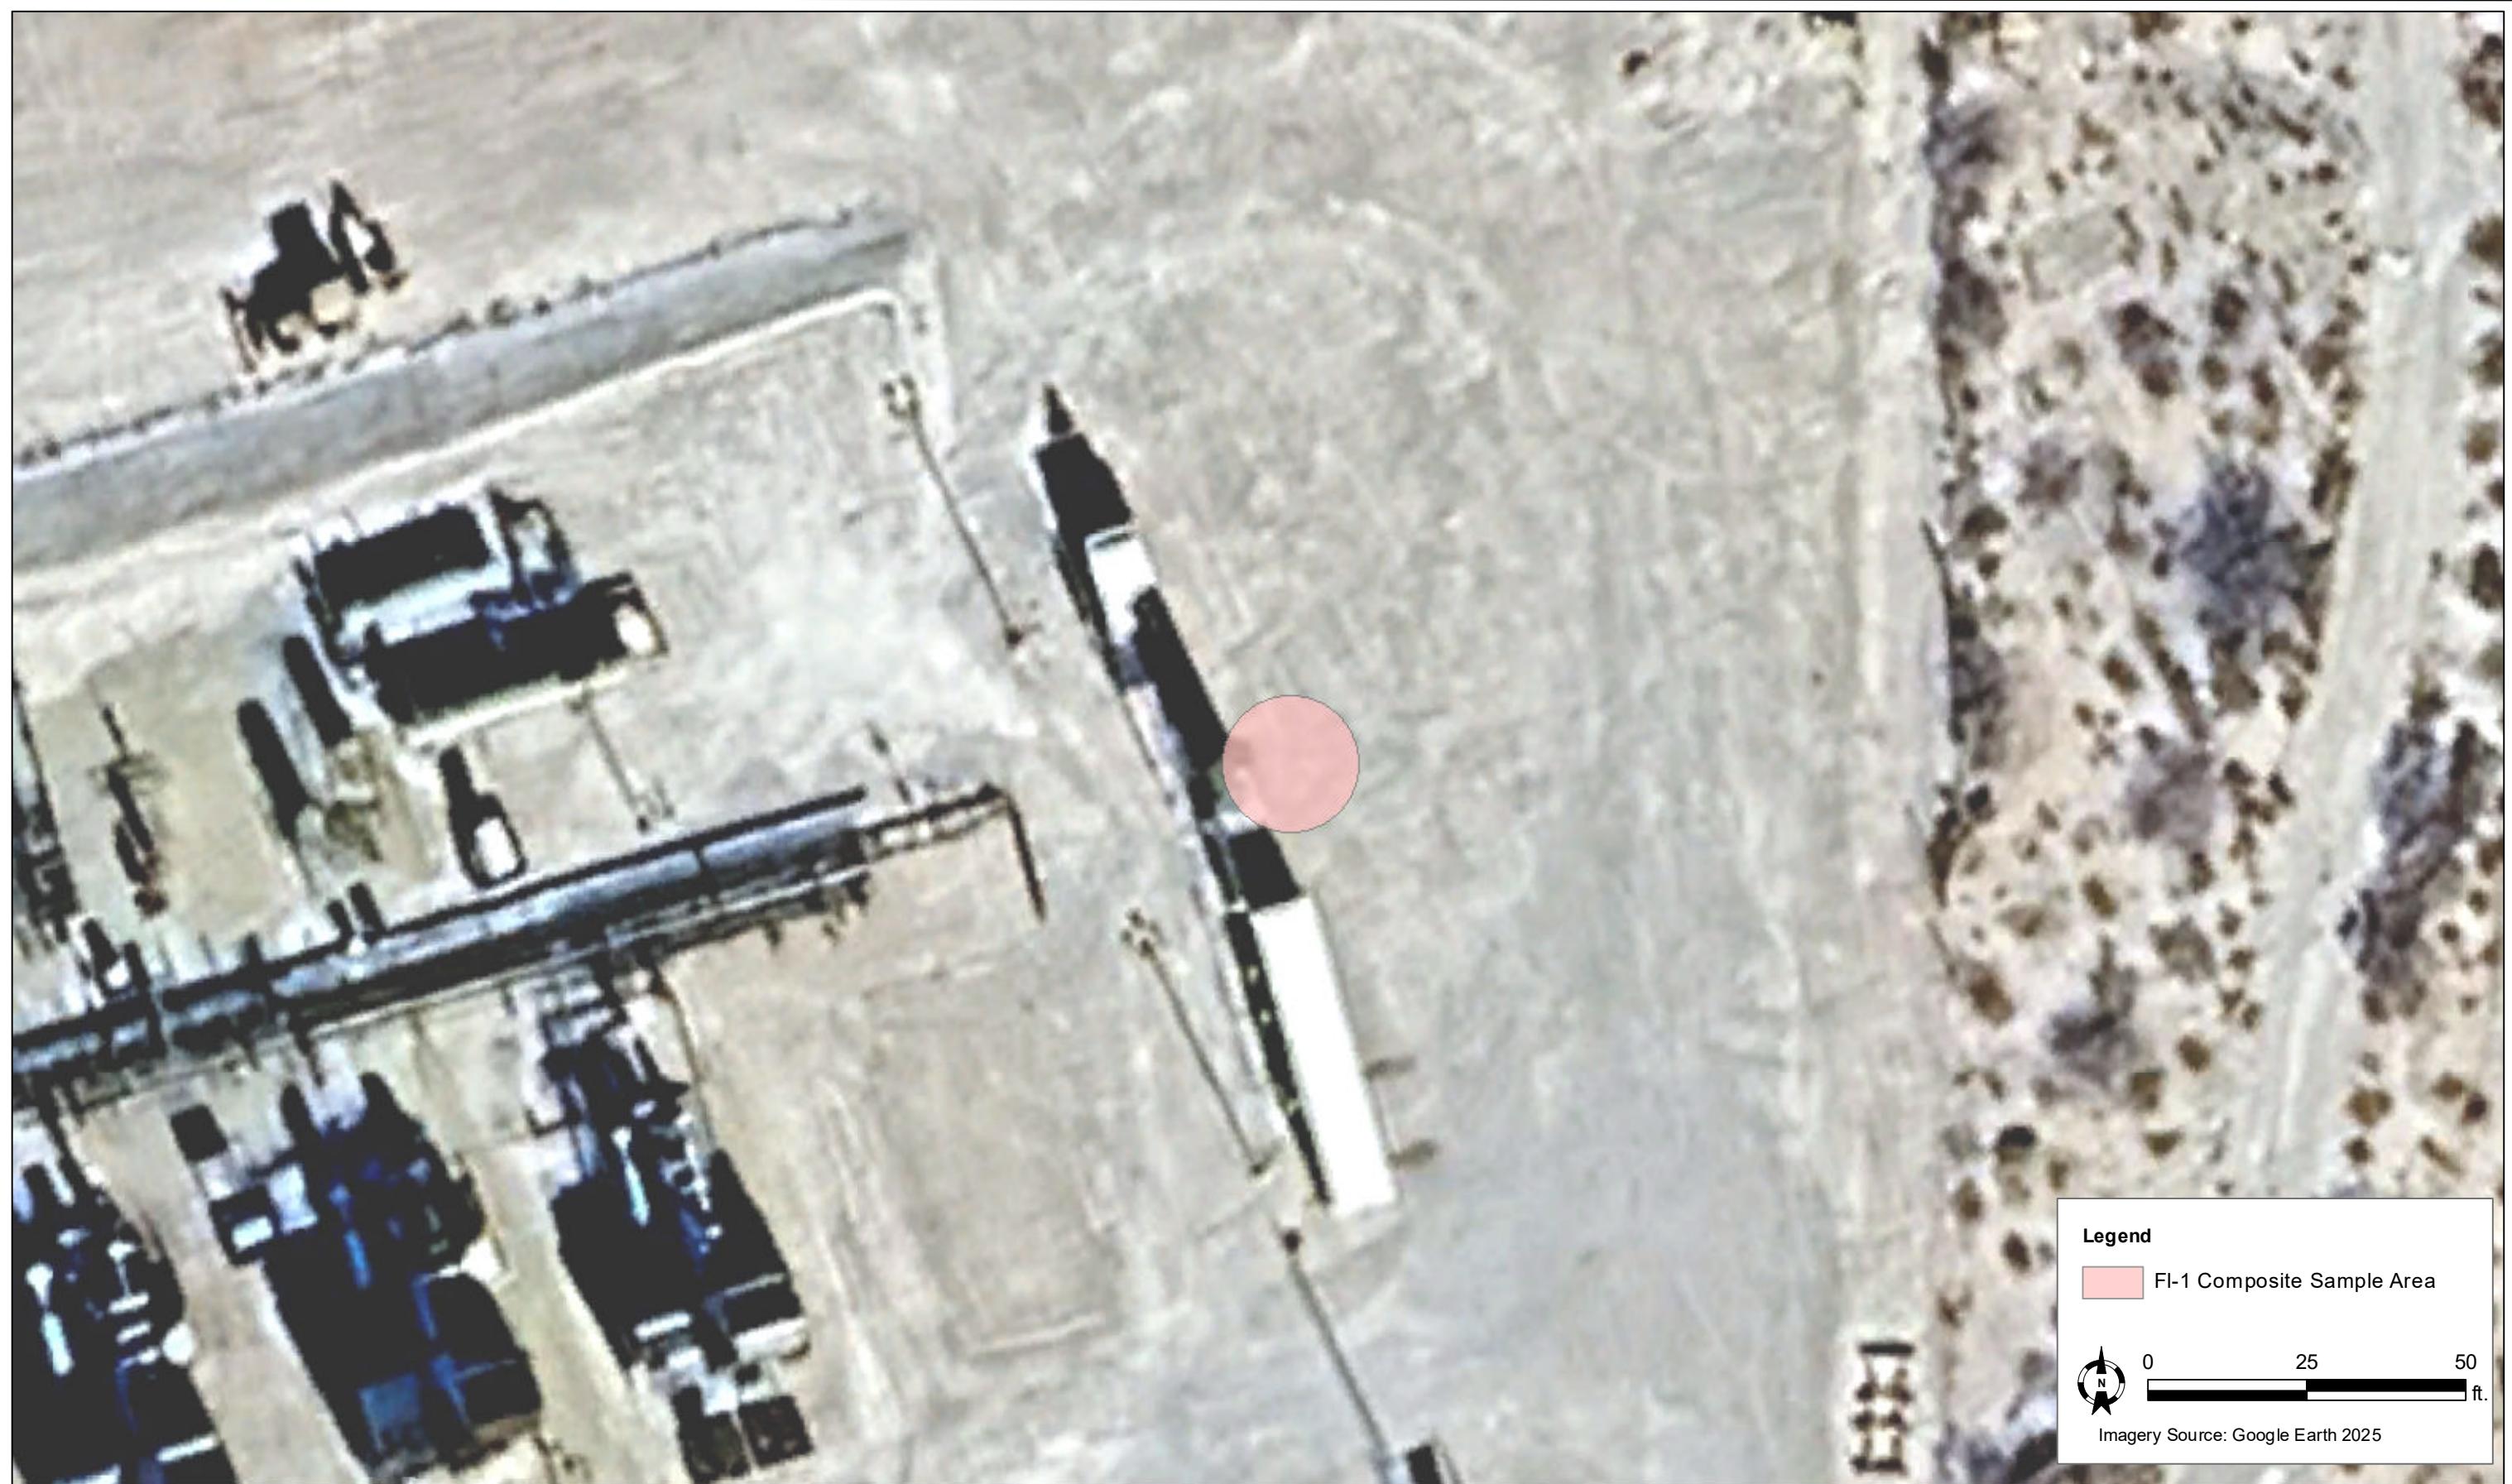
**Figure  
4**

On September 11, 2025, Tasman mobilized to the site to photo document the site and collect confirmation samples per NMOCD request. During activities no evidence of soil impacts were observed. Therefore, one five-point composite sample was collected from within a 200 square foot area surrounding the generator and submitted for laboratory analysis in accordance with the above Section 4.

A photographic log is included as Appendix C and the location of the confirmation sample is illustrated on Figure 4.
