**Incident ID: nAPP2514142619**  
**REMEDATION AND CLOSURE REPORT**  
**Hayhurst NM Section 2 SWD Facility (Gravitas SWD)**  
**Produce Water Release**  
**Eddy County, New Mexico**

LAI Project No: 25-0101-02

November 18, 2025

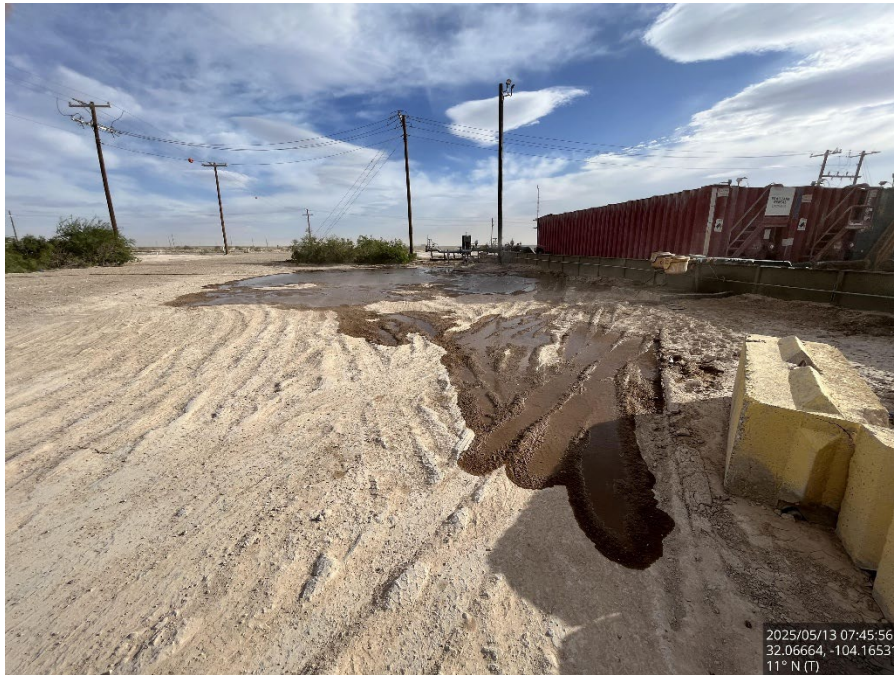
Spill area, viewing north.

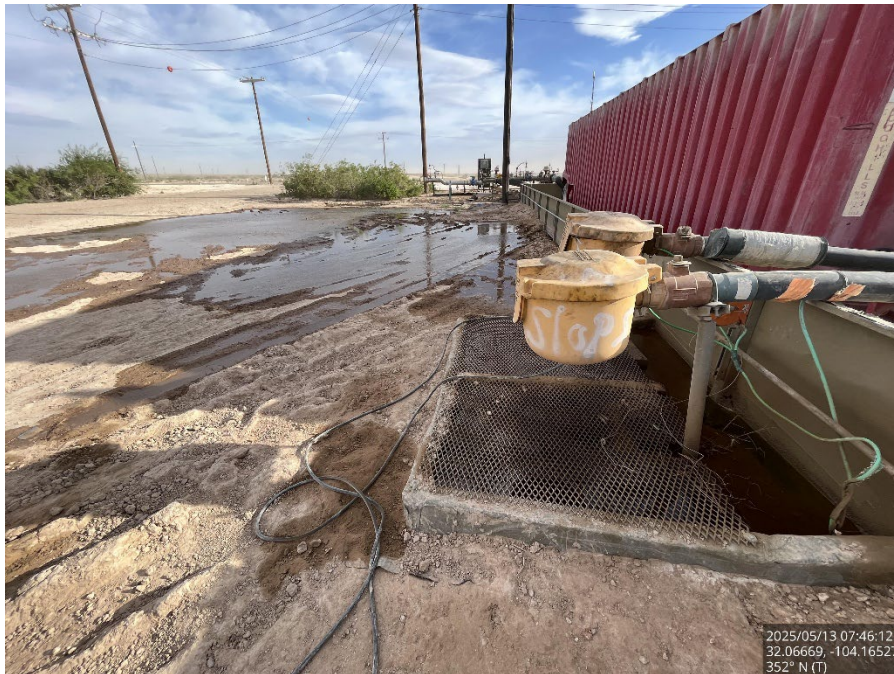
Spill area, viewing north.

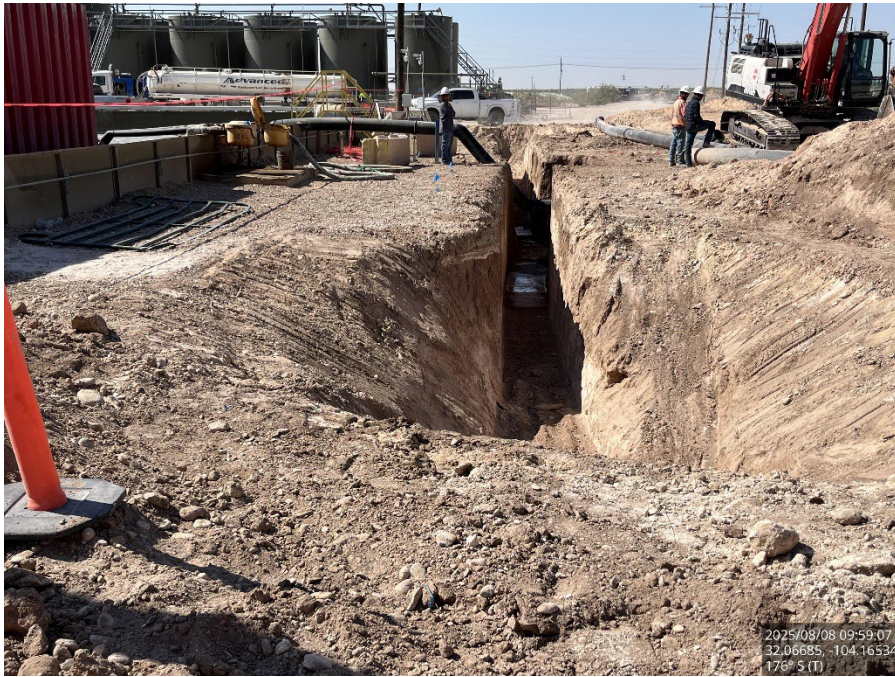
Trench through remediation area, viewing south.

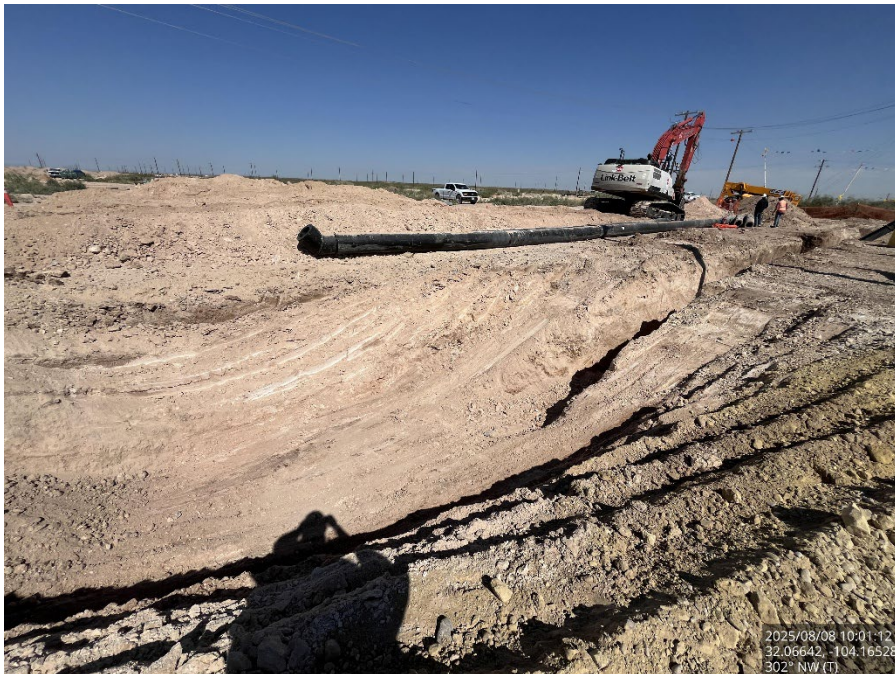
Trench through remediation area, viewing northwest.

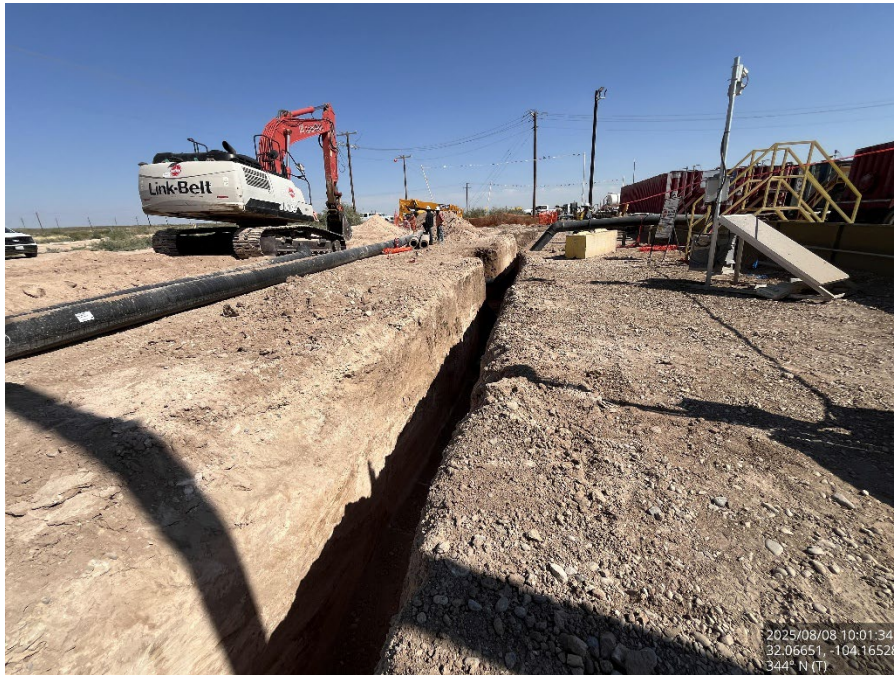
Trench through remediation area, viewing north.

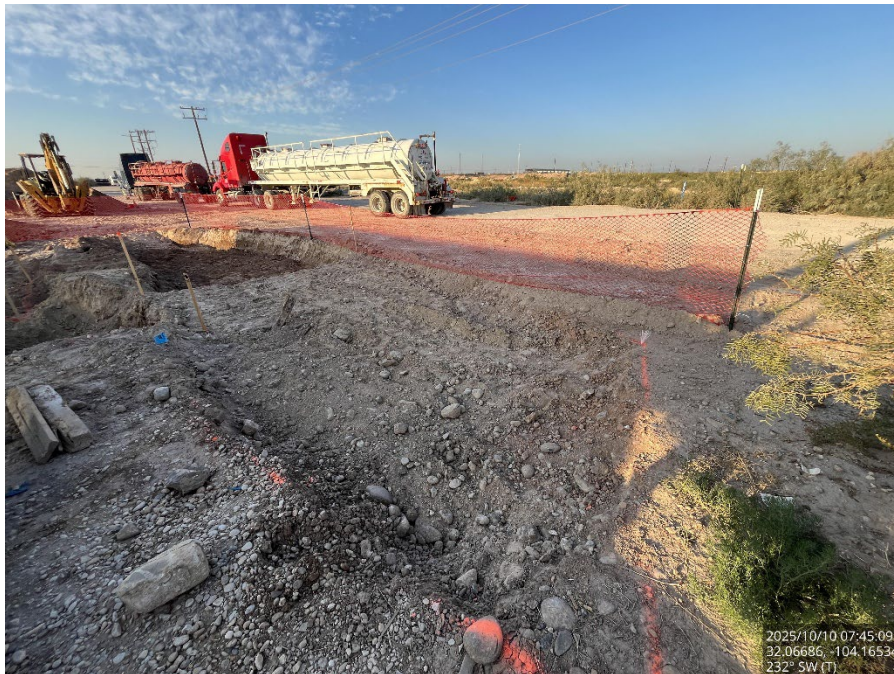
Backfilled area, viewing southwest.

Between November 10 and 13, 2025, Apeck backfilled the excavation with the non-waste containing backfill material collected from the nearby borrow pit and restored the surface to a similar condition prior to remediation. Table 2 presents the backfill sample analytical summary. Appendix E presents the laboratory reports. Appendix D presents the final sampling notifications. Appendix F presents photographic documentation.

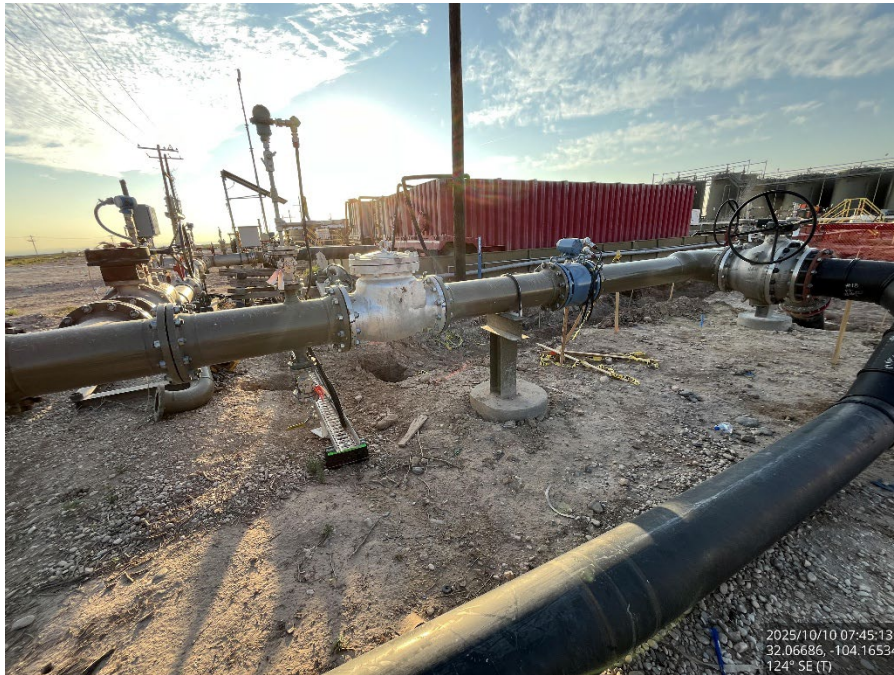
Excavated area, viewing southeast.

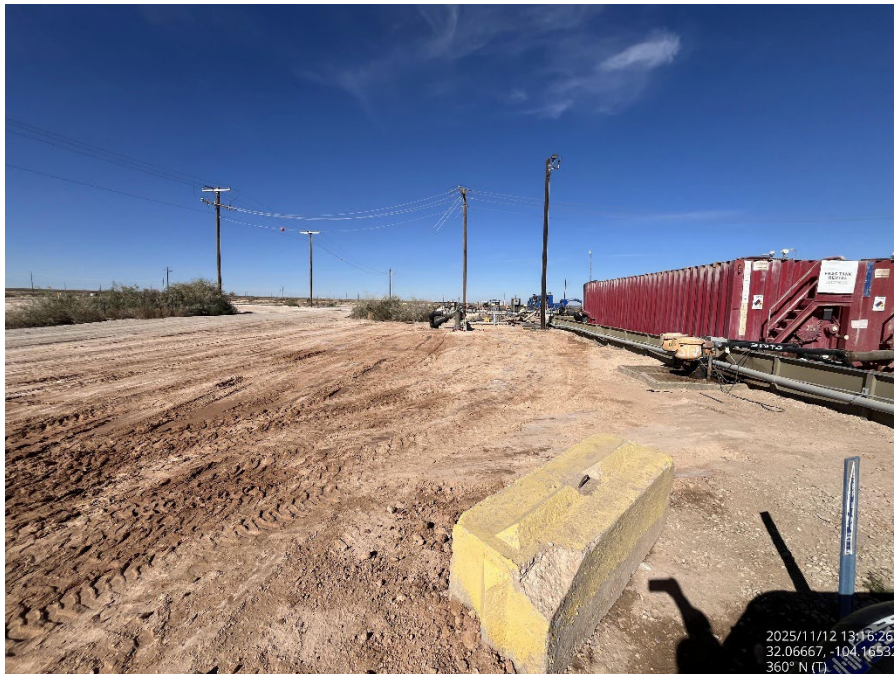
Backfilled area, viewing north.
