**Re: Remediation Work Plan**  
**Tiger 14 CDP**  
**Incident Number: nAPP2513455553**  
**Eddy County, New Mexico**

Ensolum, LLC (Ensolum), on behalf of San Mateo Black River Oil Pipeline, LLC (San Mateo), has prepared this *Remediation Work Plan (RWP)* to document assessment and soil sampling activities performed at the Tiger 14 CDP (Site). The purpose of the Site assessment and soil sampling activities was to assess for the presence or absence of impacted and waste-containing soil resulting from a crude oil release. San Mateo is submitting this *RWP*, describing analytical results from soil sampling and karst survey activities associated with Incident Number nAPP2513455553 and proposing to assess the current sensitive Site receptor (high karst potential) of the subject matter release prior to beginning excavation activities and prior to submitting a *Closure or Deferral Request*.

# **Environmental Karst Study Report**

## **Tiger 14 CDP**

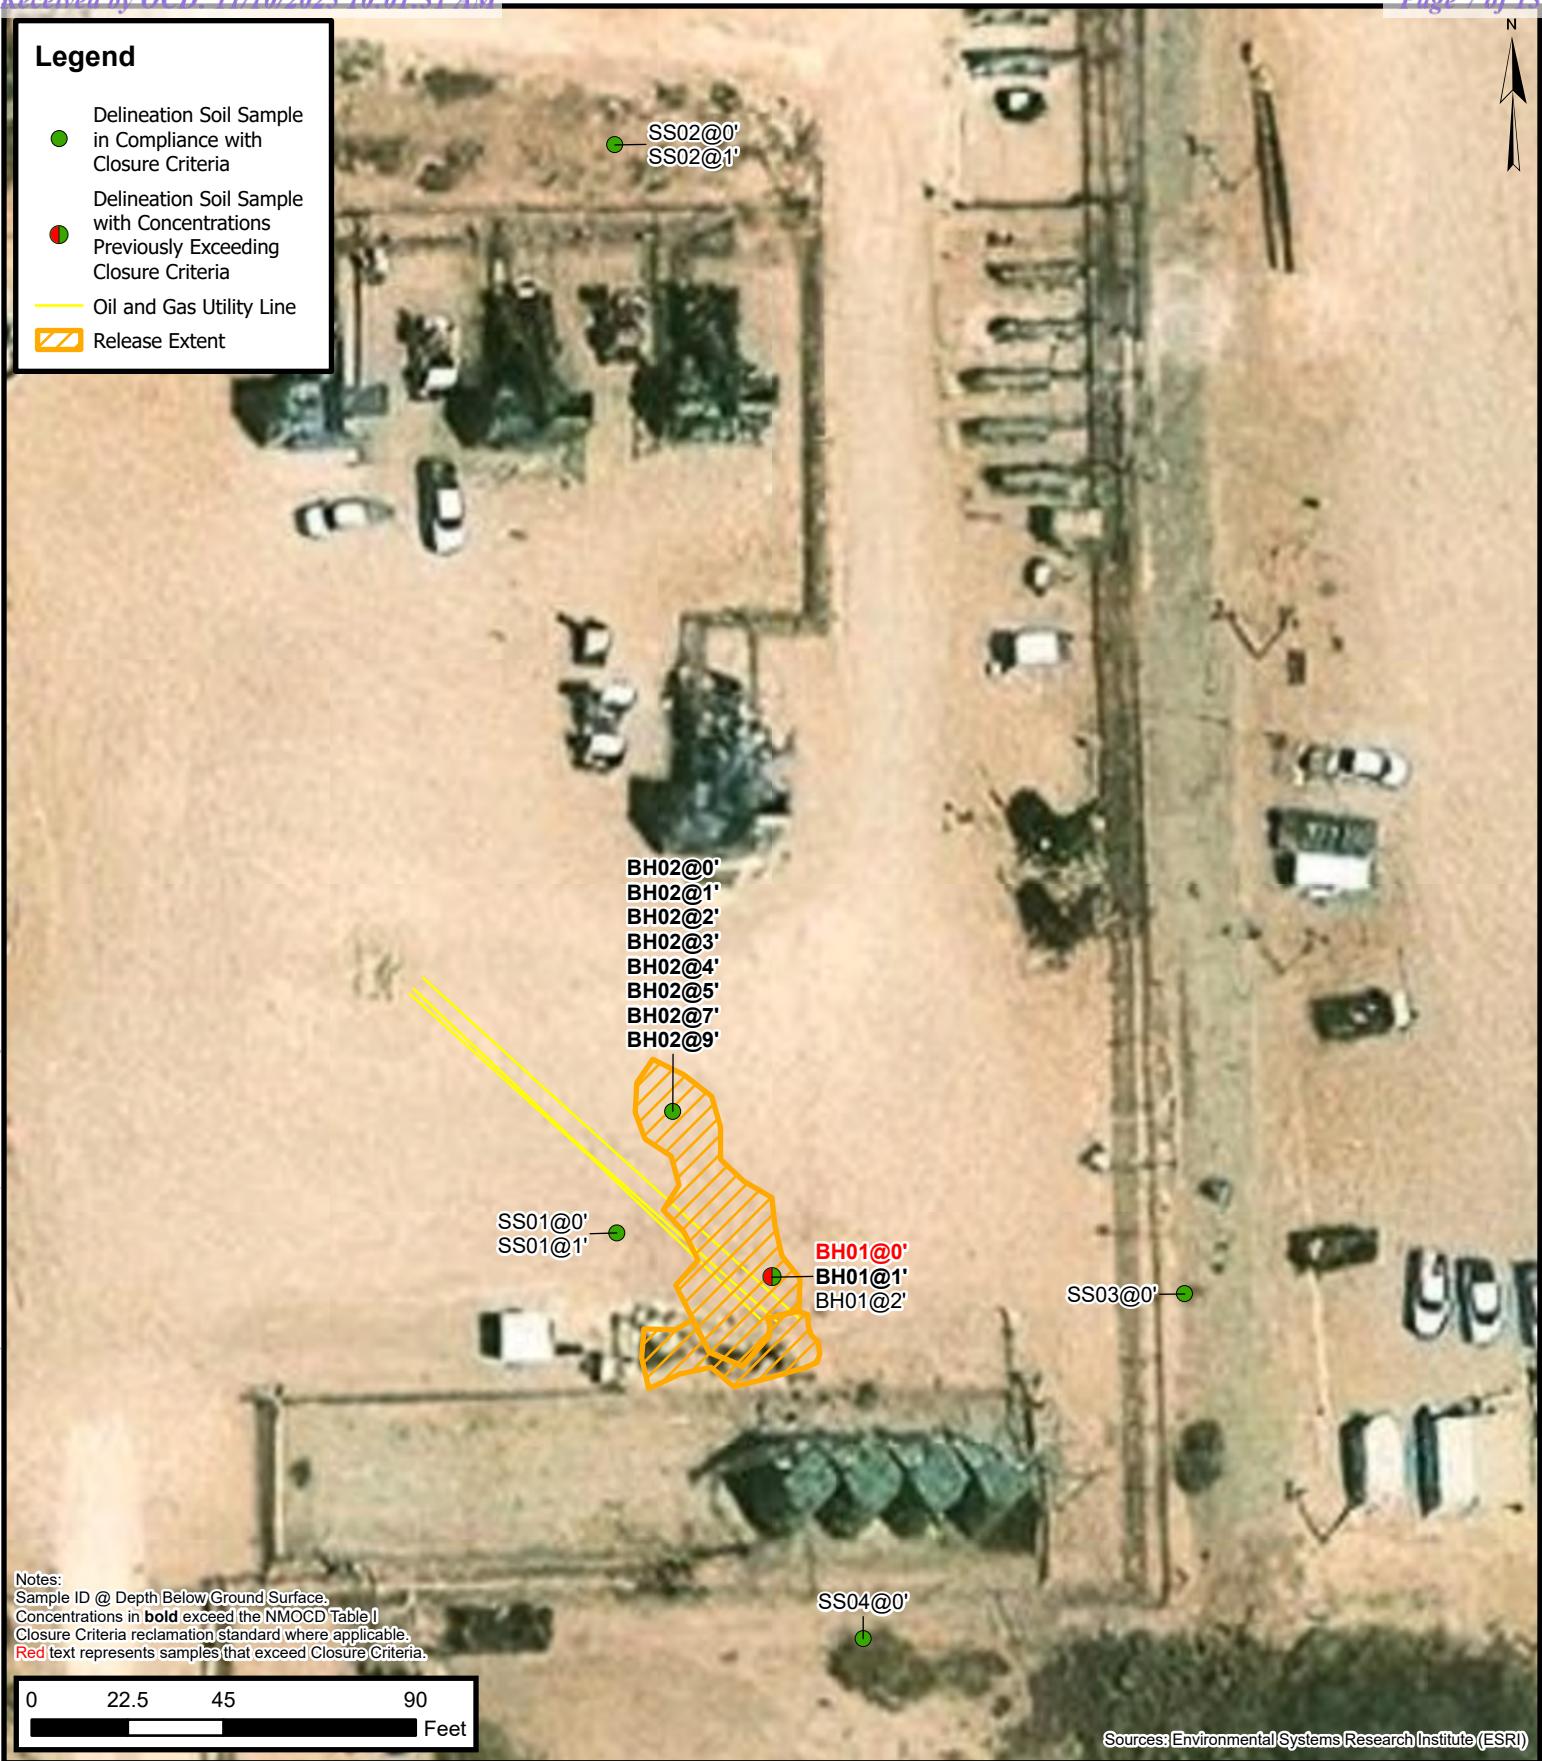
**FIGURE  
2**

## Delineation Soil Sample Locations

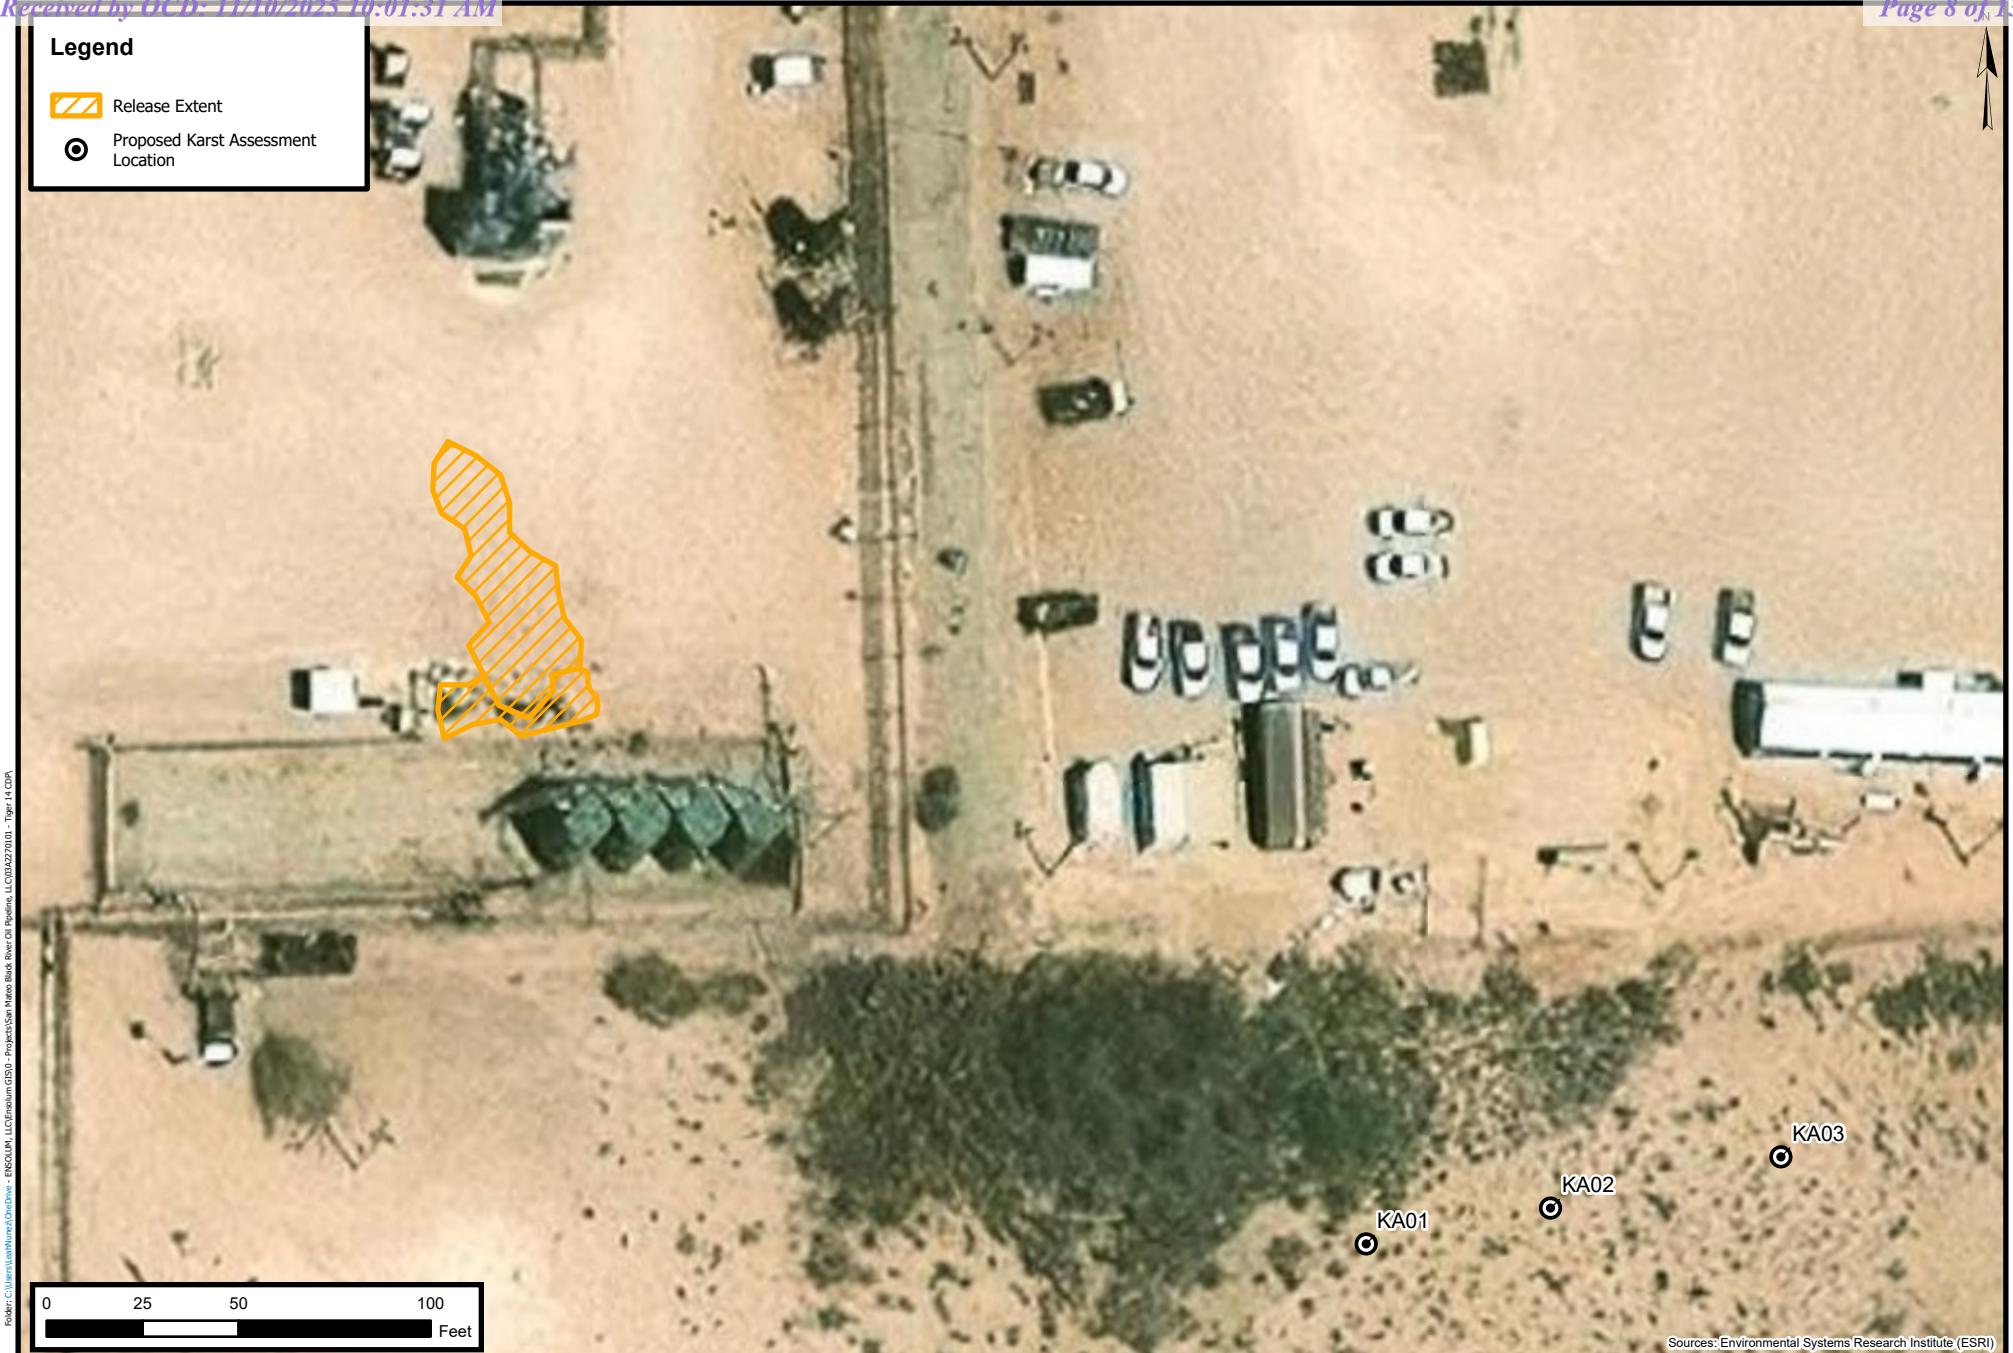
- San Mateo intends to complete soil borings to confirm the presence of potential unstable geology and subsurface karst features at the Site prior to performing excessive remediation. The soil borings will be advanced to a depth of approximately 44 feet bgs, which is the depth the off-site anomaly was observed in the ER survey. The proposed karst assessment soil borings locations are included on Figure 3

### Proposed Karst Assessment Locations

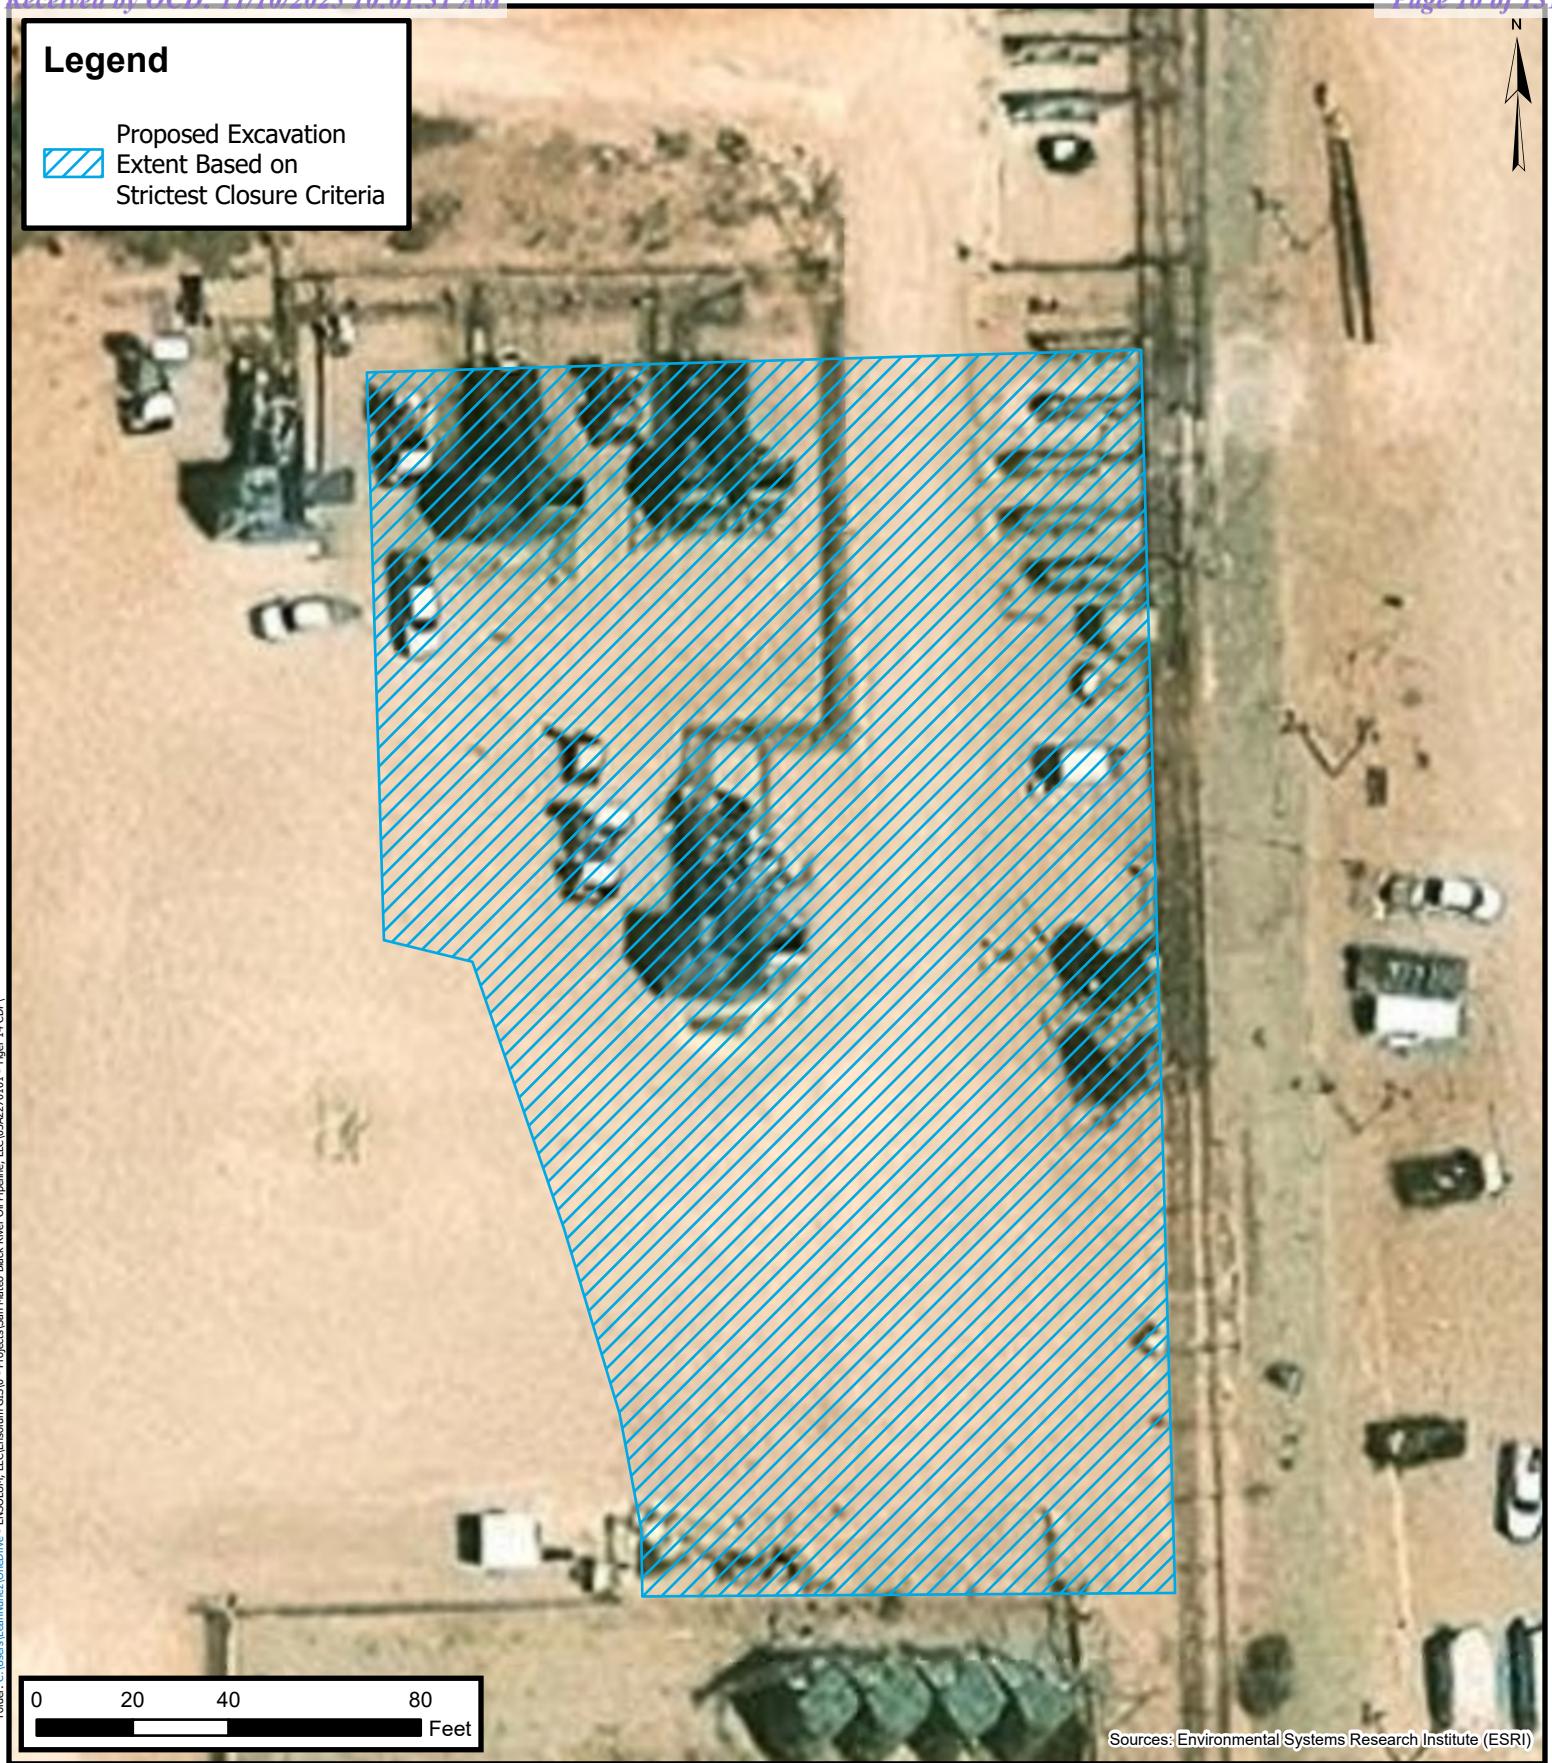
Proposed Excavation  
Extent Based on  
Strictest Closure Criteria

## Proposed Excavation Extent

- Following the removal of impacted soil, Ensolum will collect 5-point composite soil samples representing no more than 200 square feet from the floor and sidewalls of the excavation. The 5-point composite samples will be collected by placing five equivalent aliquots of soil into a resealable plastic bag and homogenizing the samples by thoroughly mixing. The excavation soil samples will be collected, handled, and analyzed following the same procedures as described above. The excavation will be backfilled and recontoured to match pre-existing conditions.

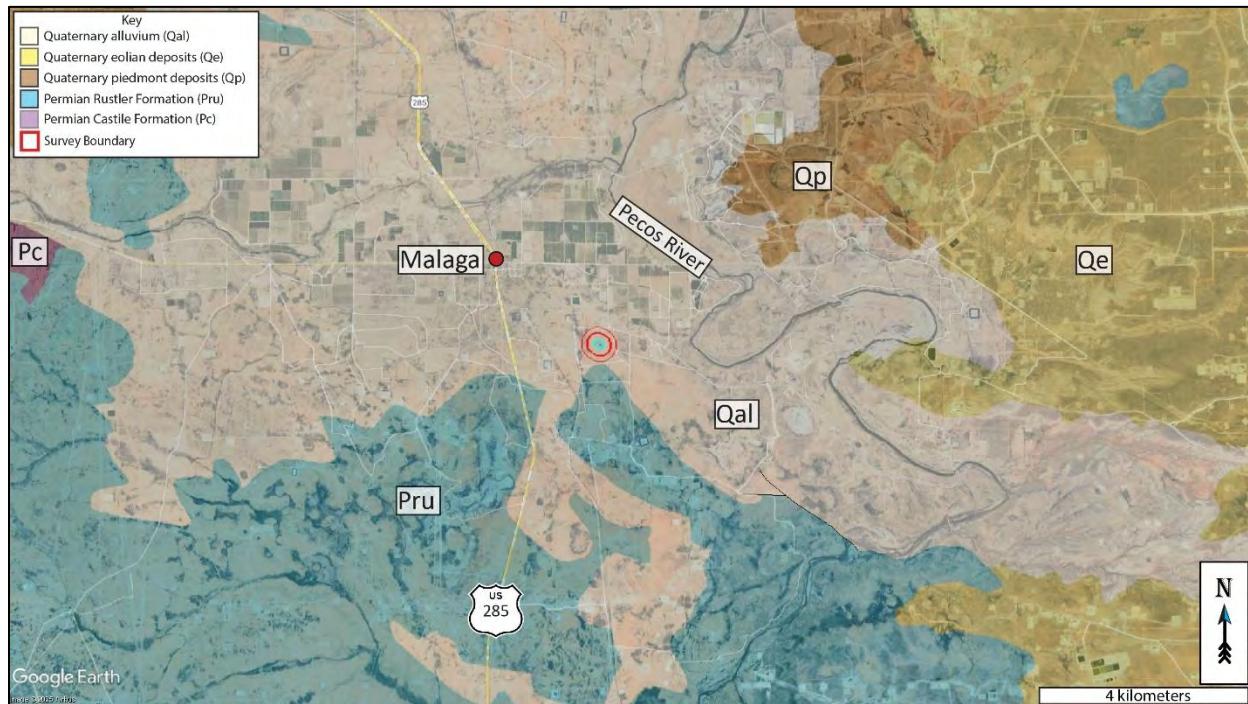
The site for the TG14 survey is located at an elevation of 904 meters (2,965 feet),  $\pm$  3 meters (9.8 feet). This region is entirely underlain by the Permian Rustler Formation (Pru). The area is mantled by thin gypsiferous soils (gypssite), Quaternary alluvial piedmont (Qp), eolian deposits (Qe), and alluvium (Qal)<sup>[11]</sup> up to 5 meters in depth (Figure 3).

Figure 3: Geology overview. Geology map credit: The Digital Geologic Map of New Mexico in ARC/INFO Format. Background image credit: Google Earth. Image date: July 13, 2024. Image datum: WGS-84.

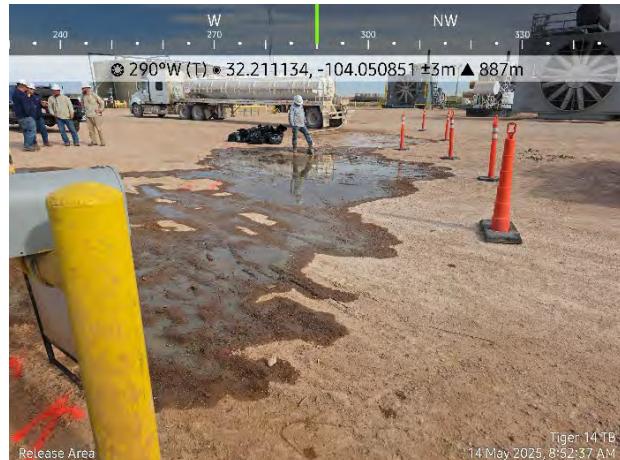
Photograph 2  
Description: Release Area  
View: West

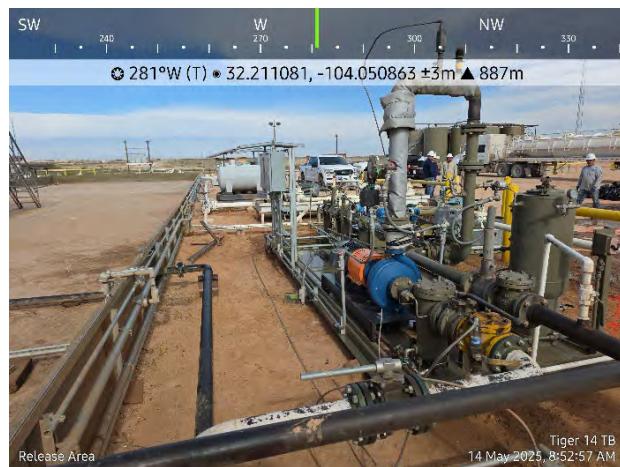
Photograph 4  
Description: Release Area  
View: West

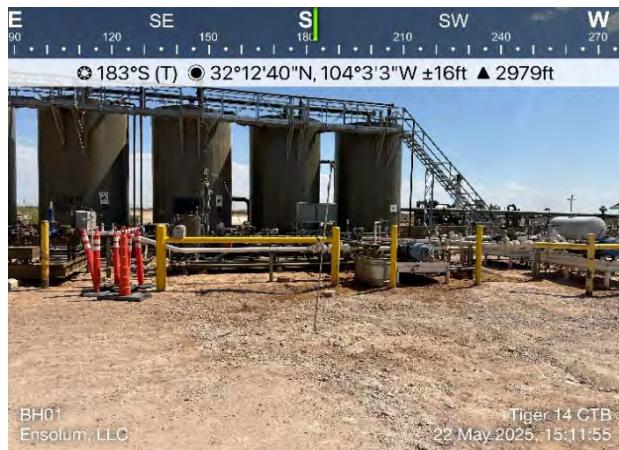
Photograph 5

Description: Delineation (BH01)

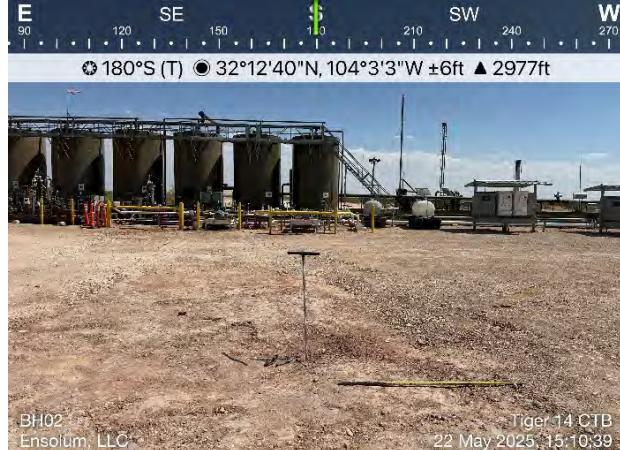
Photograph 6

Description: Delineation (BH02)

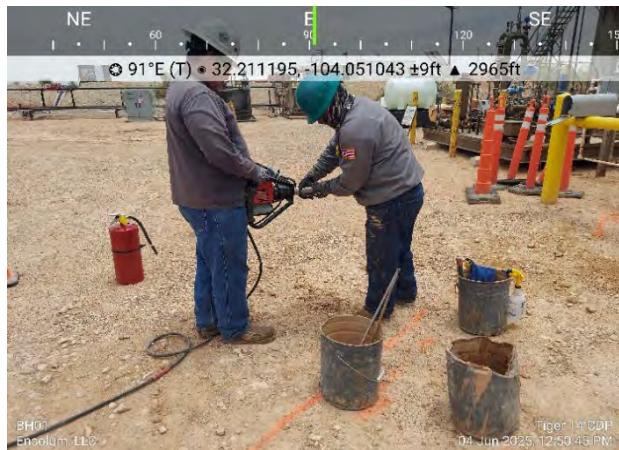
Photograph 7

Description: Delineation (BH01)
