Liner Inspection and Closure

East Pecos Federal 22 #003H
Section 22, Township 26 South, Range 29 East
API: 30-015-42285
County: Eddy
Vertex File Number: 25A-04701

Devon Energy Production Company, LP (Devon) retained Vertex Resource Services Inc. (Vertex) to conduct a Liner Inspection and Closure for a produced water release that occurred on August 25, 2025, at East Pecos Federal 22 #003H API 30-015-42285 (hereafter referred to as the "site"). Devon submitted an initial C-141 Release Notification to New Mexico Oil Conservation Division (NMOCD) District 2 on August 28, 2025. Incident ID number nAPP2523824000 was assigned to this incident.

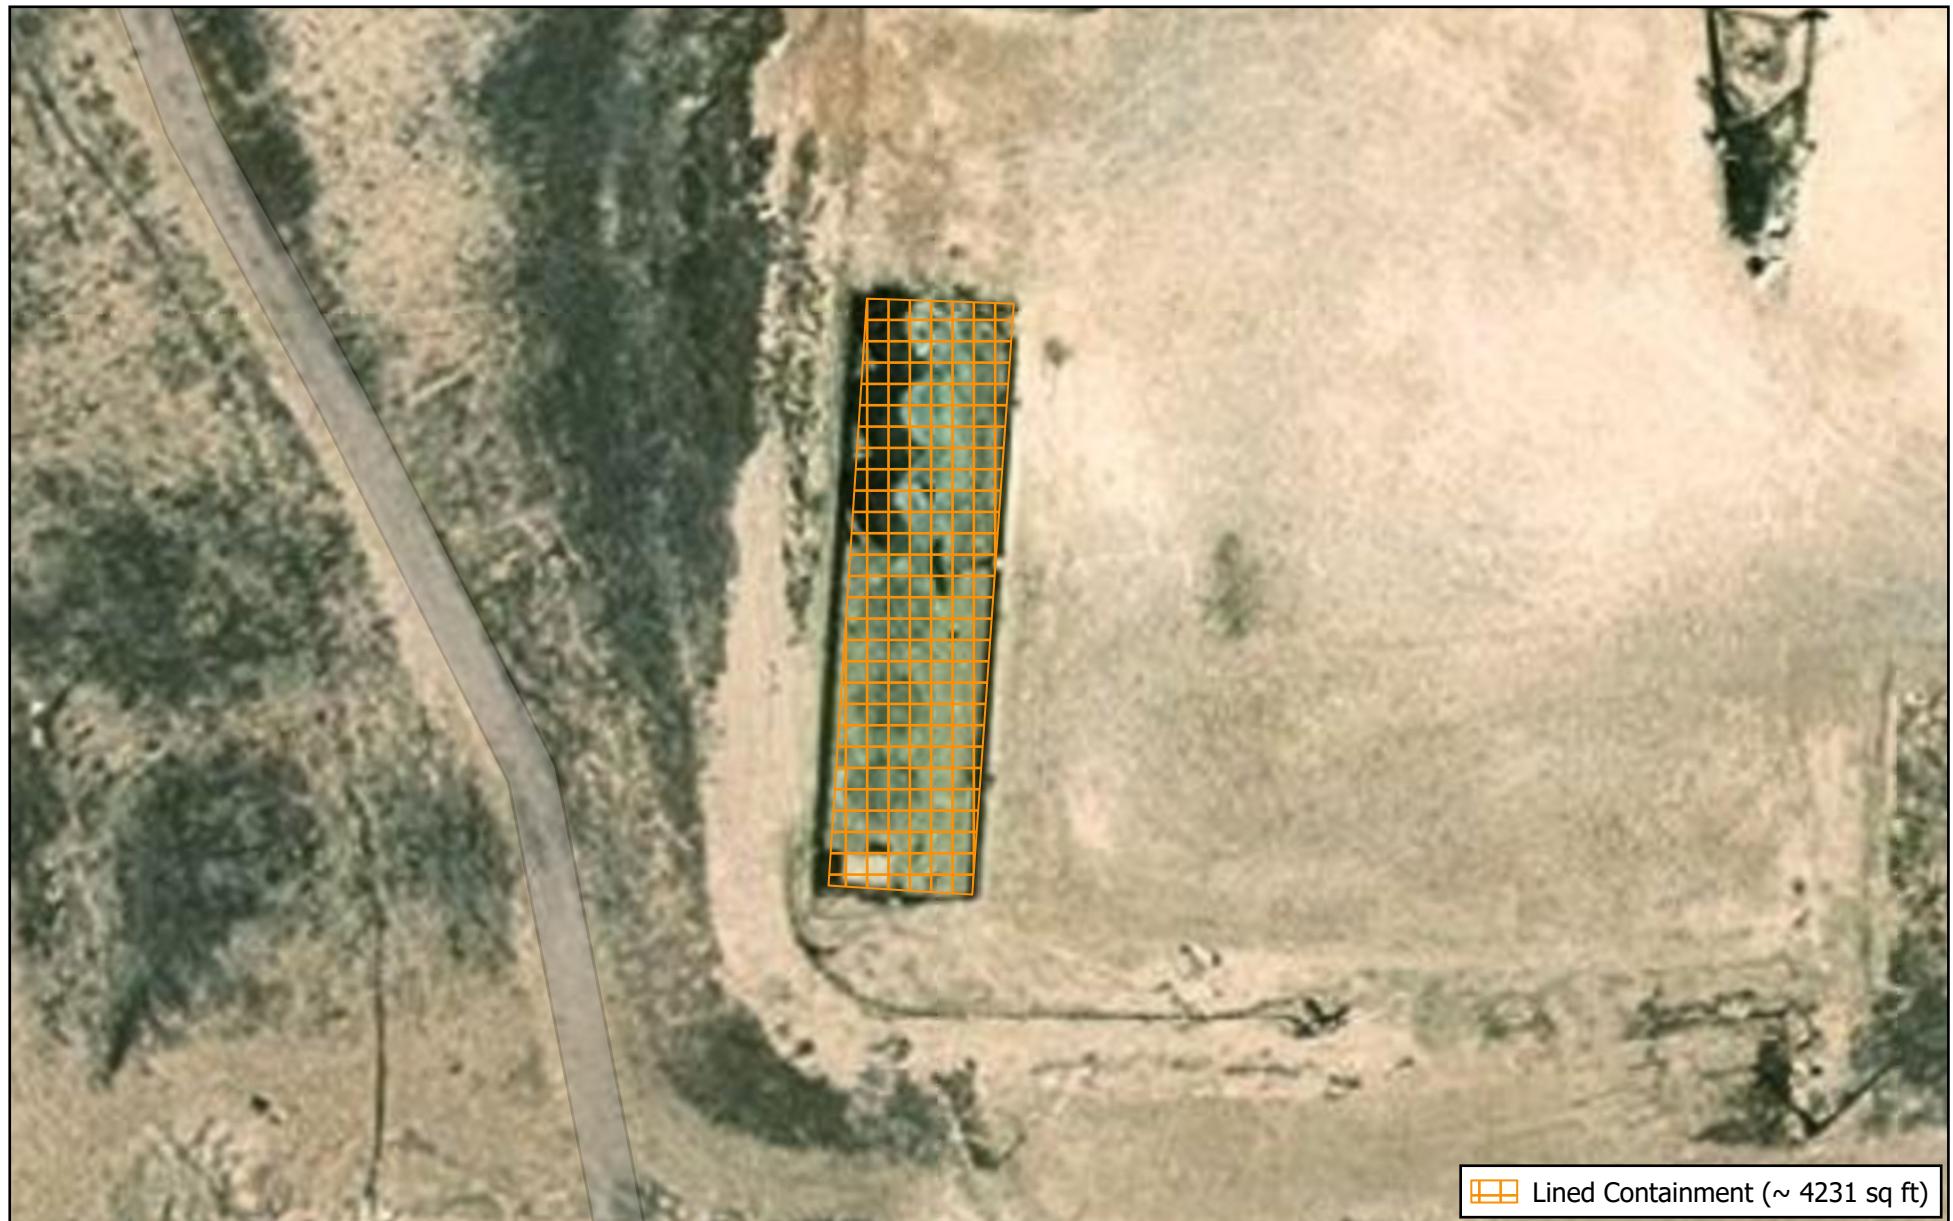
FIGURE:
1

Lined Containment (~ 4231 sq ft)

Liner Inspection Schematic
East Pecos Federal 22 #003H

Notification that a liner inspection was scheduled to be completed was provided to the NMOCD. The liner inspection was completed on November 10, 2025. Visual observation of the liner was completed on all sides and the base of the containment, around equipment, and of all seams in the liner. The patches in the liner were inspected and remain firmly glued with strong seals. As evidenced in the DFR (Appendix B), liner integrity was confirmed and had the ability to contain the release.

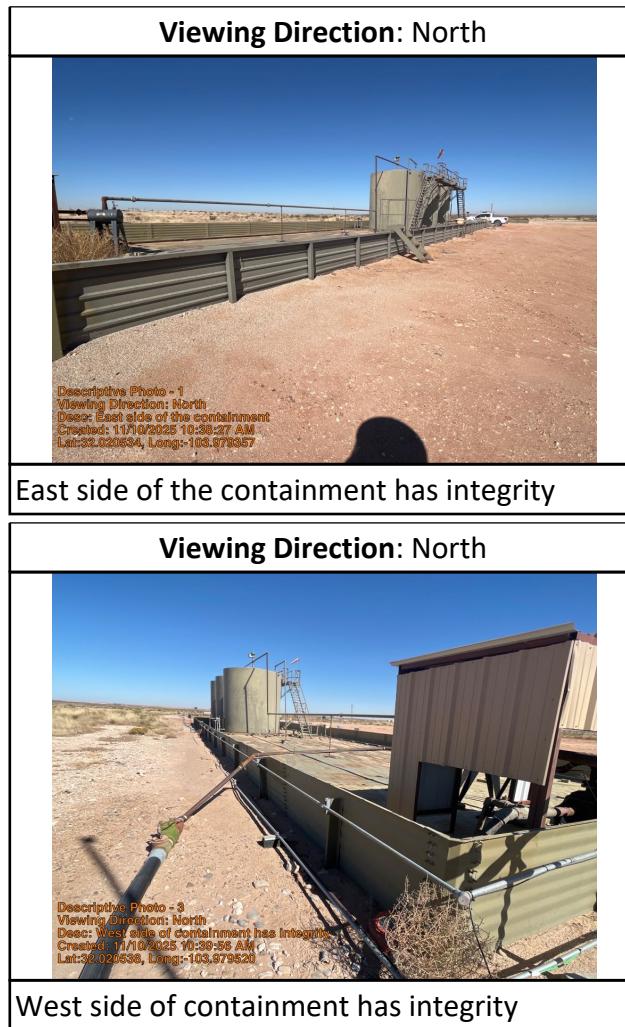
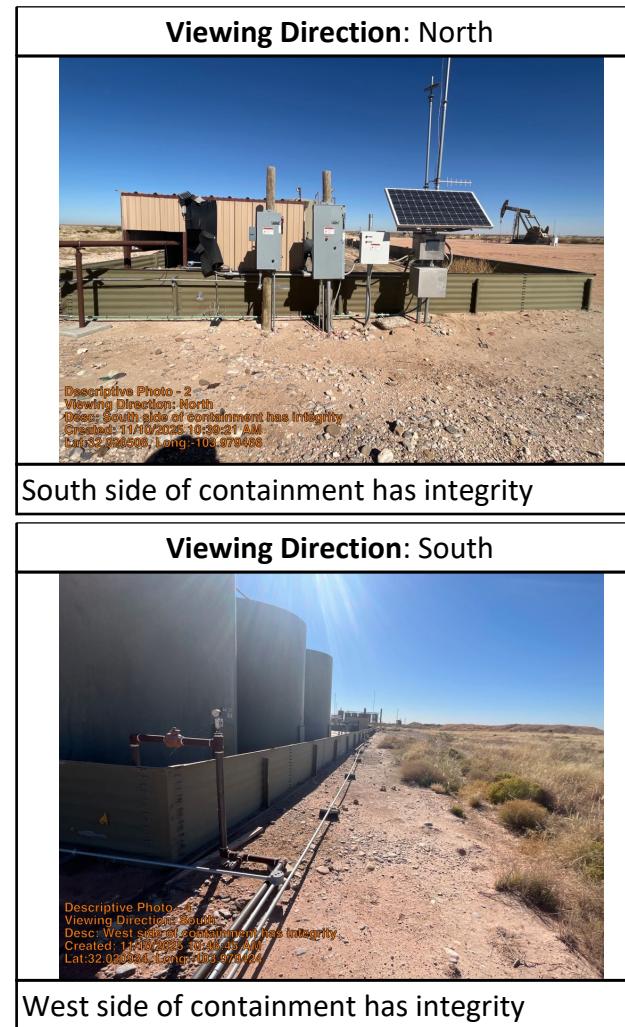
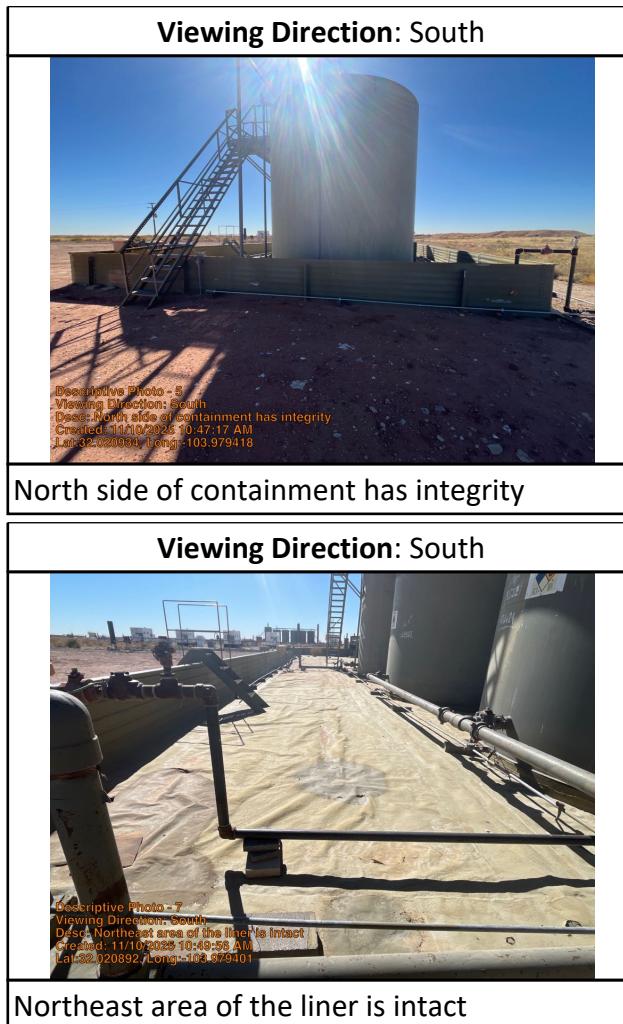
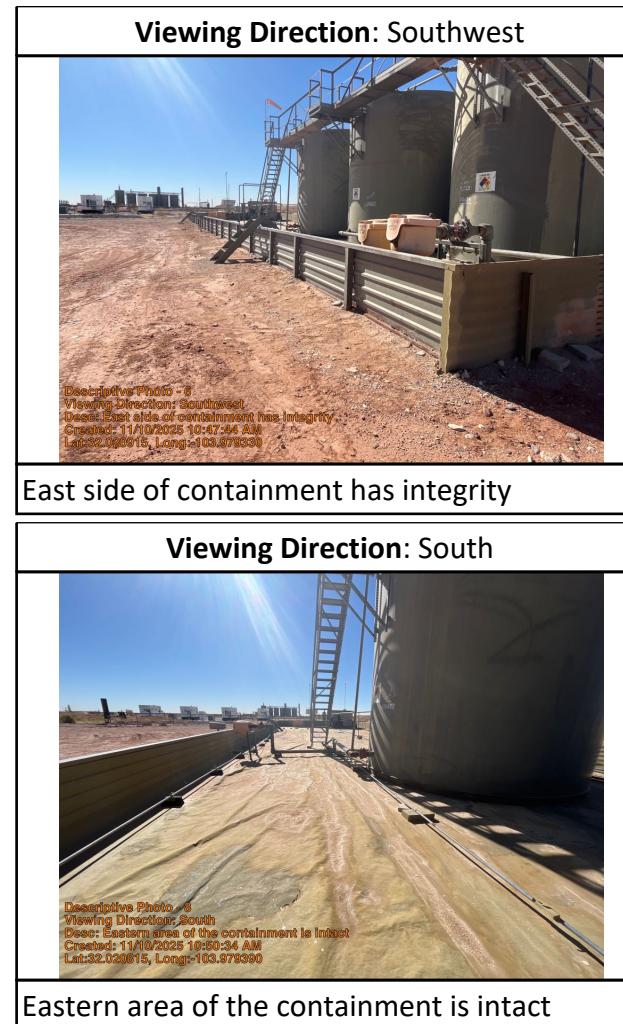
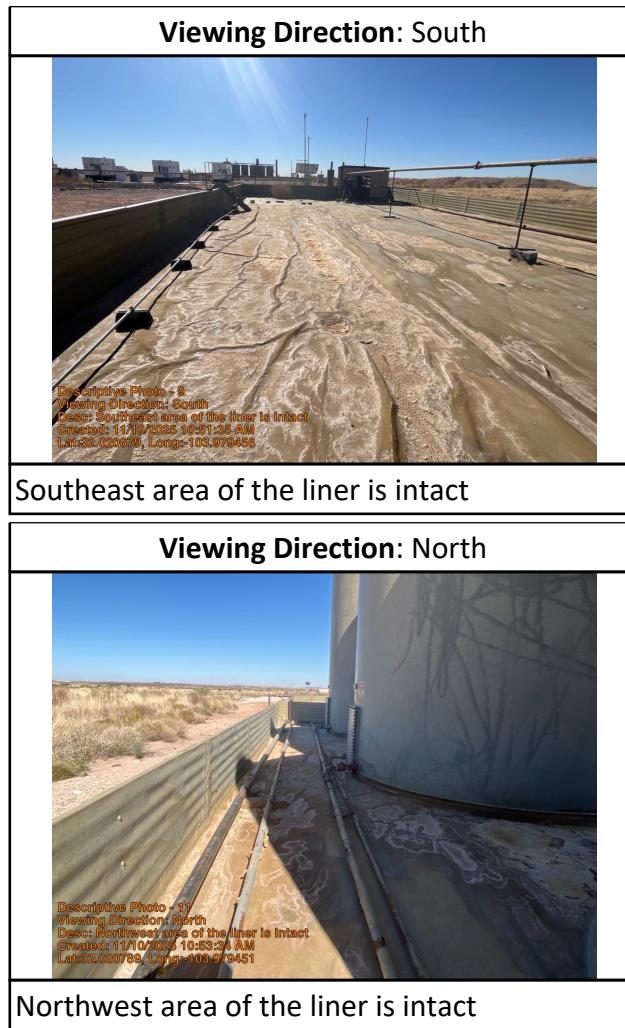
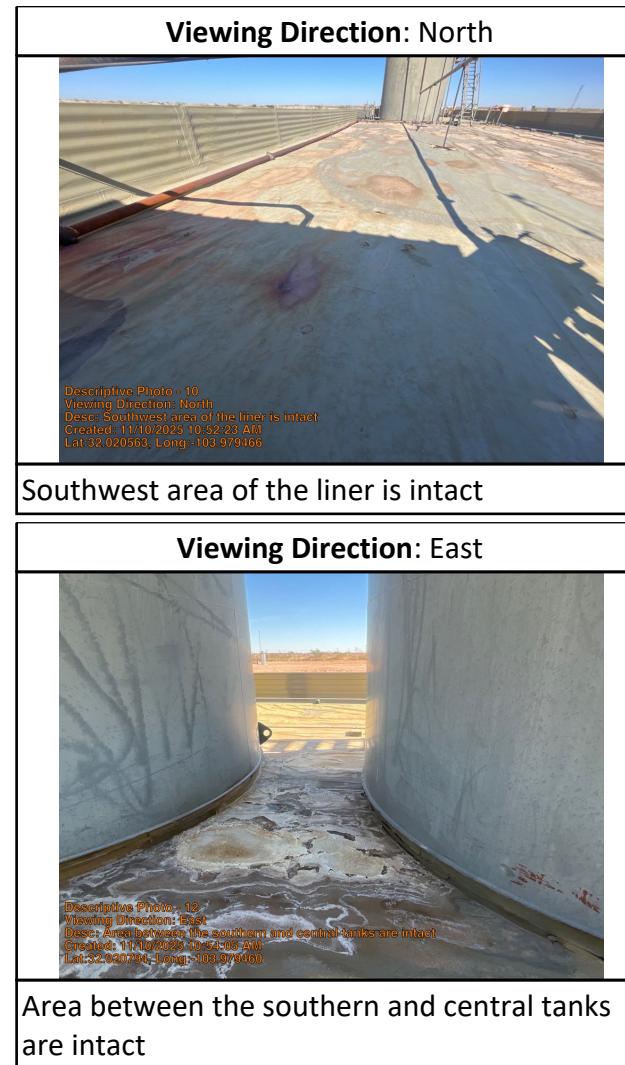
Site Photos

- 10:36 Completed safety paperwork upon arrival
- 10:36 Inspected the outside of the containment and found no breach of containment
- 10:56 Inspected the inside of the liner and found no holes or significant wear
- 10:57 The liner was determined to be intact and as such has adequate liner integrity to contain the release

Vertex recommends no remediation action to address the release. The release area was fully investigated on November 10, 2025, which determined the secondary containment was intact and contained the release. There are no anticipated risks to human, ecological, or hydrological receptors associated with the release site.
