Closure Report
Lea Unit West Flare (12.03.2025)
Incident ID: nAPP2533752426
Lea County, New Mexico
Unit D, Sec 12, T20S, R34E
32.59241, -103.51972

Crude Oil Release
Point of Release: Flare Fire
Release Date: 12.03.2025
Volume Released: 0.01 Barrels of Crude Oil
Volume Recovered: 0 Barrels of Crude Oil

Re: **Closure Report**
Lea Unit West Flare (12.03.2025)
Incident ID: NAPP2533752426
Coterra Energy Operating Co.
Site Location: Unit D, S12, T20S, R34E
32.59241, -103.51972
Lea County, New Mexico

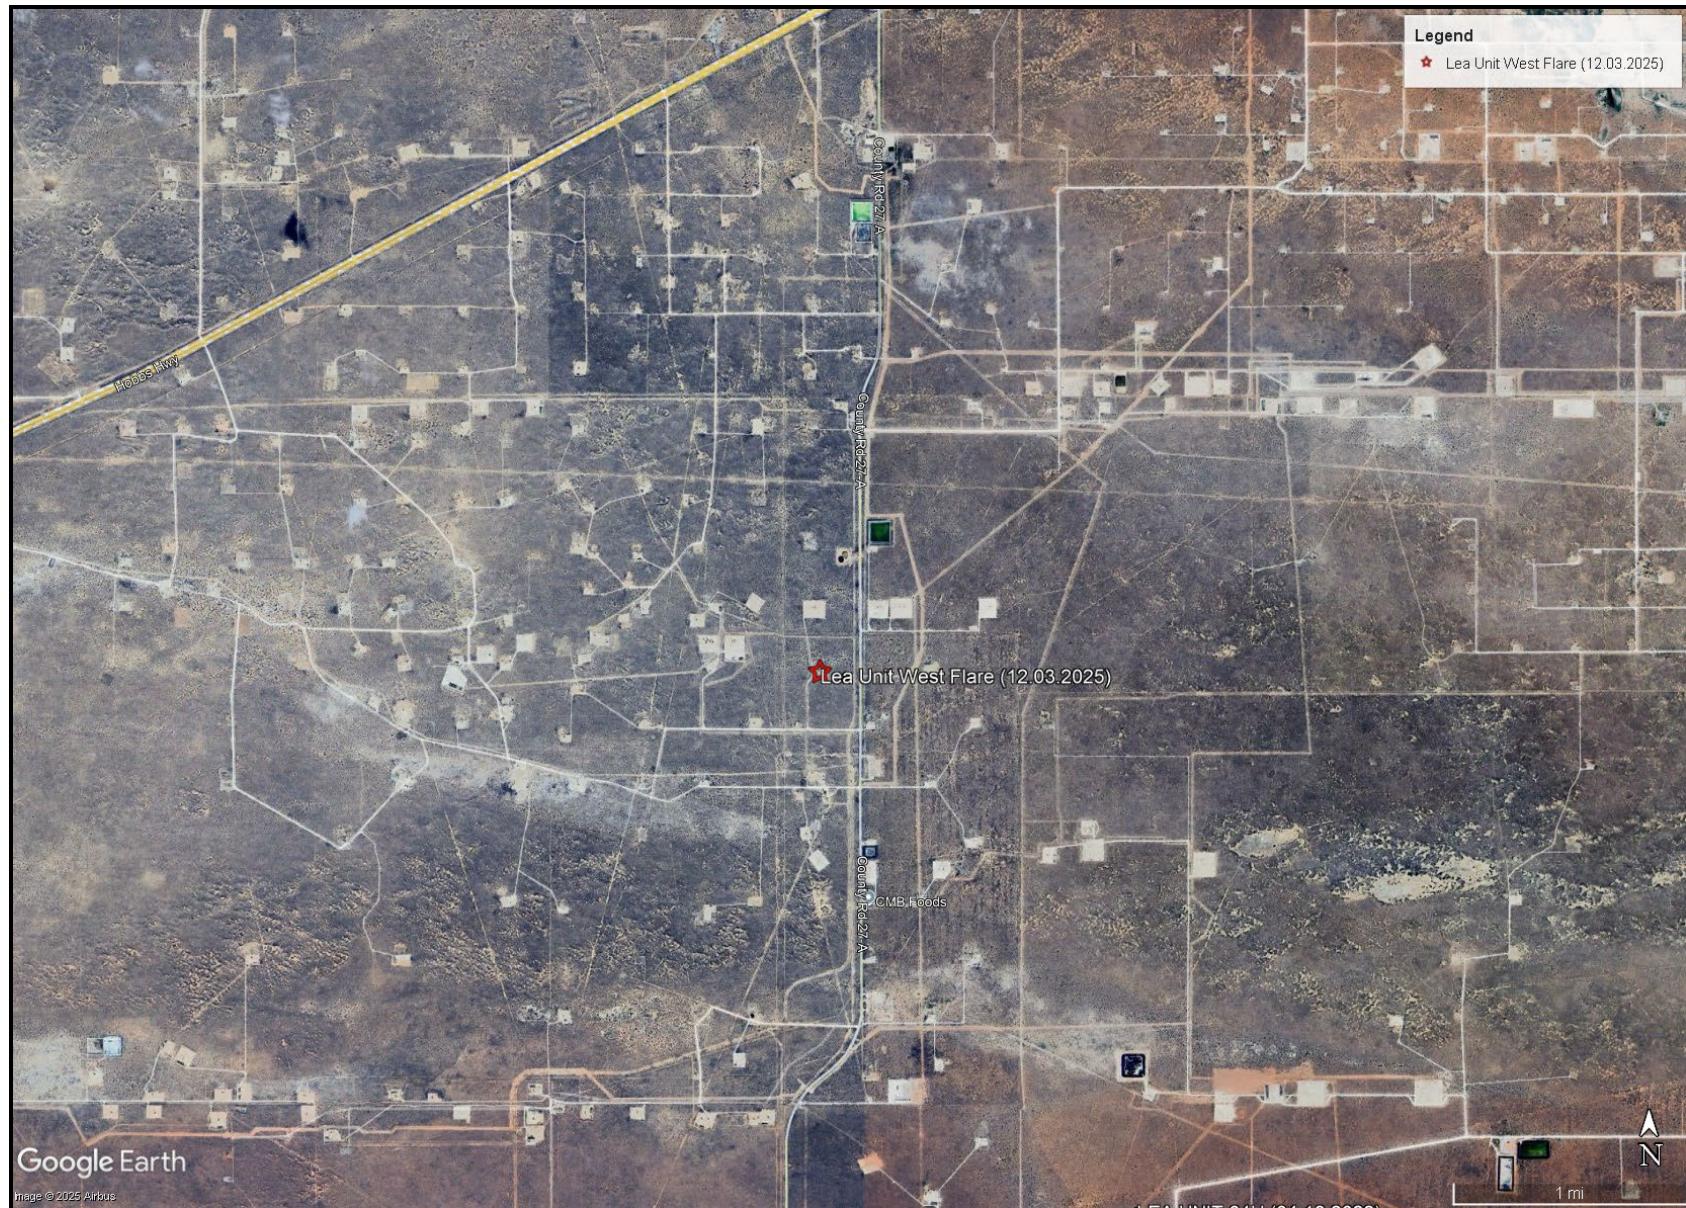
FIGURE 1

OVERVIEW MAP
COTERRA ENERGY OPERATING CO
LEA UNIT WEST FLARE (12.03.2025)
LEA COUNTY, NEW MEXICO
32.59241, -103.51972

At the request of Coterra Energy Operating Co. (Coterra, formerly known as Avant Operating, LLC) Carmona Resources LLC, has prepared this letter to document the site remediation conducted at the Lea Unit West Flare, located at 32.59241, -103.51972 within Unit D, S12, T20S, R34E, in Lea County, New Mexico (Figures 1 and 2).

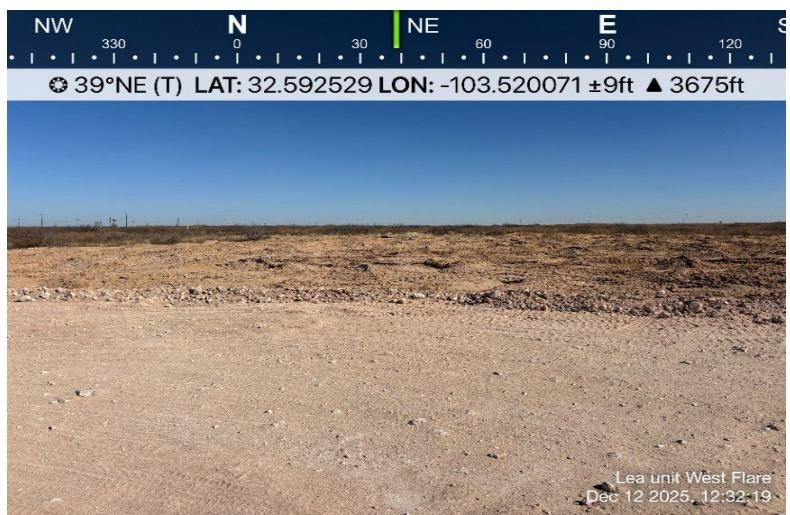
Photograph No. 1**Facility:** Lea Unit West Flare (12.03.2025)**County:** Lea County, New Mexico**Description:**

View Northeast, Area of CS-1 through CS-4.

On December 12, 2025, Carmona Resources personnel were onsite to supervise the remediation activities, collect confirmation samples, and document backfill activities. Before collecting composite confirmation samples, the NMOCD division office was notified via NMOCD portal on December 5, 2025, per Subsection D of 19.15.29.12 NMAC, see Appendix C. The area was excavated to a depth of 0.25 ft bgs. A total of four (4) horizontal samples (H-1 through H-4) were collected for horizontal delineation, and four (4) confirmation floor samples (CS-1 through CS-4) were collected every 200 square feet to ensure the proper removal of contaminated soil. Composite confirmation sidewall samples were not collected due to the excavation depth not exceeding 0.5' ft bgs. For chemical analysis, the soil samples were collected and placed into laboratory-provided sample containers, stored on ice, and transported under the proper chain-of-custody protocol to Eurofins Laboratories in Midland, Texas in accordance with established chain-of-custody protocols. All collected samples were analyzed for TPH analysis by EPA method 8015 modified, BTEX by EPA method 8021B, and Chloride by EPA method 300. Copies of laboratory analysis and chain-of-custody documentation are included in Appendix E.

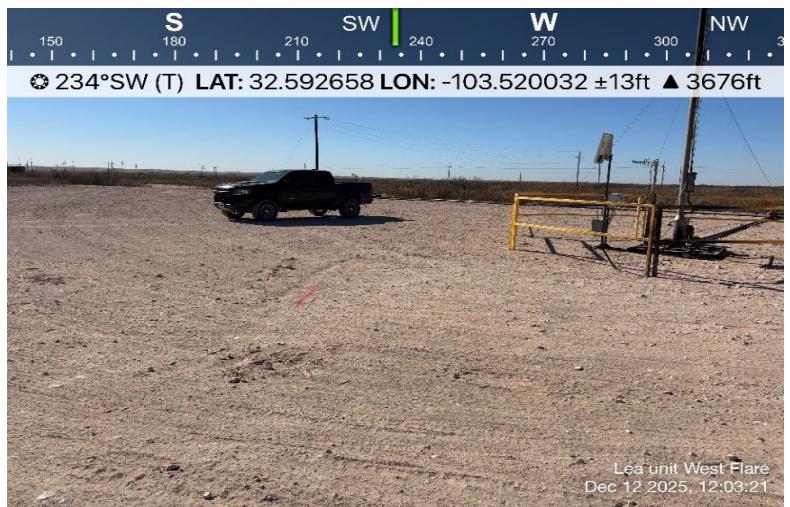
**Photograph No. 2****Facility:** Lea Unit West Flare (12.03.2025)**County:** Lea County, New Mexico**Description:**

View Southwest, Area of CS-1 through CS-4.

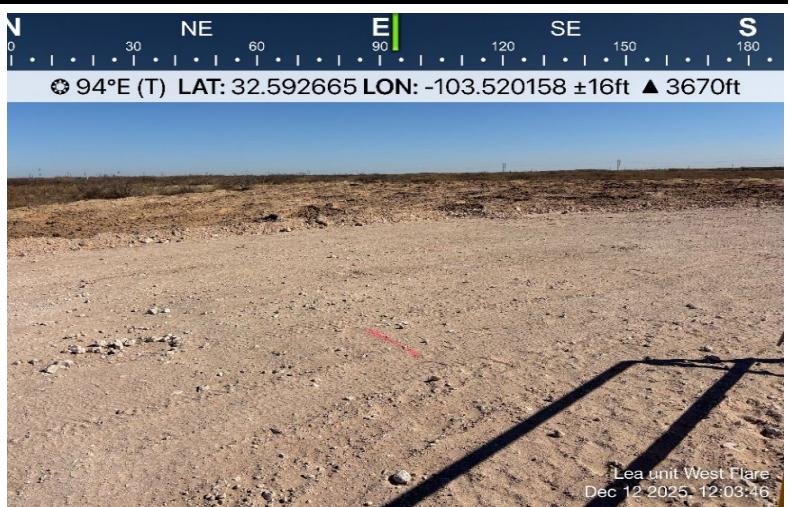
**Photograph No. 3****Facility:** Lea Unit West Flare (12.03.2025)**County:** Lea County, New Mexico**Description:**

View East, Area of CS-1 though CS-4.
