**Re: Closure Request
Avion Federal 301H
Incident Number nAPP2535249646
Lea County, New Mexico**

LINER INTEGRITY INSPECTION ACTIVITIES

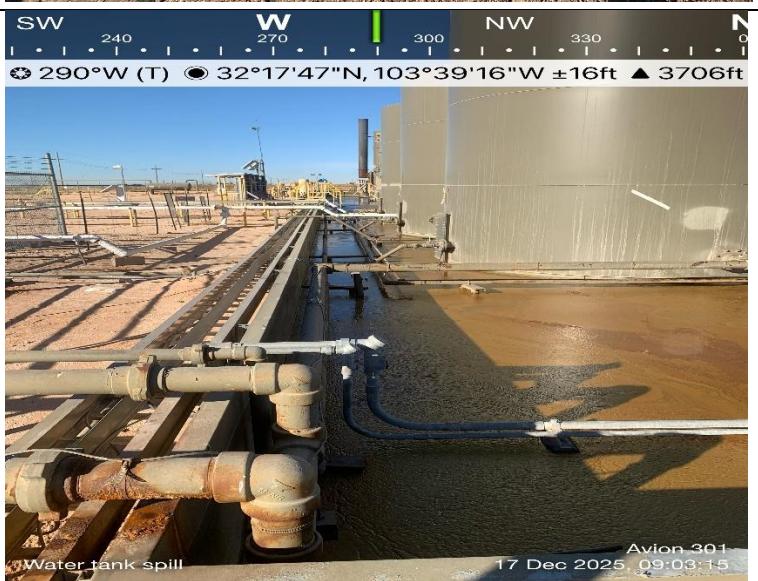
| <p>Facility: Avion Federal 301H</p> <p>County: Lea County, New Mexico</p> <p>Description: Original release photo from 12/17/2025</p> | <p>SW 240 W 270 NW 330 N 0 290°W (T) 32°17'47"N, 103°39'16"W ±16ft ▲ 3706ft</p> <p>Water tank spill</p> <p>Avion 301 17 Dec 2025 09:03:15</p> |

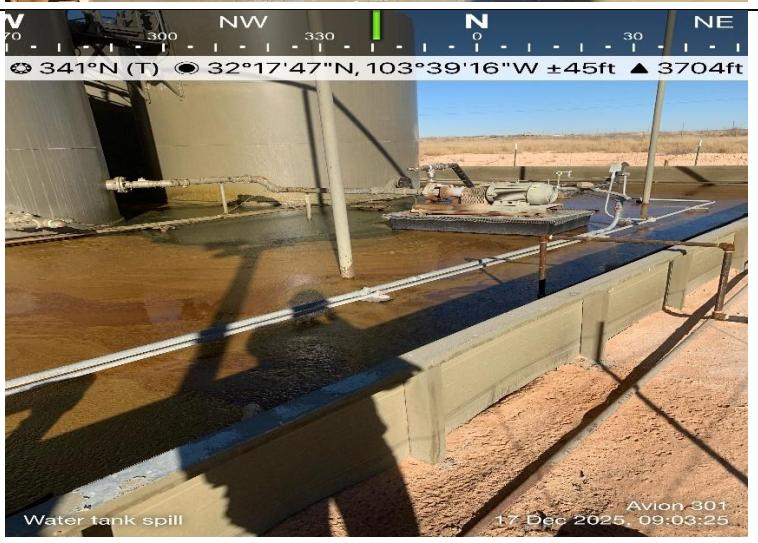
| <p>Facility: Avion Federal 301H</p> <p>County: Lea County, New Mexico</p> <p>Description: Original release photo from 12/17/2025</p> | <p>M 300 NW 330 N 0 NE 30 341°N (T) 32°17'47"N, 103°39'16"W ±45ft ▲ 3704ft</p> <p>Water tank spill</p> <p>Avion 301 17 Dec 2025 09:03:25</p> |

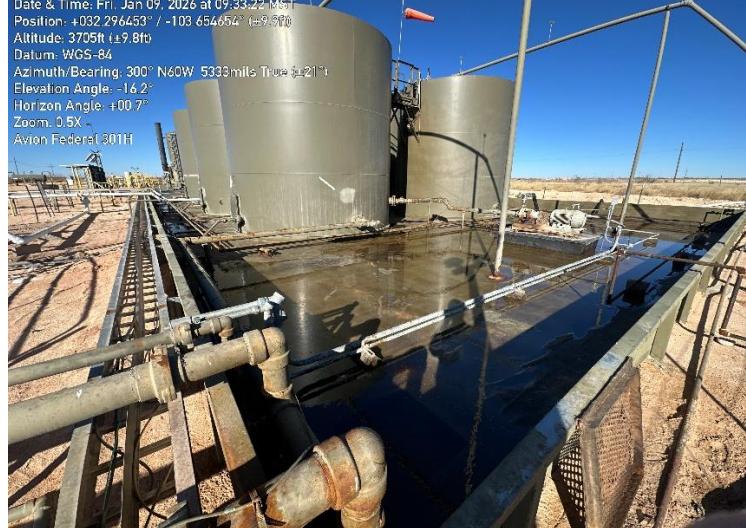
| <p>Facility: Avion Federal 301H</p> <p>County: Lea County, New Mexico</p> <p>Description: View facing Northwest. Lined area East of production tanks. (Fluid in containment is rainwater from the previous night)</p> | <p>Date & Time: Fri, Jan 09, 2026 at 09:33:22 MST Position: +032 294453° / -103 634654° (±9.8ft) Altitude: 3705ft (±9.8ft) Datum: WGS-84 Azimuth/Bearing: 300° N60W 5333mils True (±21°) Elevation Angle: -16.2° Horizon Angle: +00.7° Zoom: 0.5X Avion Federal 301H</p> |

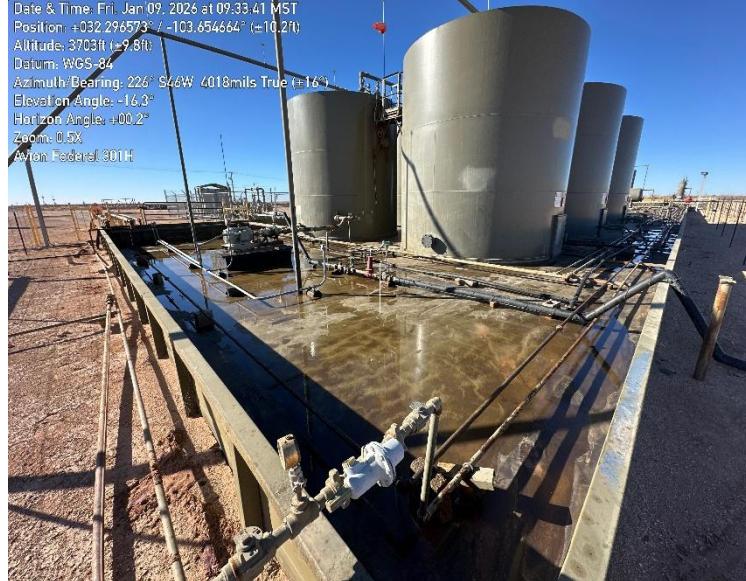
| <p>Facility: Avion Federal 301H</p> <p>County: Lea County, New Mexico</p> <p>Description: View facing Southwest. (Fluid in containment is rainwater from the previous night)</p> | <p>Date & Time: Fri, Jan 09, 2026 at 09:33:41 MST Position: +032 294573° / -103 634664° (±10.2ft) Altitude: 3703ft (±9.8ft) Datum: WGS-84 Azimuth/Bearing: 226° S46W 4018mils True (±16°) Elevation Angle: -16.3° Horizon Angle: +00.2° Zoom: 0.5X Avion Federal 301H</p> |

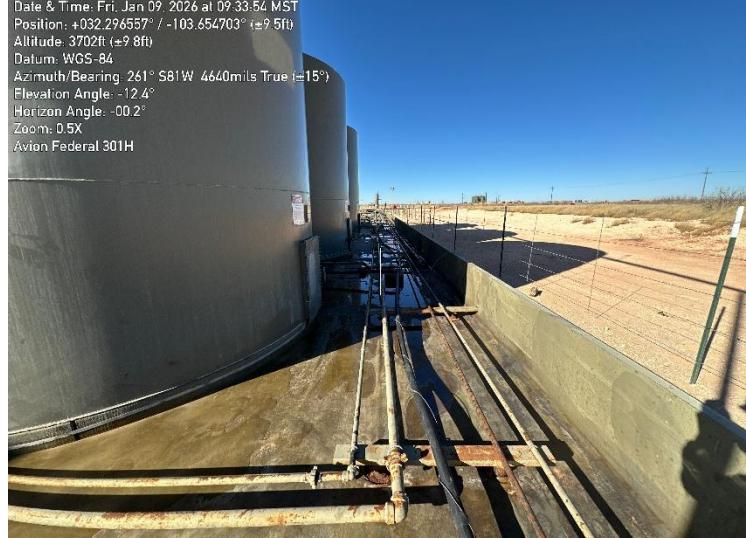
| <p>Facility: Avion Federal 301H</p> <p>County: Lea County, New Mexico</p> <p>Description: View facing West. Lined area North of production tank. (Fluid in containment is rainwater from the previous night)</p> | <p>Date & Time: Fri, Jan 09, 2026 at 09:33:54 MST Position: +032 294557° / -103 634703° (±9.5ft) Altitude: 3702ft (±9.8ft) Datum: WGS-84 Azimuth/Bearing: 261° S81W 4640mils True (±15°) Elevation Angle: -12.4° Horizon Angle: -00.2° Zoom: 0.5X Avion Federal 301H</p> |

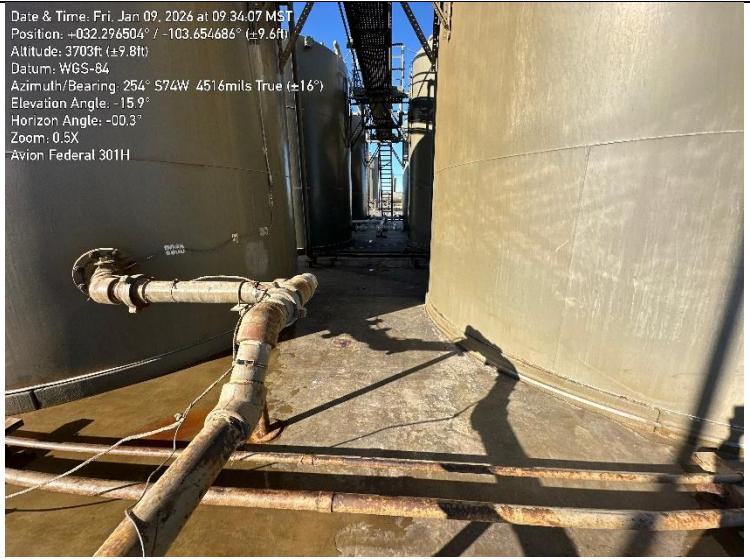
| <p>Facility: Avion Federal 301H</p> <p>County: Lea County, New Mexico</p> <p>Description: View facing West. Lined area between production tanks. (Fluid in containment is rainwater from the previous night)</p> | <p>Date & Time: Fri, Jan 09, 2026 at 09:34:07 MST Position: +032.296804° / -103.654686° (±9.6ft) Altitude: 3703ft (±9.8ft) Datum: WGS-84 Azimuth/Bearing: 254° S74W 4516mils True (±16°) Elevation Angle: -15.9° Horizon Angle: -00.3° Zoom: 0.5X Avion Federal 301H</p> |

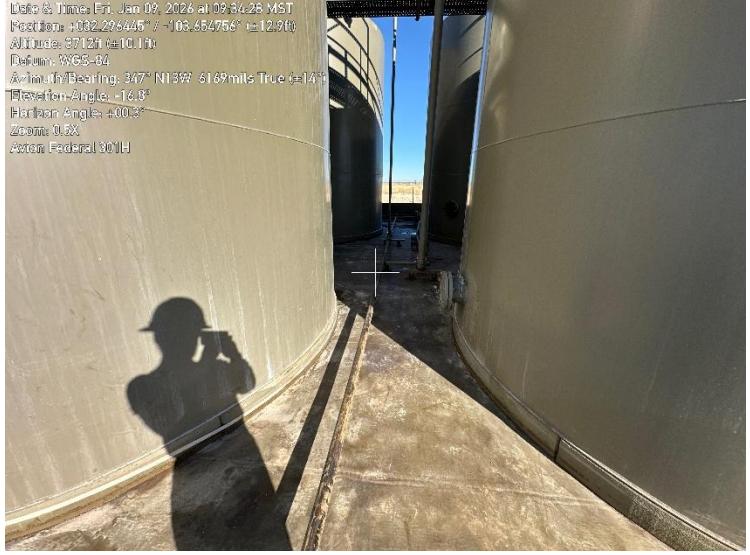
| <p>Facility: Avion Federal 301H</p> <p>County: Lea County, New Mexico</p> <p>Description: View facing East. View facing West. Lined area between production tanks. (Fluid in containment is rainwater from the previous night)</p> | <p>Date & Time: Fri, Jan 09, 2026 at 09:34:28 MST Position: +032.296445° / -103.654756° (±12.9ft) Altitude: 3712ft (±10.1ft) Datum: WGS-84 Azimuth/Bearing: 347° N13W 5169mils True (±14°) Elevation Angle: -16.0° Horizon Angle: +00.3° Zoom: 0.5X Avion Federal 301H</p> |

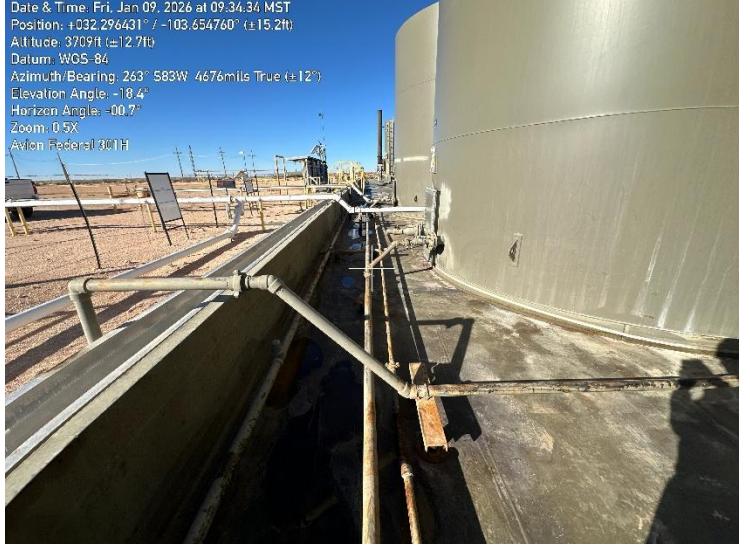
| <p>Facility: Avion Federal 301H</p> <p>County: Lea County, New Mexico</p> <p>Description: View facing West. Lined area South of production tanks. (Fluid in containment is rainwater from the previous night)</p> | <p>Date & Time: Fri, Jan 09, 2026 at 09:34:34 MST Position: +032.296431° / -103.654760° (±15.2ft) Altitude: 3709ft (±12.7ft) Datum: WGS-84 Azimuth/Bearing: 263° S83W 4676mils True (±12°) Elevation Angle: -18.4° Horizon Angle: -00.7° Zoom: 0.5X Avion Federal 301H</p> |

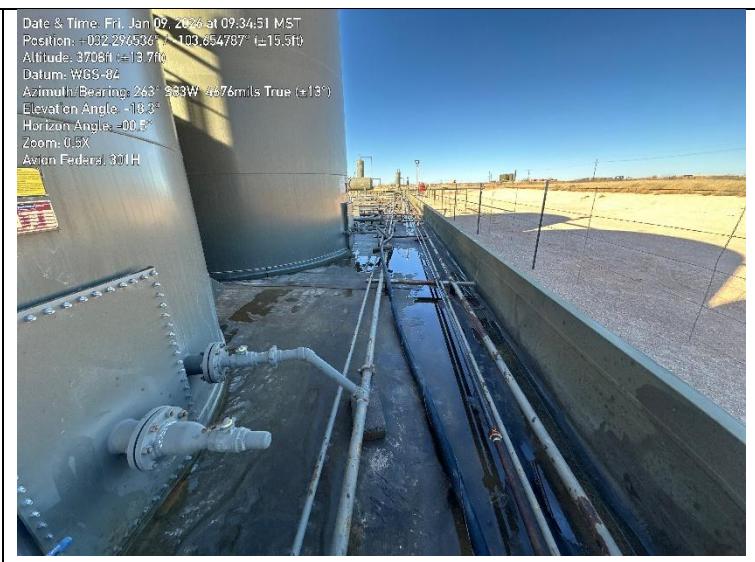
| <p>Facility: Avion Federal 301H</p> <p>County: Lea County, New Mexico</p> <p>Description: View facing West. Lined area North of production tank. (Fluid in containment is rainwater from the previous night)</p> | Date & Time: Fri, Jan 09, 2026 at 09:34:51 MST Position: -032.296536° / -103.654787° ±15.9ft Altitude: 3708ft ±13.7ft Datum: WGS-84 Azimuth/Bearing: 263° 333W 4676mils True (±13°) Elevation Angle: -18.3° Horizon Angle: -00.6° Zoom: 0.5X Avion Federal 301H |

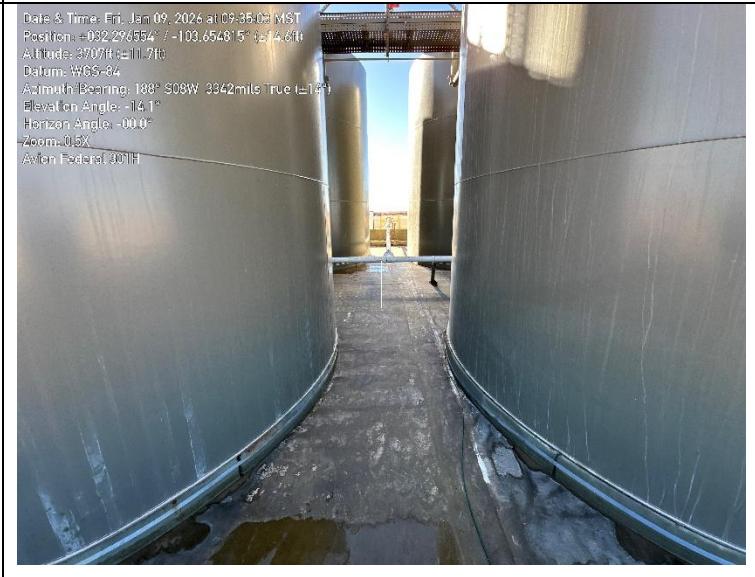
| <p>Facility: Avion Federal 301H</p> <p>County: Lea County, New Mexico</p> <p>Description: View facing East. View facing West. Lined area between production tanks. (Fluid in containment is rainwater from the previous night)</p> | Date & Time: Fri, Jan 09, 2026 at 09:35:02 MST Position: -032.296554° / -103.654815° ±14.6ft Altitude: 3707ft ±11.2ft Datum: WGS-84 Azimuth/Bearing: 180° 308W 3342mils True (±14°) Elevation Angle: -14.1° Horizon Angle: -00.0° Zoom: 0.5X Avion Federal 301H |

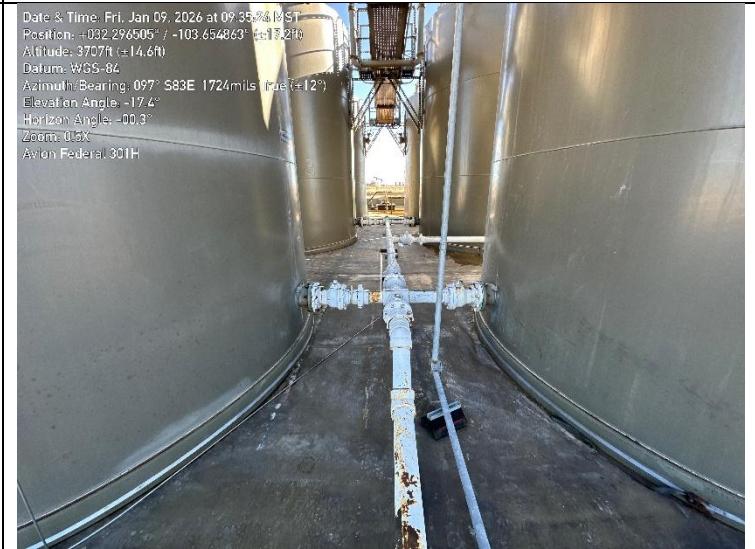
| <p>Facility: Avion Federal 301H</p> <p>County: Lea County, New Mexico</p> <p>Description: View facing East. Lined area between production tanks. (Fluid in containment is rainwater from the previous night)</p> | Date & Time: Fri, Jan 09, 2026 at 09:35:26 MST Position: -032.296505° / -103.654863° ±17.2ft Altitude: 3707ft ±11.0ft Datum: WGS-84 Azimuth/Bearing: 097° 583E 1724mils True (±12°) Elevation Angle: -17.4° Horizon Angle: -00.3° Zoom: 0.5X Avion Federal 301H |

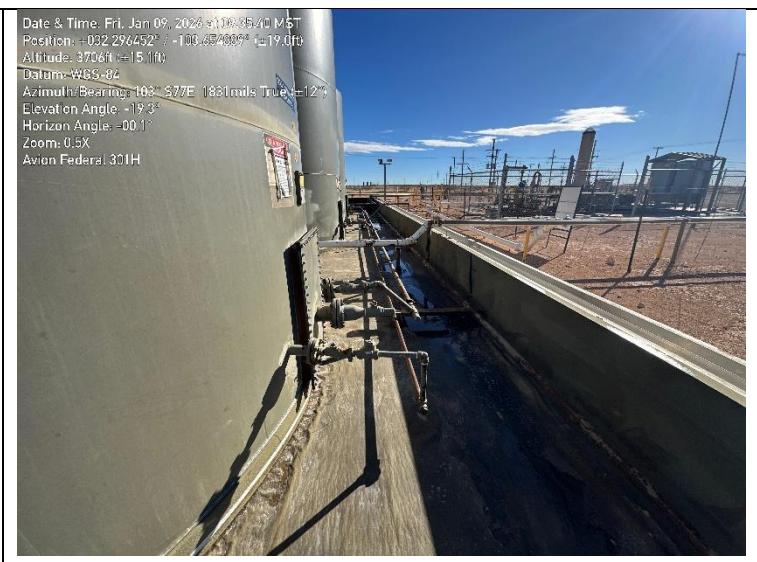
| <p>Facility: Avion Federal 301H</p> <p>County: Lea County, New Mexico</p> <p>Description: View facing East. Lined area South of production tanks. (Fluid in containment is rainwater from the previous night)</p> | Date & Time: Fri, Jan 09, 2026 at 09:35:40 MST Position: +032 296452° / -103.654007° (±19.0ft) Altitude: 3706ft (±15.1ft) Datum: WGS-84 Azimuth/Bearing: 103° S77E 1831mils True (±12°) Elevation Angle: +19.3° Horizon Angle: -00.1° Zoom: 0.5X Avion Federal 301H |

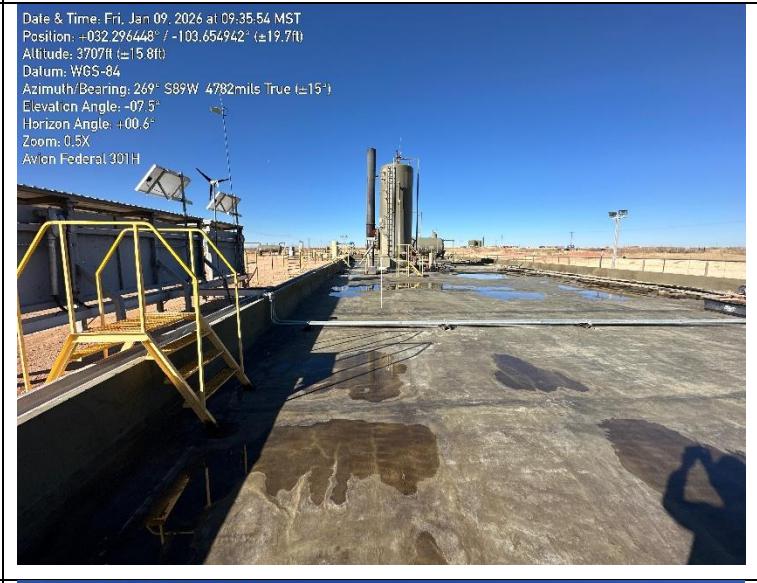
| <p>Facility: Avion Federal 301H</p> <p>County: Lea County, New Mexico</p> <p>Description: View facing West. Lined area West of production tanks. (Fluid in containment is rainwater from the previous night)</p> | Date & Time: Fri, Jan 09, 2026 at 09:35:54 MST Position: +032 296448° / -103.654942° (±19.7ft) Altitude: 3707ft (±15.8ft) Datum: WGS-84 Azimuth/Bearing: 269° S89W 4782mils True (±15°) Elevation Angle: -07.5° Horizon Angle: +00.6° Zoom: 0.5X Avion Federal 301H |

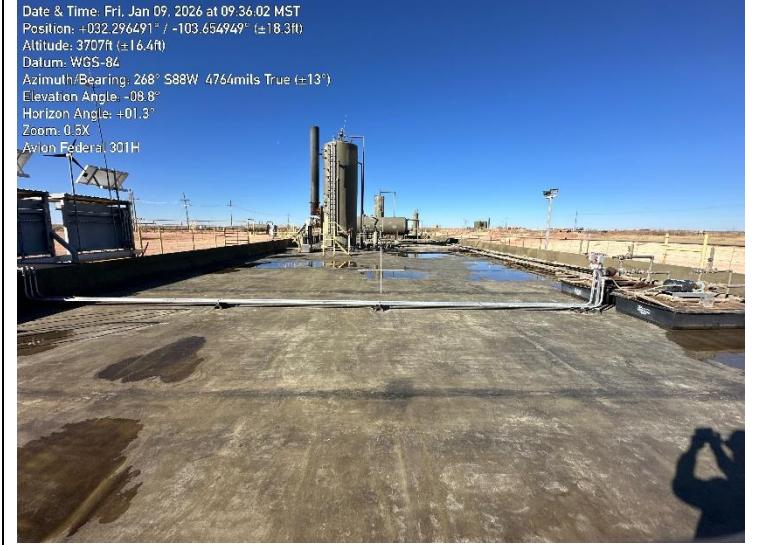
| <p>Facility: Avion Federal 301H</p> <p>County: Lea County, New Mexico</p> <p>Description: View facing West. Lined area West of production tanks. (Fluid in containment is rainwater from the previous night)</p> | Date & Time: Fri, Jan 09, 2026 at 09:36:02 MST Position: +032 296491° / -103.654949° (±18.3ft) Altitude: 3707ft (±16.4ft) Datum: WGS-84 Azimuth/Bearing: 268° S88W 4754mils True (±13°) Elevation Angle: -08.8° Horizon Angle: +01.3° Zoom: 0.5X Avion Federal 301H |

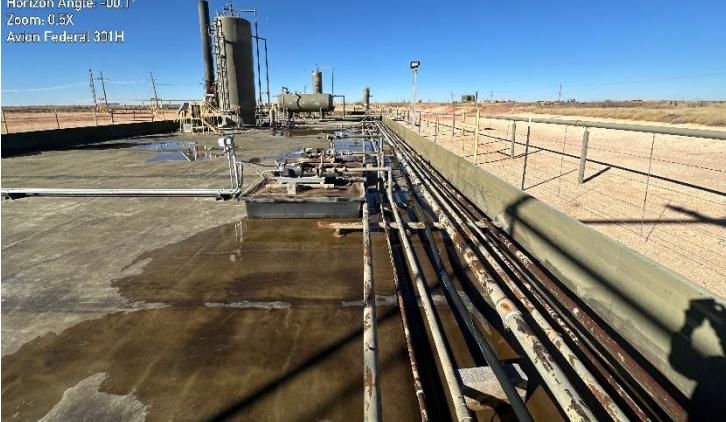
| <p>Facility: Avion Federal 301H</p> <p>County: Lea County, New Mexico</p> <p>Description: View facing West. Lined area West of production tanks and production piping. (Fluid in containment is rainwater from the previous night)</p> | Date & Time: Fri, Jan 09, 2026 at 09:36:14 MST Position: -032 296552° / -103.654953° (±19.5ft) Altitude: 3707ft (±16.0ft) Datum: WGS-84 Azimuth/Bearing: 269° S89W 4782mils True (±13°) Elevation Angle: -11° 5° Horizon Angle: -00° 1° Zoom: 0.5X Avion Federal 301H |

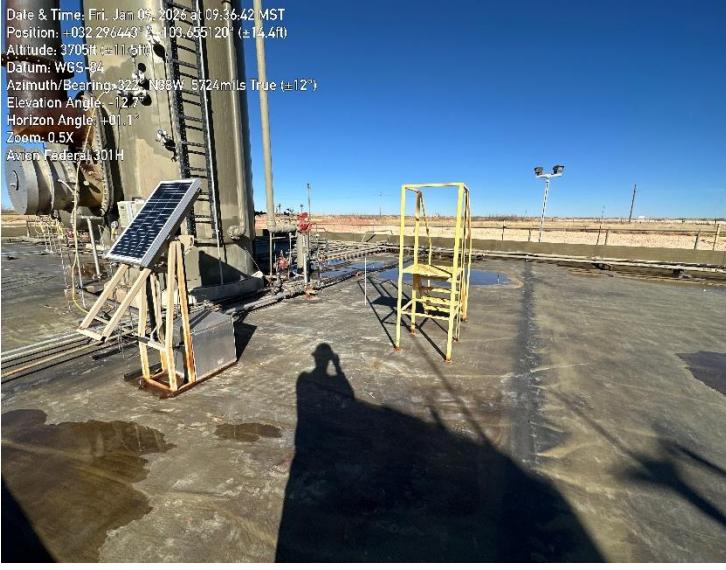
| <p>Facility: Avion Federal 301H</p> <p>County: Lea County, New Mexico</p> <p>Description: View facing Northwest. Lined area near production equipment. (Fluid in containment is rainwater from the previous night)</p> | Date & Time: Fri, Jan 09, 2026 at 09:36:42 MST Position: -032 296440° / -103.655120° (±14.4ft) Altitude: 3705ft (±11.6ft) Datum: WGS-84 Azimuth/Bearing: 322° N88W 5124mils True (±12°) Elevation Angle: -12° 7° Horizon Angle: -00° 1° Zoom: 0.5X Avion Federal 301H |

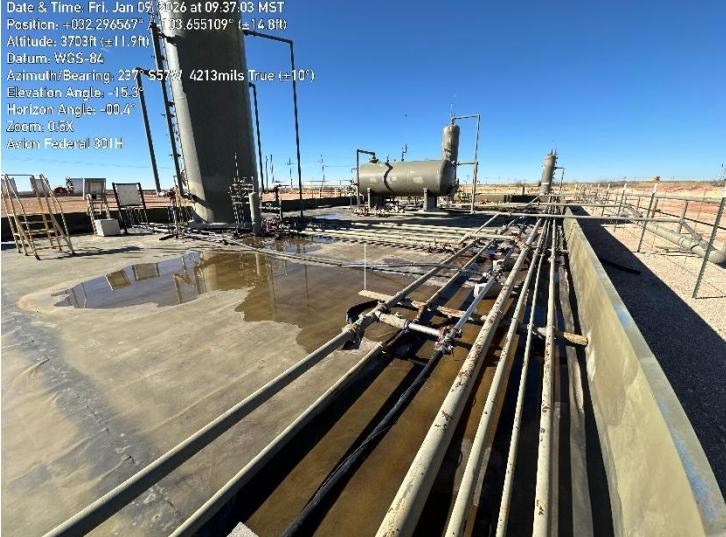
| <p>Facility: Avion Federal 301H</p> <p>County: Lea County, New Mexico</p> <p>Description: View facing Southwest. Lined area near production equipment and production piping. (Fluid in containment is rainwater from the previous night)</p> | Date & Time: Fri, Jan 09, 2026 at 09:37:03 MST Position: -032 296567° / -103.655109° (±14.8ft) Altitude: 3703ft (±11.9ft) Datum: WGS-84 Azimuth/Bearing: 237° S57W 4213mils True (±10°) Elevation Angle: -15° 3° Horizon Angle: -00° 4° Zoom: 0.5X Avion Federal 301H |

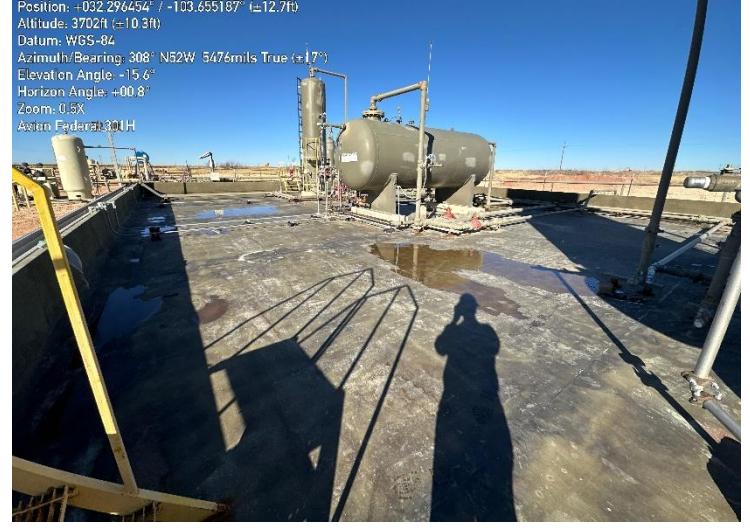
| <p>Facility: Avion Federal 301H</p> <p>County: Lea County, New Mexico</p> <p>Description: View facing Northwest. Lined area near production equipment. (Fluid in containment is rainwater from the previous night)</p> | <p>Date & Time: Fri, Jan 09, 2026 at 09:37:26 MST Position: -032 296454° / -103.655187° (±12.7ft) Altitude: 3702ft (±10.3ft) Datum: WGS-84 Azimuth/Bearing: 308° N52W 5476mils True (±17°) Elevation Angle: -15.6° Horizon Angle: +00.8° Zoom: 0.5X Avion Federal 301H</p> |

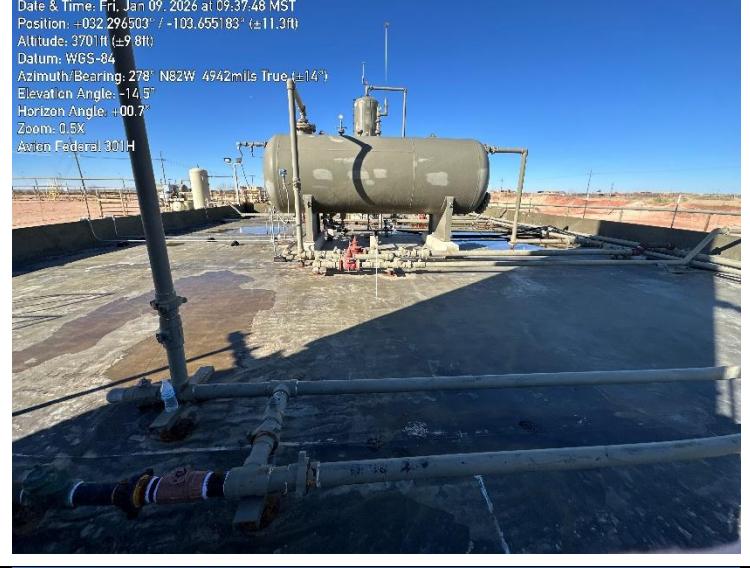
| <p>Facility: Avion Federal 301H</p> <p>County: Lea County, New Mexico</p> <p>Description: View facing West. Lined area near production equipment. (Fluid in containment is rainwater from the previous night)</p> | <p>Date & Time: Fri, Jan 09, 2026 at 09:37:48 MST Position: -032 296503° / -103.655183° (±11.3ft) Altitude: 3701ft (±9.8ft) Datum: WGS-84 Azimuth/Bearing: 278° N82W 4942mils True (±14°) Elevation Angle: -14.5° Horizon Angle: +00.7° Zoom: 0.5X Avion Federal 301H</p> |

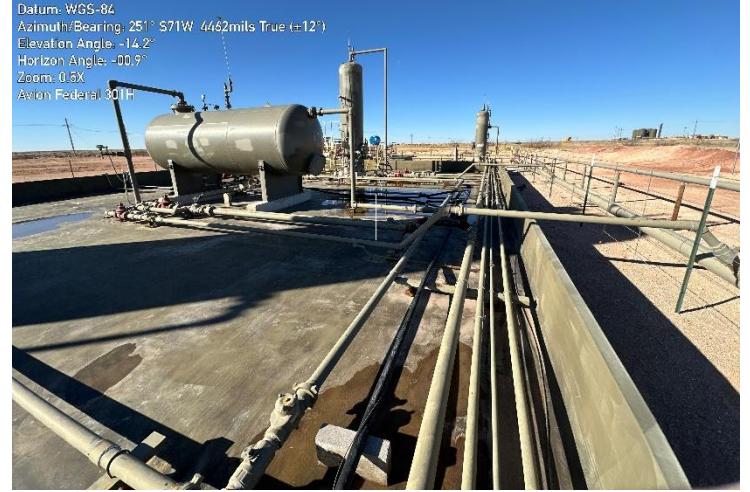
| <p>Facility: Avion Federal 301H</p> <p>County: Lea County, New Mexico</p> <p>Description: View facing Southwest. Lined area near production equipment and production piping. (Fluid in containment is rainwater from the previous night)</p> | <p>Date & Time: Fri, Jan 09, 2026 at 09:38:02 MST Position: -032 296557° / -103.655202° (±12.9ft) Altitude: 3706ft (±10.5ft) Datum: WGS-84 Azimuth/Bearing: 251° S71W 4462mils True (±12°) Elevation Angle: -14.2° Horizon Angle: +00.9° Zoom: 0.5X Avion Federal 301H</p> |

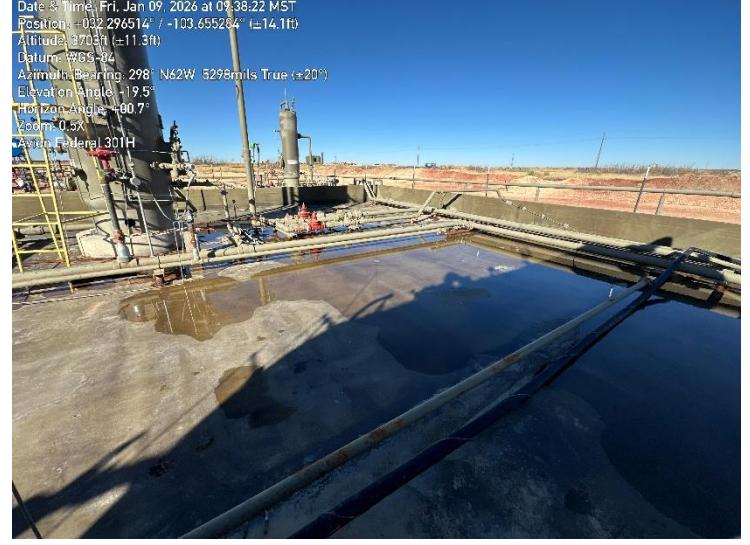
| <p>Facility: Avion Federal 301H</p> <p>County: Lea County, New Mexico</p> <p>Description: View facing Northwest. Lined area near production equipment and production piping. (Fluid in containment is rainwater from the previous night)</p> | Date & Time: Fri, Jan 09, 2026 at 09:38:22 MST Position: -032° 29'6514" / -103° 65'52" (±14.1ft) Altitude: 3703ft (±11.3ft) Datum: WGS-84 Azimuth/Bearing: 298° N62W 5298mils True (±20°) Elevation Angle: +19.5° Horizon Angle: -00.7° Zoom: 0.5X Avion Federal 301H |

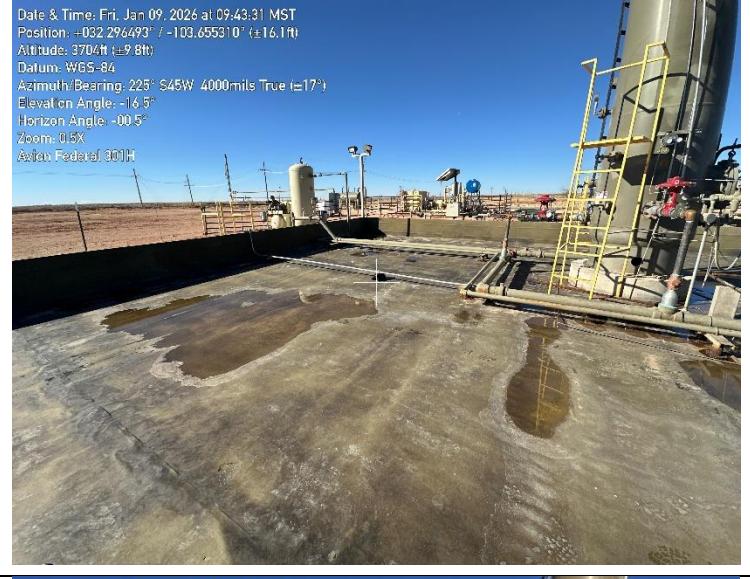
| <p>Facility: Avion Federal 301H</p> <p>County: Lea County, New Mexico</p> <p>Description: View facing Southwest. Lined area near production equipment and production piping. (Fluid in containment is rainwater from the previous night)</p> | Date & Time: Fri, Jan 09, 2026 at 09:43:31 MST Position: -032° 29'6493" / -103° 65'53" (±16.1ft) Altitude: 3704ft (±9.8ft) Datum: WGS-84 Azimuth/Bearing: 225° S45W 4000mils True (±17°) Elevation Angle: -16.3° Horizon Angle: -00.5° Zoom: 0.5X Avion Federal 301H |

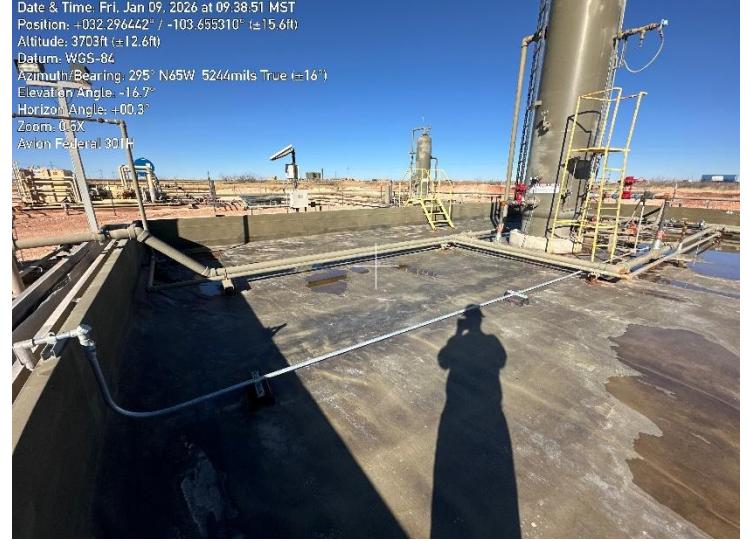
| <p>Facility: Avion Federal 301H</p> <p>County: Lea County, New Mexico</p> <p>Description: View facing Northwest. Lined area near production equipment and production piping. (Fluid in containment is rainwater from the previous night)</p> | Date & Time: Fri, Jan 09, 2026 at 09:38:51 MST Position: -032° 29'6442" / -103° 65'53" (±15.6ft) Altitude: 3703ft (±12.6ft) Datum: WGS-84 Azimuth/Bearing: 295° N65W 5244mils True (±16°) Elevation Angle: -16.7° Horizon Angle: +00.3° Zoom: 0.5X Avion Federal 301H |

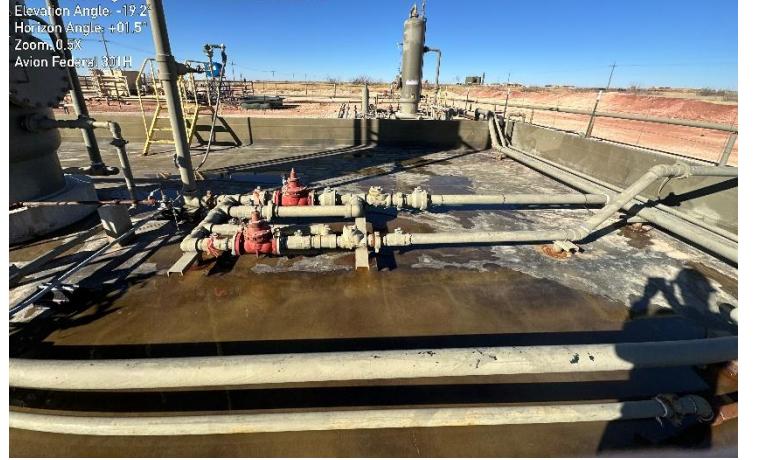
| <p>Facility: Avion Federal 301H</p> <p>County: Lea County, New Mexico</p> <p>Description: View facing West. Lined area near production equipment and production piping. (Fluid in containment is rainwater from the previous night)</p> | <p>Date & Time: Fri, Jan 09, 2026 at 09:39:05 MST Position: +032.296534° / -103.655322° (±12.9ft) Altitude: 3703ft (±10.1ft) Datum: WGS-84 Azimuth/Bearing: 270° S90W 4800mils True (±14°) Elevation Angle: -19.2° Horizon Angle: -01.5° Zoom: 0.5X Avion Federal 301H</p> |

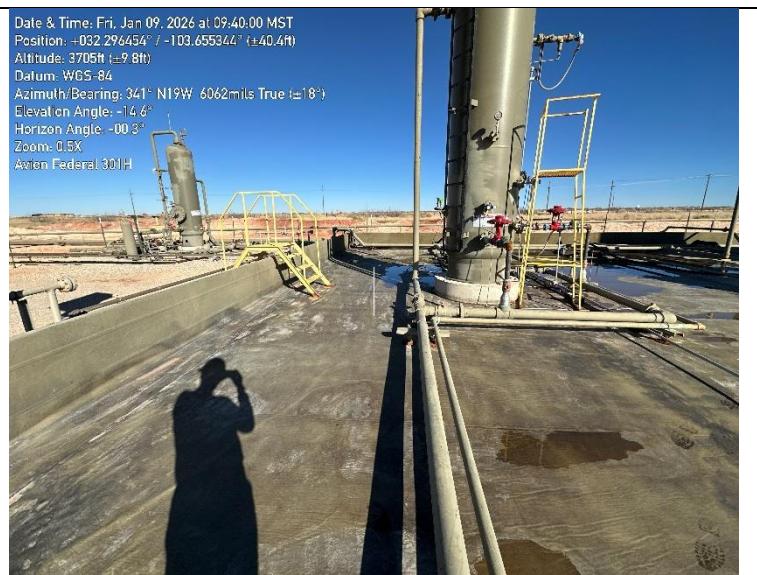
| <p>Facility: Avion Federal 301H</p> <p>County: Lea County, New Mexico</p> <p>Description: View facing North. Lined area near production equipment and production piping. (Fluid in containment is rainwater from the previous night)</p> | <p>Date & Time: Fri, Jan 09, 2026 at 09:40:00 MST Position: +032.296454° / -103.655344° (±40.4ft) Altitude: 3705ft (±9.8ft) Datum: WGS-84 Azimuth/Bearing: 341° N19W 6062mils True (±18°) Elevation Angle: -14.6° Horizon Angle: -00.3° Zoom: 0.5X Avion Federal 301H</p> |
