20200 EXT. LINE Remediation Action Plan

NMOCD Incident No. nAPP2420056258
UL "D", Sec. 24, T23S, R31E
32.675955 -103.790129
Eddy County, New Mexico

July 30, 2025

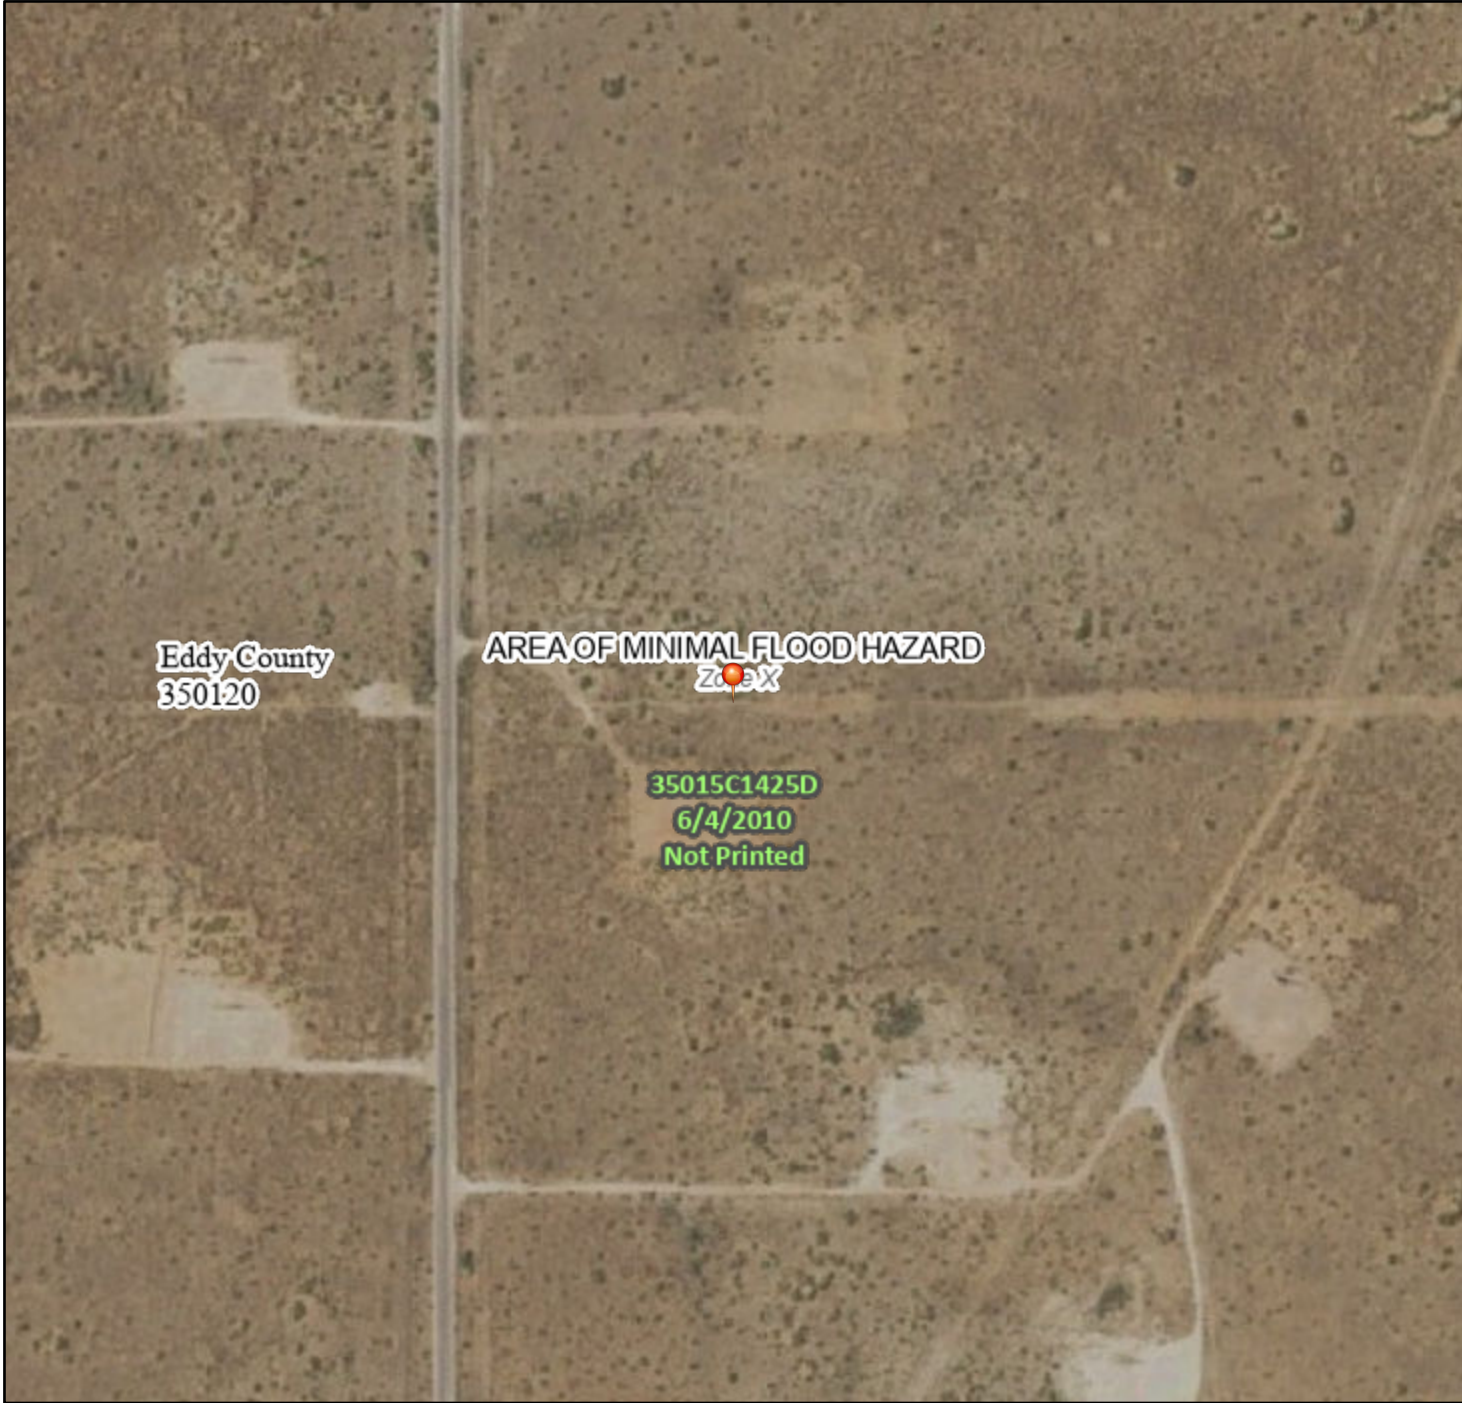
Figure 4

Review of flood map data published by the Federal Emergency Management Agency (FEMA) indicates the site is not located within a 100-year floodplain. A copy of the FEMA FIRMete Map can be found attached as Figure 4.
