Re: Closure Report

Thistle Unit 22 CTB 2
Incident Number nAPP2515351849
Lea County, New Mexico

Safety & Environmental Solutions (SESI), on behalf of Devon Energy Production Company, LP (Devon), has prepared this Closure Report to document assessment and soil sampling activities at the Thistle Unit 22 CTB 2 (Site) in Unit A, Section 22, Township 23 South, Range 33 East, in Lea County, New Mexico (Figure 1). The Site (32.295136,-103.554495 NAD83) is associated with oil and gas exploration and production operations on Federal Land managed by the Bureau of Land Management (BLM). The purpose of the Site assessment and soil sampling activities was to assess the presence or absence of impacts to soil following a release of produced water at the Site. Based on field observations, field screening activities, and soil sample laboratory analytical results, Devon is submitting this Closure Report, describing Site assessment, delineation and excavation activities that have occurred to date for Incident Number nAPP2515351849.

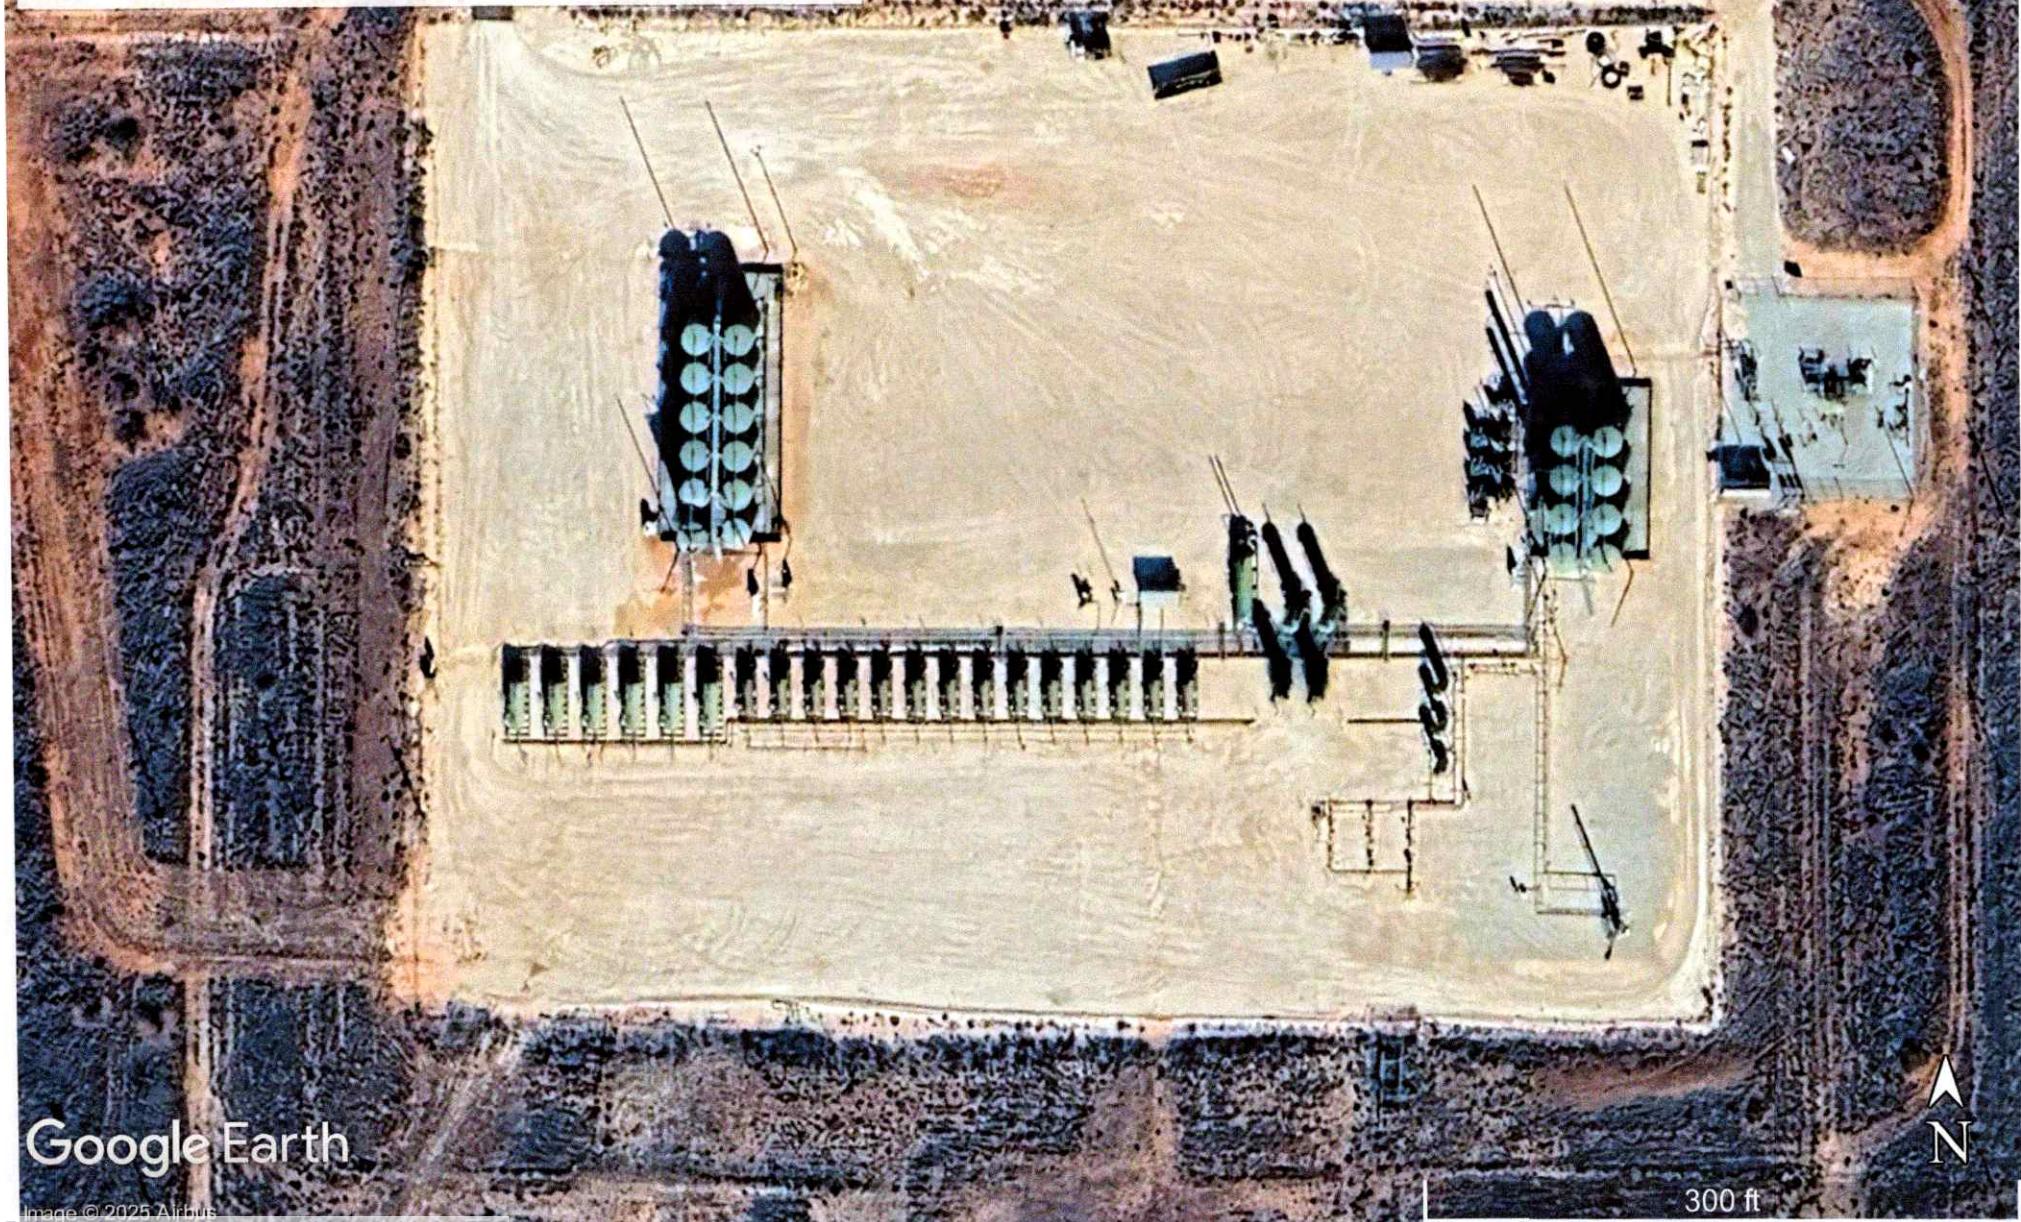
Figure 1. Site Vicinity and Receptor Map

The Site was characterized to assess the applicability of Table I Closure Criteria for Soils Impacted by a Release, as specified in 19.15.29 NMAC. Results of the desktop review are summarized below; receptors are identified in Figure 1, with well records provided in Appendix A.

- Surface elevation is approximately 3710 feet above mean sea level (msl).
- The nearest continuously flowing water course (Pecos River) is located 25 miles to the west of the site.

- The nearest wetland (riverine) is located 0.64 miles to the east of the site.
- The nearest freshwater pond habitat is located 1.01 miles east of the site.

- The nearest lakebed, sinkhole, or playa lake (Bell Lake) is located about 4.2 miles south southeast of the site.
- The nearest subsurface mine >20 miles west northwest, associated with Mosaic Potash Carlsbad.

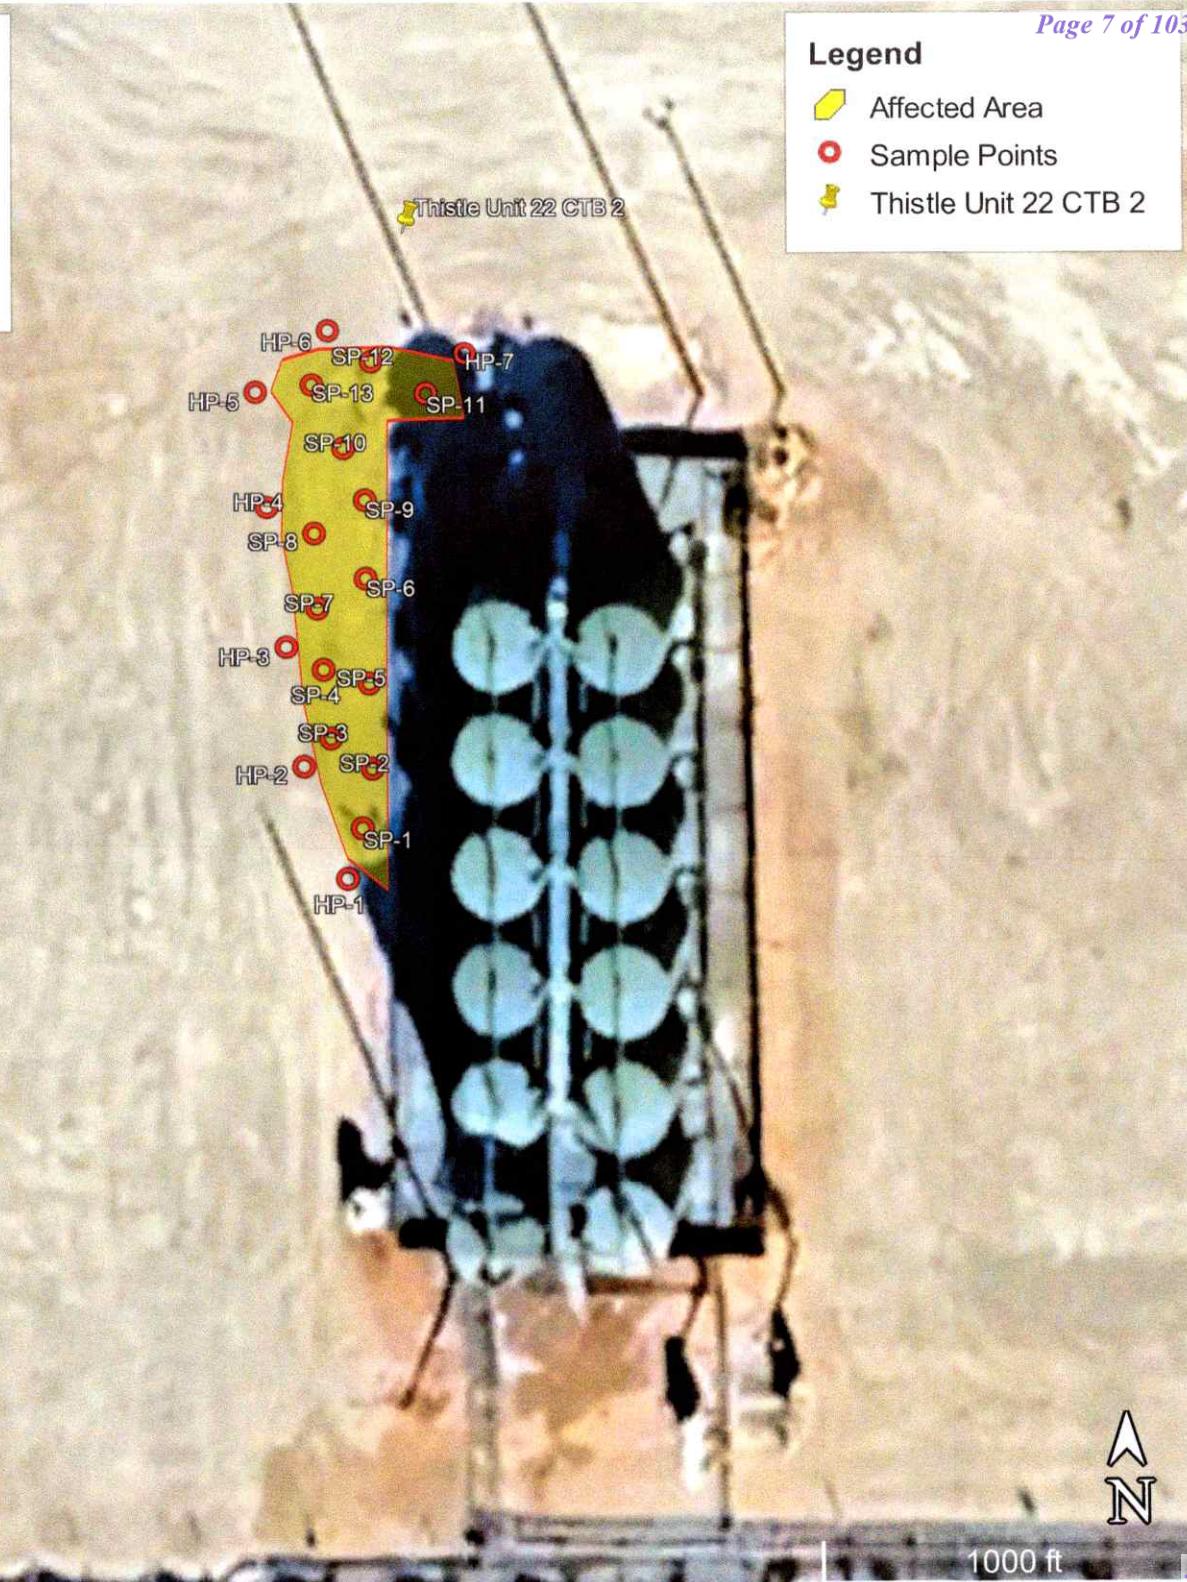
Sample Point Map

- On June 10, 2025, twelve (12) delineation soil samples (SP-1 through SP-12) were collected from 0-1 ft bgs, and seven (7) horizontal soil samples (HP-1 through HP-7) and field screened for chloride concentrations.
- On July 30, 2025, following 48-hour notification to the NMOCD, twenty (20) confirmation samples were collected, packaged, and shipped under strict chain-of-custody to Envirotech Analytical Laboratory (Farmington, NM). Samples were analyzed for BTEX (EPA 8021B), TPH-GRO/DRO/ORO (EPA 8015M/D), and chloride (EPA 300.0).
- On August 26, 2025, a backfill sample was collected (BF-1-S), packaged, and shipped under strict chain-of-custody to Envirotech Analytical Laboratory (Farmington, NM). Samples were analyzed for BTEX (EPA 8021B), TPH-GRO/DRO/ORO (EPA 8015M/D), and chloride (EPA 300.0).

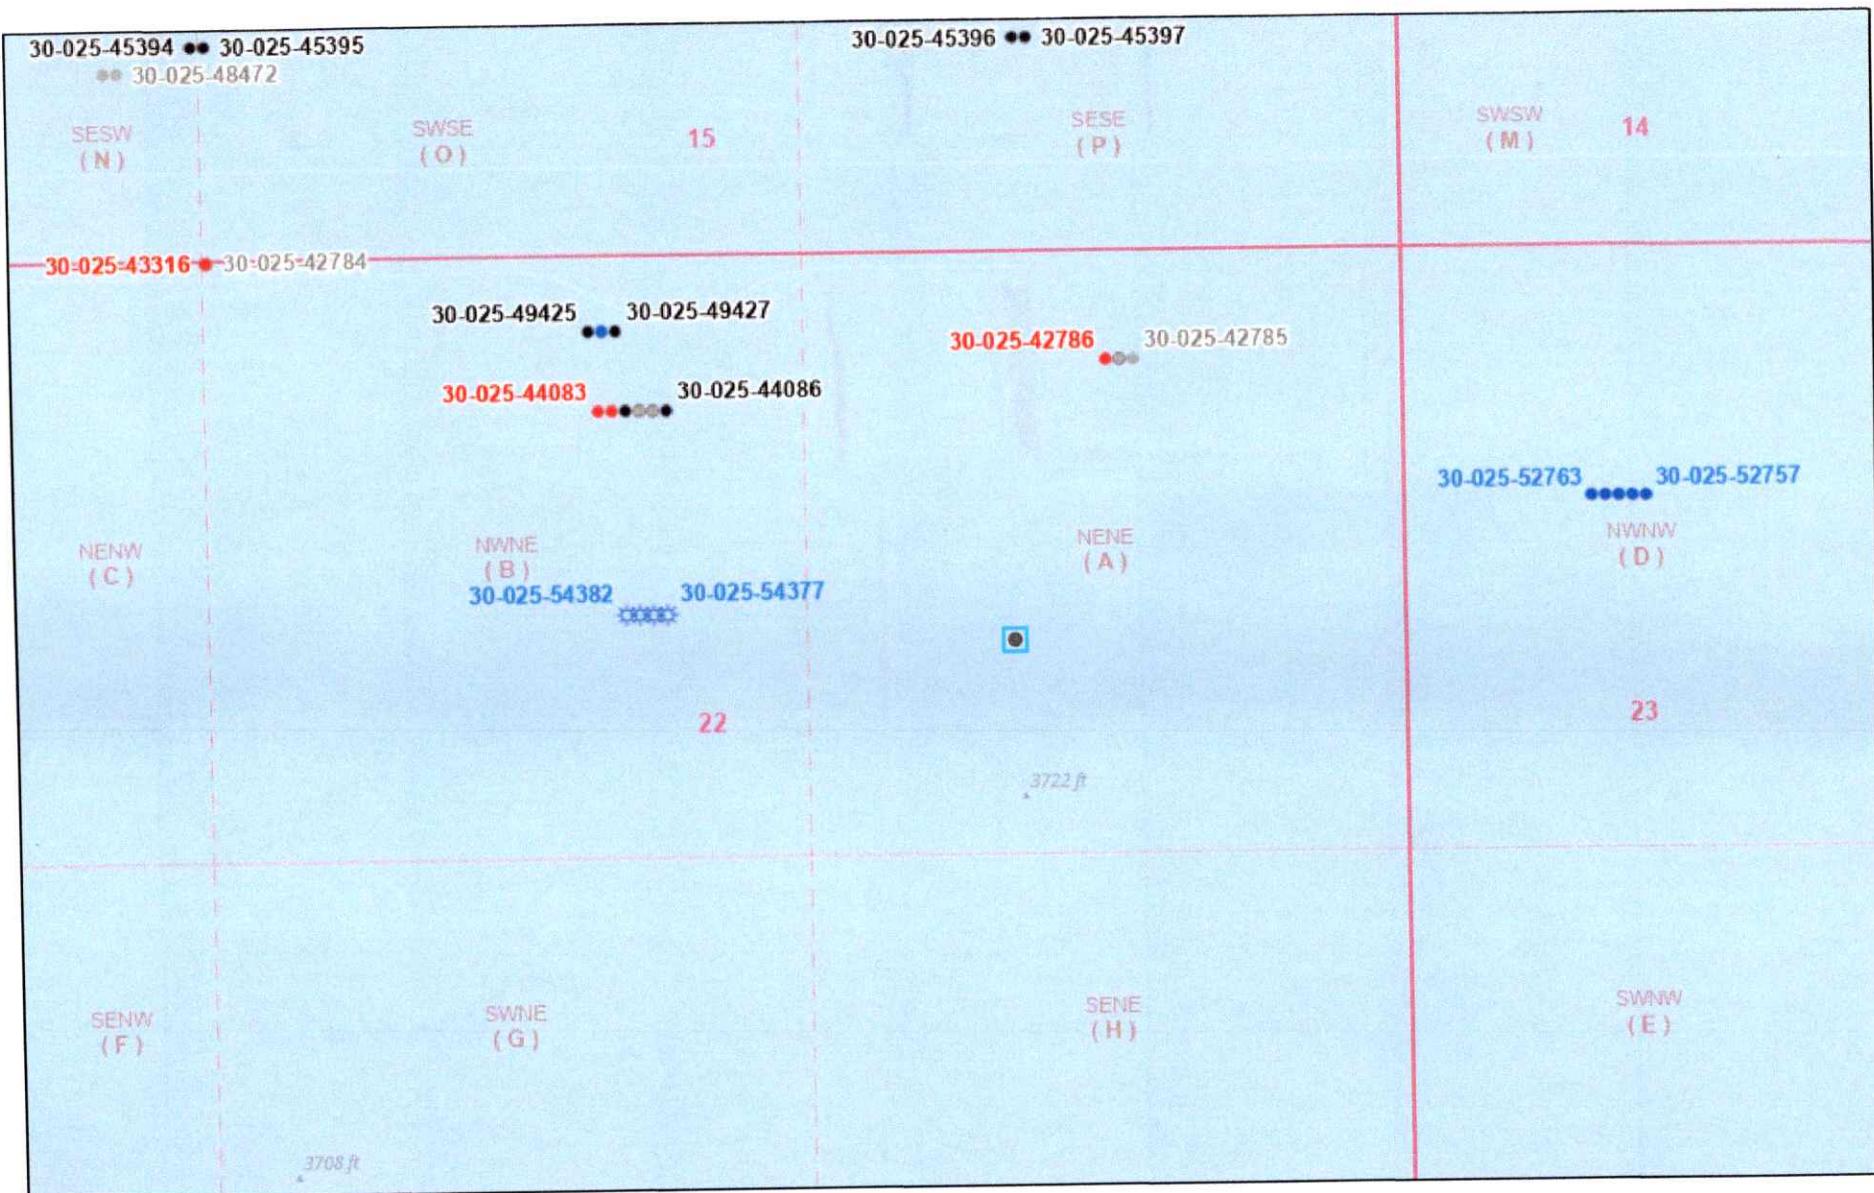
OCD Well Locations | Karst Map

- USGS karst occurrence potential data designates the area as low risk.

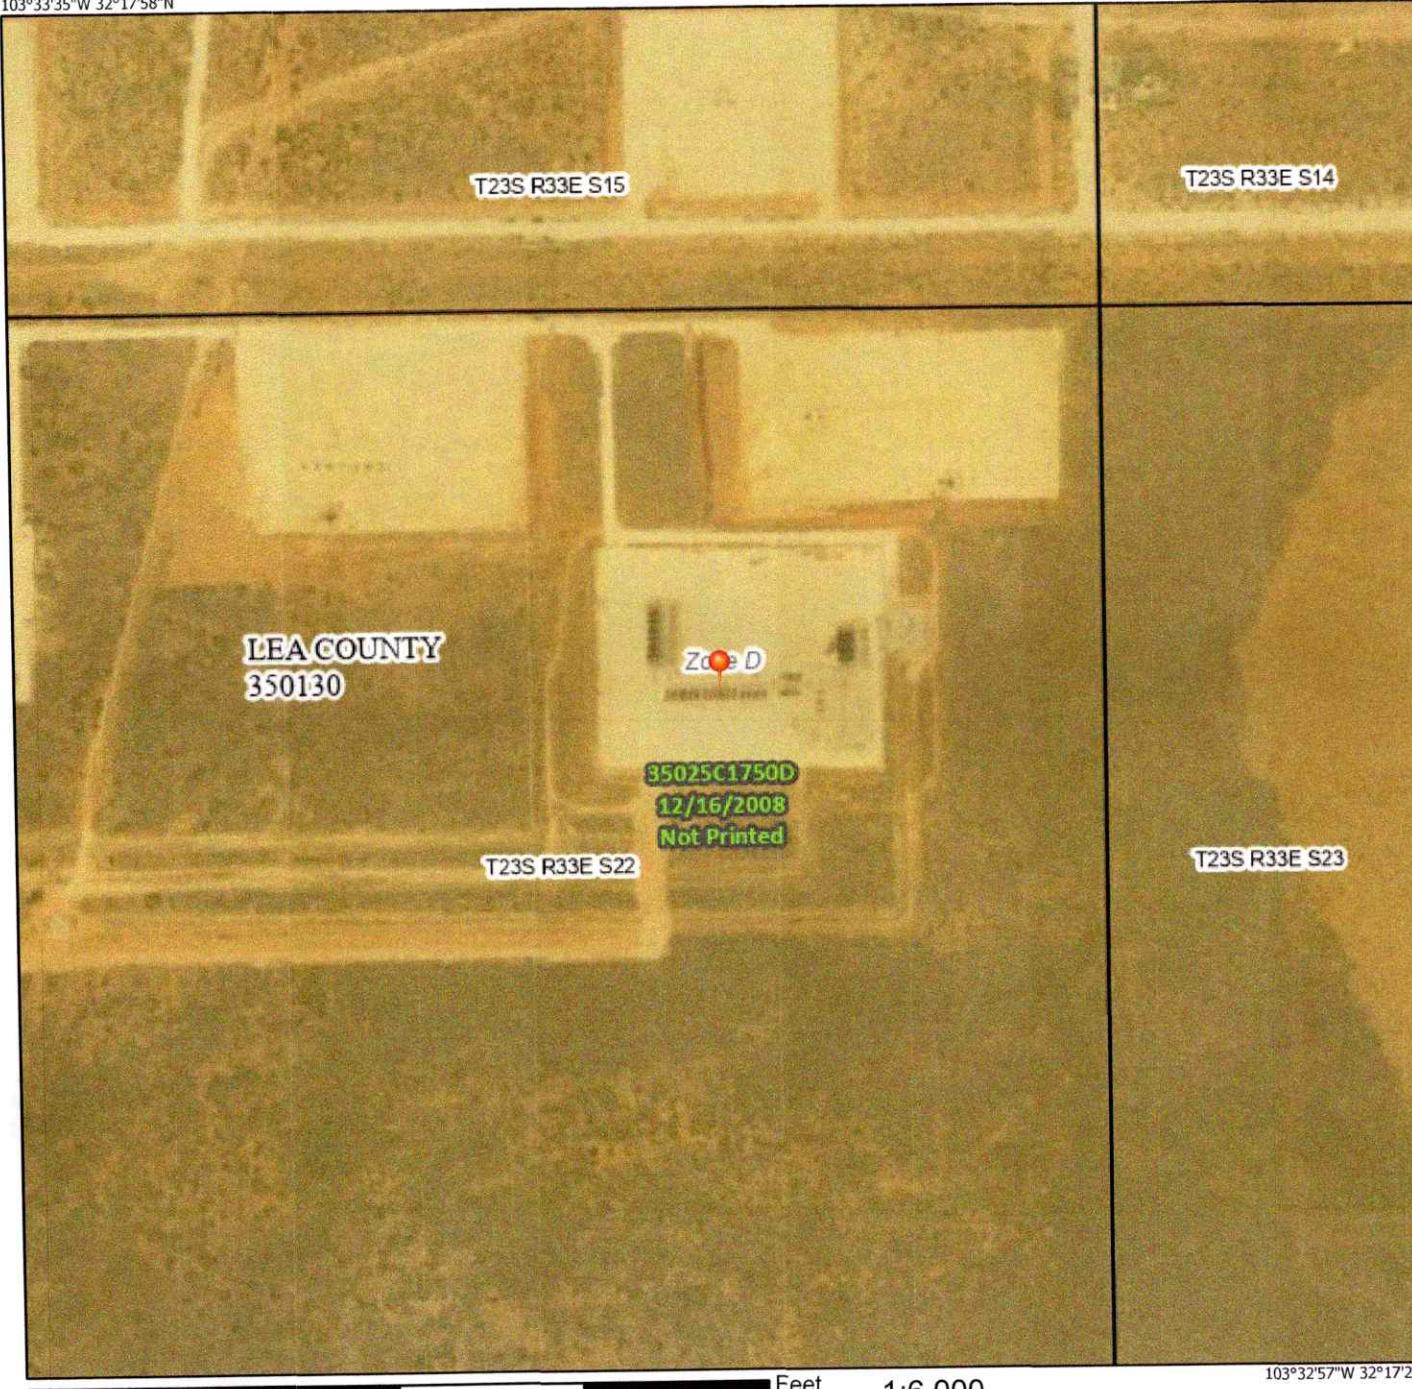
National Flood Hazard Layer FIRMette

- According to the FEMA National Flood Hazard Layer (NFHL) FIRMette map, the Site is located entirely within Zone D (Area of Undetermined Flood Hazard). The property is not located within a 100-year floodplain, and no regulatory floodways are mapped at or immediately adjacent to the Site.

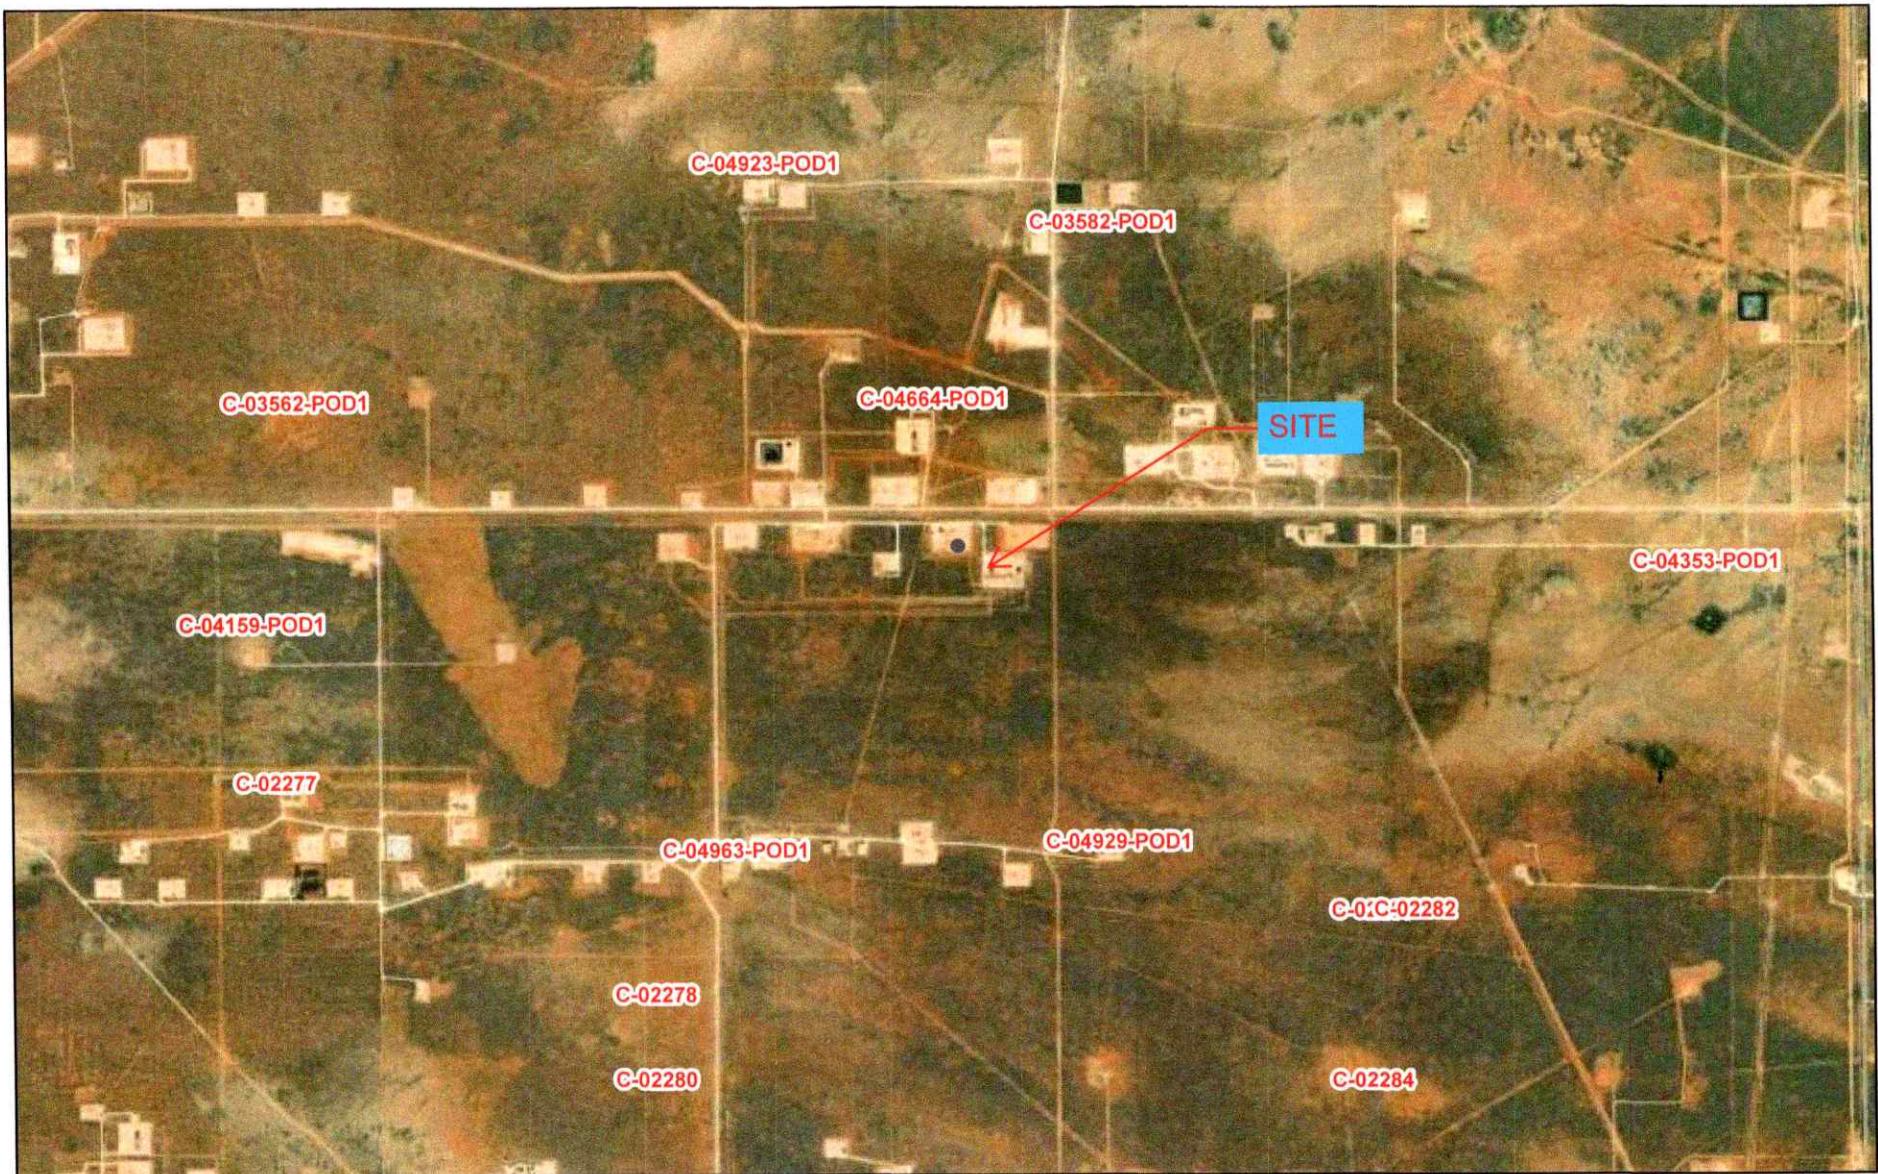
OSE POD Location Map

- Groundwater was determined utilizing the New Mexico Office of the State Engineers (NMOSE) database for registered water wells. The closest registered Point of Diversion (POD), identified as C-04664-POD1, is located approximately 0.38 miles northwest of the release site at coordinates 32.30251, -103.37444 (SE NW SE, Section 15, Township 23 South, Range 33 East). This well was drilled by Devon Energy on September 7, 2022, to a depth of 55 feet below ground surface (bgs) using a hollow stem auger. No groundwater was encountered during drilling, and the well was classified as a dry hole.

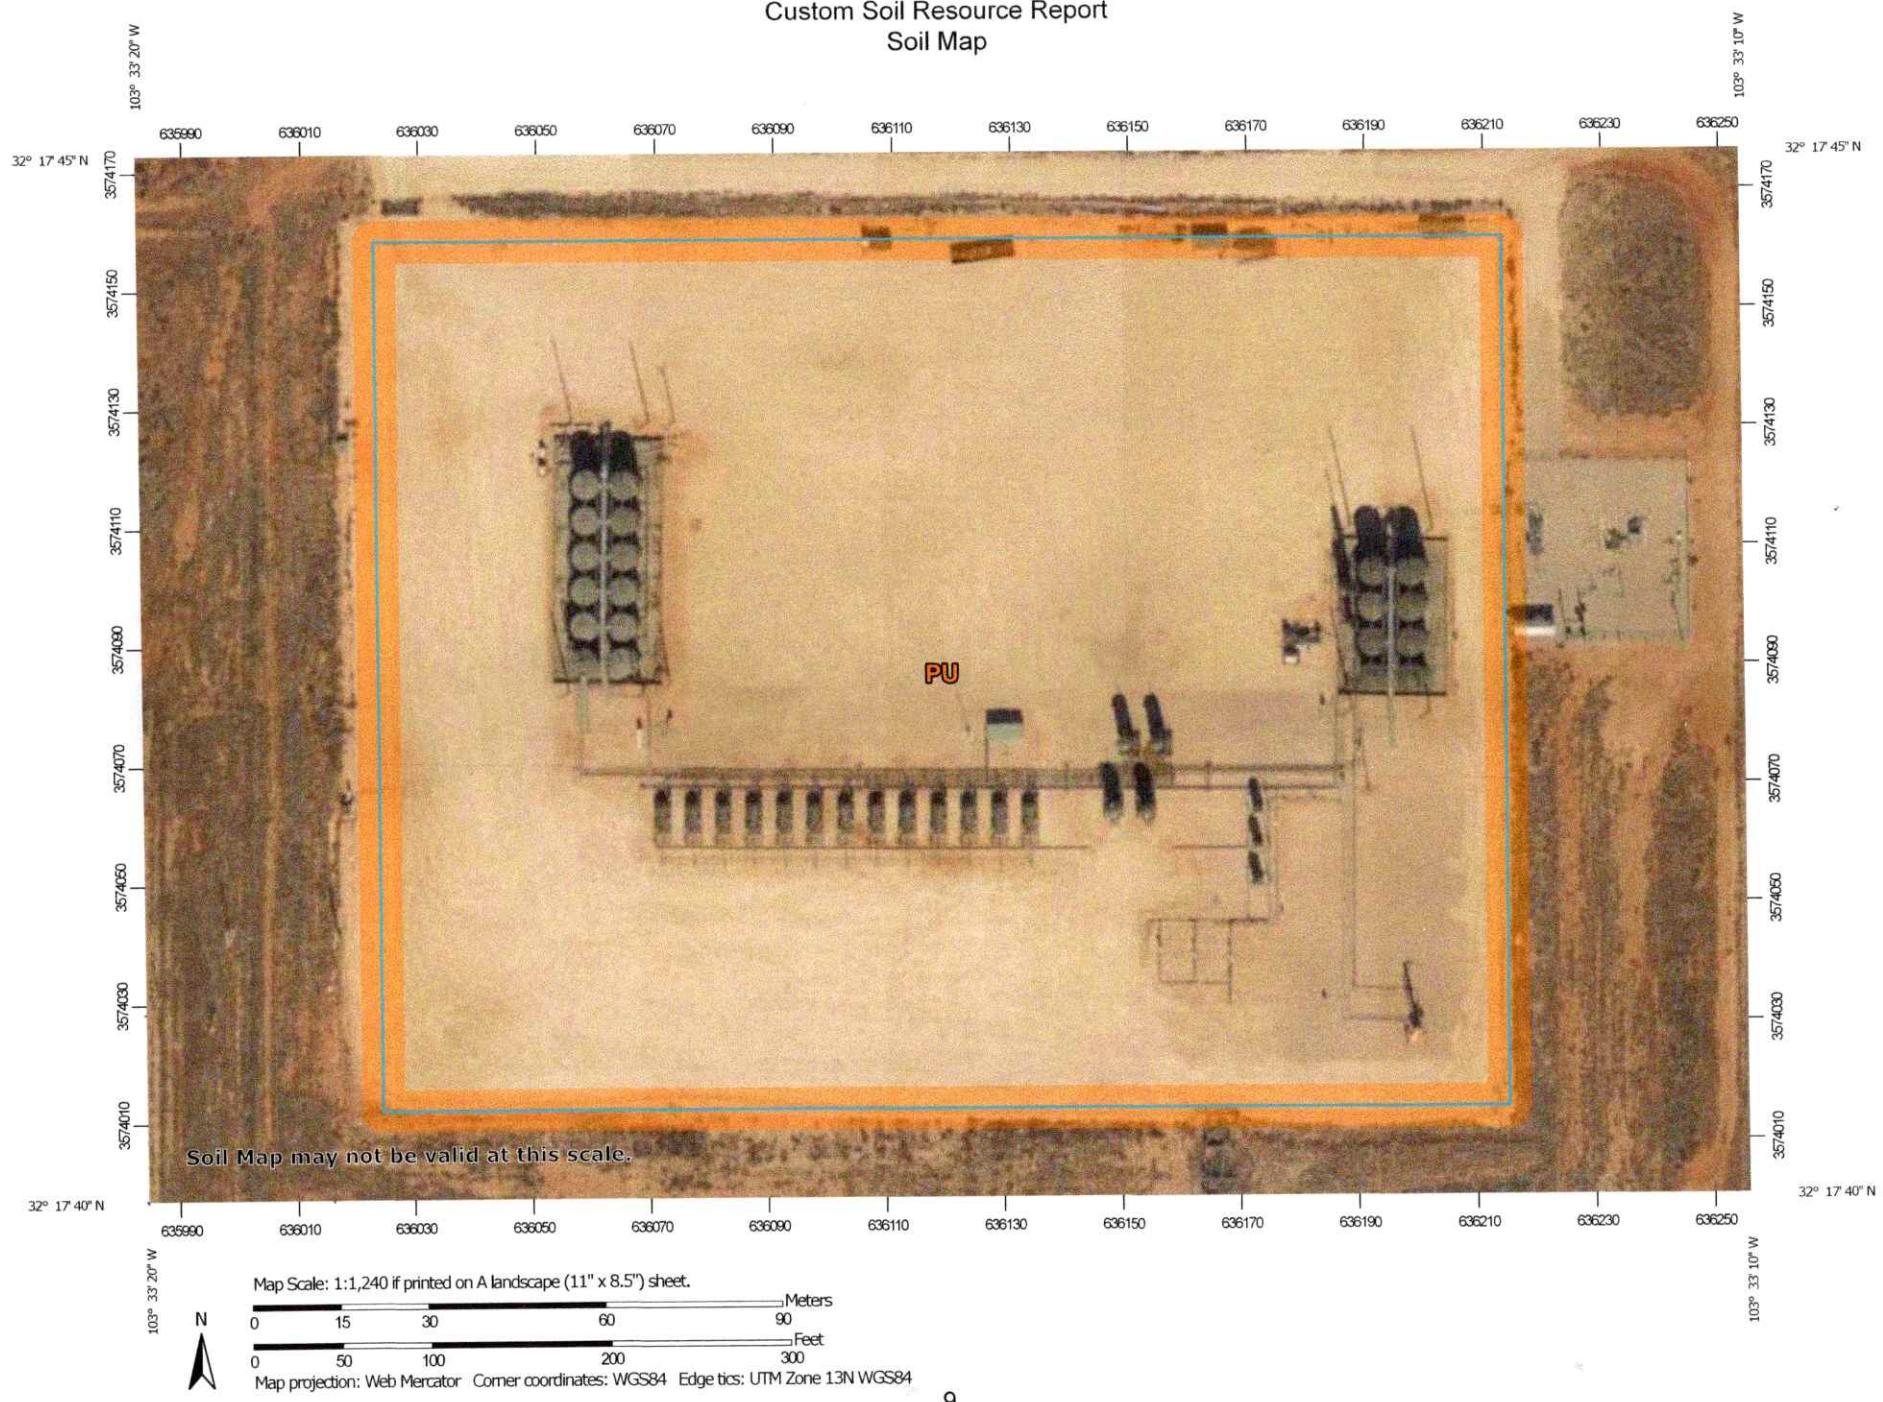
Figure 2. Soil Survey Map

- According to the United States Department of Agriculture Natural Resources Conservation Service, the soil in this area is classified as Pyote and Maljamar fine sands, with 0 to 3 percent slopes. These soils are derived from sandy eolian deposits formed on plains and rises. The Pyote series consists of fine sand to fine sandy loam with no restrictive features to a depth of over 80 inches and is classified as well drained with negligible runoff. The Maljamar series includes a petrocalcic horizon at 40–60 inches and also drains well with very low runoff potential. Both soils exhibit low available water supply and are rated as non-hydric. The area lies within Ecological Site R070BD003NM (Loamy Sand). This location is not classified as prime farmland and has a high permeability with limited salinity, low gypsum content, and minimal risk of flooding or ponding.

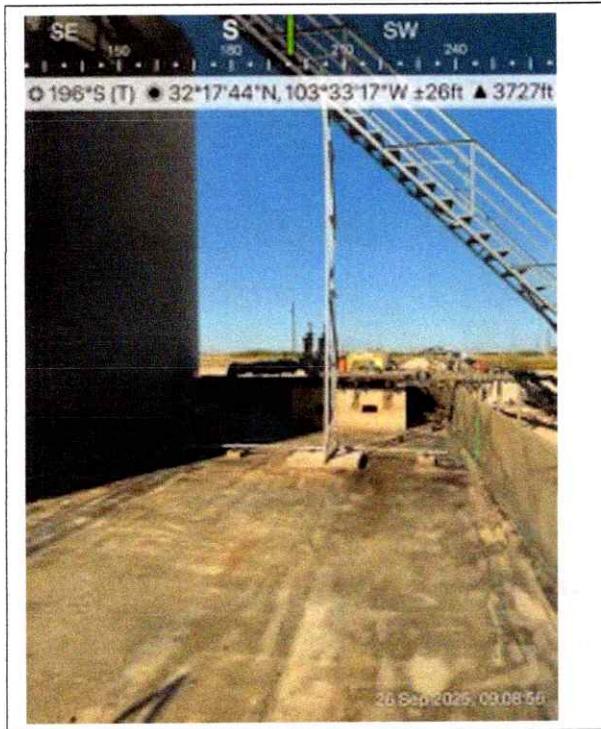
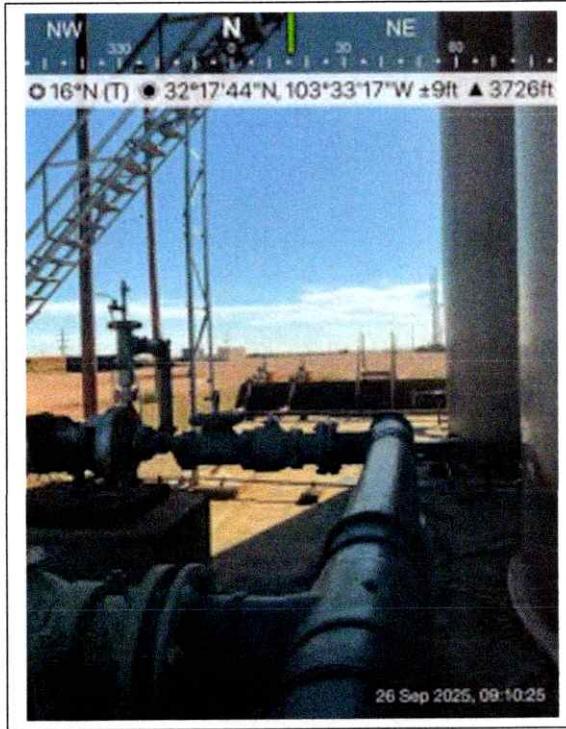
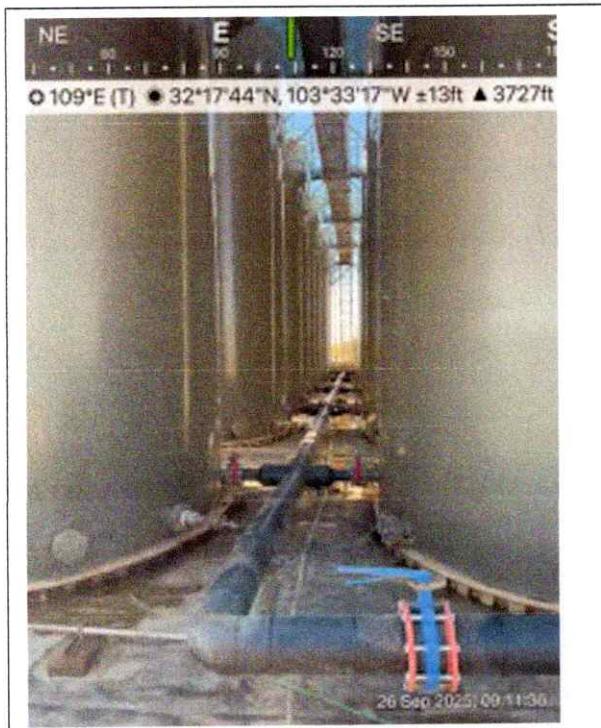
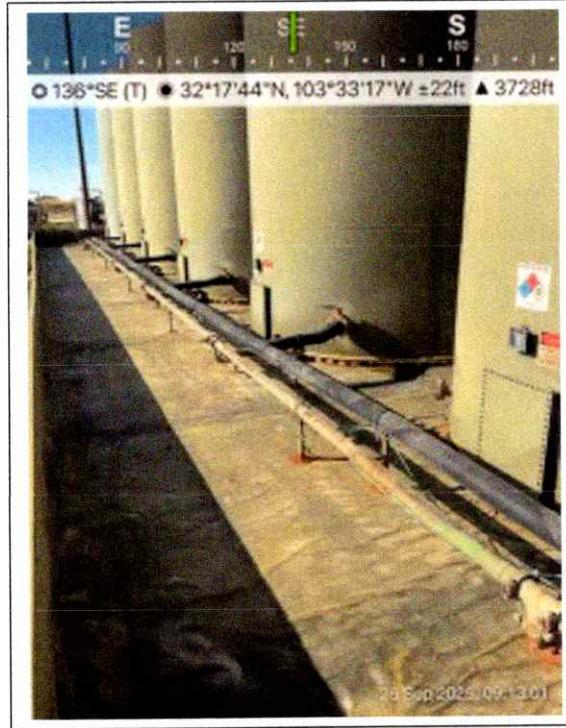
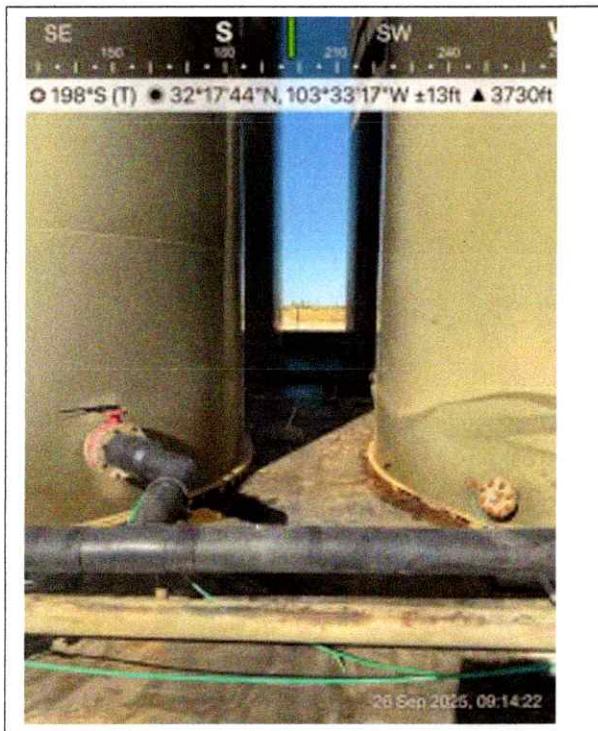
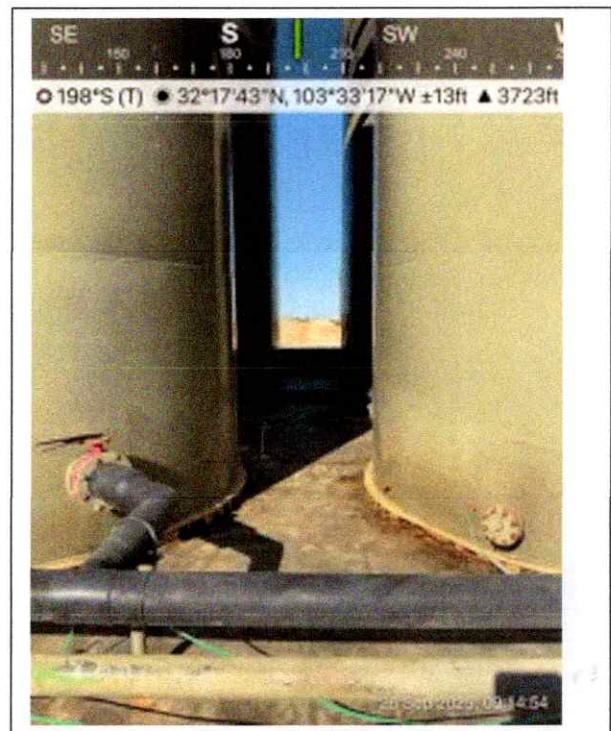
Liner Inspection – September 26, 2025

No liner integrity issue noted from vegetation.
Some staining was visually inspected on liner.
No degradation of liner.

- no cracks, bulges, chips, seepage, noted. ~~Some staining was noted~~
- None noted
- None noted
- None noted
- None noted

On September 24, 2025, 48-hour advance notification of the liner inspections was submitted and approved. On September 26, 2025, SESI conducted liner inspection activities to evaluate liner integrity at the Site. SESI personnel performed a visual inspection and confirmed that the liner was intact, with no evidence of damage or loss of integrity, and operating as designed. A photographic log documenting liner conditions at the time of inspection is attached, along with a copy of the 48-hour advance notification of the liner inspection activities provided to the NMOCD.

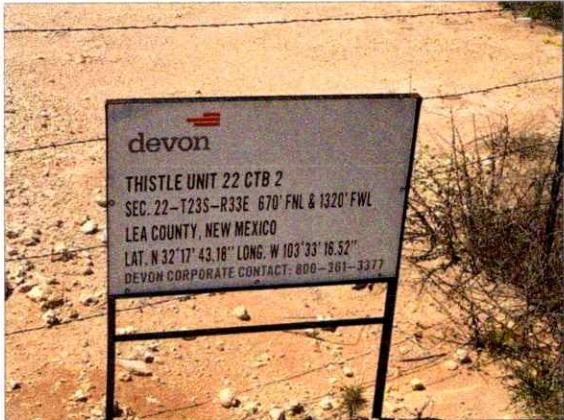
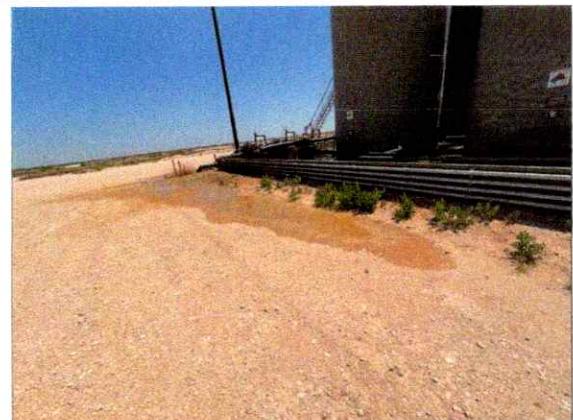
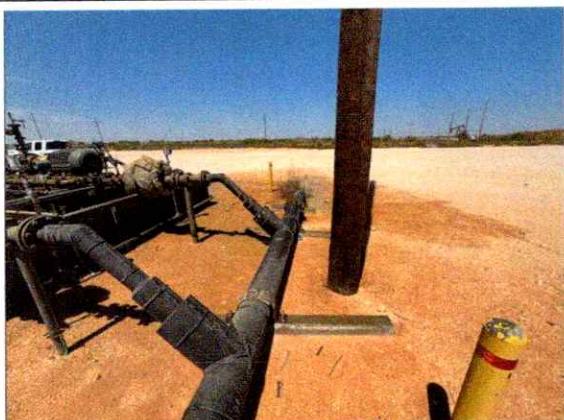
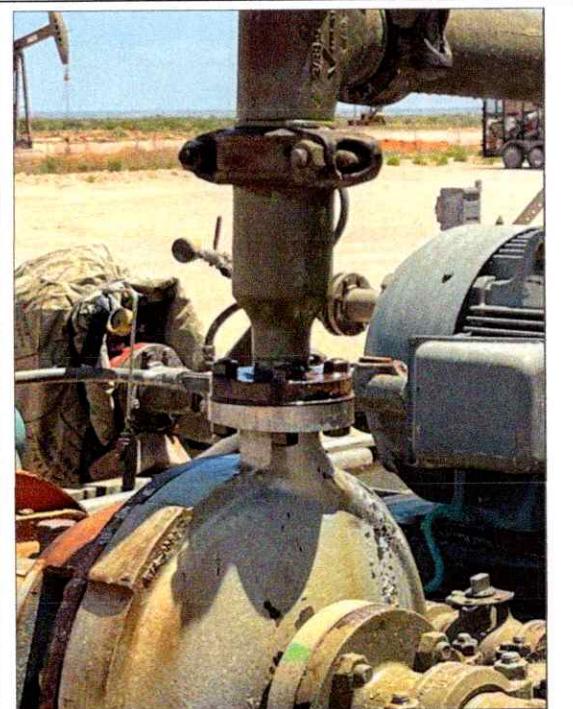
Thistle Unit 22 CTB 2

Description of Event: (What & How)	Notified from SWD team about an active leak. The leak was caused by overspray due to a threaded 3"x1" swedge to flange connection on the discharge side of WTP 507.
---------------------------------------	---

Immediate Actions:	WTP taken OOS and leak isolated. LO notified PA and collected proper documentation.
--------------------	---
