# Remediation Summary & Soil Closure Request

## Permian Resources Operating, LLC Vitalizer 33 Battery #2

Lea County, New Mexico  
Unit Letter "P", Section 33, Township 21 South, Range 34 East  
Latitude 32.42890001° North, Longitude 103.4680001° West  
**NMOCD Reference No. nAPP2521134185**

**November 7, 2025**

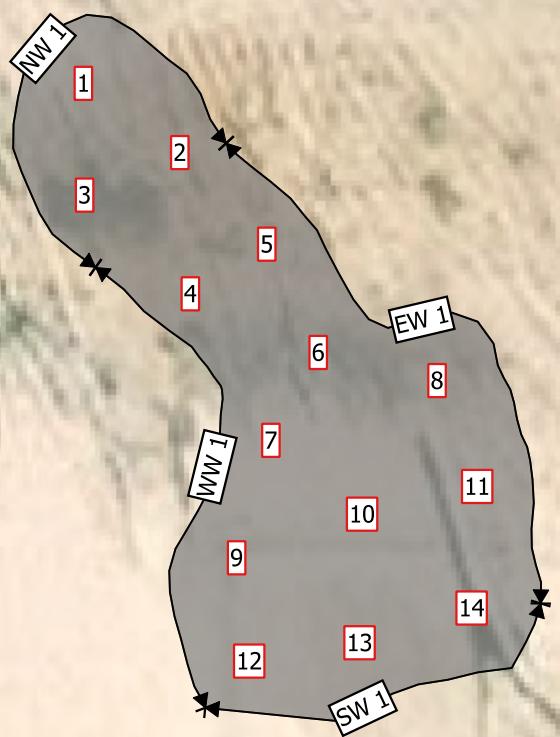
**Figure 3**  
**Sample Location Map**

- Excavation Extent
- Composite Floor Sample
- ◀→ Composite Wall Sample

Red Border with Shading: Highest observed concentration.

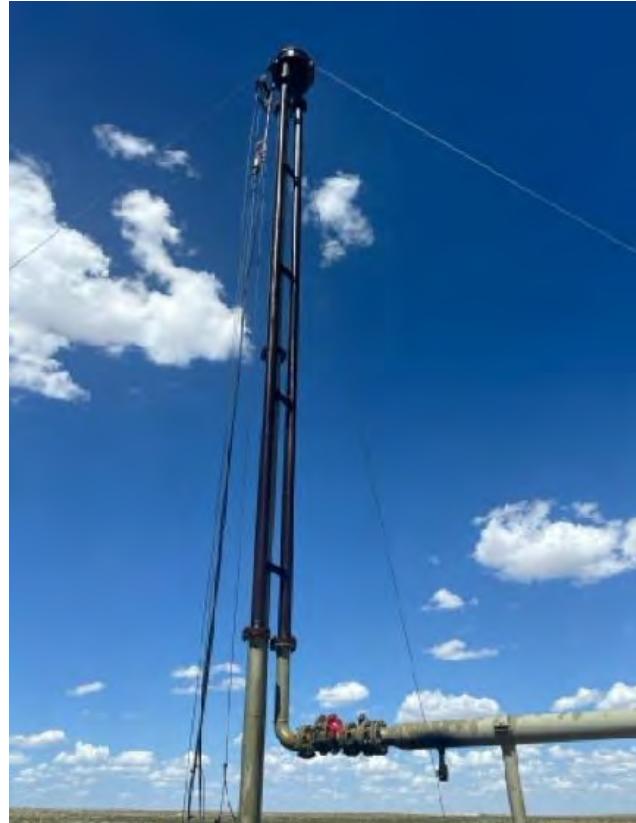
<b>Photo Number:</b> 1

<b>Photo Direction:</b> Northeast	
<b>Date:</b> 7/29/2025	
<b>Coordinates:</b> 32.429315,-103.467045	
<b>Photo Description:</b>  Release point.

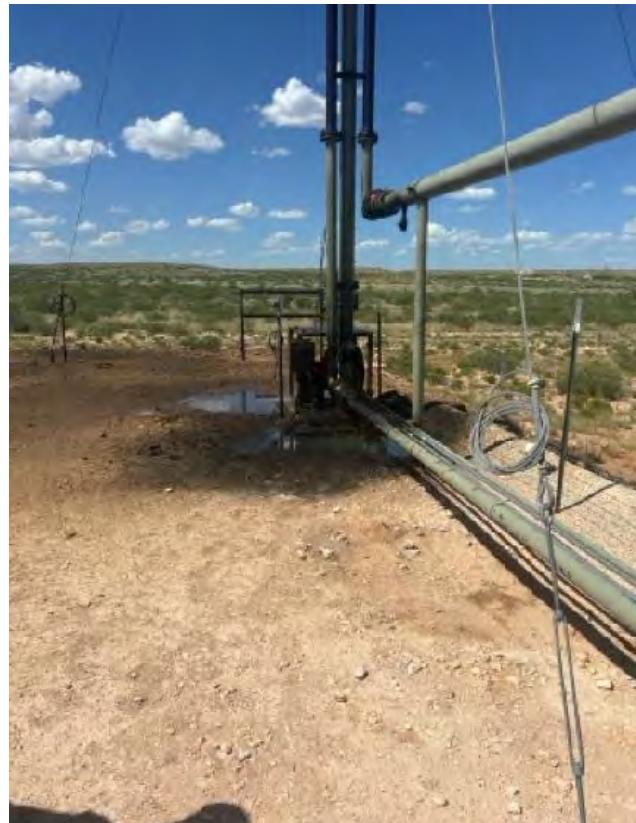
<b>Photo Number:</b> 2

<b>Photo Direction:</b> North-Northeast	
<b>Date:</b> 7/29/2025	
<b>Coordinates:</b> 32.429241,-103.467038	
<b>Photo Description:</b>  View of the affected area.

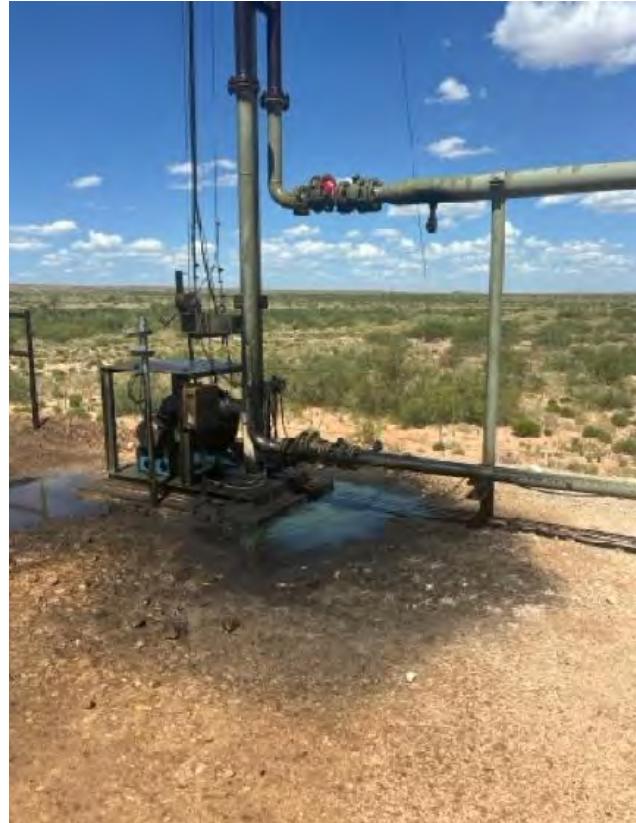
<b>Photo Number:</b> 3

<b>Photo Direction:</b> Northeast	
<b>Date:</b> 7/29/2025	
<b>Coordinates:</b> 32.429286,-103.467066	
<b>Photo Description:</b>  View of the affected area.

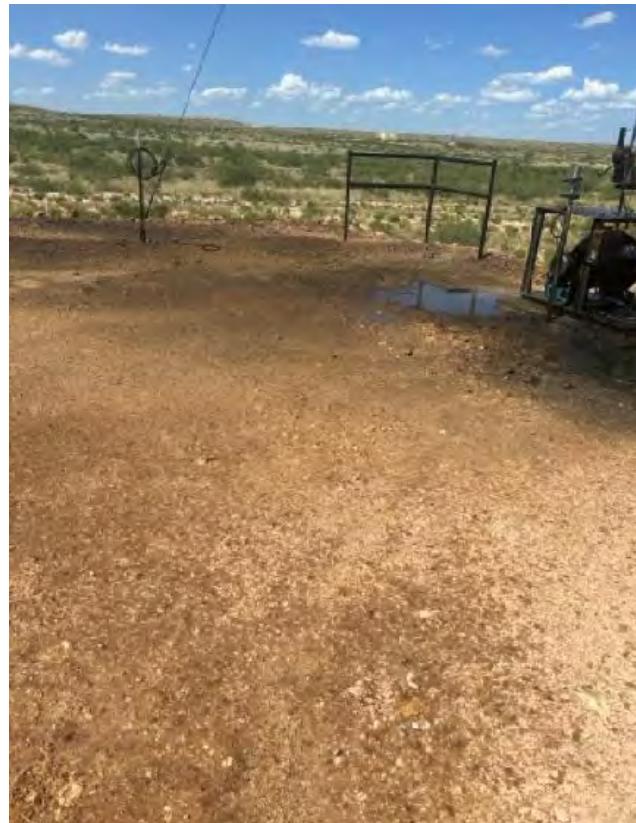
<b>Photo Number:</b> 4

<b>Photo Direction:</b> North-Northeast	
<b>Date:</b> 7/29/2025	
<b>Coordinates:</b> 32.429289,-103.467073	
<b>Photo Description:</b>  View of the affected area.

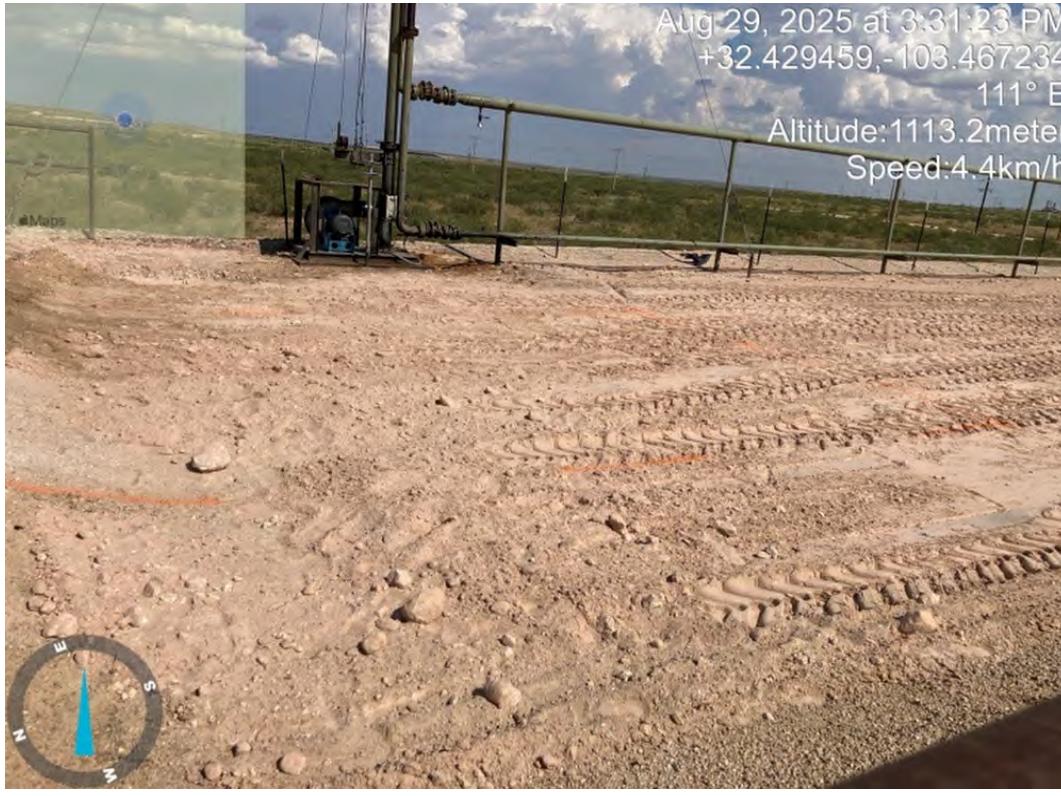
<b>Photo Number:</b> 5

A photograph showing a large, irregularly shaped excavation pit in a dry, brownish soil area. The pit is bounded by a red string. In the background, there is a green metal structure, possibly a pump or valve, connected to a long green pipe. The sky is blue with scattered white clouds. A compass rose is overlaid in the bottom left corner of the image.
<b>Photo Direction:</b> East-Southeast	Aug 29, 2025 at 3:31:23 PM +32.429459, -103.467234 111° E Altitude: 1113.2meter Speed: 4.4km/h

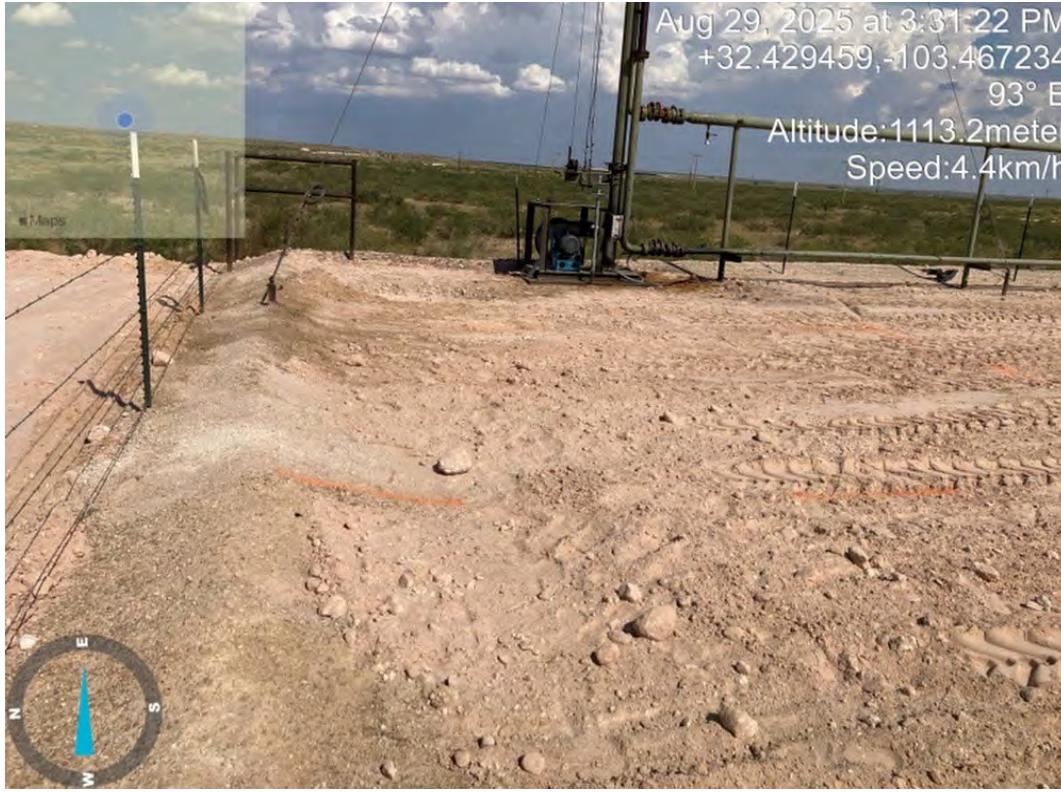
<b>Photo Number:</b> 6

A photograph showing a large, irregularly shaped excavation pit in a dry, brownish soil area. The pit is bounded by a red string. In the background, there is a green metal structure, possibly a pump or valve, connected to a long green pipe. The sky is blue with scattered white clouds. A compass rose is overlaid in the bottom left corner of the image.
<b>Photo Direction:</b> East	Aug 29, 2025 at 3:31:22 PM +32.429459, -103.467234 93° E Altitude: 1113.2meter Speed: 4.4km/h

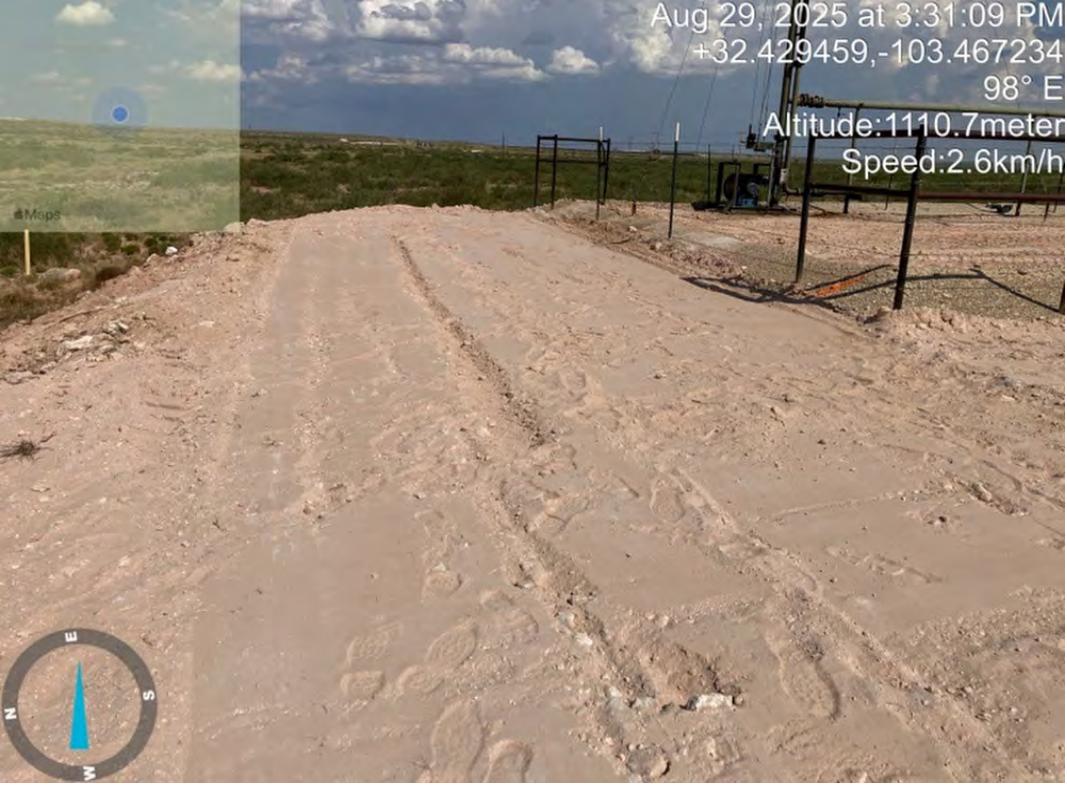
<b>Photo Number:</b> 7

A photograph showing a large, rectangular excavation site in a dry, brown earth. The site is bounded by a metal fence on the right. In the background, there are utility poles and a cloudy sky. A small compass rose is visible in the bottom left corner of the image frame.
<b>Photo Direction:</b> East	Aug 29, 2025 at 3:31:09 PM +32.429459,-103.467234 98° E Altitude:1110.7meter Speed:2.6km/h

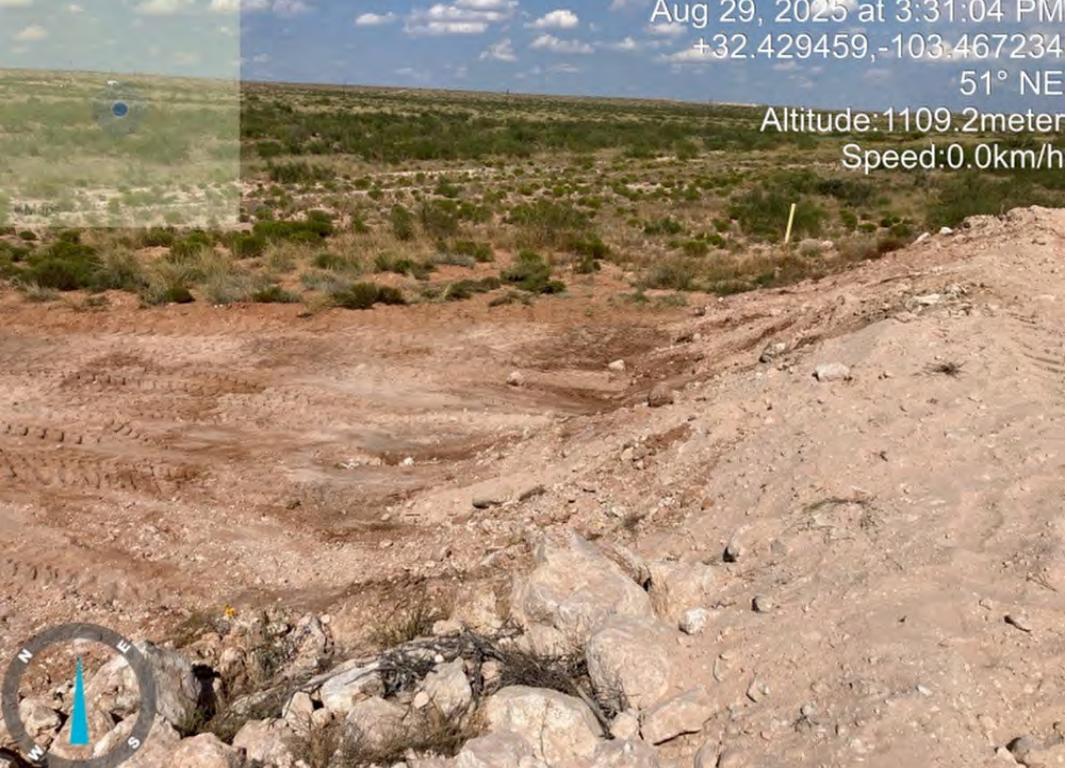
<b>Photo Number:</b> 8

A photograph showing a large, rectangular excavation site in a dry, brown earth. The site is bounded by a metal fence on the right. In the background, there are utility poles and a cloudy sky. A small compass rose is visible in the bottom left corner of the image frame.
<b>Photo Direction:</b> Northeast	Aug 29, 2025 at 3:31:04 PM +32.429459,-103.467234 51° NE Altitude:1109.2meter Speed:0.0km/h

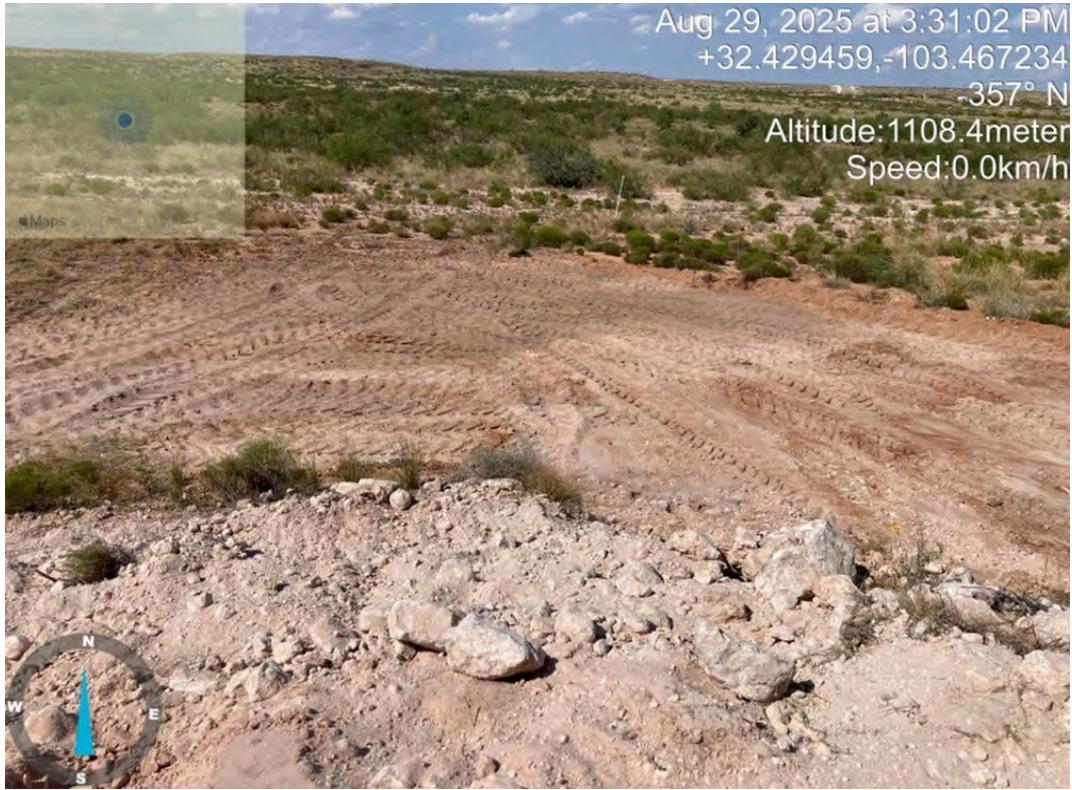
<b>Photo Number:</b> 9

A photograph showing a large, irregularly shaped excavation site in a dry, arid landscape. The ground is brown and textured with deep, parallel tracks from heavy machinery. Sparse green shrubs and grass are scattered across the horizon. In the bottom left corner of the image, there is a small compass rose overlay with cardinal directions (N, S, E, W) and a blue arrow pointing North. The sky is blue with some white clouds.
<b>Photo Direction:</b> North	Aug 29, 2025 at 3:31:02 PM +32.429459,-103.467234 -357° N Altitude:1108.4meter Speed:0.0km/h

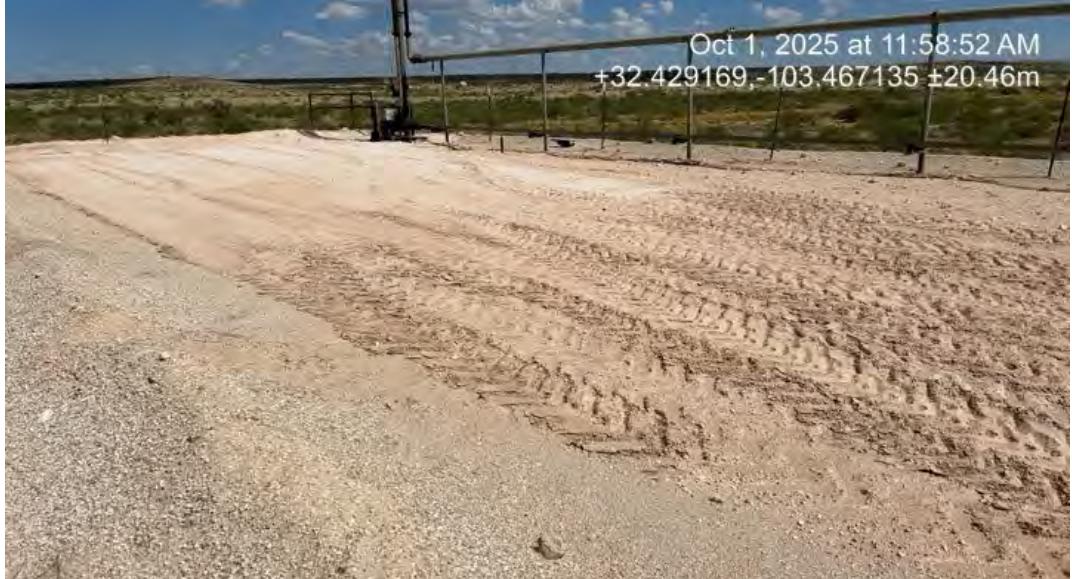
<b>Photo Number:</b> 10

A photograph of a remediated area. The ground is covered in a layer of dark, granular material, likely asphalt or a sealant, applied over a layer of backfilled soil. The surface has distinct, parallel tire tracks from a heavy-duty vehicle. In the background, there is a chain-link fence and some industrial structures, possibly storage tanks or processing units, under a clear blue sky.
<b>Photo Direction:</b> Northeast	Oct 1, 2025 at 11:58:52 AM +32.429169,-103.467135 ±20.46m

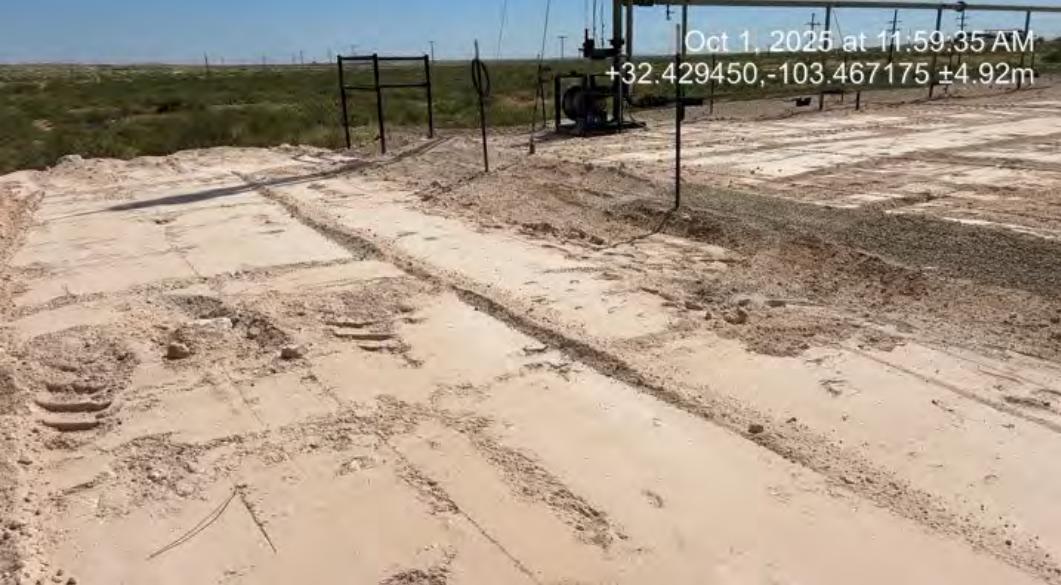
<b>Photo Number:</b> 11	
<b>Photo Direction:</b> Southeast	
<b>Photo Description:</b>  View of the remediated area following backfill and regrading.

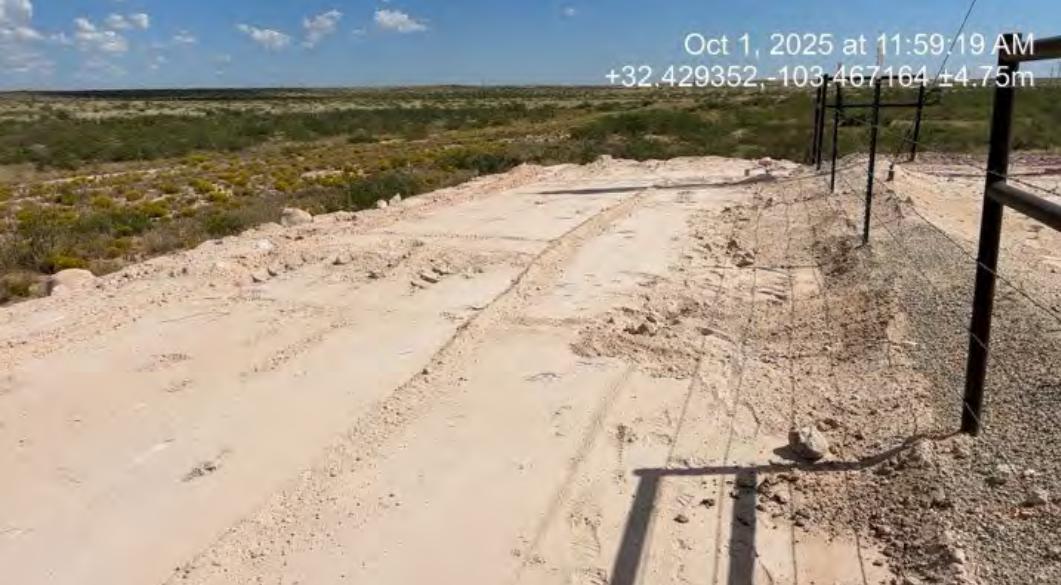
<b>Photo Number:</b> 12	
<b>Photo Direction:</b> East-Northeast	
<b>Photo Description:</b>  View of the remediated area following backfill and regrading.

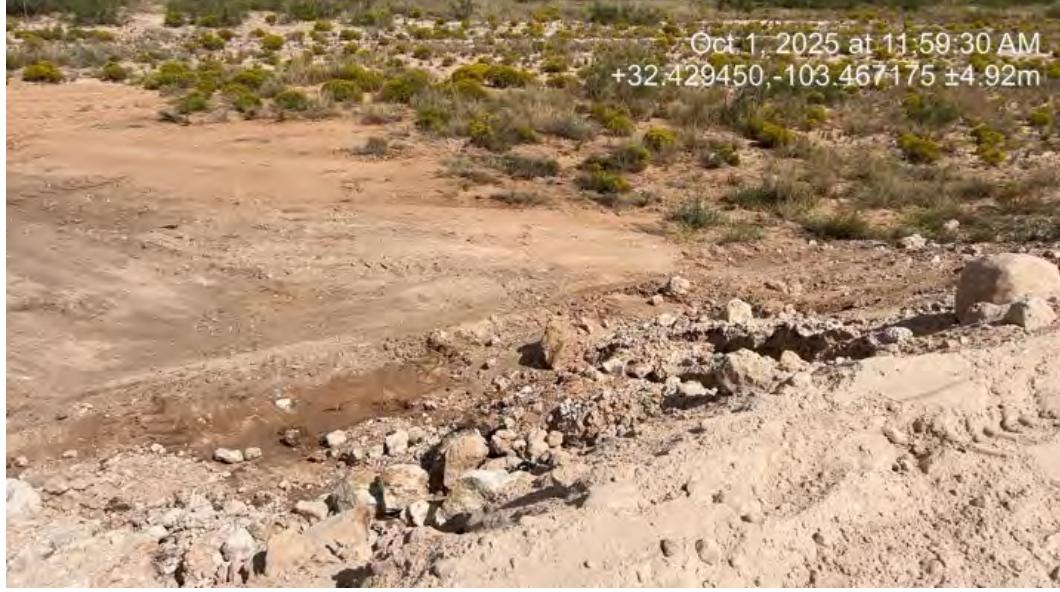
<b>Photo Number:</b> 13	
<b>Photo Direction:</b> Northeast	
<b>Photo Description:</b>    View of the remediated area following backfill and regrading.

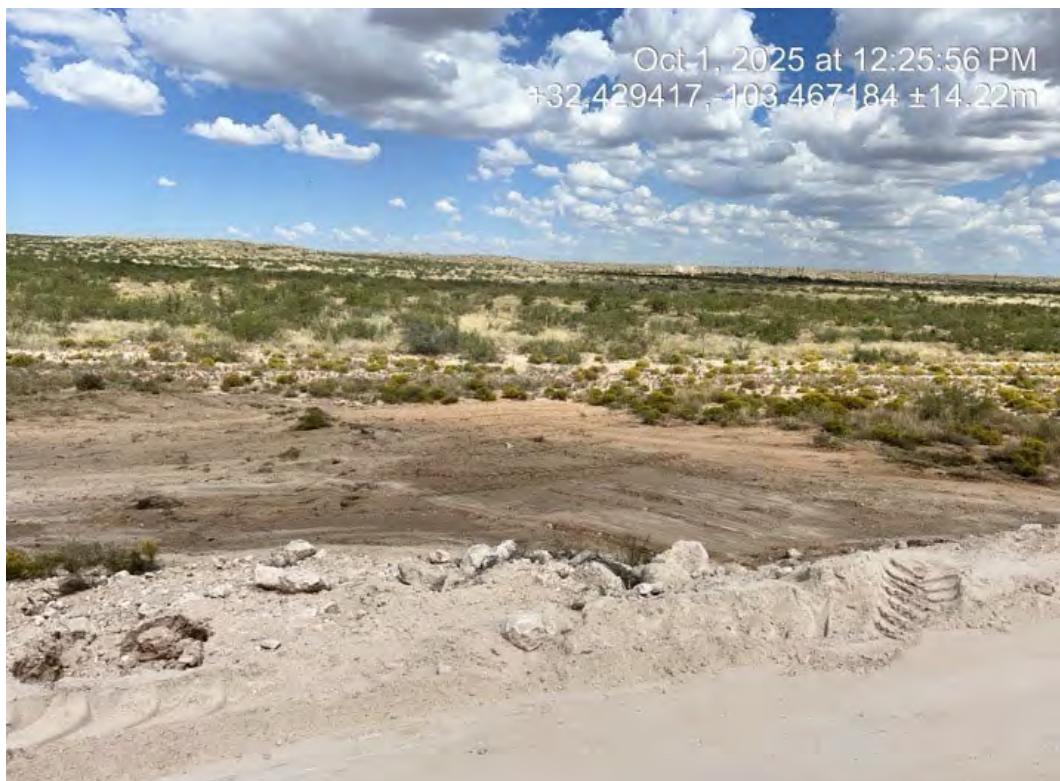
<b>Photo Number:</b> 14	
<b>Photo Direction:</b> Northeast	
<b>Photo Description:</b>    View of the remediated area following backfill and regrading.
