## Amended Remediation Summary & Soil Closure Request

### Mewbourne Oil Company PWMS Magnum Road Riser

Eddy County, New Mexico  
Unit Letter "P", Section 25, Township 25 South, Range 28 East  
Latitude 32.53939 North, Longitude 104.12453 West  
NMOCD Reference No. nAPP2401652735

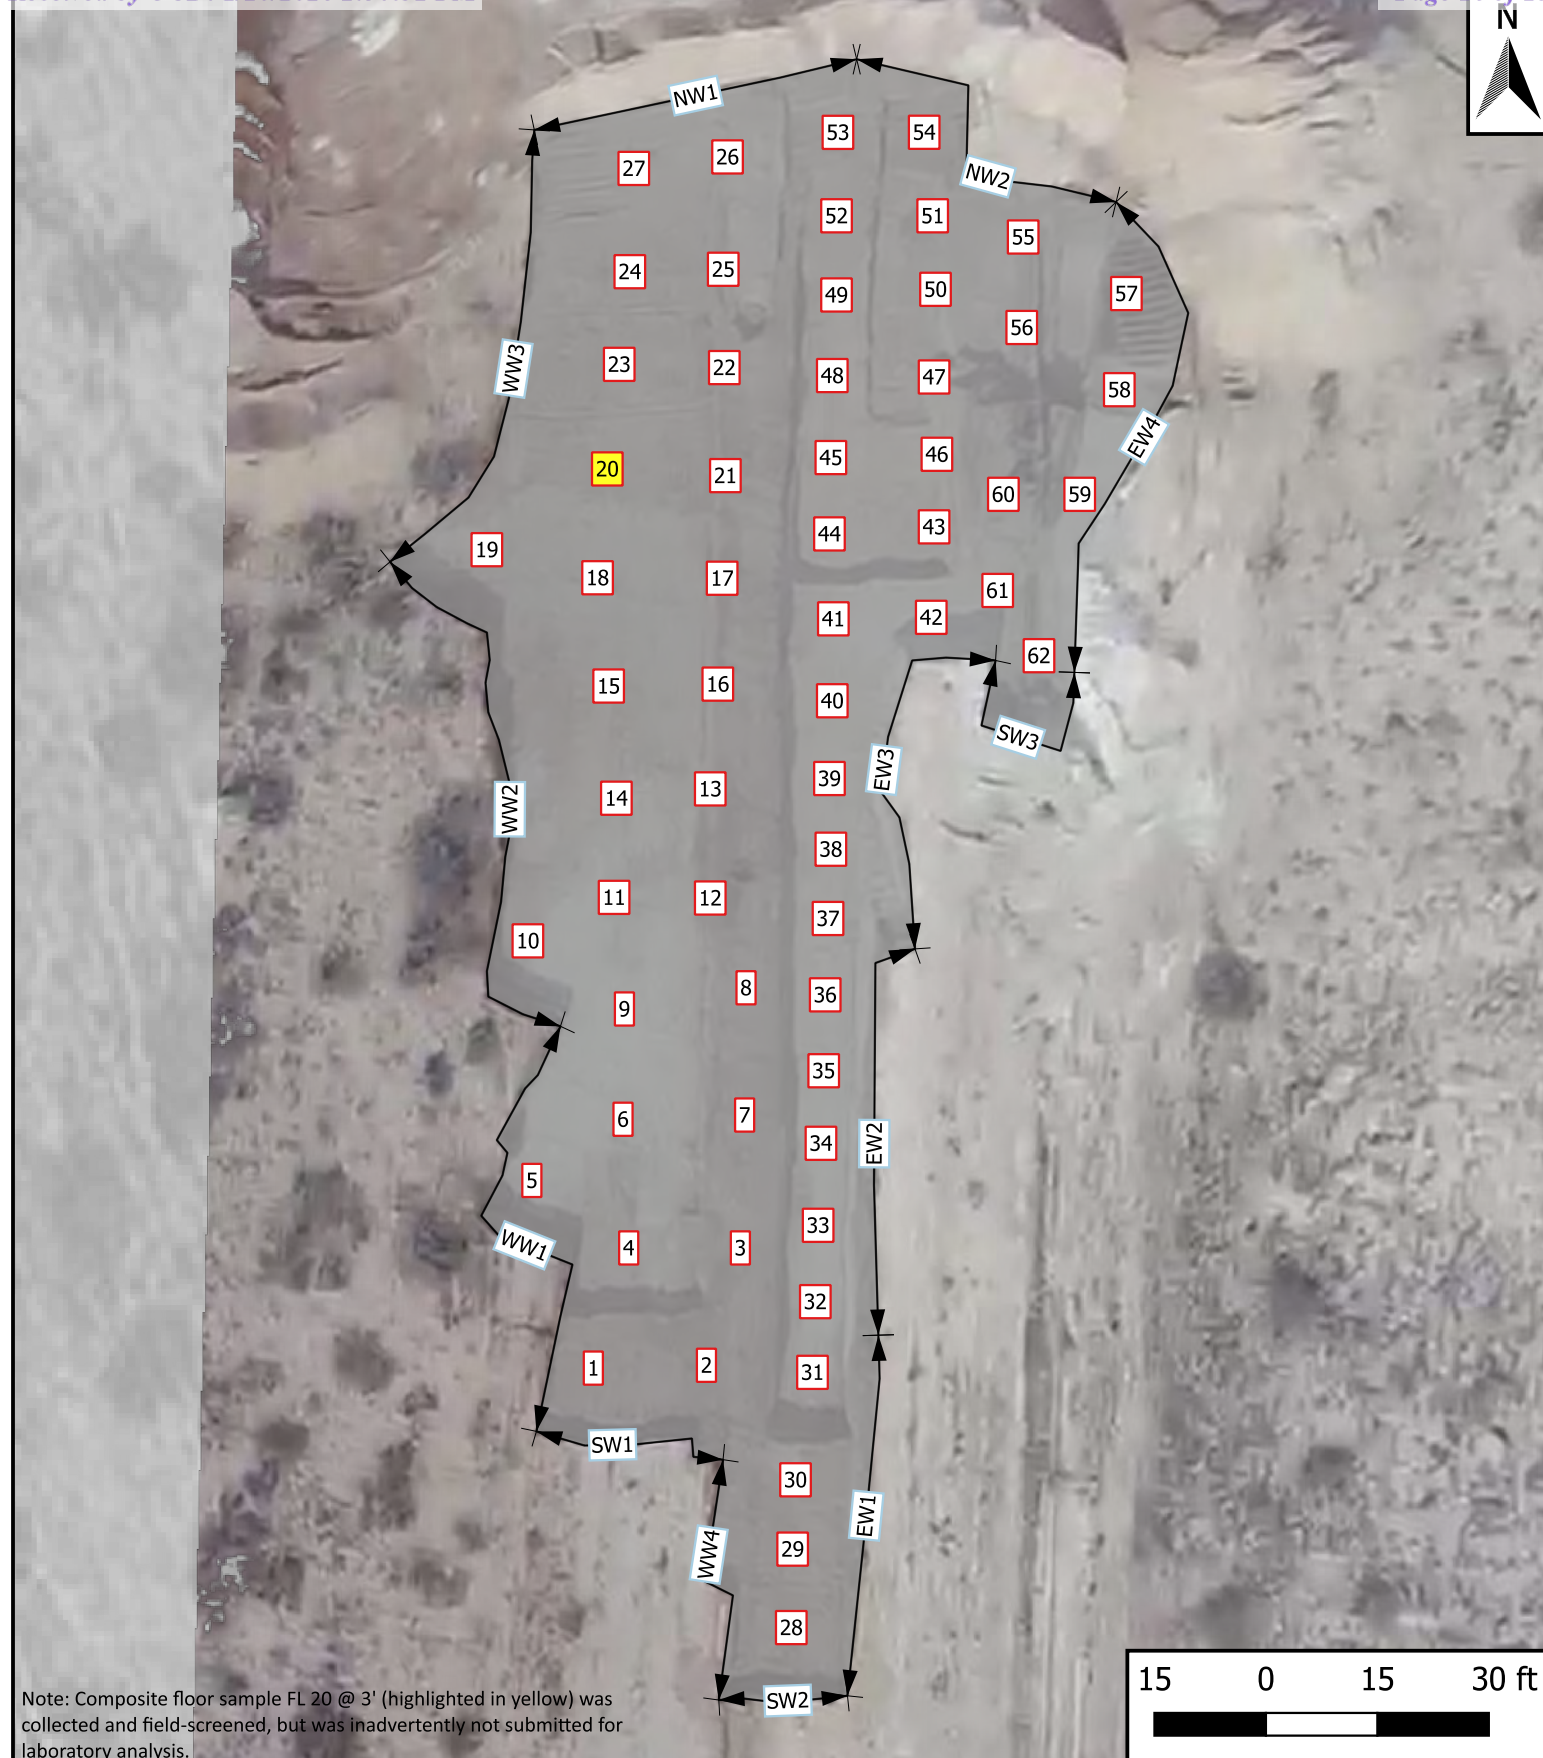
### **Sample Maps**

- Excavation Extent
- Composite Floor Sample
- Composite Wall Sample

On December 19, 2025, the Amended Closure Request was rejected by the NMOCD due to perceived inconsistencies between the excavation depths reported in Table 1 and the provided photographic documentation, including the presence of an apparent higher section within the interior of the excavation. It was also noted that composite floor sample FL 20 was shown in Figure 3 but was missing from Table 1. The NMOCD requested appropriate updates to Table 1 and Figure 3 to address these discrepancies, as well as clarification on whether soil samples were collected along interior sidewalls (in addition to perimeter walls) to confirm that the excavation did not need to be further extended laterally.

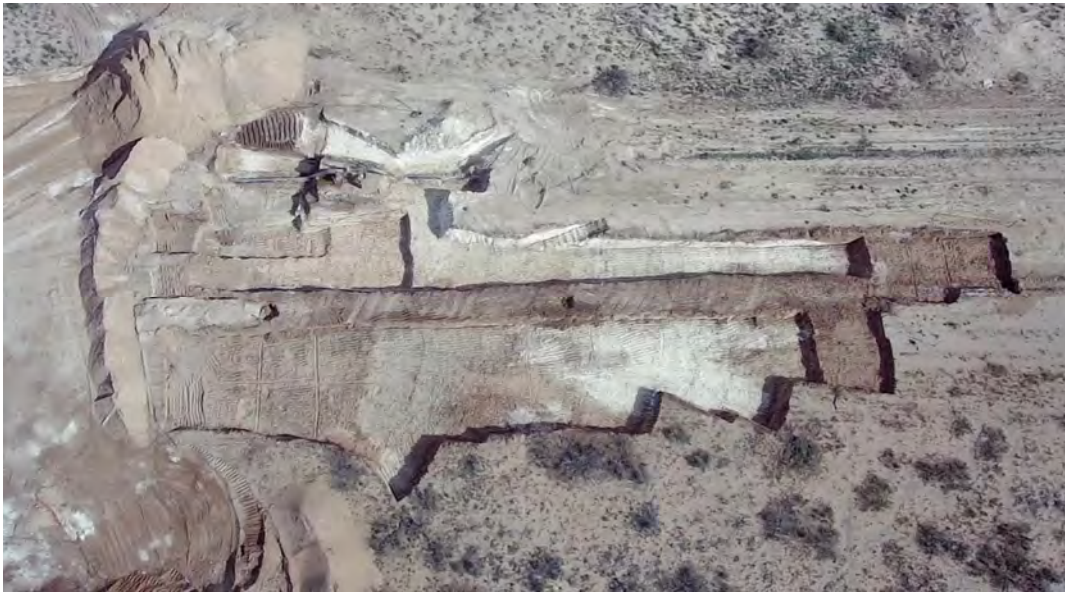
<b>Photo Number:</b> 5

<b>Photo Direction:</b> Overhead/Bird's Eye View	
<b>Date:</b> January 30, 2024	
<b>Coordinates:</b> 32.539255,-104.124712	
<b>Photo Description:</b>  View of the excavated area.

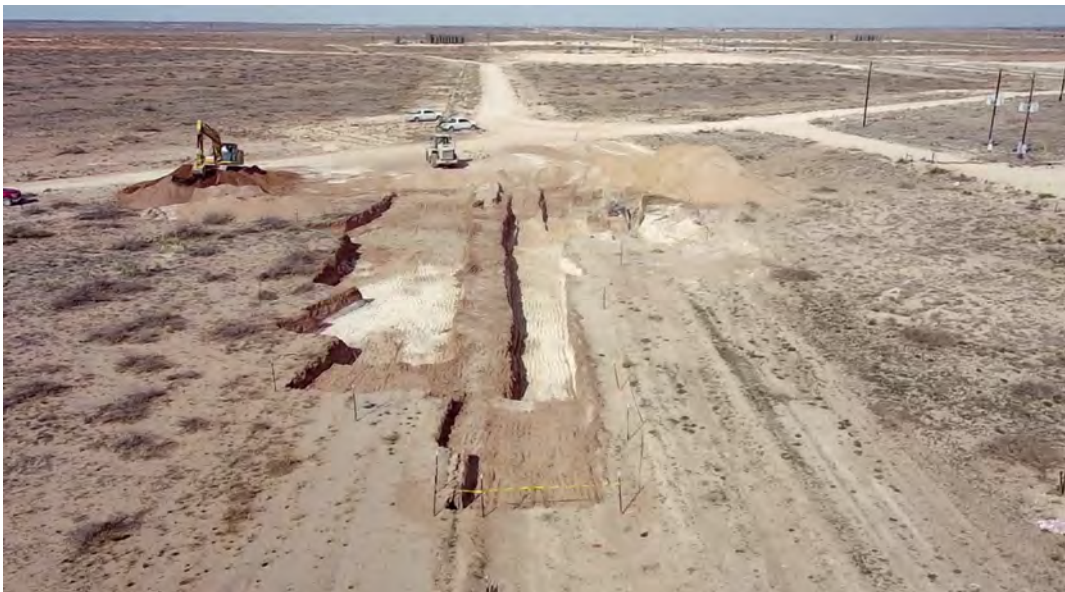
<b>Photo Number:</b> 6

<b>Photo Direction:</b> North	
<b>Date:</b> January 30, 2024	
<b>Coordinates:</b> 32.538661,-104.124707	
<b>Photo Description:</b>  View of the excavated area.

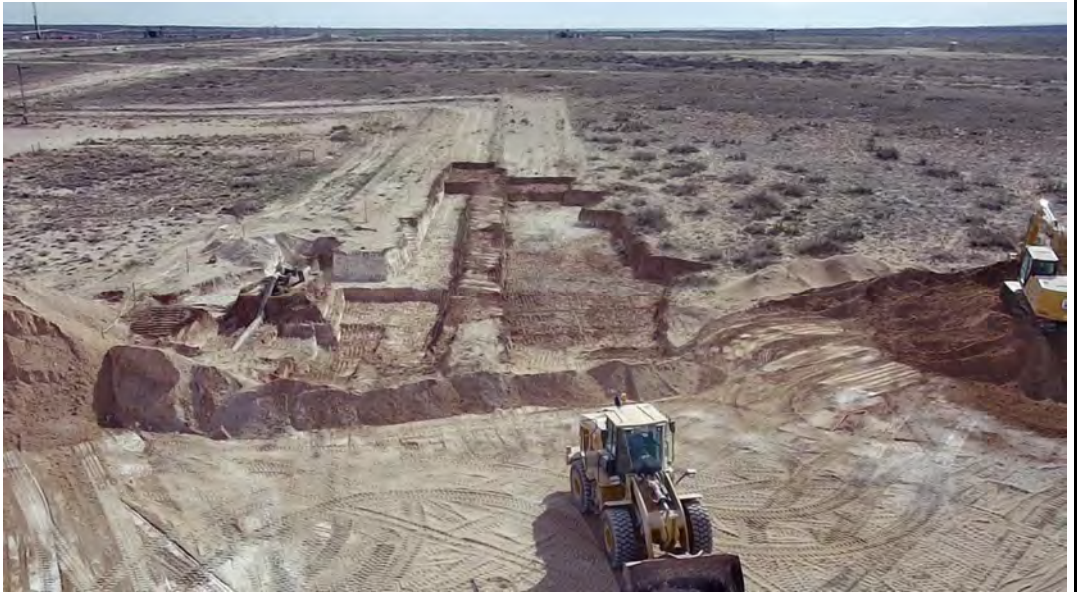
<b>Photo Number:</b> 7

<b>Photo Direction:</b> South	
<b>Date:</b> January 30, 2024	
<b>Coordinates:</b> 32.539806,-104.124696	
<b>Photo Description:</b>  View of the excavated area.

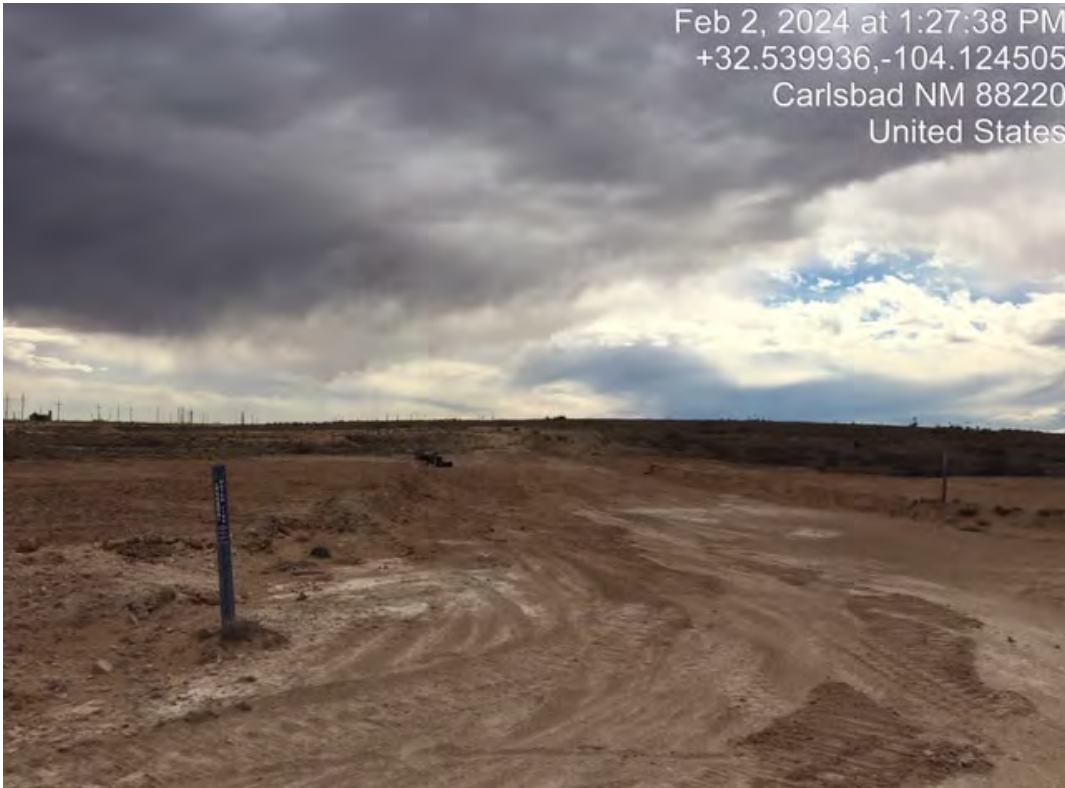
<b>Photo Number:</b> 9	<div>Feb 2, 2024 at 1:27:38 PM +32.539936,-104.124505 Carlsbad NM 88220 United States</div>

<b>Photo Direction:</b> North	
<b>Photo Description:</b>  View of the remediated area after backfill and regrading.

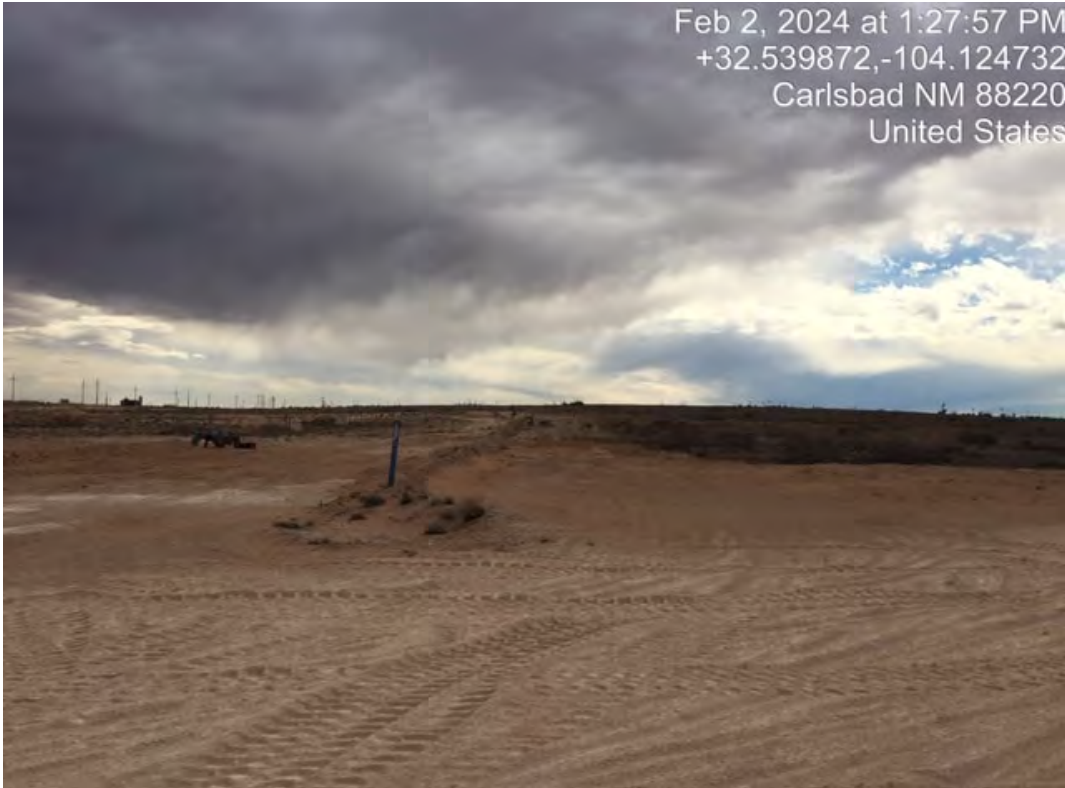
<b>Photo Number:</b> 10	<div>Feb 2, 2024 at 1:27:57 PM +32.539872,-104.124732 Carlsbad NM 88220 United States</div>

<b>Photo Direction:</b> North	
<b>Photo Description:</b>  View of the remediated area after backfill and regrading.

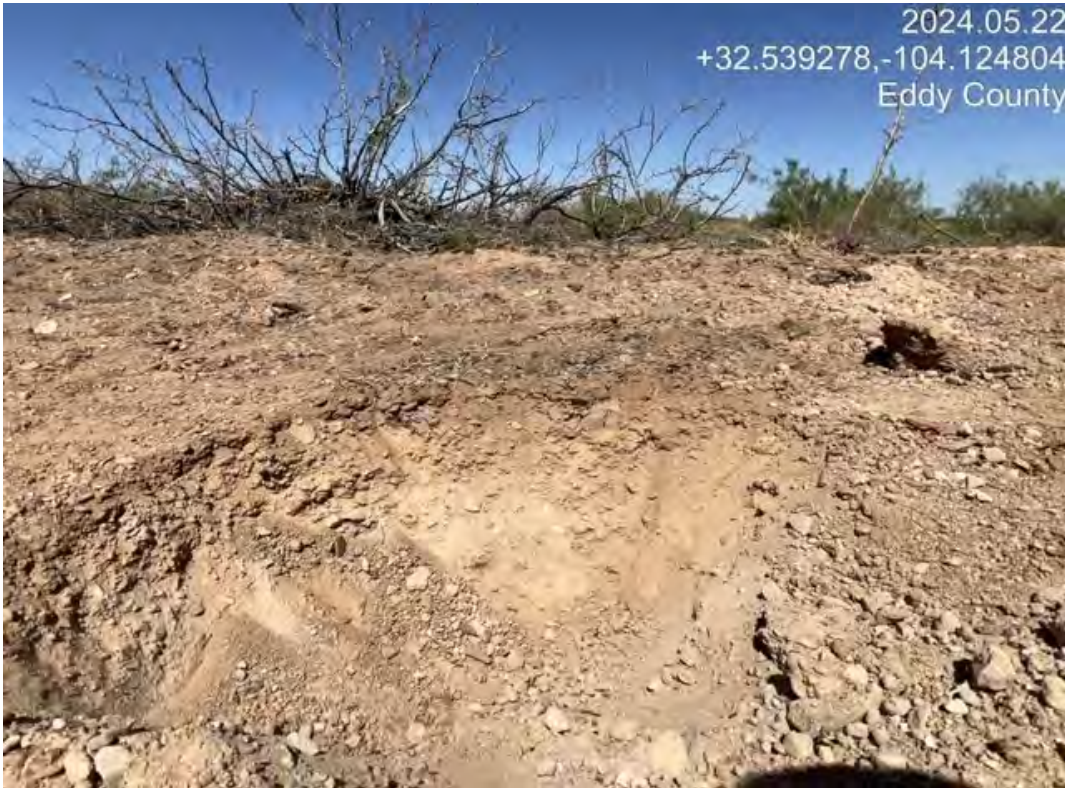
<b>Photo Number:</b> 11

<b>Photo Direction:</b> West	
<b>Photo Description:</b>  View of the remediated area showing the background thickness of topsoil.

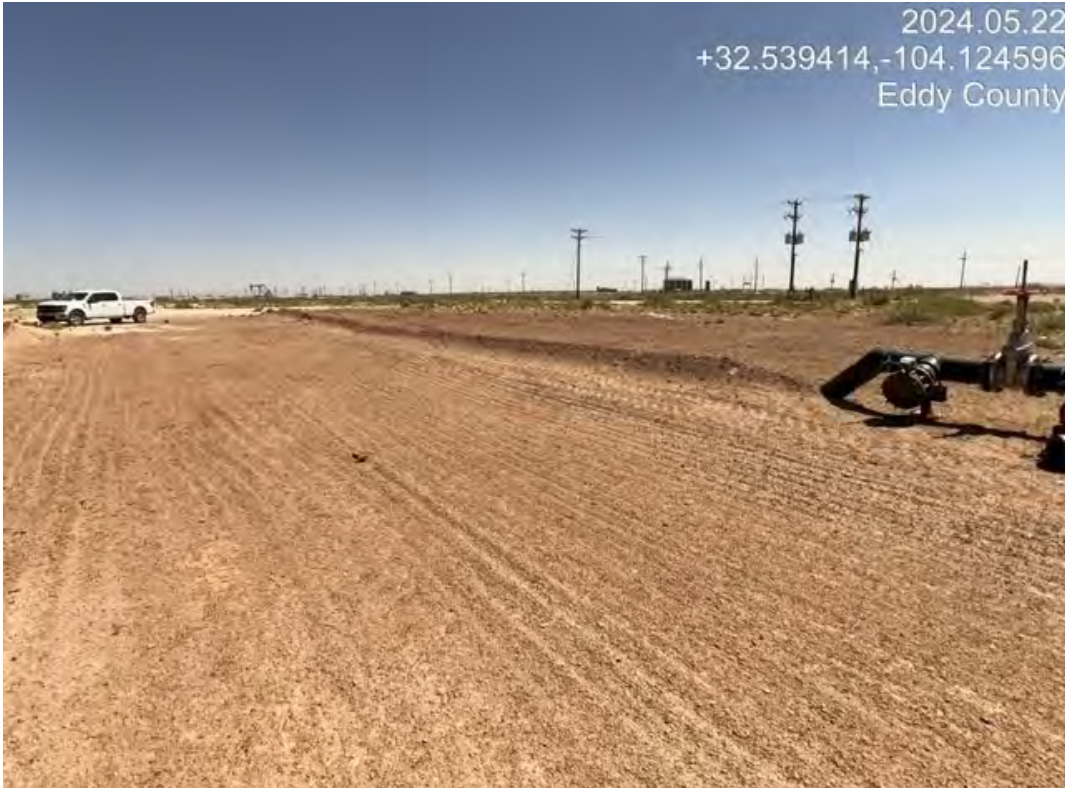
<b>Photo Number:</b> 16

<b>Photo Direction:</b> South-Southwest	
<b>Photo Description:</b>  View of the restored area and vegetation regrowth.

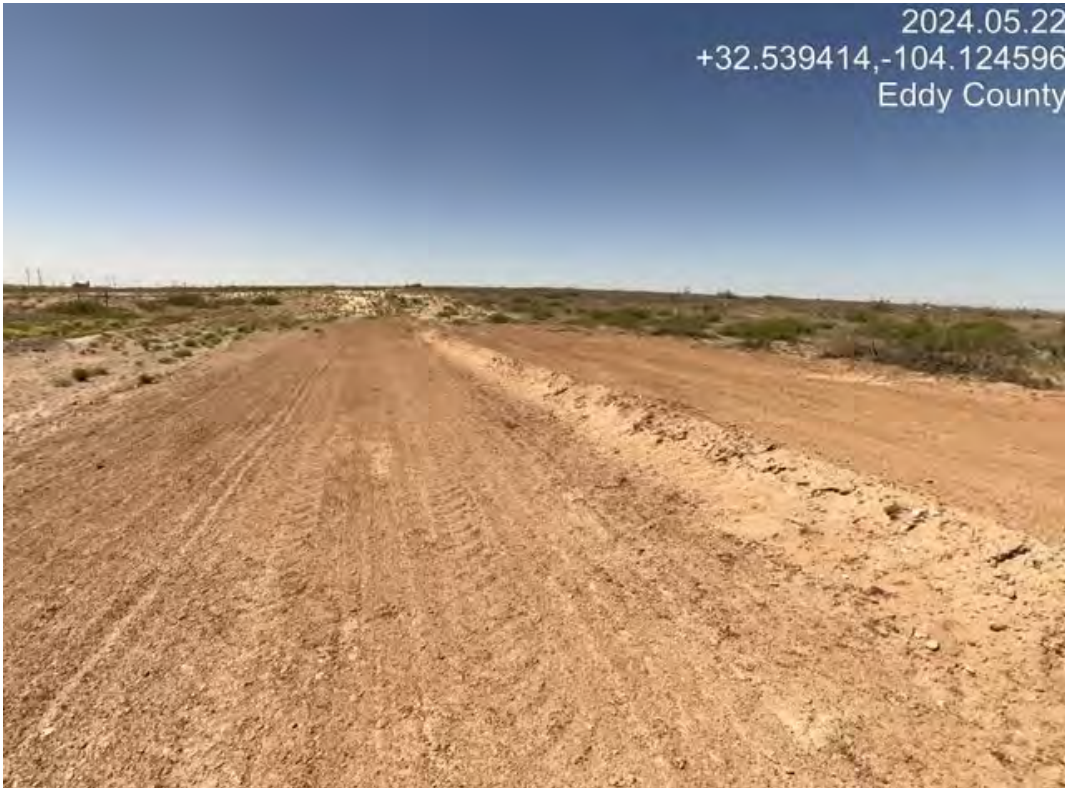
<b>Photo Number:</b> 17

<b>Photo Direction:</b> South	
<b>Photo Description:</b>  View of the restored area and vegetation regrowth.

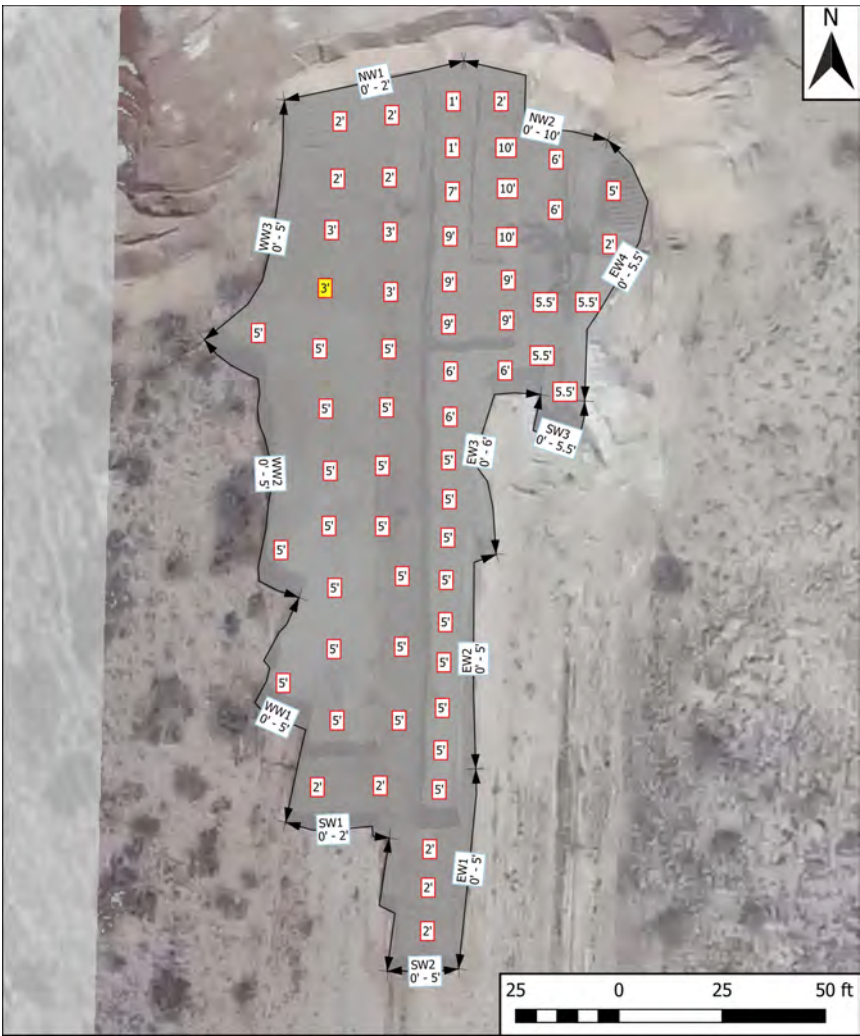
For the perimeter wall samples (NW1 & 2, EW1-EW4, etc.), the depths listed in Table 1 are ranges (e.g., 0-2, 0-5, etc.), as composite subsamples were collected along the walls at varying depths between ground surface and the base of the excavation in each section. The upper limits of the ranges reflect the deepest depth sampled for each composite. For example, the floor in the areas of wall samples EW 1 and WW3 ranged from 2 to 5 feet in depth, as shown in the figure below:

In regard to item 2.1 in your rejection of the closure request for the PWMS Magnum Road Riser release (nAPP2401652735, email included below this message), the depths listed in Table 1 of the report reflect the depth of the deepest composite subsample collected within the given sampling zone. I did not personally visit the site and did not draft the Sample Location Map (I only made revisions). However, based on the depths of the samples collected at the southern end of the excavation (i.e., FL 1, 2, 28, 29, and 30), the composite subsamples for FL 3, 4, 7, 8, 12, 13, 16, and 17, which were in/around the higher section of the excavation, would have been collected at depths ranging from 2 to 5 feet bgs. Subsamples in the deeper sections on the eastern side of the excavation would have been collected both along the excavation floor and along any interior walls per Etech's SOP, again with the deepest sample depth for each composite reflected in Table 1 and/or the sample name.
