**Re: 2025 Q1 Groundwater Monitoring Report
Northeast Drinkard Unit (NEDU) 527 Site
Unit Letter L, Sec 10, T21S, R37E
GPS Coordinates: 32.489811°N, -103.158592°W
Lea County, New Mexico
NMOCD Release Number: nPAC0631334833**

SITE LOCATION MAP
SITE PLAN
HILCORP ENERGY
 NEDU #527
 LEA COUNTY, NEW MEXICO
 32.489811, -103.158592

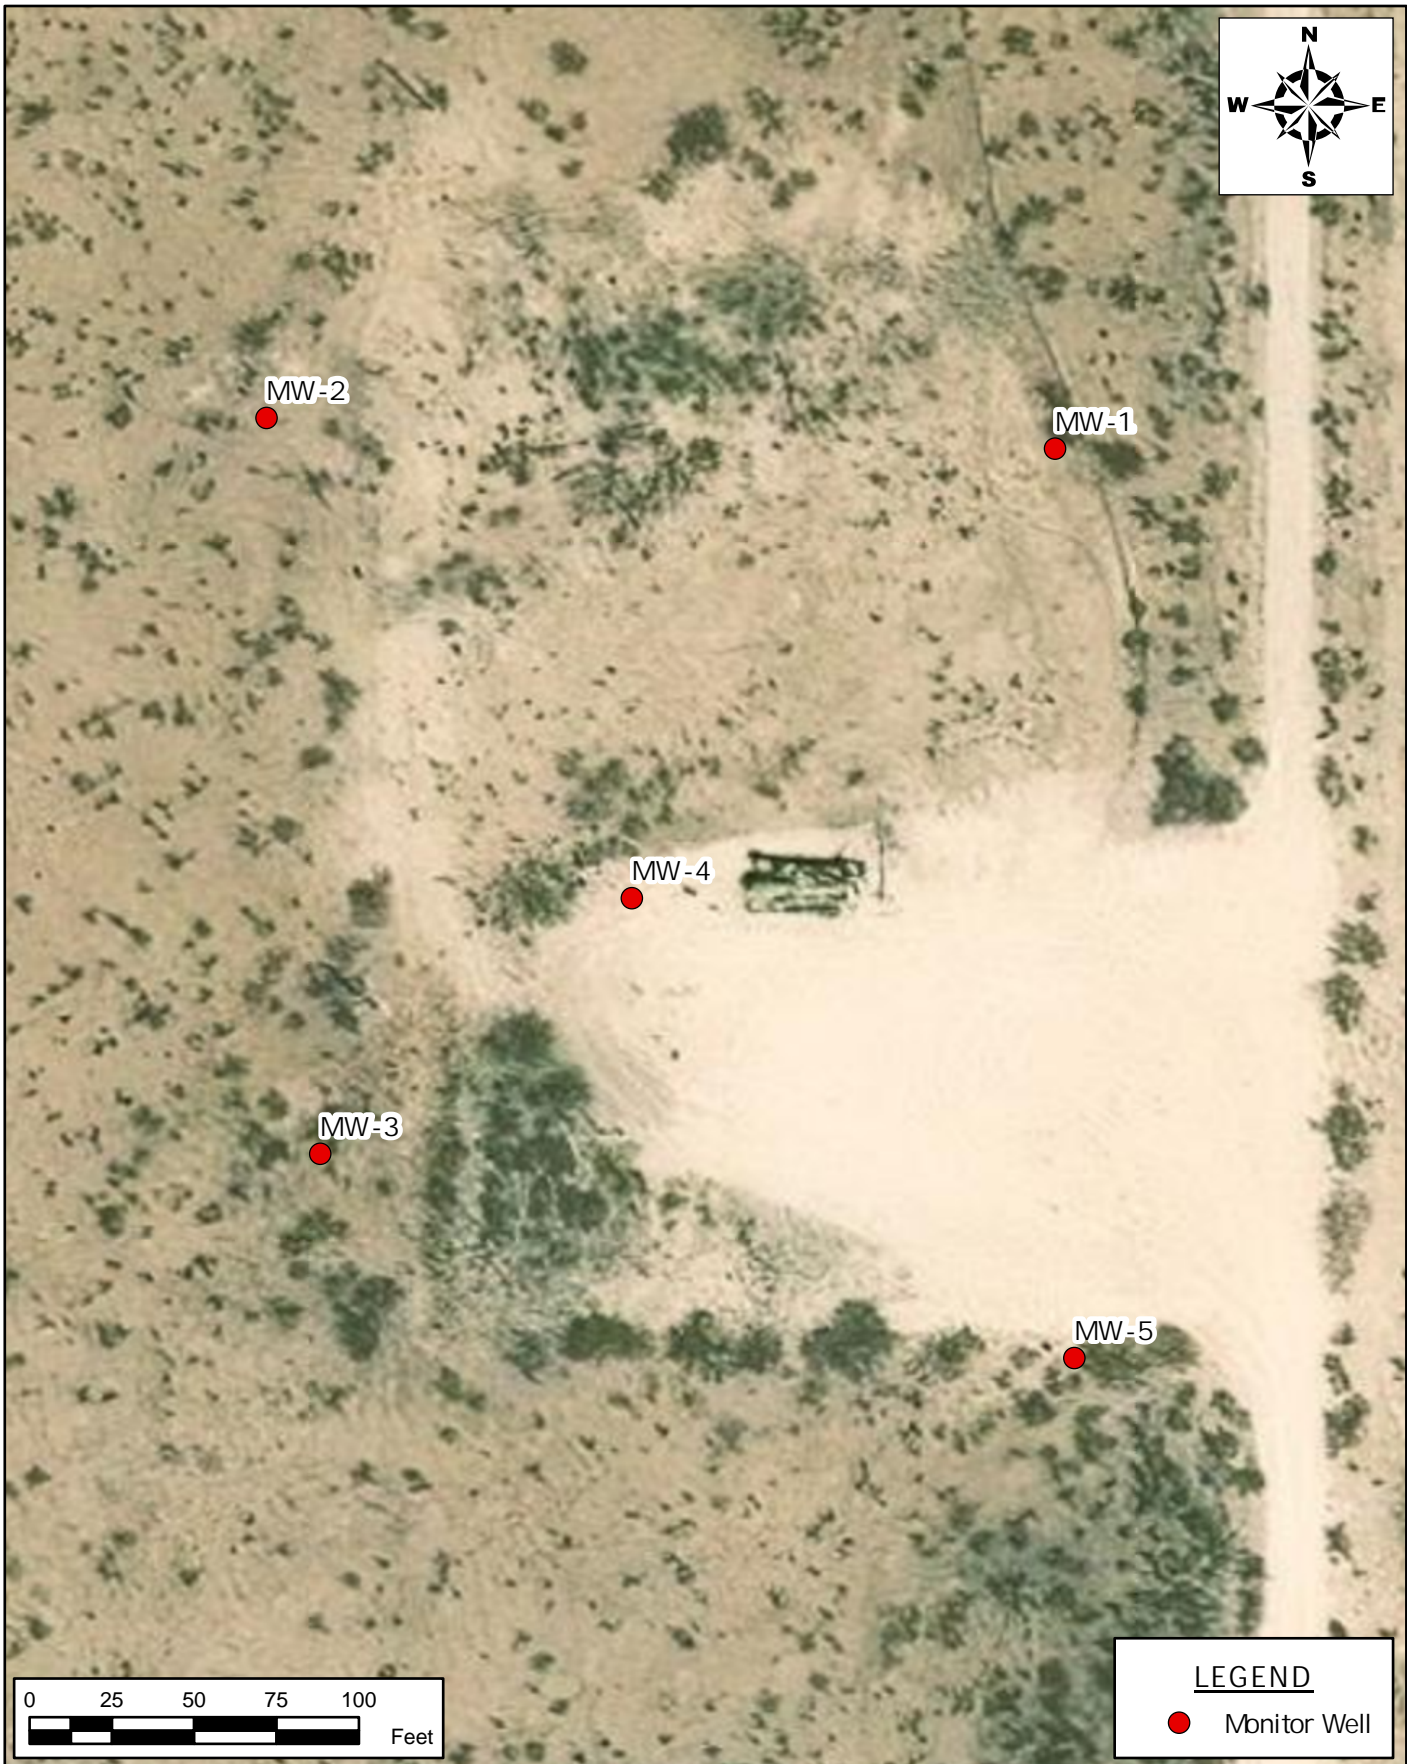
Hungry Horse installed three (3) monitoring wells (MW-1, MW-2, and MW-3) at the approximate locations presented on Figure 3. No drilling or completion details are available for these monitoring wells.

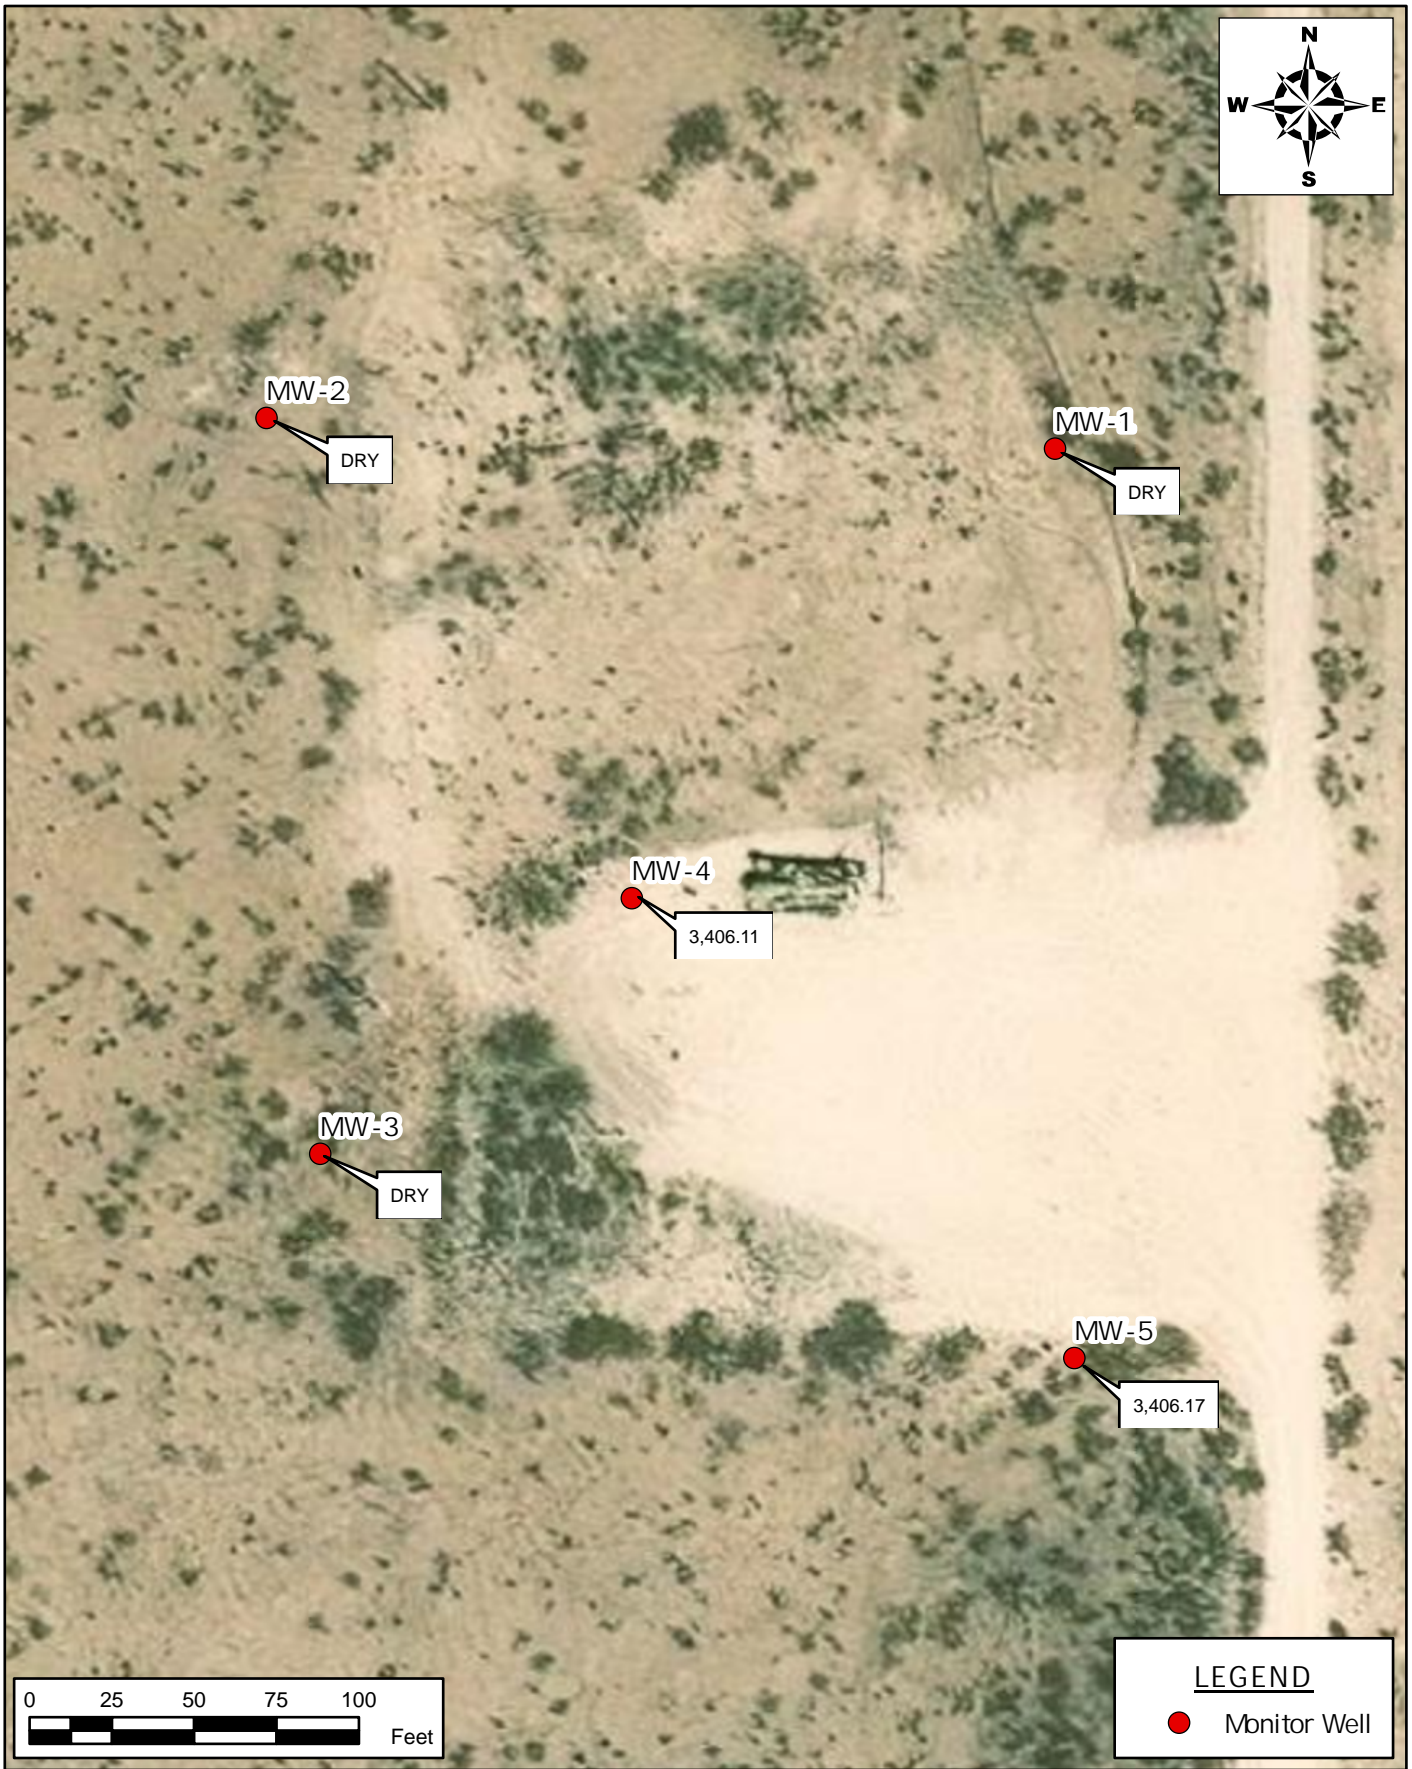
DRAWING NUMBER:
FIGURE 4

On March 13, 2025, NTGE was onsite to complete the groundwater gauging and sampling event for the first quarter 2025. All five (5) monitor wells (MW-1 through MW-5) were gauged to determine the static groundwater depths and measure LNAPL, if any. Utilizing a water level indicator each of the wells was gauged from a mark on the north side of the well casing to the depth of first encountered groundwater and to the base of the monitoring well. Three (3) of the monitoring wells (MW-1 through MW-3) were found to be dry and monitoring wells MW-4 and MW-5 were gauged at depths to groundwater of 60.88 ft bgs and 59.89 ft bgs, respectively. Since only two (2) of the five (5) monitoring wells had measurable water, a groundwater gradient map was not generated. However, based on previous reporting, it is presumed the groundwater gradient is to the southeast. The monitoring well locations are shown on Figure 4 and the current and historical monitoring well gauging data is included in Table 1.

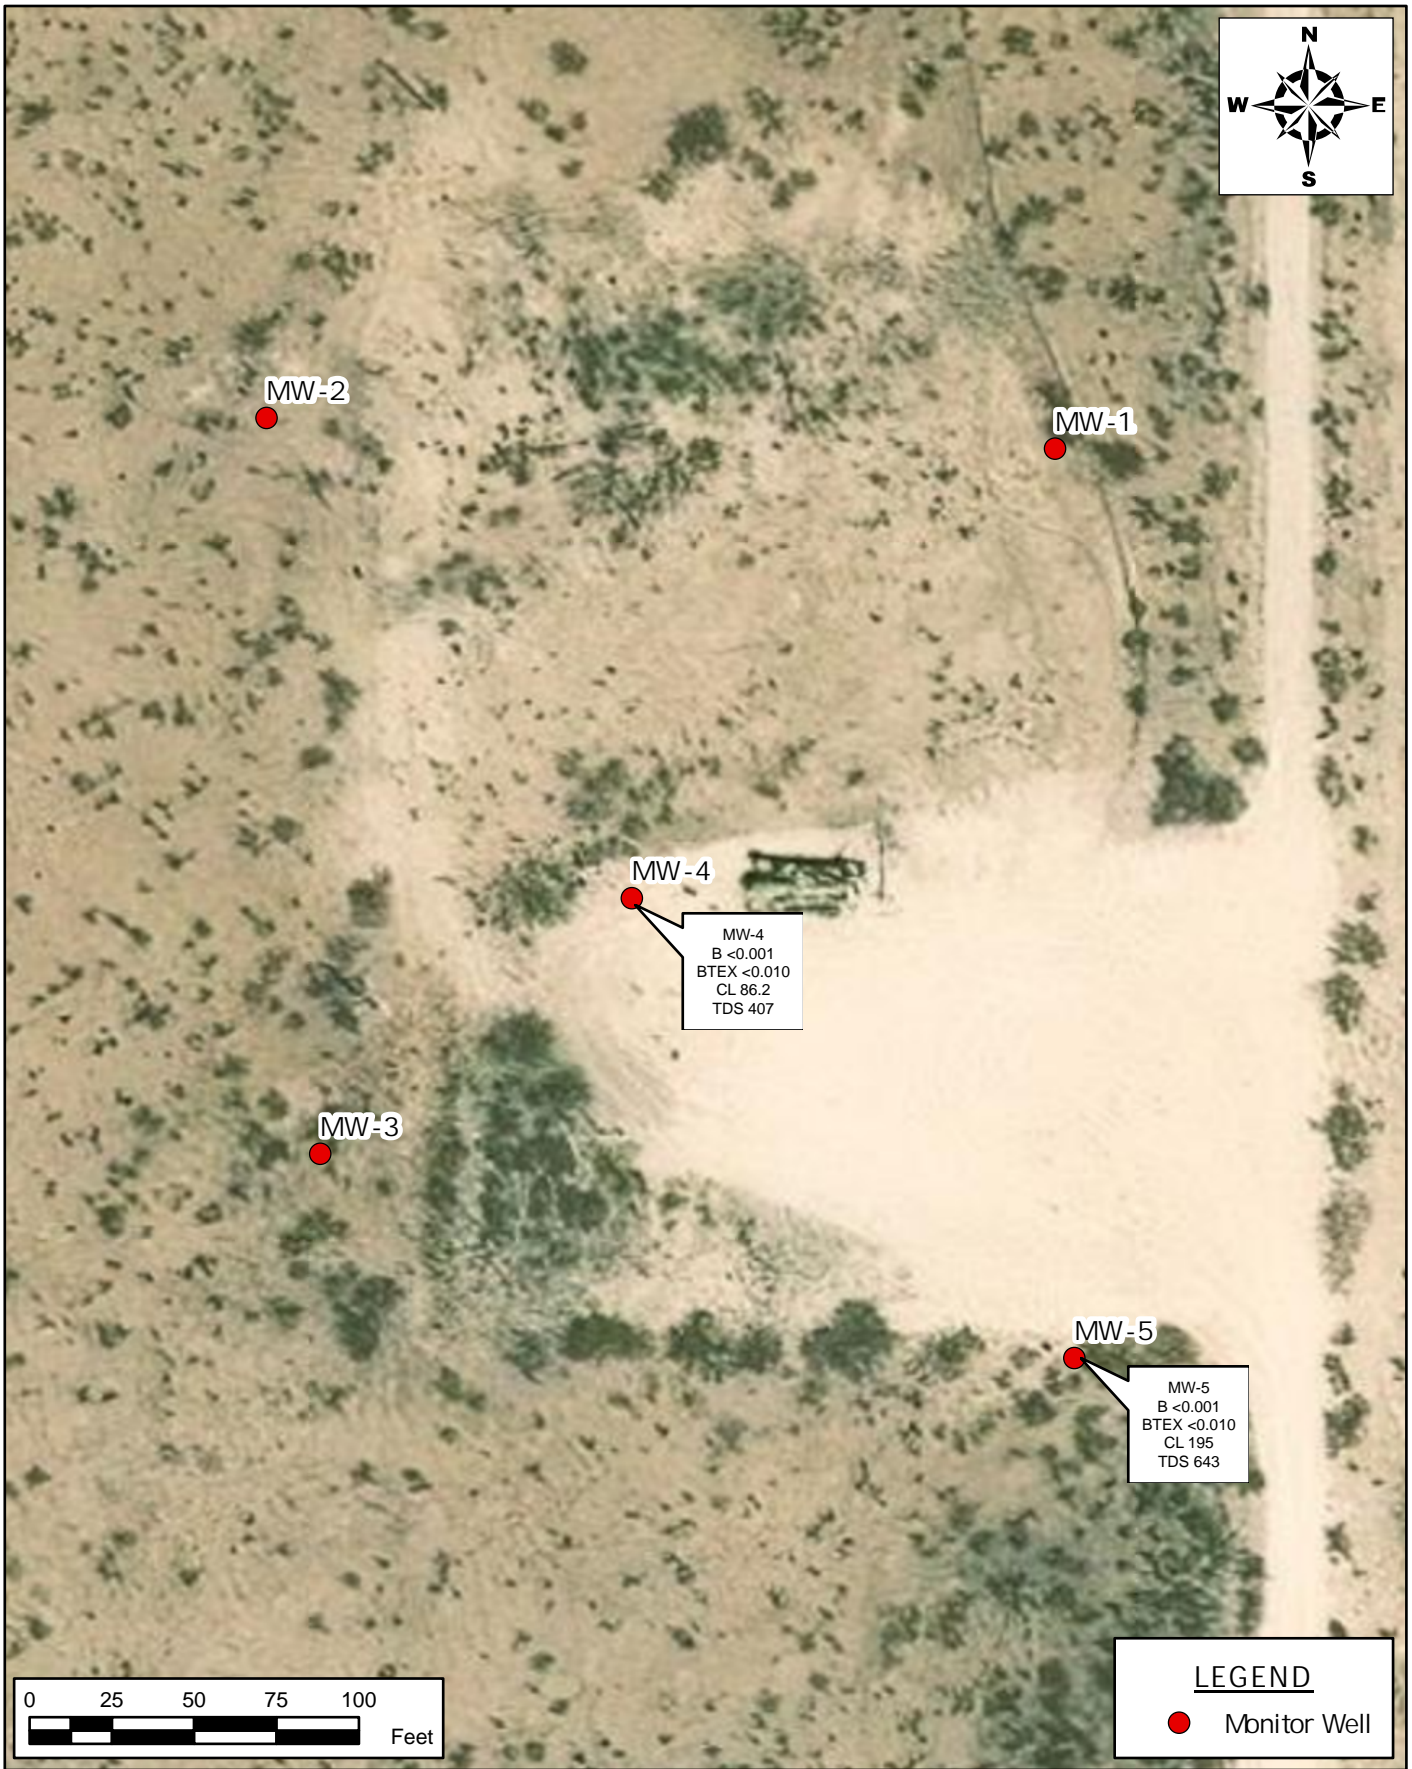
Analytical results indicated all samples were below the NMWQCC standards for BTEX, chlorides, and TDS. Chlorides in monitoring wells MW-4 and MW-5 were 86.2 milligrams per Liter (mg/L) and 195 mg/L, respectively, while TDS in monitoring wells MW-4 and MW-5 were 407 mg/L and 576 mg/L, respectively. The two (2) monitor wells have remained below the NMWQCC standards since May 24, 2022. The analytical results are presented in Table 2. See Appendix A for laboratory analytical results.

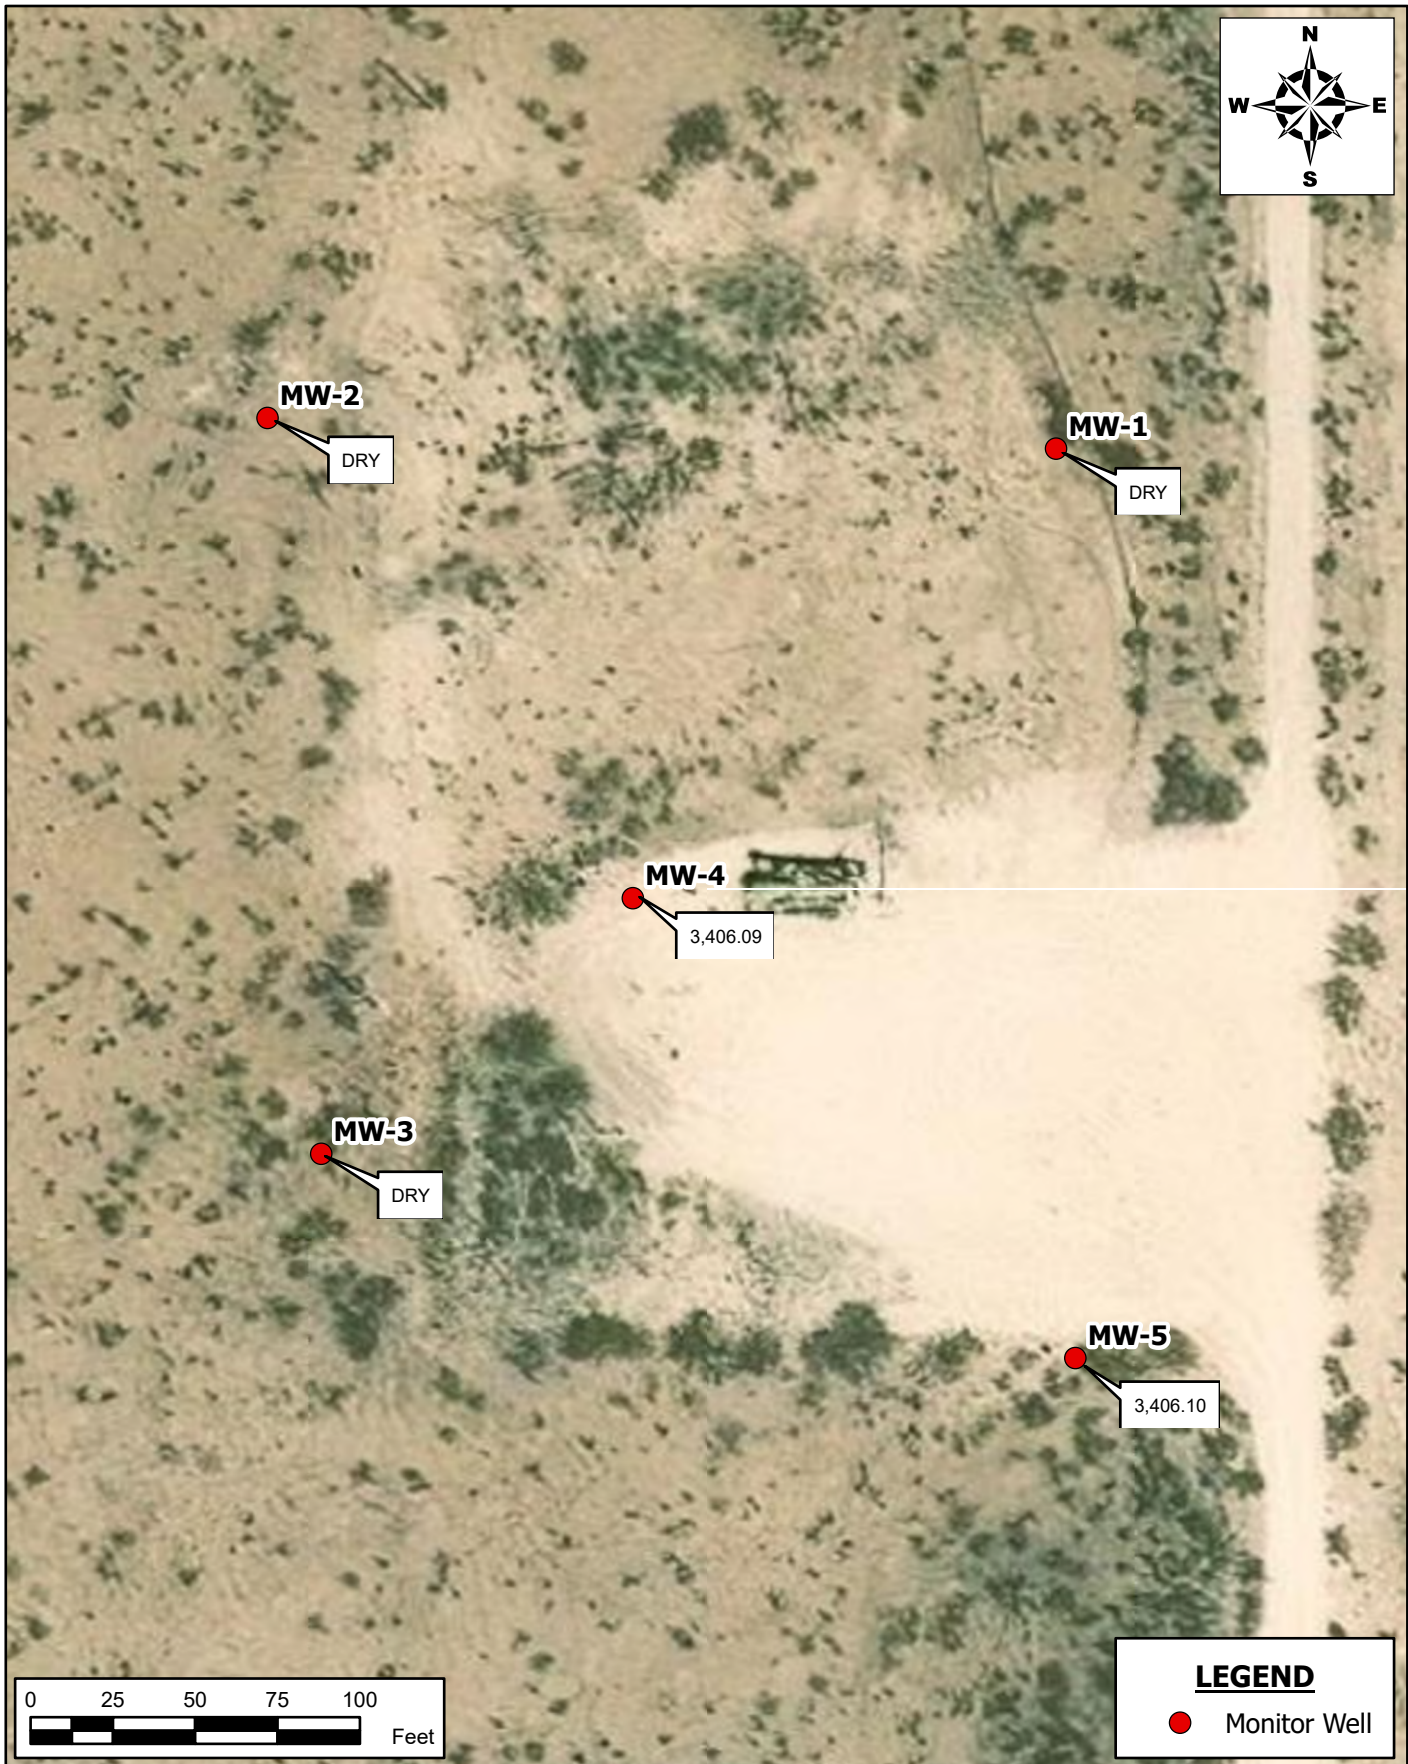
**GROUNDWATER GRADIENT MAP
SITE PLAN
HILCORP ENERGY
NEDU #527
LEA COUNTY, NEW MEXICO
32.489811, -103.158592**

On June 13, 2025, NTGE was onsite to complete the groundwater gauging and sampling event for the second quarter 2025. All five (5) monitor wells (MW-1 through MW-5) were gauged to determine the static groundwater depths and measure LNAPL, if any. Utilizing a water level indicator each of the wells was gauged from a mark on the north side of the well casing to the depth of the first encountered groundwater and to the base of the monitoring well. Three (3) of the monitoring wells (MW-1 through MW-3) were found to be dry and monitoring wells MW-4 and MW-5 were gauged at depths to groundwater of 60.99 ft bgs and 59.96 ft bgs, respectively. Since only two (2) of the five (5) monitoring wells had measurable water, a groundwater gradient map was not generated. However, based on previous reporting, it is presumed the groundwater gradient is to the southeast. The monitoring well locations are shown on Figure 4 and the current and historical monitoring well gauging data is included in Table 1.

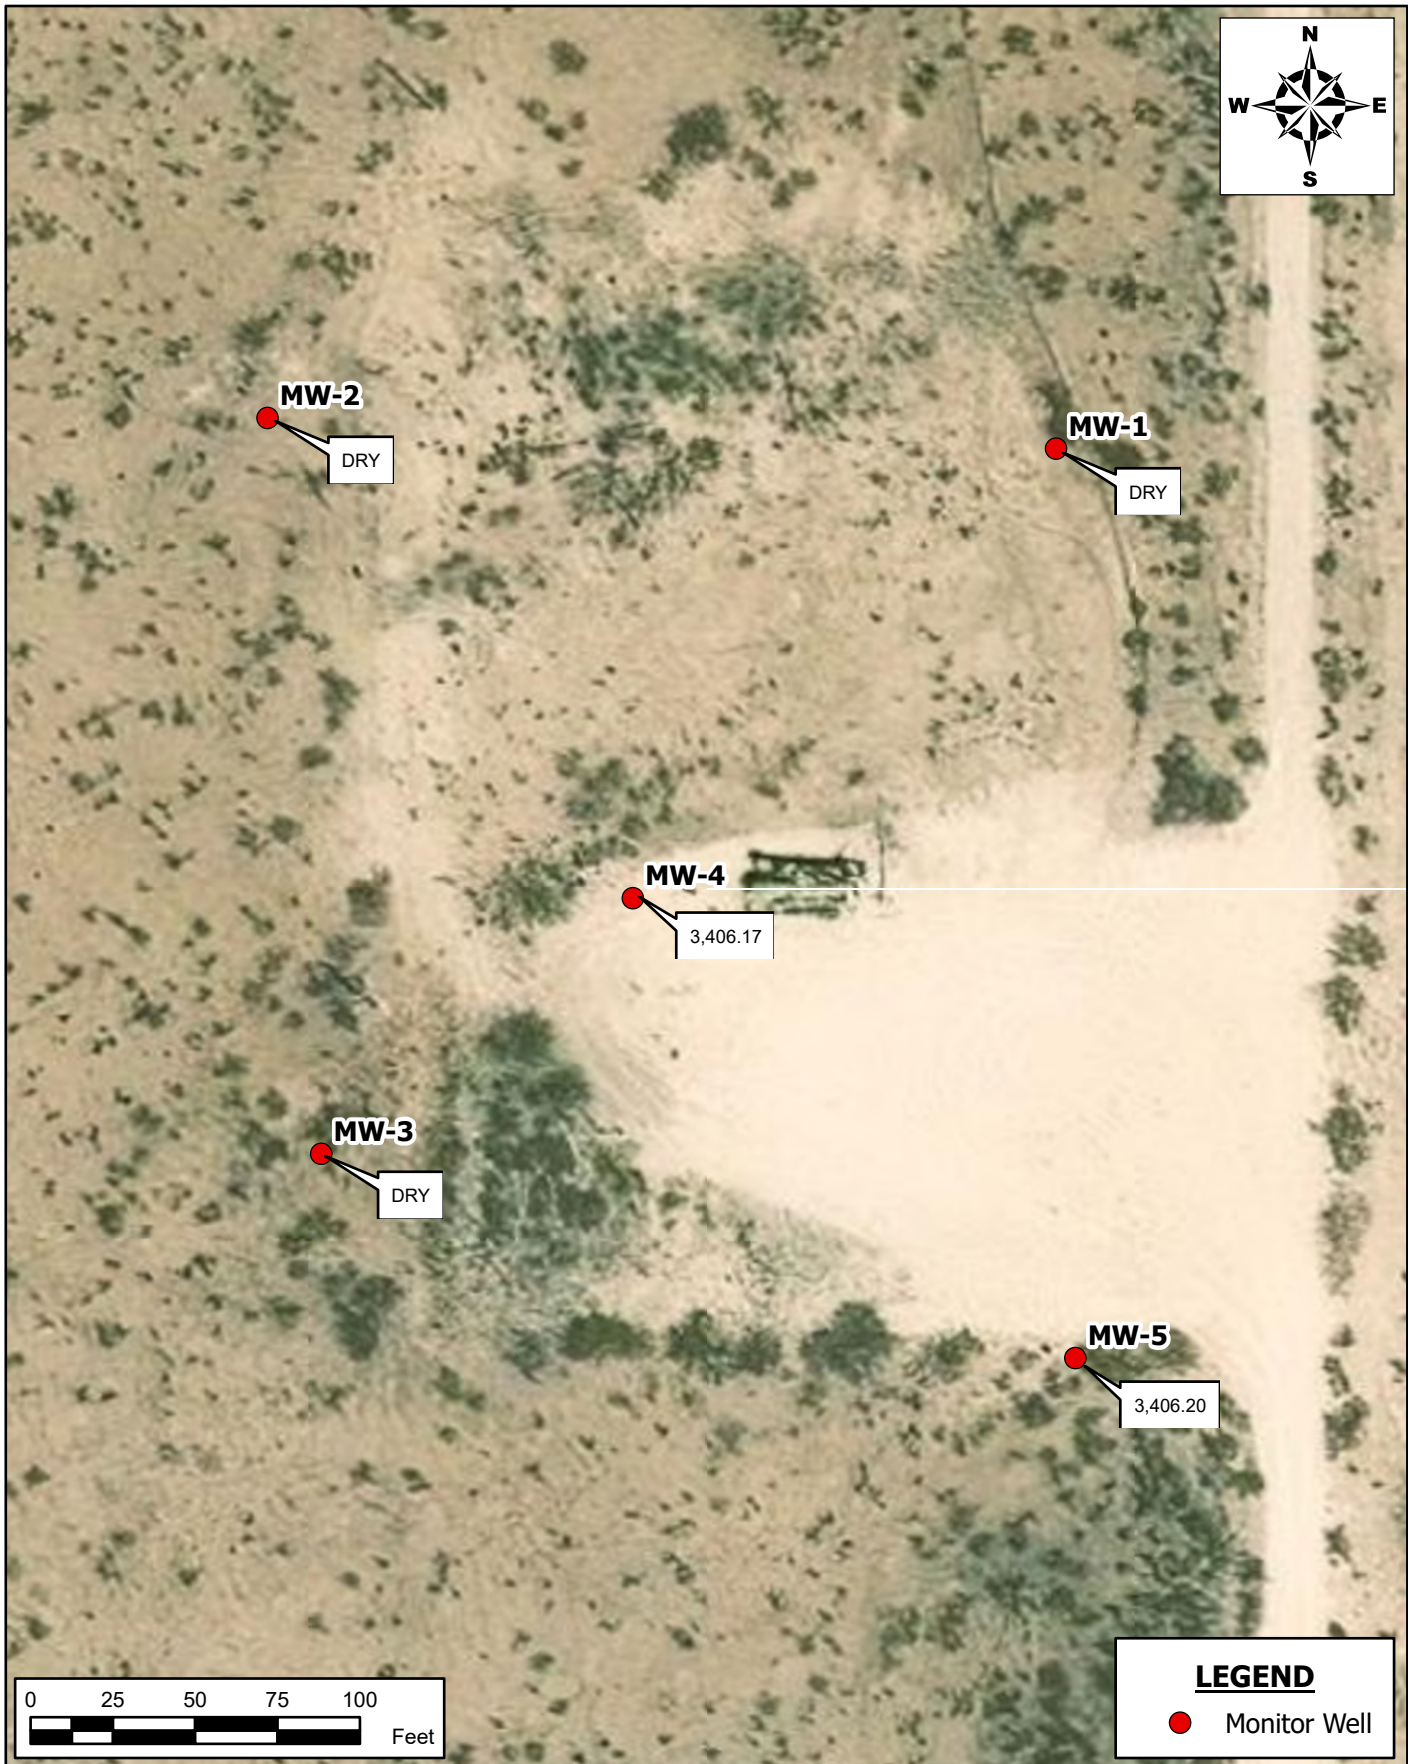
**GROUNDWATER GRADIENT MAP
SITE PLAN
HILCORP ENERGY
NEDU #527
LEA COUNTY, NEW MEXICO
32.489811, -103.158592**

On September 16, 2025, NTGE was onsite to complete the groundwater gauging and sampling event for the third quarter of 2025. All five (5) monitor wells (MW-1 through MW-5) were gauged to determine the static groundwater depths and measurable LNAPL, if any. Utilizing a water level indicator each of the wells was gauged from a mark on the north side of the well casing to the depth of the first encountered groundwater and to the base of the monitoring well. Three (3) of the monitoring wells (MW-1 through MW-3) were found to be dry and monitoring wells MW-4 and MW-5 were gauged at depths to groundwater of 60.82 ft bgs and 59.86 ft bgs, respectively. Since only two (2) of the five (5) monitoring wells had measurable water, a groundwater gradient map was not generated. However, based on previous reporting, it is presumed the groundwater gradient is to the southeast. The monitoring well locations are shown on Figure 4 and the current and historical monitoring well gauging data is included in Table 1.

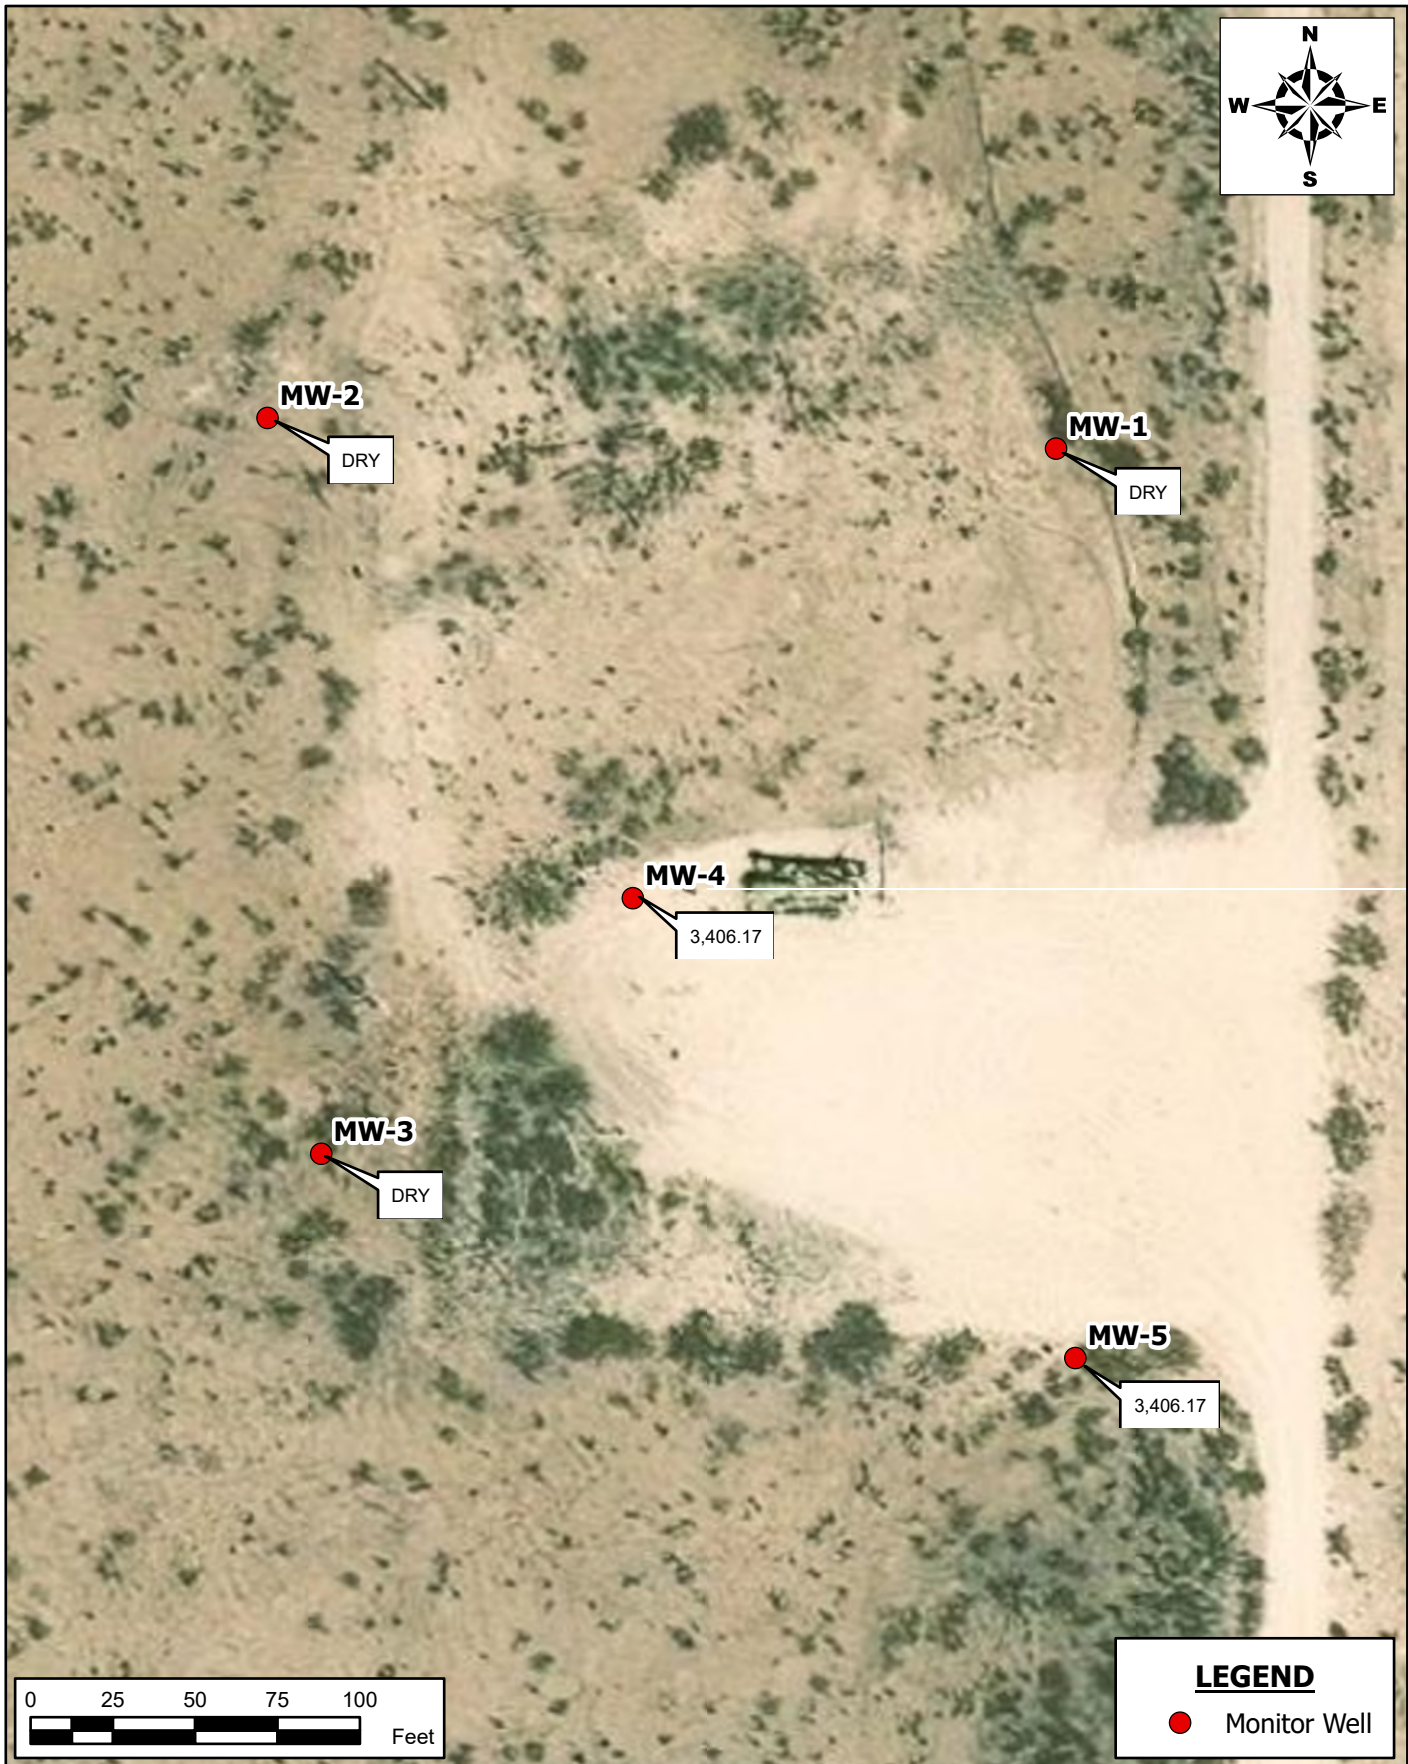
**GROUNDWATER GRADIENT MAP
SITE PLAN
HILCORP ENERGY
NEDU #527
LEA COUNTY, NEW MEXICO
32.489811, -103.158592**

On December 3, 2025, NTGE was onsite to complete the groundwater gauging and sampling event for the fourth quarter of 2025. All five (5) monitor wells (MW-1 through MW-5) were gauged to determine the static groundwater depths and measure LNAPL, if any. Utilizing a water level indicator each of the wells was gauged from a mark on the north side of the well casing to the depth of the first encountered groundwater and to the base of the monitoring well. Three (3) of the monitoring wells (MW-1 through MW-3) were found to be dry and monitoring wells MW-4 and MW-5 were gauged at depths to groundwater of 60.82 ft bgs and 59.89 ft bgs, respectively. Since only two (2) of the five (5) monitoring wells had measurable water, a groundwater gradient map was not generated. However, based on previous reporting, it is presumed the groundwater gradient is to the southeast. The monitoring well locations are shown on Figure 4 and the current and historical monitoring well gauging data is included in Table 1.
