Welch A 28 ST COM CTB

Incident ID NAPP2526529586

PREPARED BY:
PIMA ENVIRONMENTAL SERVICES, LLC

Remediation, Liner Inspection and
Closure Report

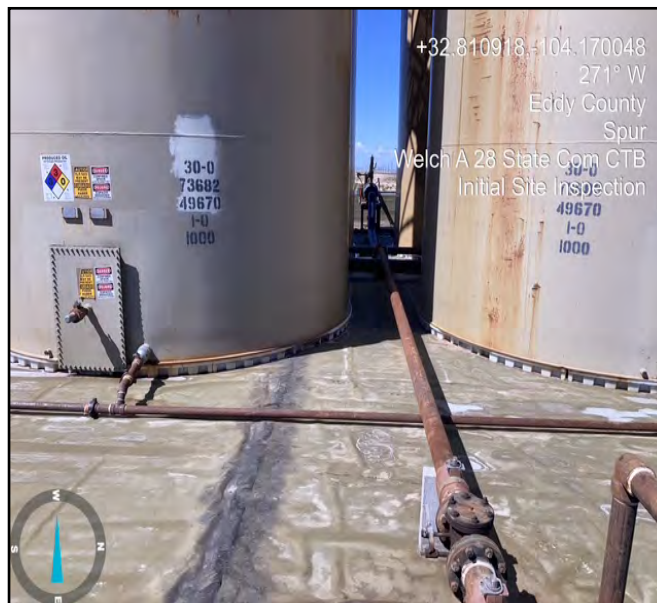
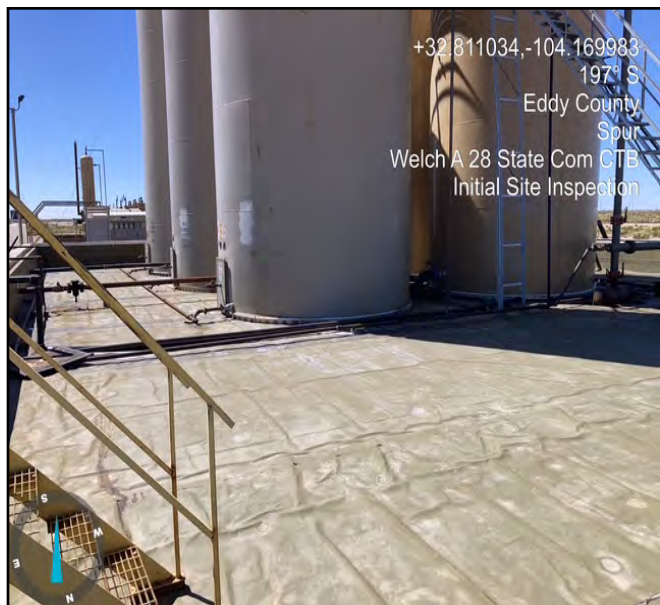
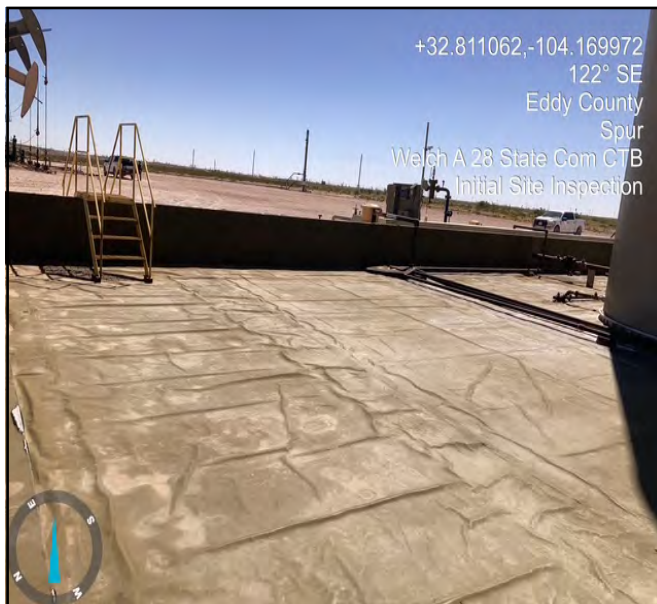
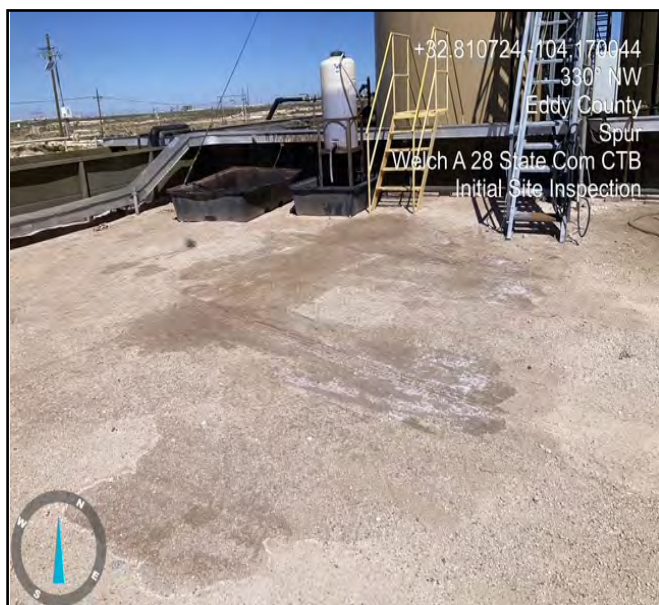
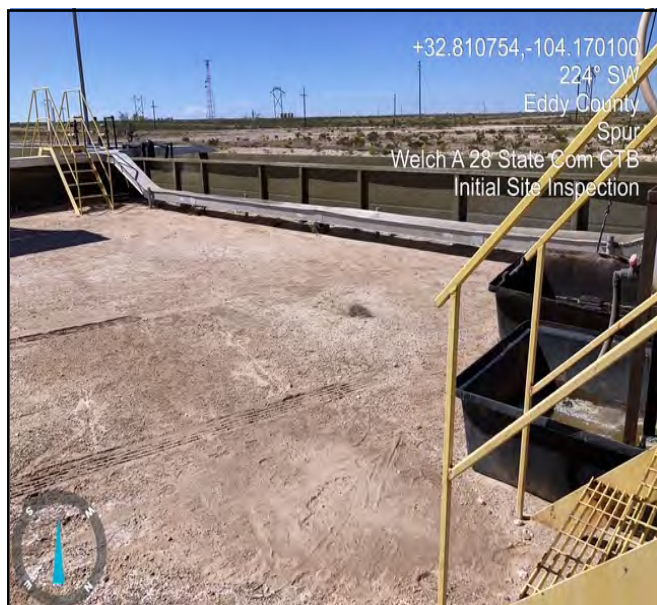
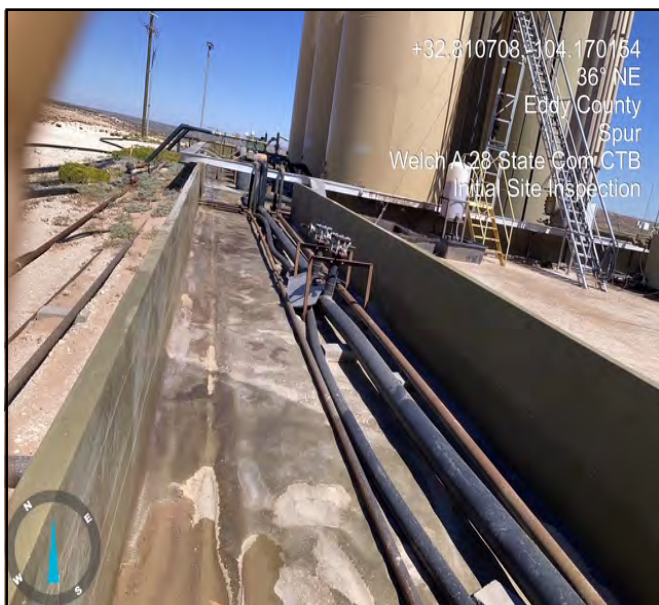
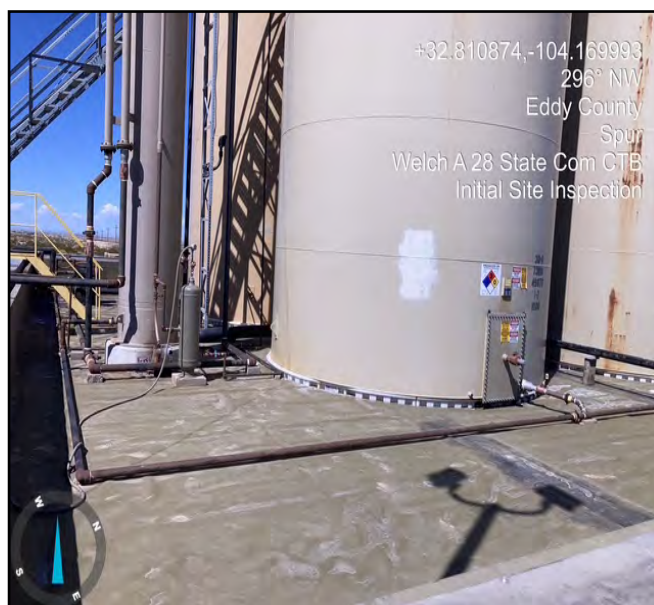
Visualization	Yes	No	Comments
Is there a tear in the liner?		X	
Are there holes in the liner?		X	
Is the liner retaining any fluids?	X		Standing fluid is visible inside the lined containment due to power washing efforts.
Does the liner have integrity to contain a leak?	X

Photo of liner taken during initial liner inspection facing west.

Photo of liner taken during initial liner inspection facing south.

Photo of liner taken during initial liner inspection facing southeast.

Photo of liner taken during initial liner inspection facing northwest.

Photo of liner taken during initial liner inspection facing southwest.

Photo of liner taken during initial liner inspection facing northeast.

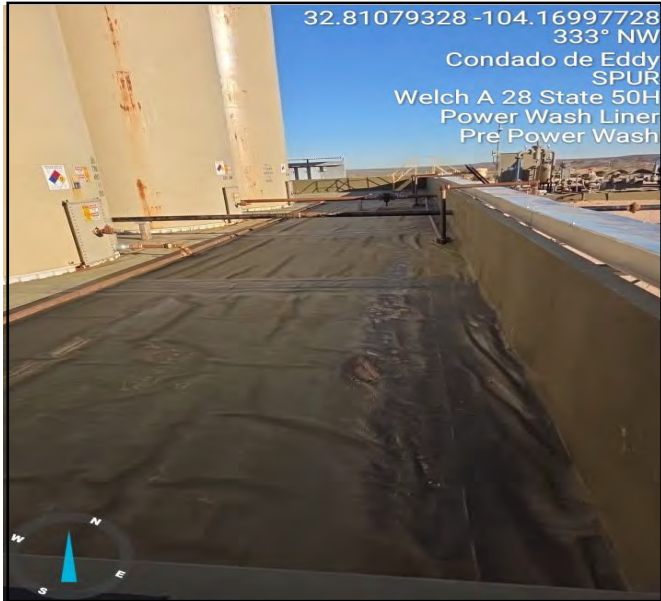
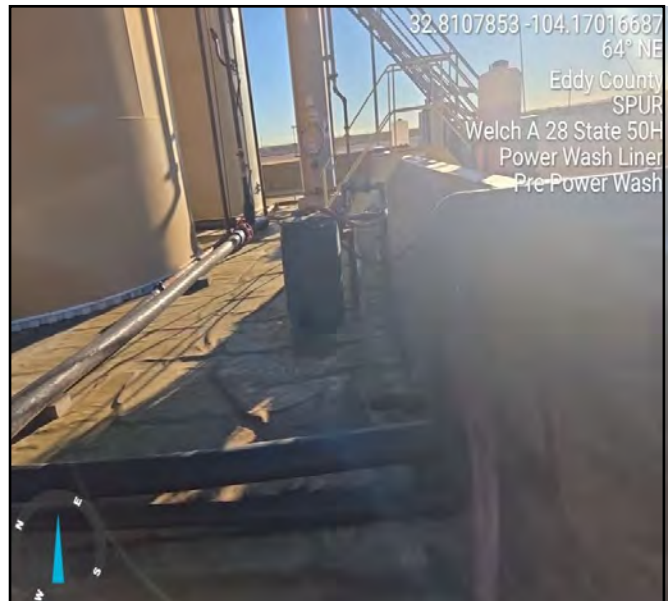
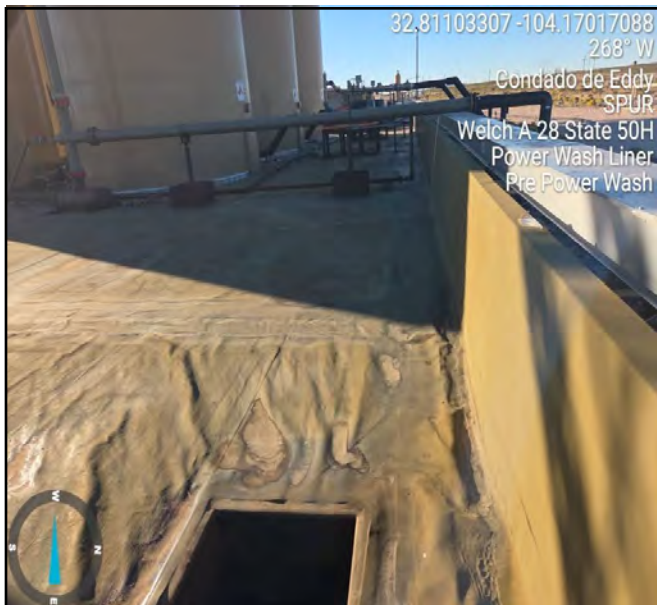
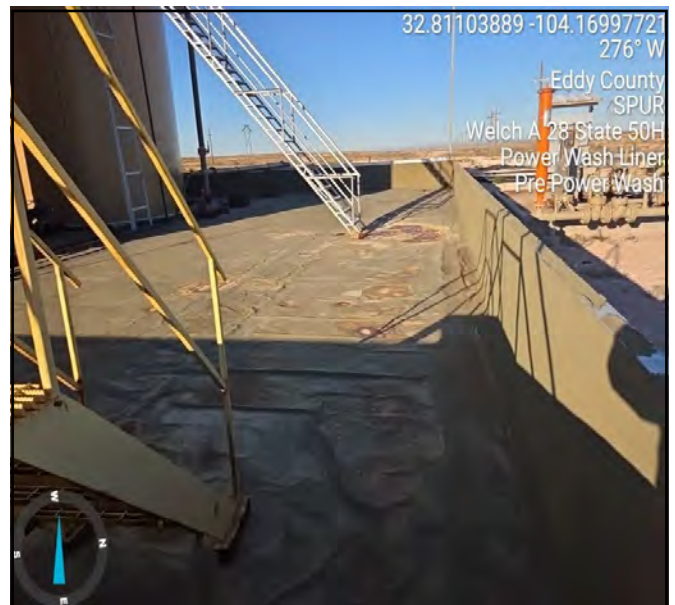
Photograph taken pre power-wash process facing northwest.

Photograph taken pre power-wash process facing northeast.

Photograph taken pre power-wash process facing west.

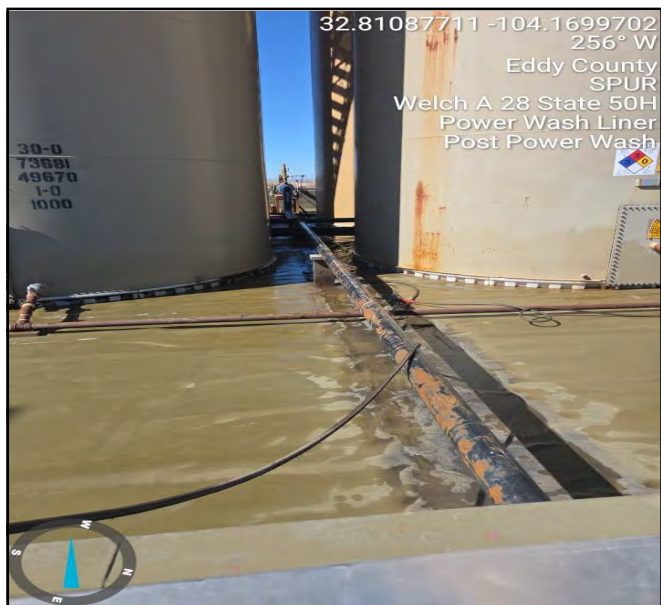
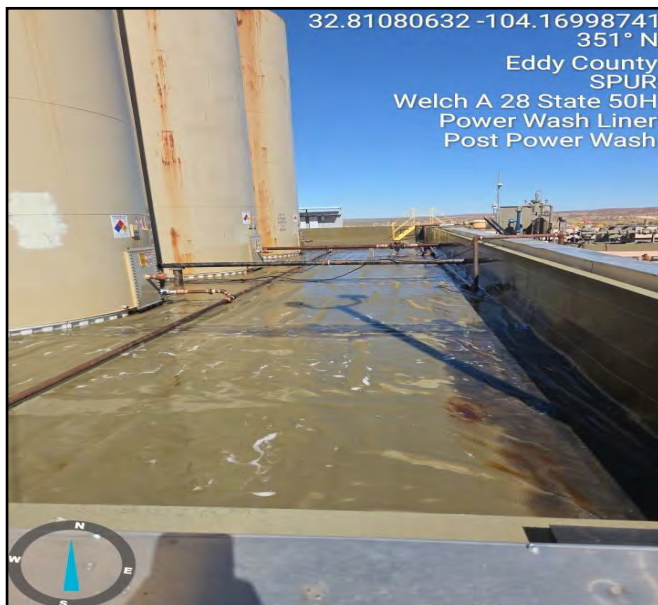
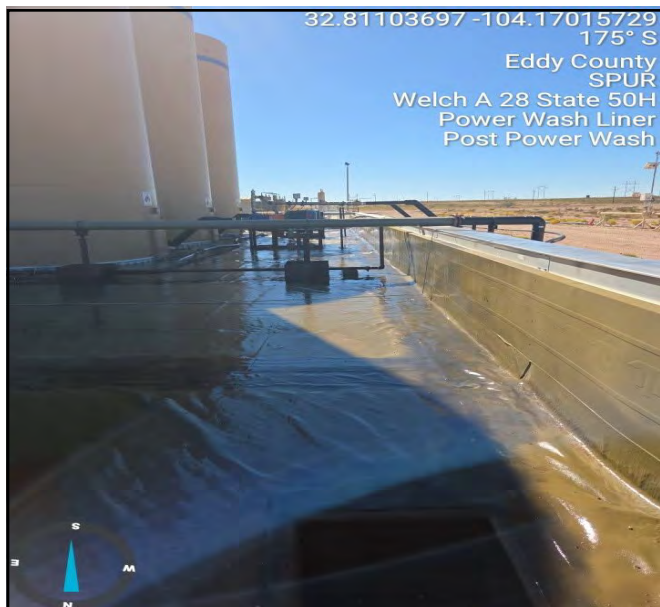
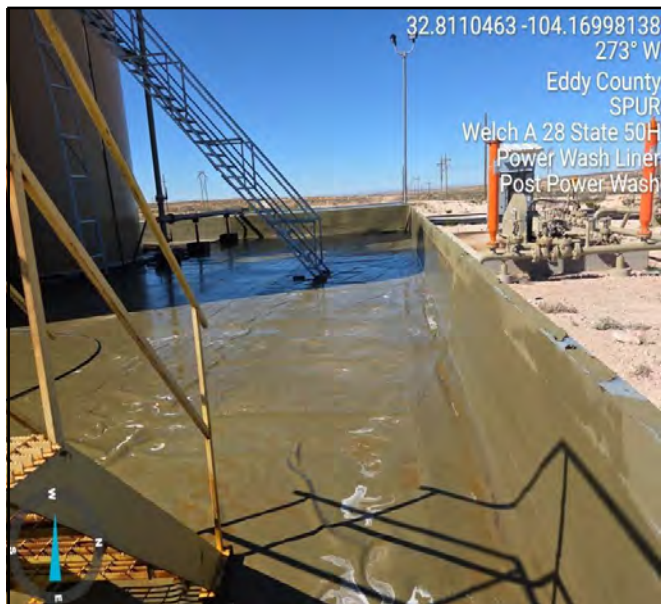
Photo of location taken post power wash facing west.

Photo of location taken post power wash facing north.

Photo of location taken post power wash facing south.

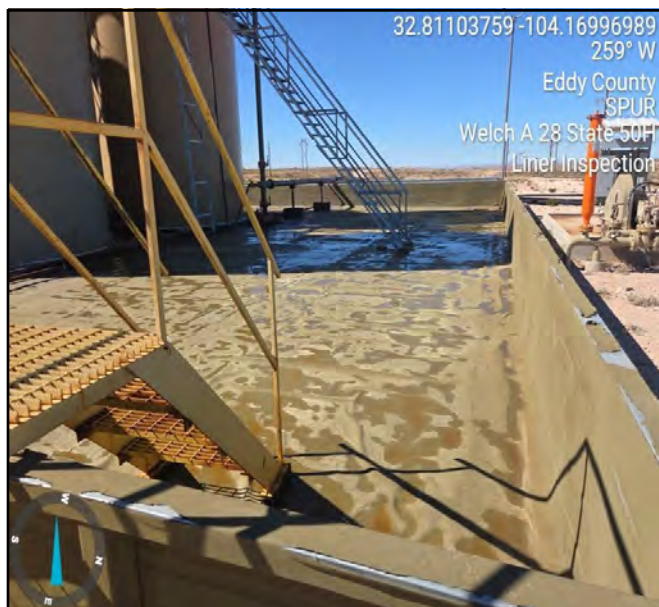
Photo of liner taken during liner inspection facing east.

Photo of liner taken during liner inspection facing south.

Photo of liner taken during liner inspection facing west.

Photo of liner taken during liner inspection facing north.

On October 26, 2025, Pima Environmental conducted a thorough inspection of the lined containment area. The evaluation process included cleaning the liner with a power washer and using a vacuum truck to ensure the complete removal of any residual fluids. The inspection confirmed that the system remained intact and successfully retained all fluids. As a result, the liner was deemed functional, preventing any further environmental impact. A detailed report, including photographic evidence, is provided in Appendices C and D.

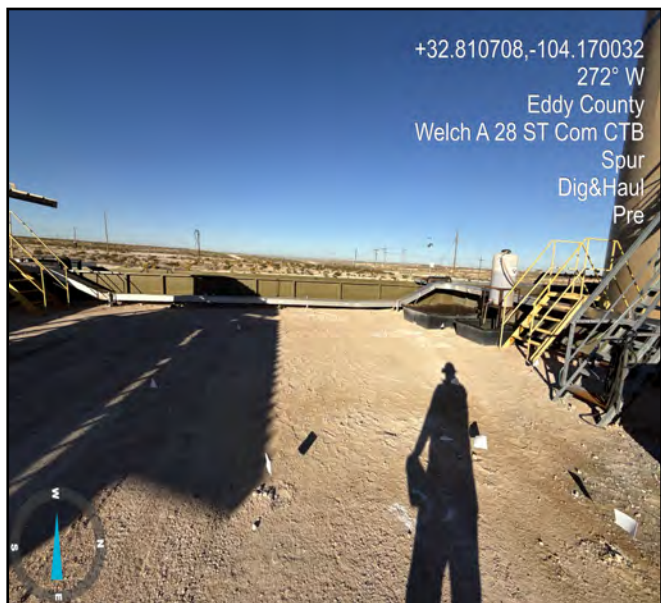
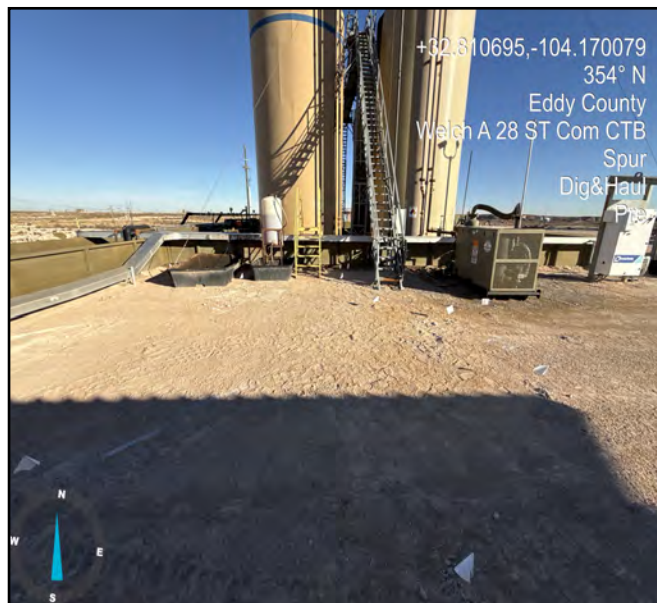
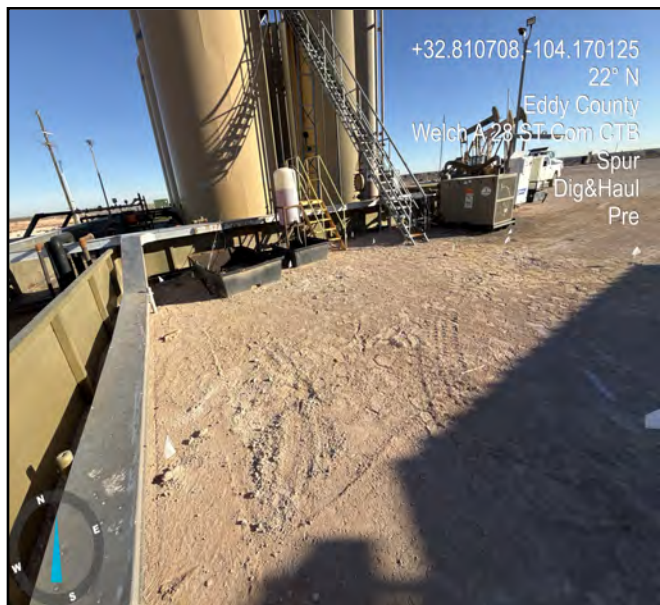
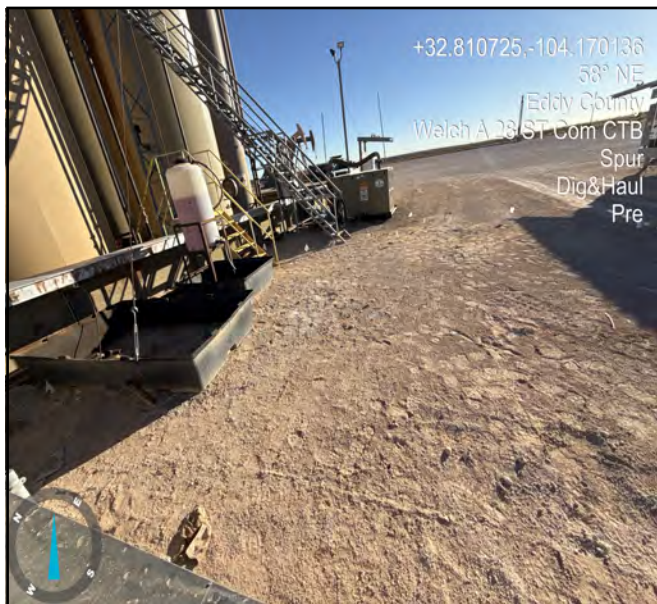
nAPP2526529586: On September 20, 2025, corrosion caused a hole in the WTP, resulting in the release of approximately 82 barrels of produced water into the lined containment. Spur personnel promptly mobilized a vacuum truck, and all standing fluids within the lined containment were successfully recovered. A fine mist extended beyond the lined containment on the south side.

Photograph taken of initial release facing west.

Photograph taken of initial release facing north.

Photograph taken of initial release facing northeast.

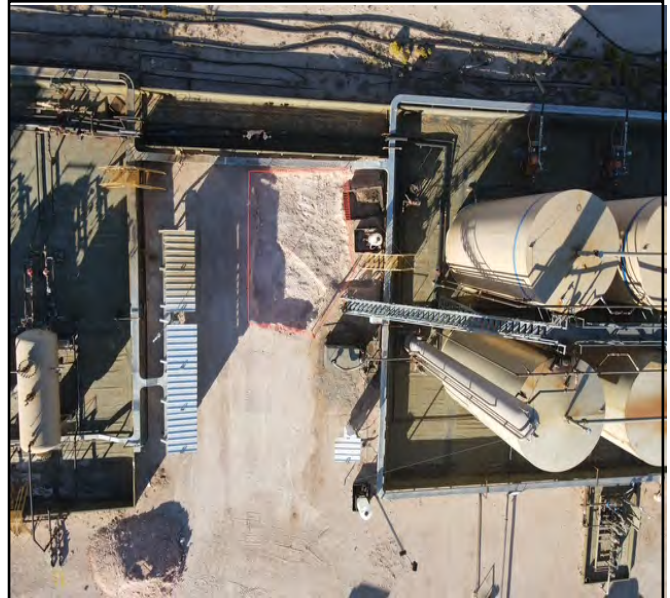
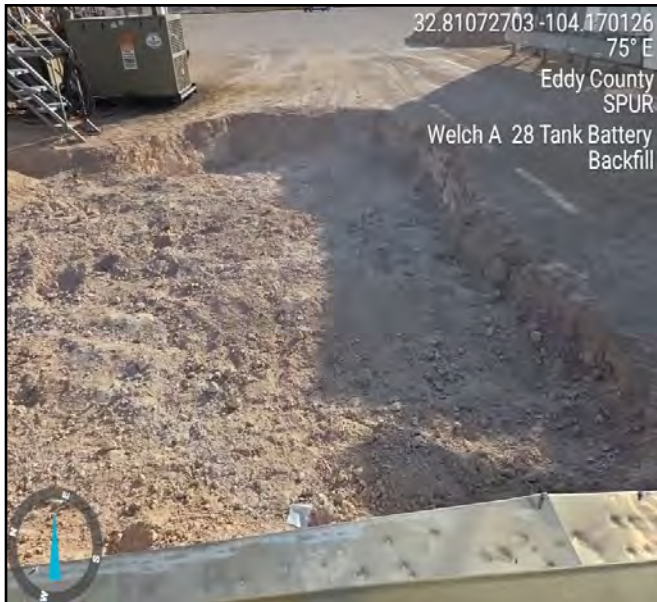
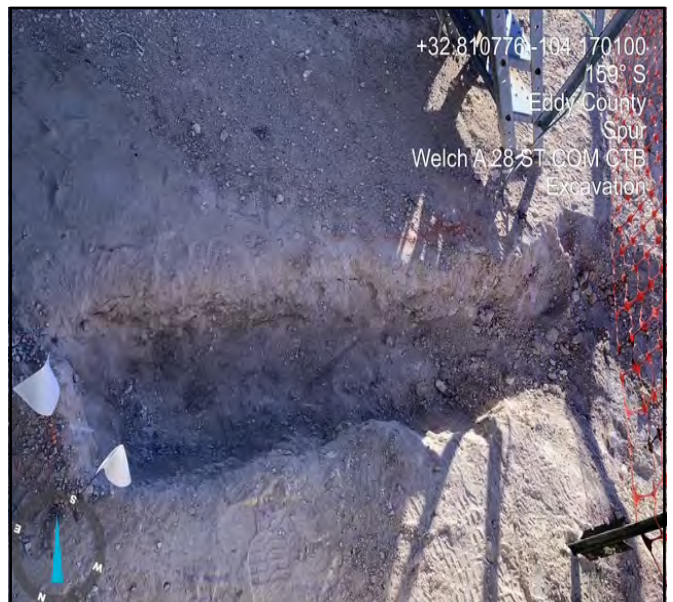
Aerial photos taken during the excavation process.

Photograph taken during the excavation process facing east.

Photograph taken during the excavation process facing south.

Between November 15 and November 18, Pima Environmental deployed a heavy equipment operator and a spotter to remediate the impacted area located on the south side of the lined containment. Areas overlapping soil samples HS1 and HS3 were excavated to a depth of one foot bgs, resulting in the removal of approximately 10 cubic yards of impacted material. Areas overlapping soil samples HS2 and HS4 were excavated to a depth of two feet bgs, resulting in the removal of approximately 15 cubic yards of impacted material. All excavated material was transported to Lea Land, an NMOCD-approved landfill, for proper disposal.

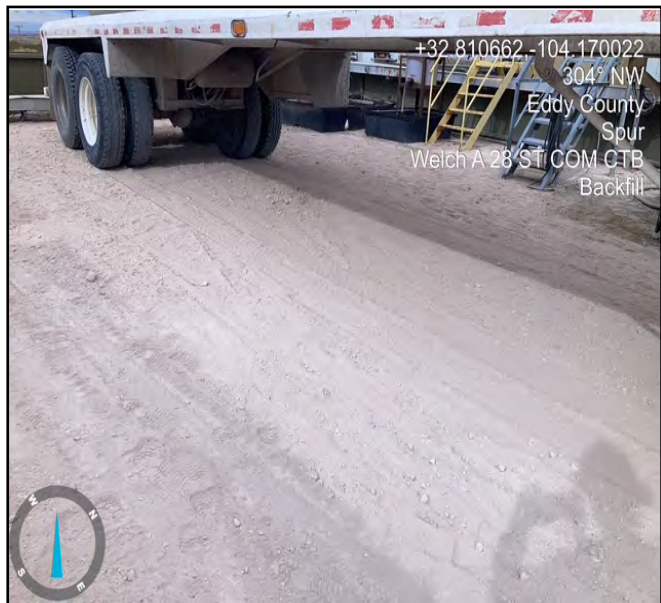
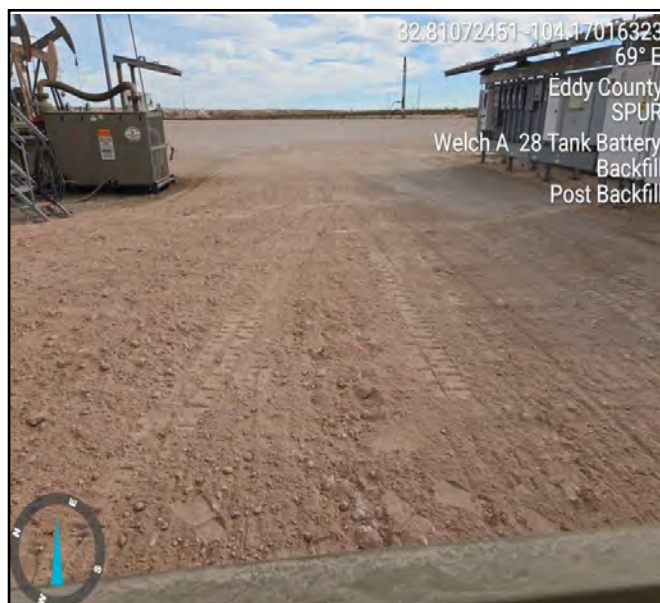
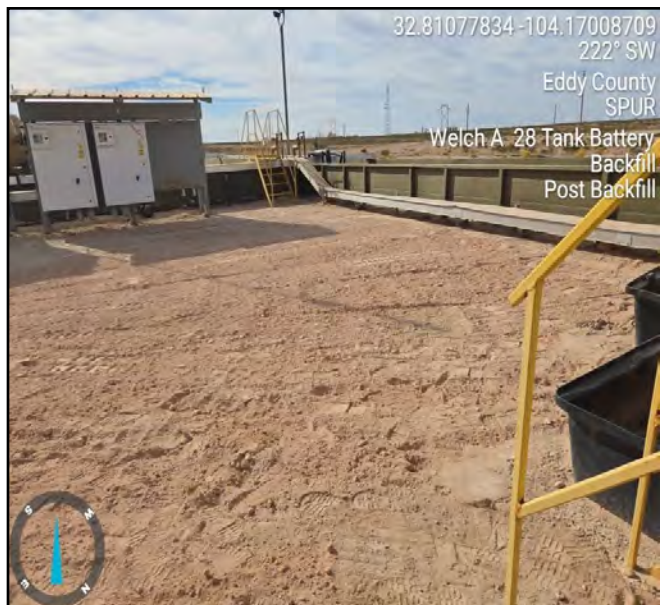
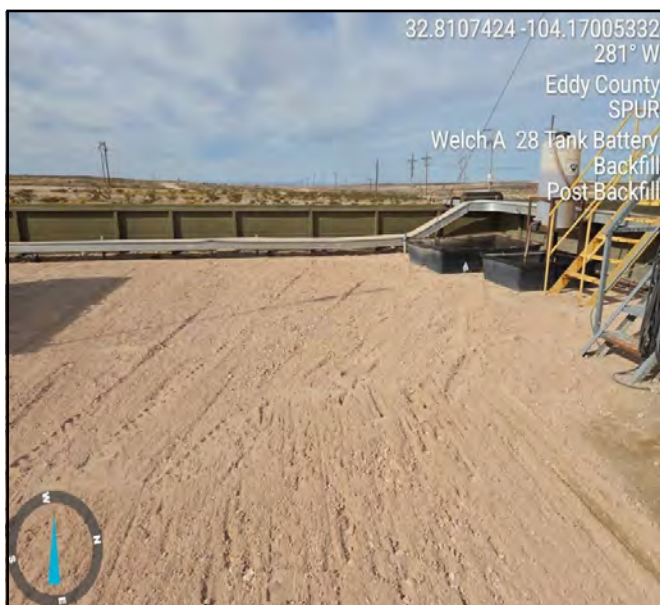
Photos taken post backfill facing northwest.

Photos taken post backfill facing east.

Photos taken post backfill facing southwest.

Photos taken post backfill facing west.

Total Surface Area (sq ft) Reclaimed What was the total surface area (in sq ft) reclaimed?	0
Remediation Summary Summarize any additional remediation activities not included by answers (above).	The impacted area located outside the lined containment was delineated and subsequently excavated. Following excavation activities, the lined containment was thoroughly power-washed and inspected to confirm its integrity. The excavated area outside the lined containment then underwent a confirmation sampling event and was backfilled with clean material.
