Site Characterization and Remediation Workplan
DEVON ENERGY PRODUCTION COMPANY, LP
Haflinger 22 27 Federal Com #610H
nAPP2529640291
API: 30-025-50065
32.122678, -103.668322
D-22-25S-32E

HAFLINGER 22 27 FEDERAL COM #610H DEVON ENERGY PRODUCTION COMPANY, LP

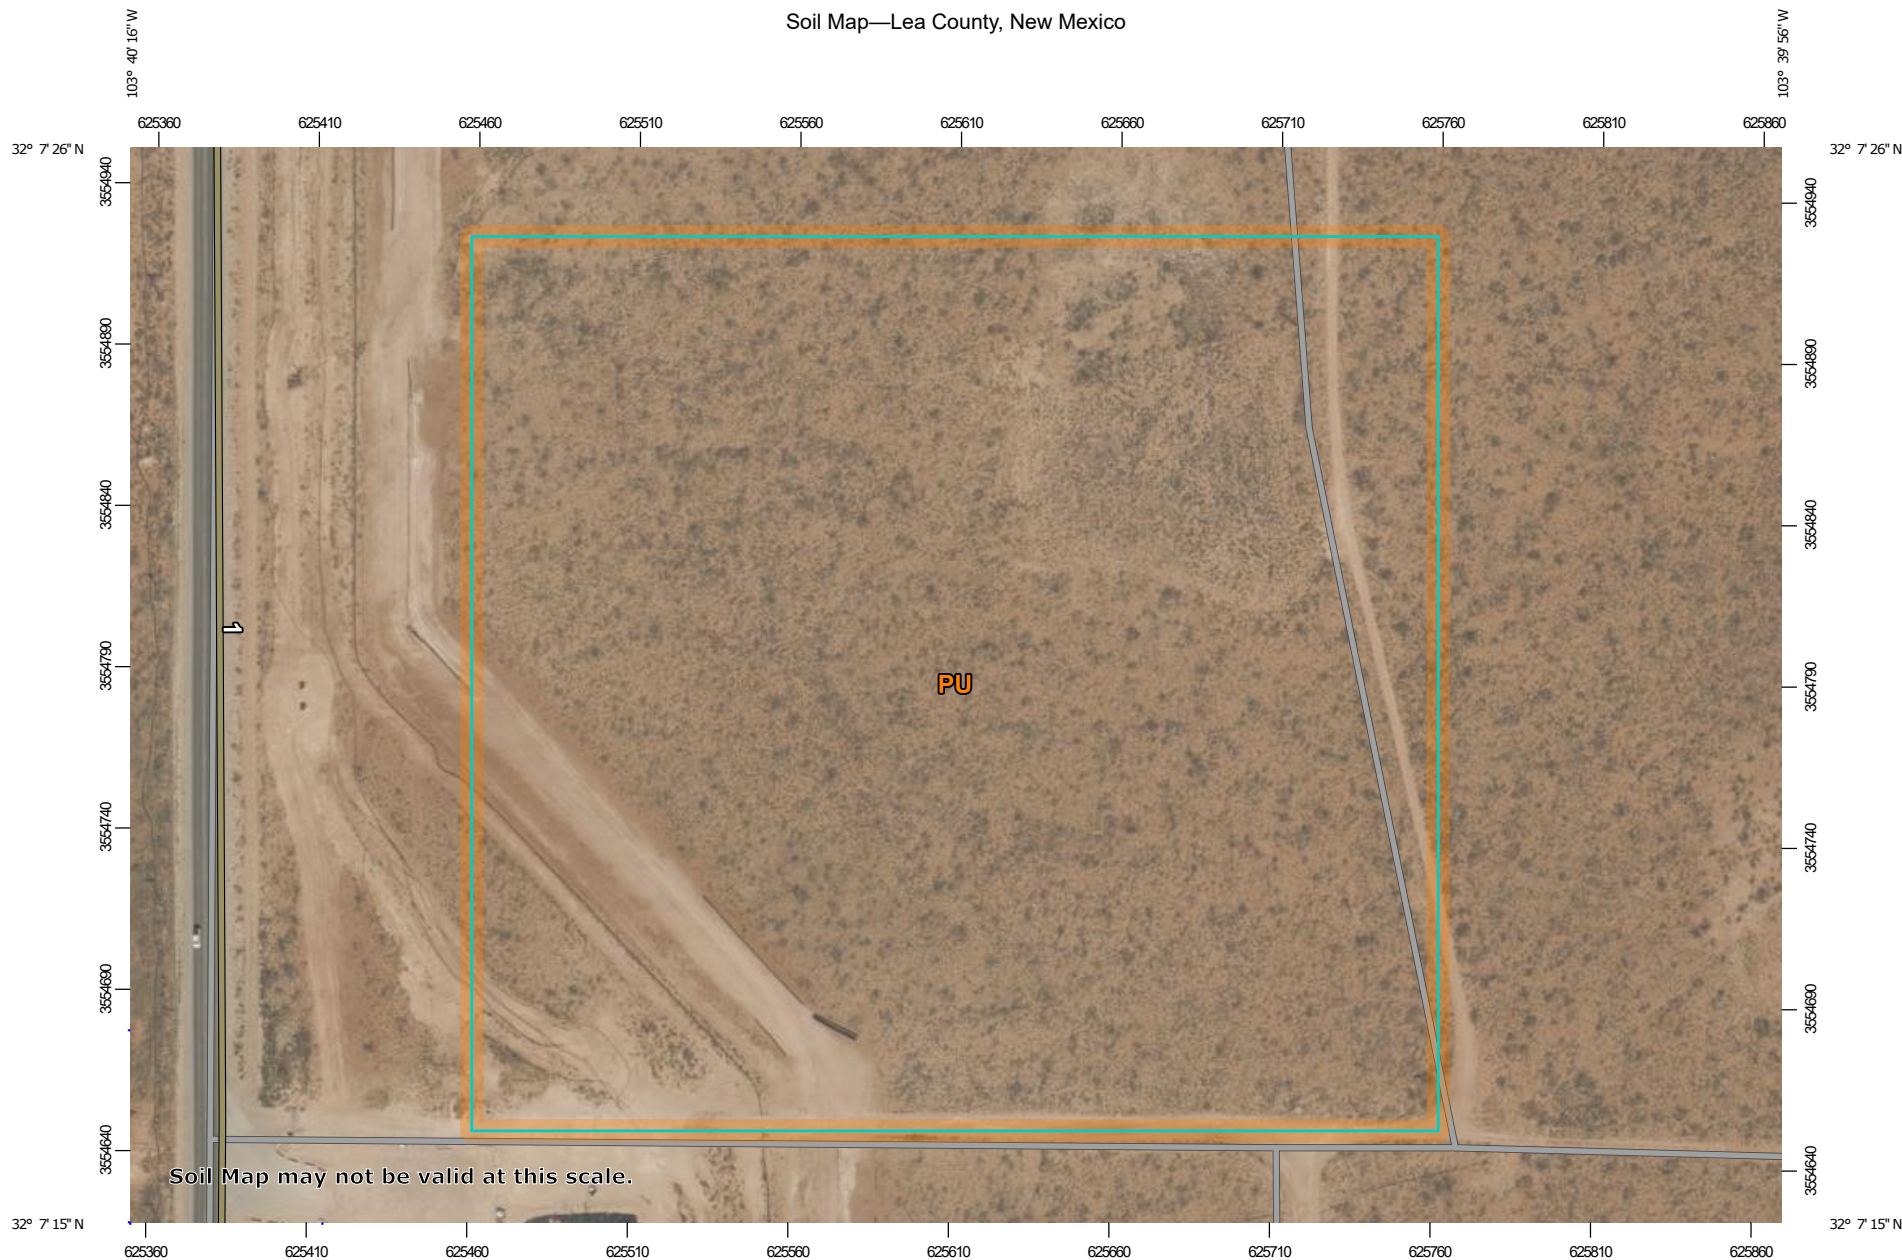
Soil Map—Lea County, New Mexico

Based on the web soil survey, the soils in and around the Site are classified as 100% Pyote and Maljamar fine sands.

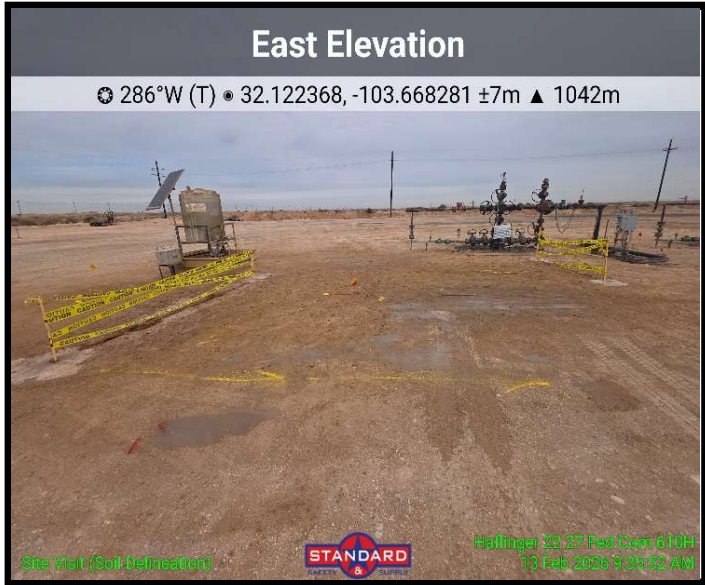
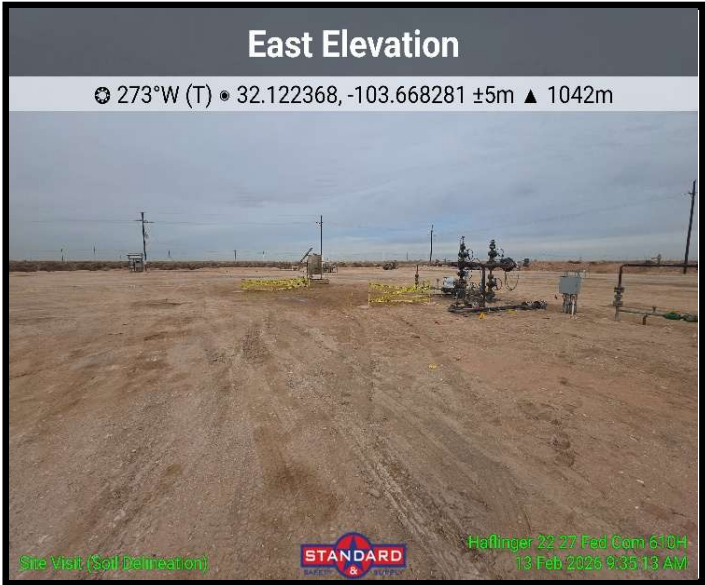
Delineation Activities
