CLOSURE REPORT

Trunk K #5

New Mexico EMNRD OCD Incident ID No. NAPP2600745335

March 27, 2026

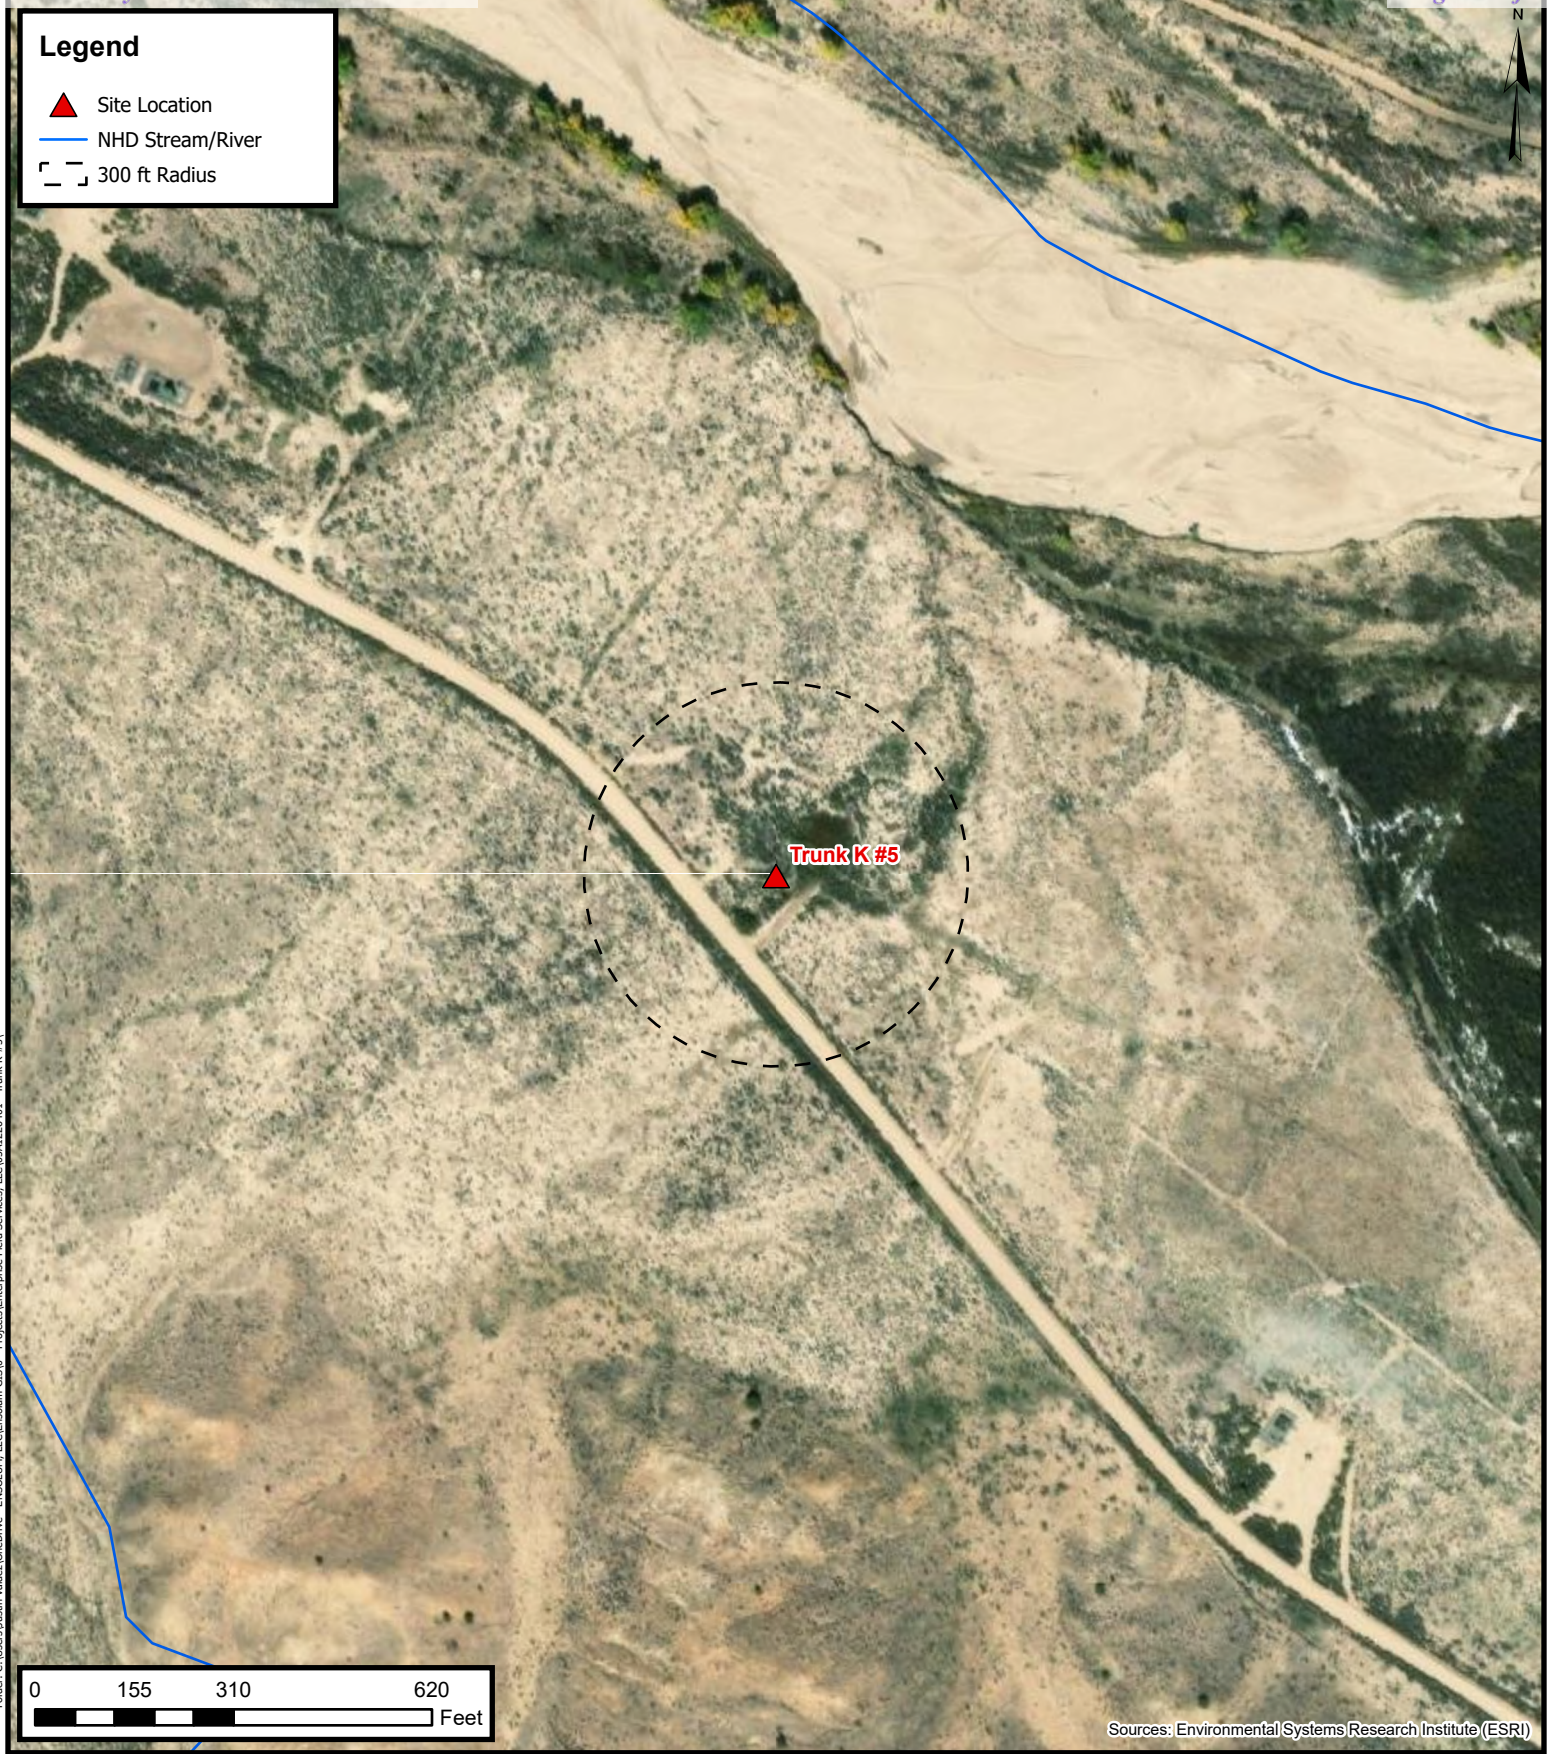
FIGURE C

- The Site is not located within 300 feet of a NM EMNRD OCD-defined significant watercourse (**Figure C, Appendix B**). A “blue line” ephemeral wash is located approximately 610 feet northeast of the Site.

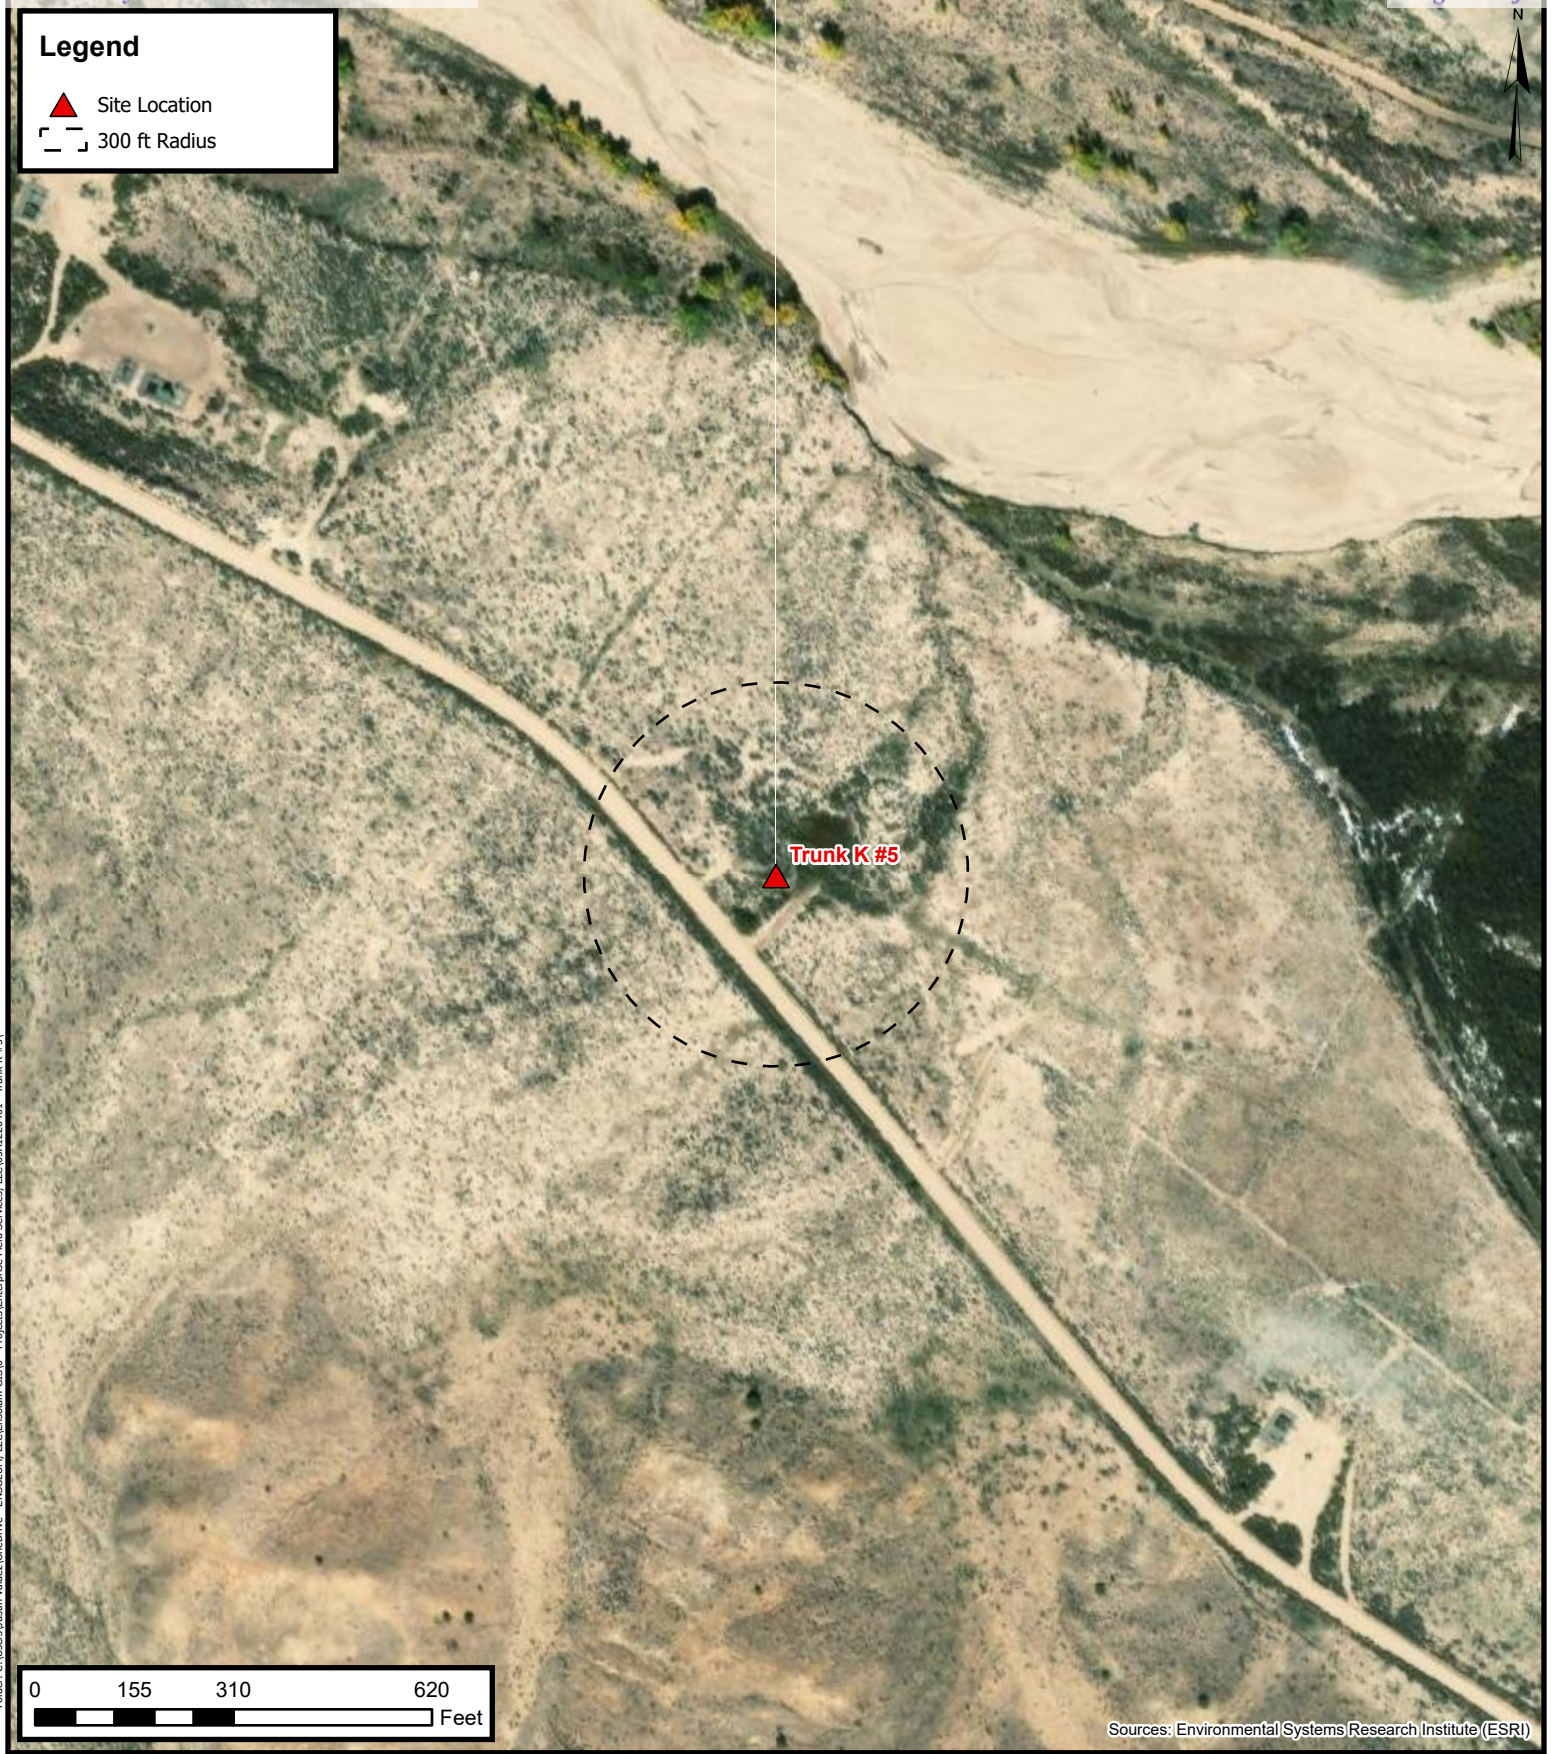
**FIGURE
D**

- The Site is not located within 300 feet of a permanent residence, school, hospital, institution, or church (**Figure D, Appendix B**).
- No springs or private domestic freshwater wells used by less than five households for domestic or stock watering purposes were identified within 500 feet of the Site (**Figure E, Appendix B**).

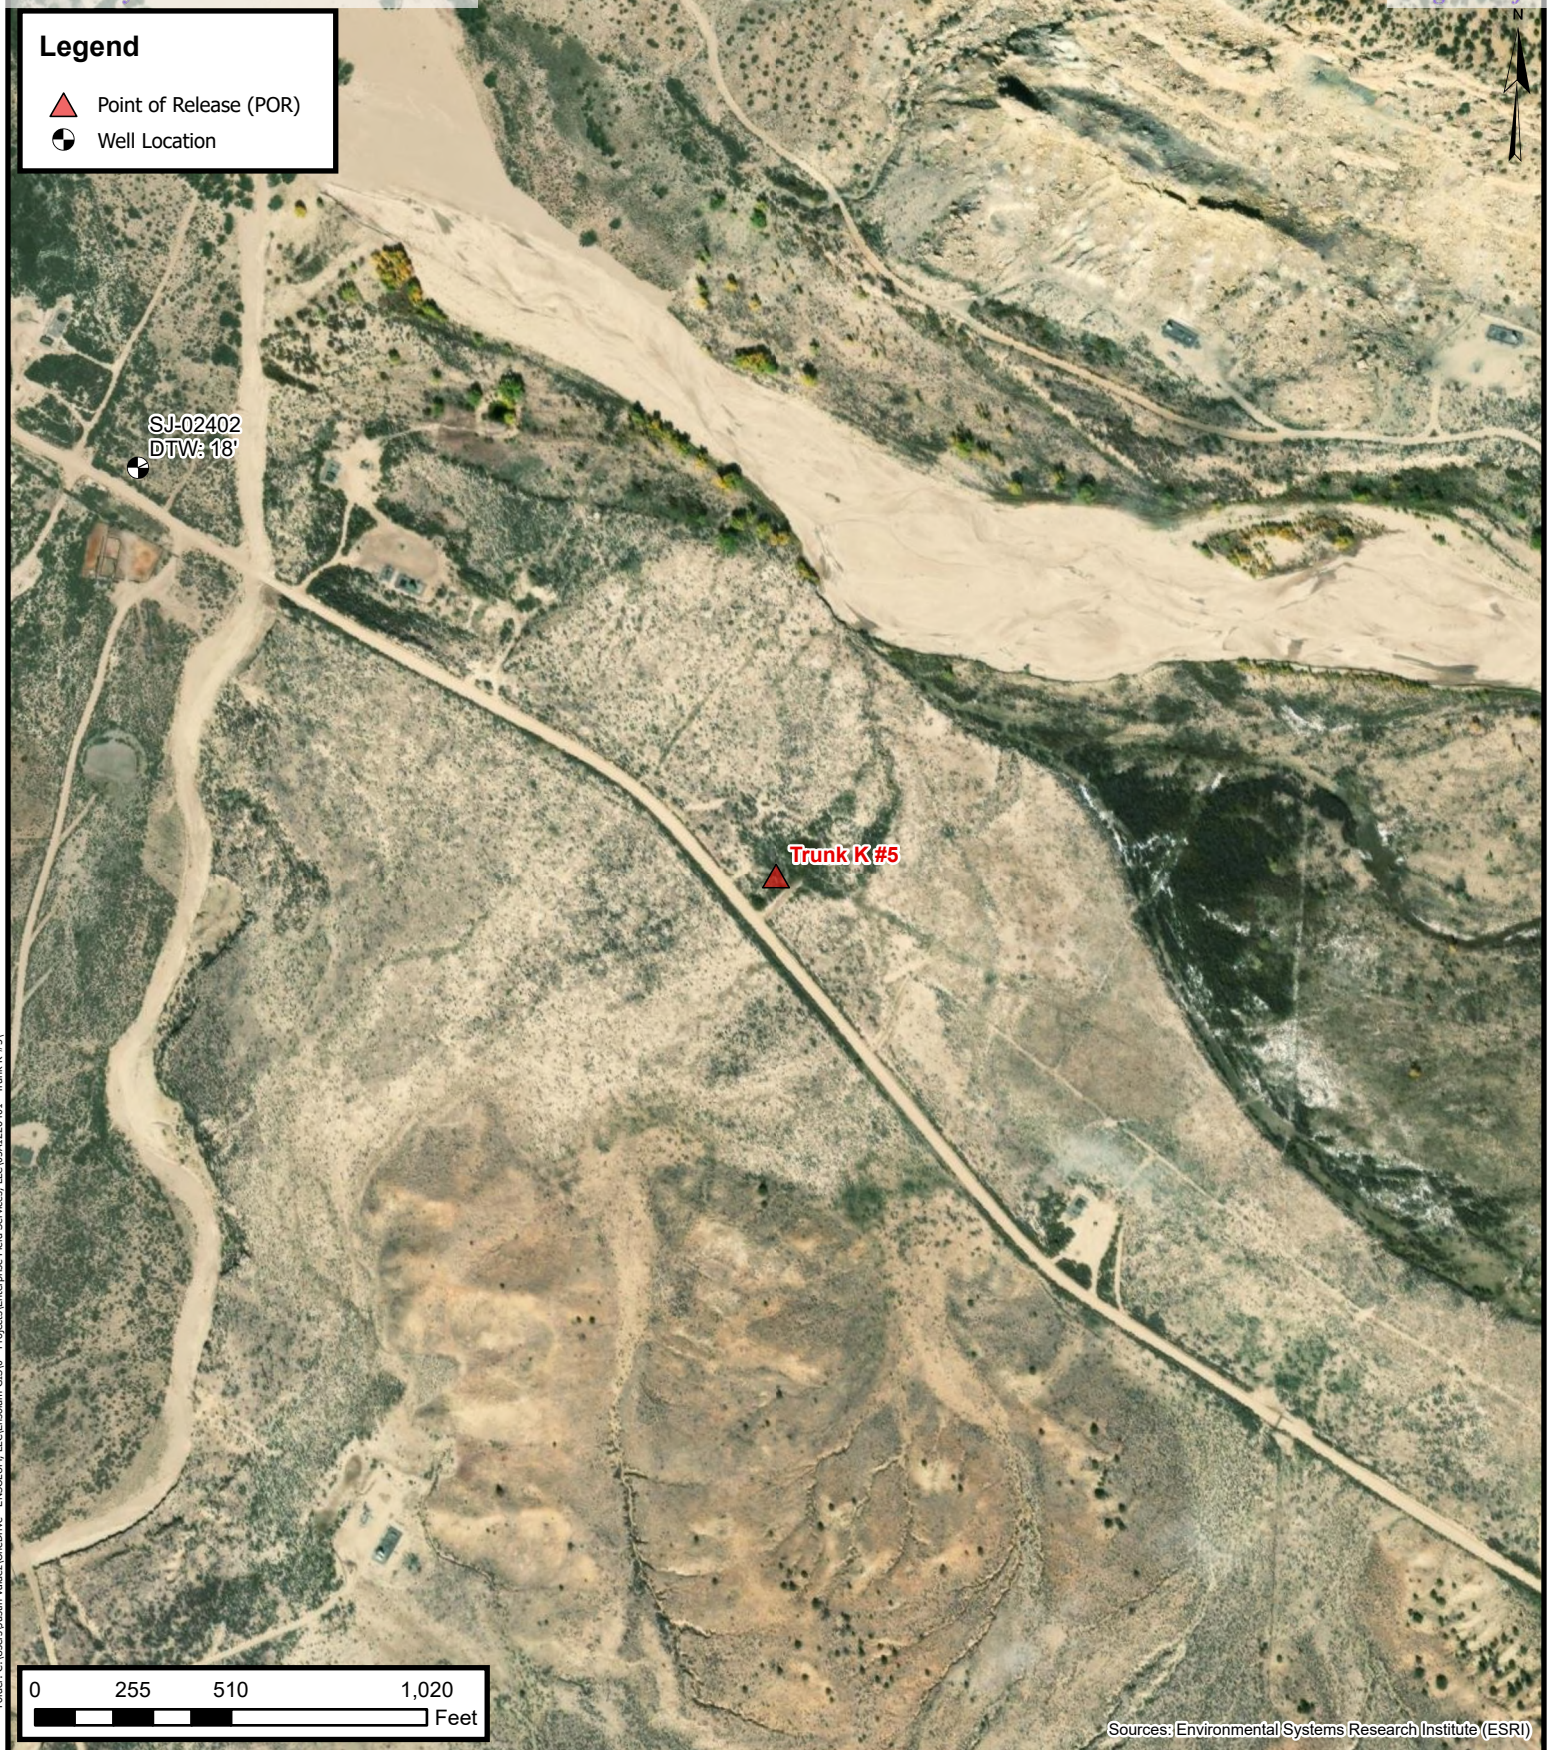
**FIGURE
E**

- The Site is not located within 1,000 feet of a spring (**Figure E, Appendix B**).
- The Site is not located within incorporated municipal boundaries or within a defined municipal fresh water well field covered under a municipal ordinance adopted pursuant to New Mexico Statutes Annotated (NMSA) 1978, Section 3-27-3.

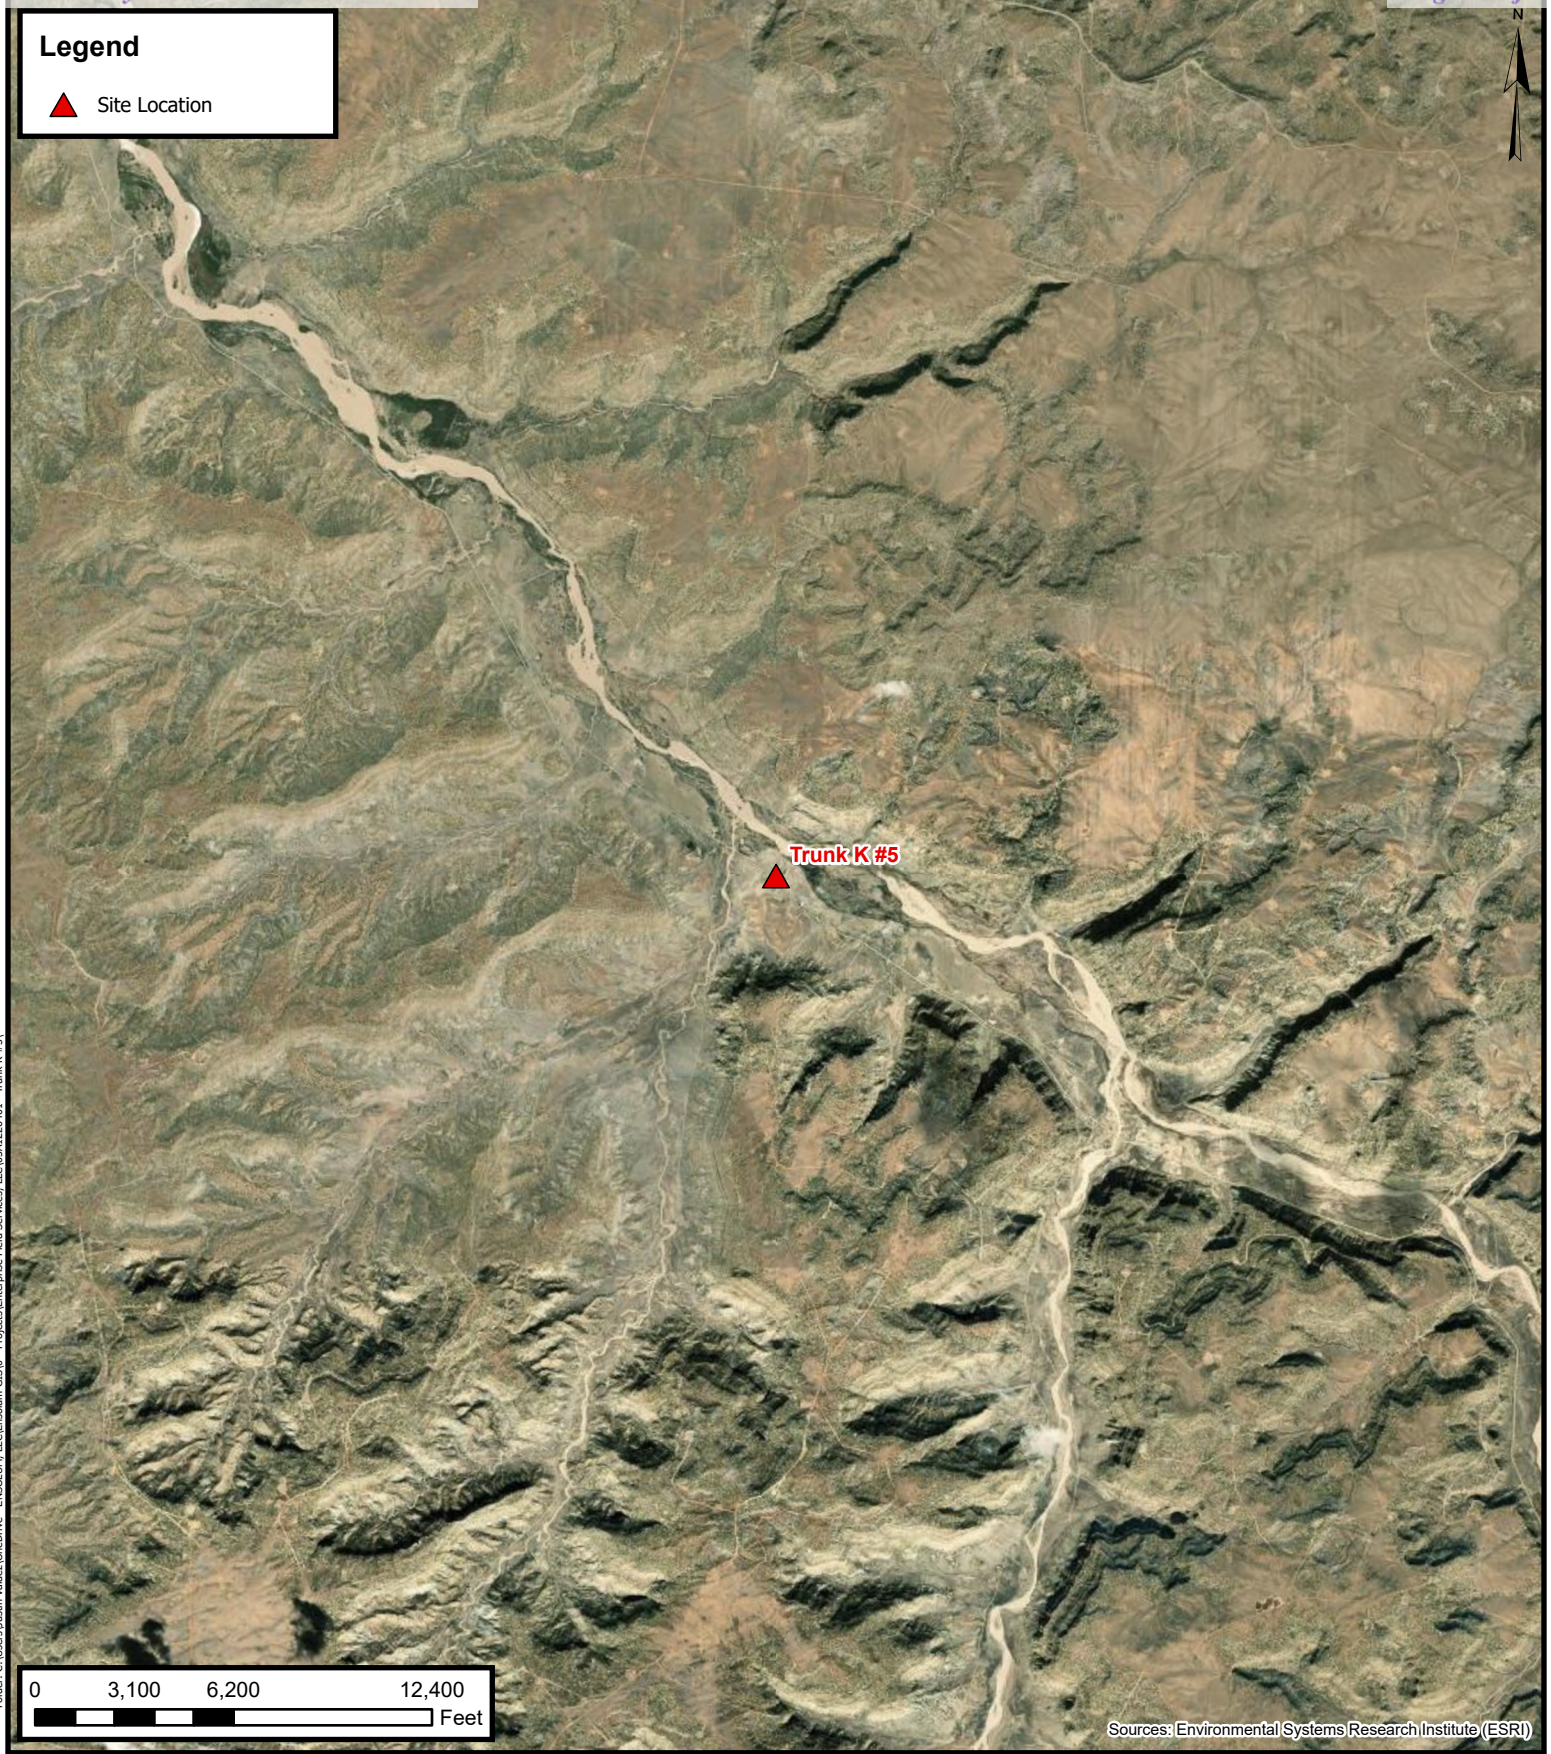
G

- Based on information identified in the NM Mining and Minerals Division’s Geographic Information System (GIS) Maps and Mine Data database, the Site is not within an area overlying a subsurface mine (**Figure G, Appendix B**).

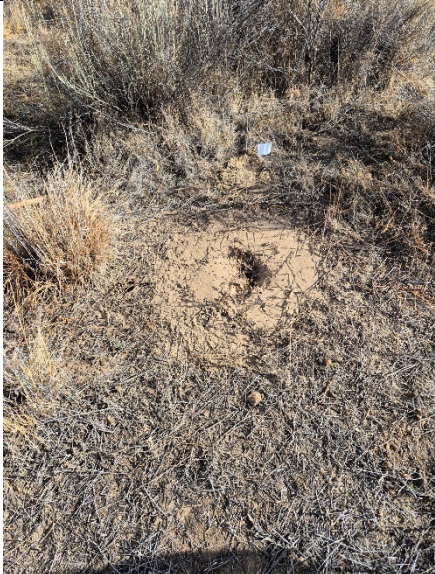
<p>Photograph</p> <p>Photograph Description: Surface expression of release.</p>

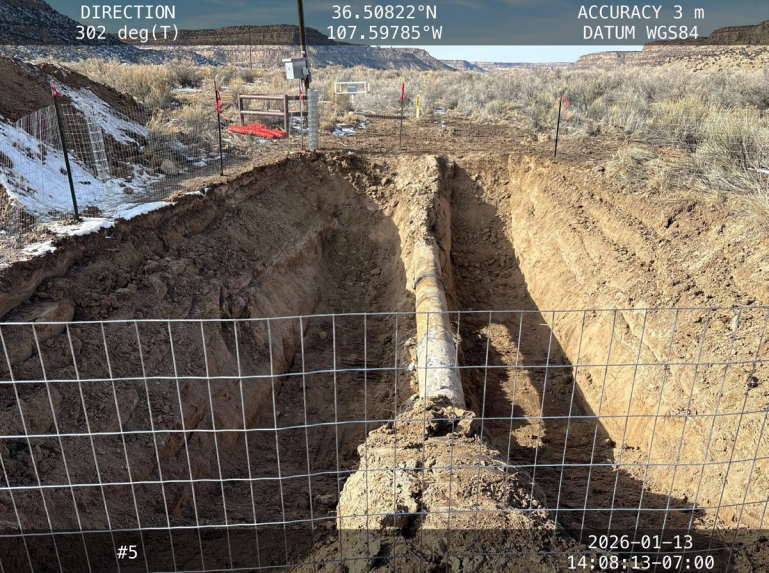
A vertical photograph showing a close-up of a soil surface with sparse, dry vegetation. A small white marker is visible on the ground.
<p>Photograph 2</p> <p>Photograph Description: View of the final excavation.</p>

The excavation measured approximately 30 feet long and 18 feet wide at the maximum extents. The calculated surface footprint is approximately 540 ft². The maximum depth of the excavation measured approximately 6.5 feet bgs. The lithology encountered during the completion of remediation activities consisted primarily of silty sand and clay.

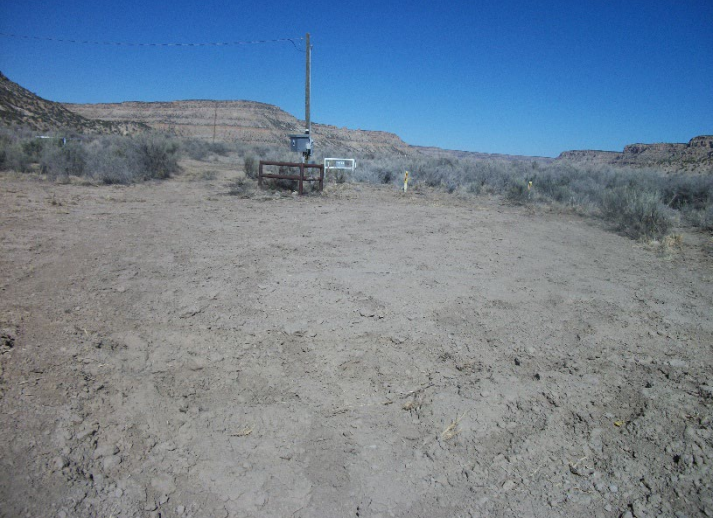
A wide-angle photograph of a deep, narrow excavation site. A large pipe is visible in the center, surrounded by earthen walls. A wire mesh fence is in the foreground. The background shows a hilly landscape under a clear sky. Metadata text is overlaid on the image: "DIRECTION 302 deg(T)", "36.50822°N", "107.59785°W", "ACCURACY 3 m", "DATUM WGS84", "#5", and "2026-01-13 14:08:13-07:00".
<p>Photograph 3</p> <p>Photograph Description: View of the final excavation after initial restoration.</p>

The excavation was backfilled with imported fill and then contoured to the surrounding grade. The backfill and the upper four feet of the excavation have been analytically verified to be below the Tier I soil standards of 50 mg/kg BTEX, 10 mg/kg benzene, 100 mg/kg total combined TPH, and 600 mg/kg Chloride. See **Appendix D** and **Appendix F** for further documentation.
