**Closure Report
Horse 29 State #1H
Lea County, New Mexico
Incident ID: NAPP2228545175
Unit B Sec 30 T25S R34E
32.108063°, -103.506677°**

**Produced Water Release
Point of Release: Pinhole on Produced Water Line
Release Date: 07/09/2022
Volume Released: >5 barrels of Produced Water
Volume Recovered: 0 barrels of Produced Water**

**Re: Closure Report
Horse 29 State #1H
EOG Resources, Inc
Incident # NAPP 2228545175
Site Location: Unit B, S30, T25S, R34E
(Lat 32.108063°, Long -103.506677°)
Lea County, New Mexico**

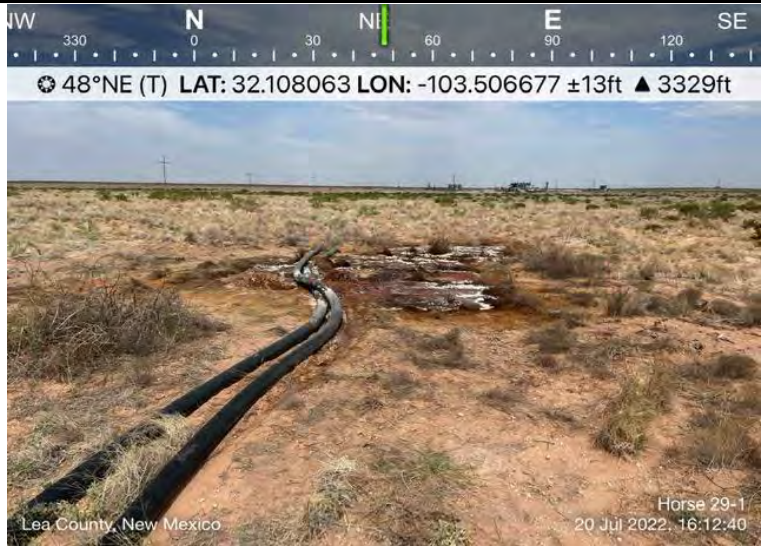
View Northeast, areas of S-1/T-1/BH-1 and S-2/T-2/BH-2.

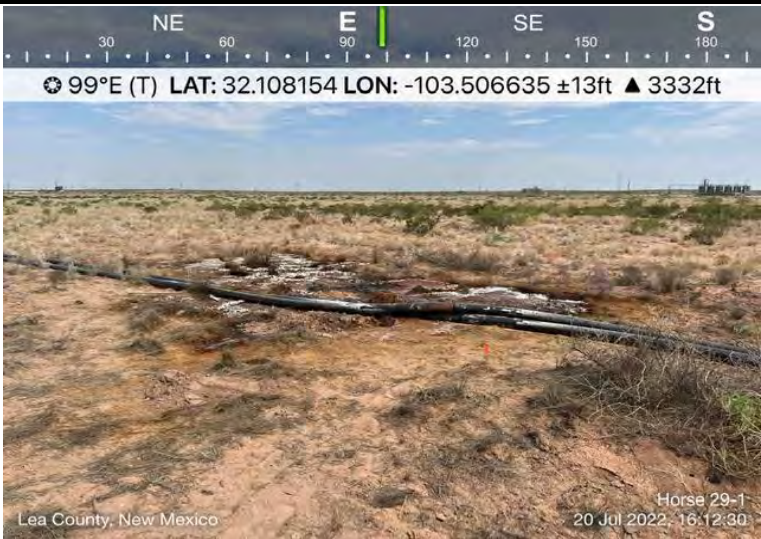
Photograph No. 2

View Northeast, areas of S-1/T-1/BH-1 and S-2/T-2/BH-2.

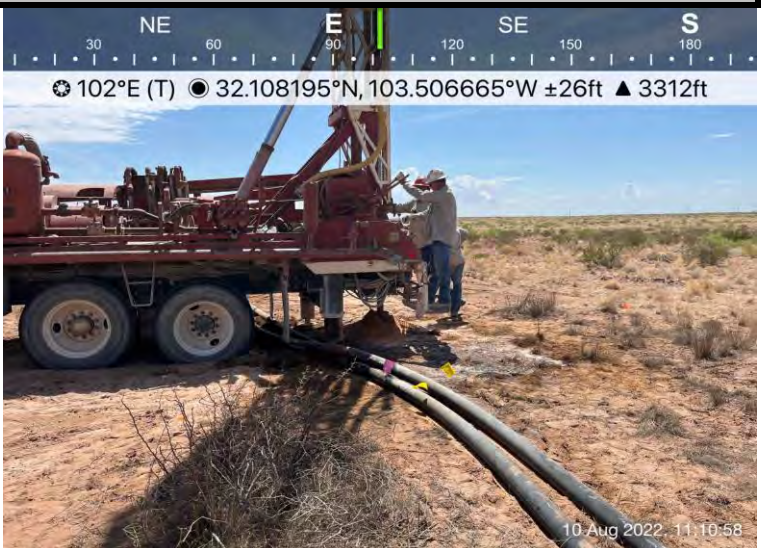
Photograph No. 3

View East, of drilling activities.

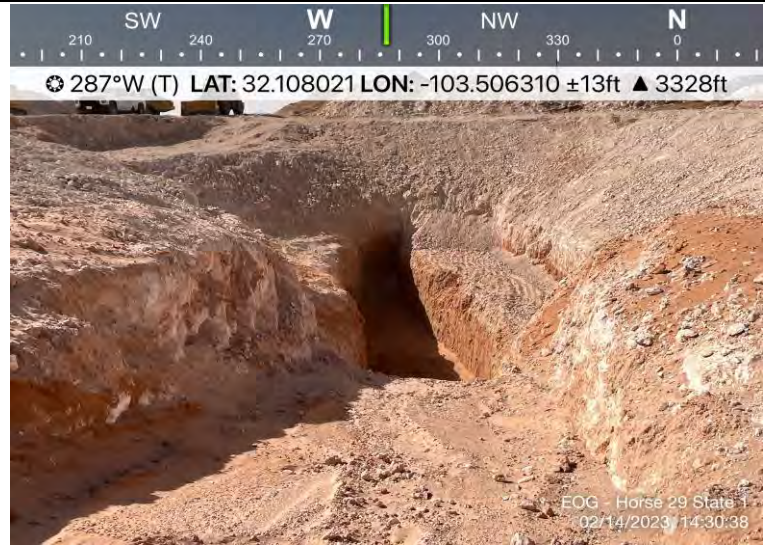
Photograph No. 5

View West, area of 25' & 35' Excavation.

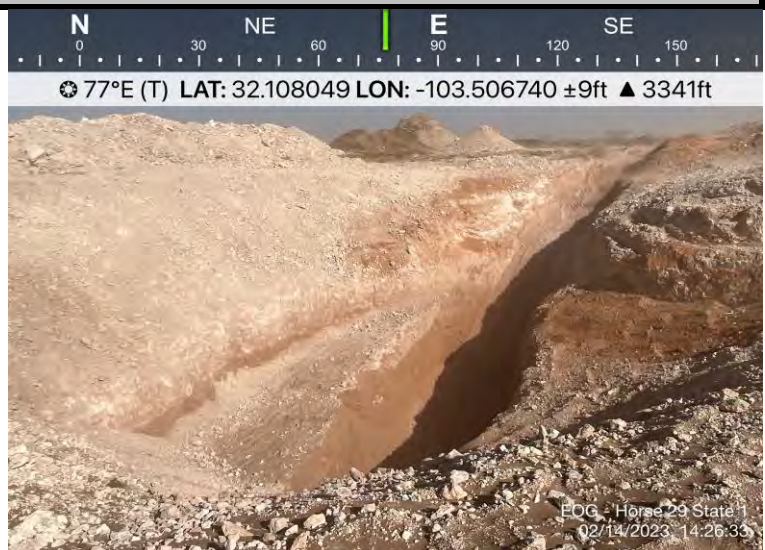
Photograph No. 6

View East, area of 25' & 35' Excavation.

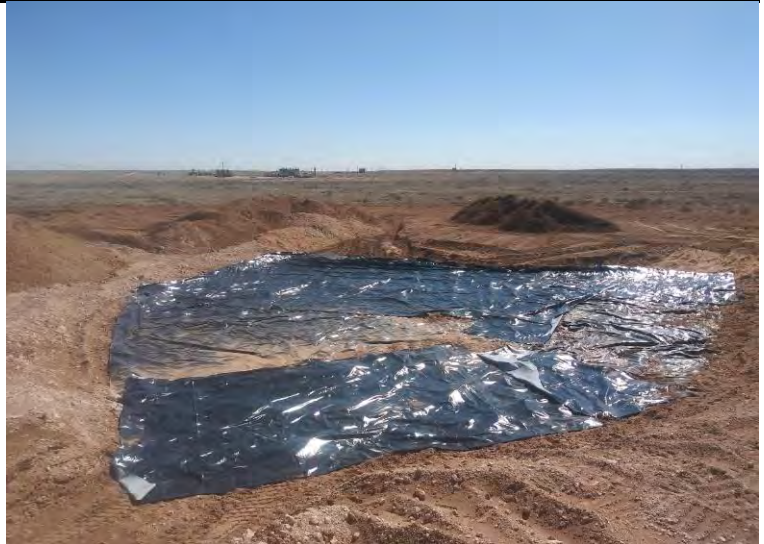
View South, of the liner installed over the backfilled excavation at 4.5'

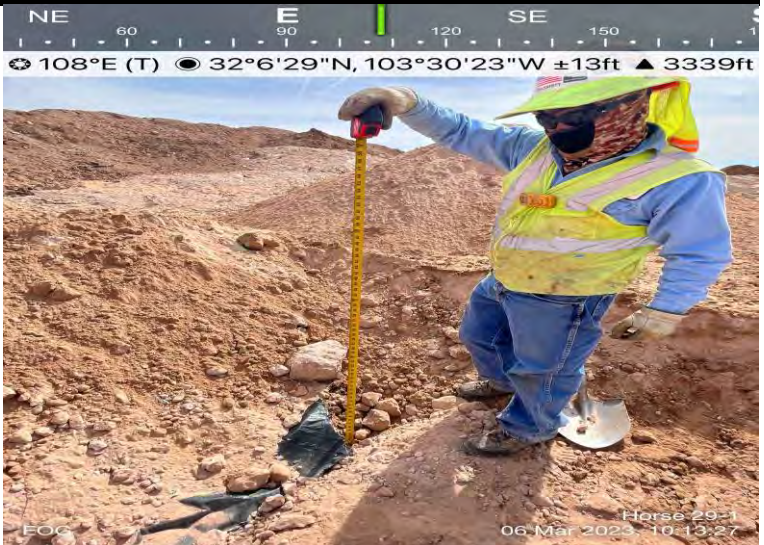
Photograph No. 10

View East, of the liner installed at 4.5' from the surface.

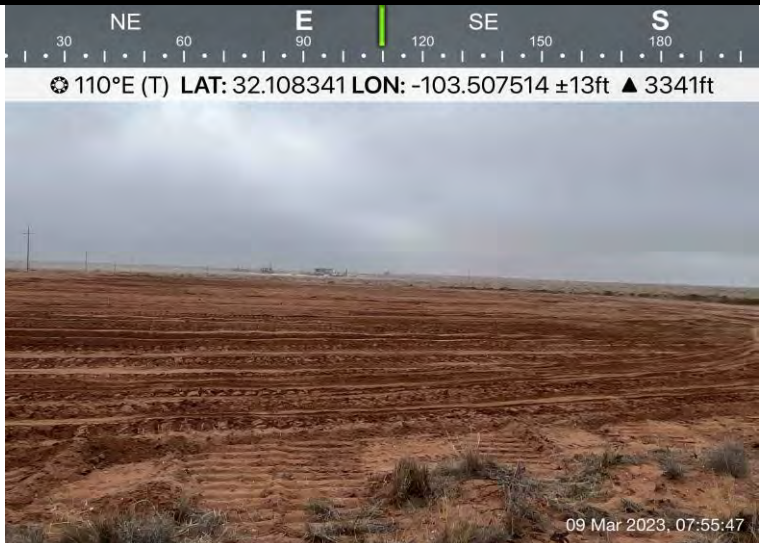
Photograph No. 11

View East, of the backfilled excavation area.
