**Re: Closure Request  
Poker Lake Unit 330H Flow Line  
Incident Number nAB1926638462  
Eddy County, New Mexico**

Ensolum, LLC (Ensolum), on behalf of XTO Energy, Inc. (XTO), has prepared this *Closure Request* to document assessment, delineation, excavation, and soil sampling activities at the Poker Lake Unit 330H Flow Line (Site). The purpose of the remedial activities was to address impacts to soil following a release of produced water along a lease road and into the adjacent pasture area. Based on field observations, field screening activities, and soil sample laboratory analytical results, XTO is submitting this *Closure Request*, describing remedial activities that have occurred and requesting no further remediation for Incident Number nAB1926638462.

XTO Energy, Inc.  
Closure Request  
Poker Lake Unit 330H Flow Line

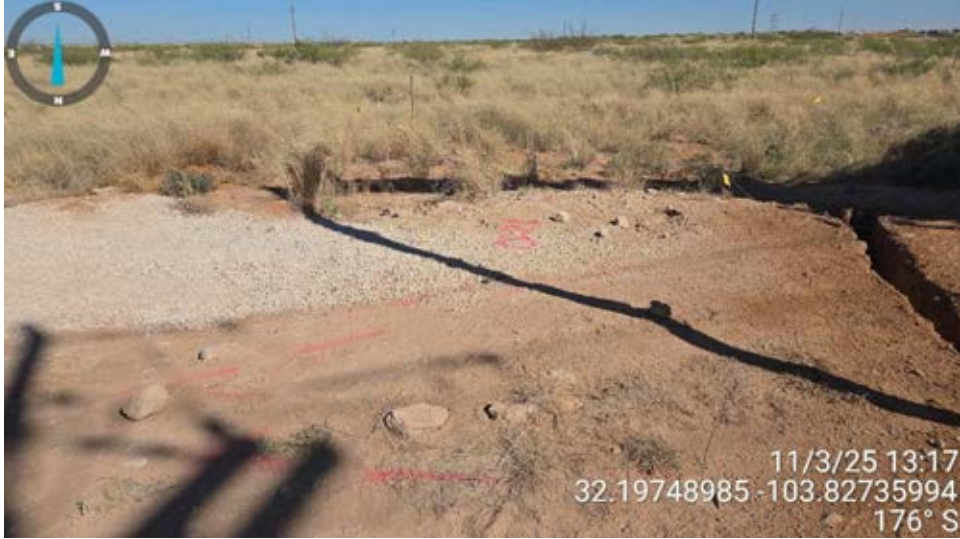
<p><u>Photograph</u> 3</p>	<p><u>Date</u> 11/3/2025</p>

<p><u>Description</u> Excavation and sampling activities near composite sampling area in pasture</p>		
<p><u>View</u> East</p>		
<p><u>Photograph</u> 4</p>	<p><u>Date</u> 11/04/2025</p>

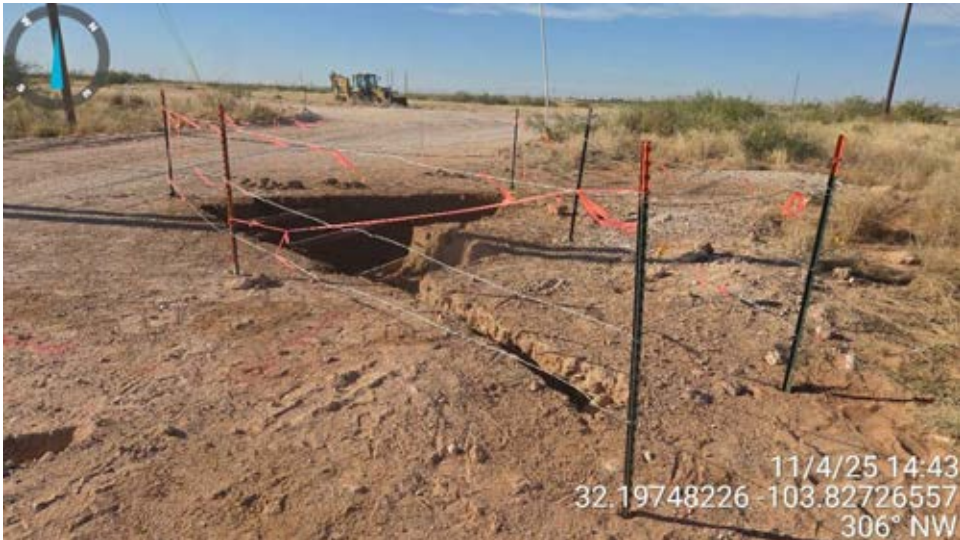
<p><u>Description</u> Hydro excavation activities on road and adjacent to pasture confirmation soil sampling</p>		
<p><u>View</u> Northwest</p>

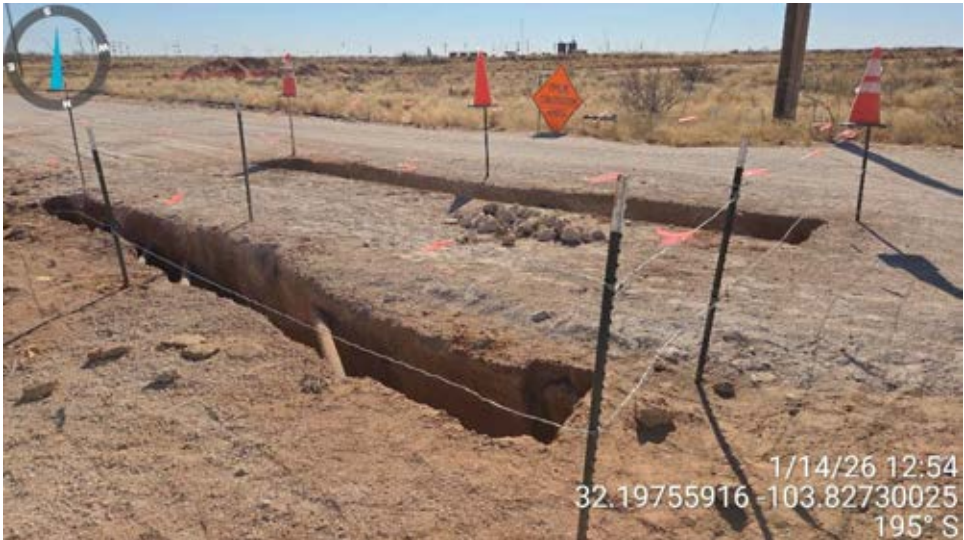
<p><u>Description</u> Backfilling activities on road, additional excavation near SW01 and SW02</p>		
<p><u>View</u> Southwest</p>

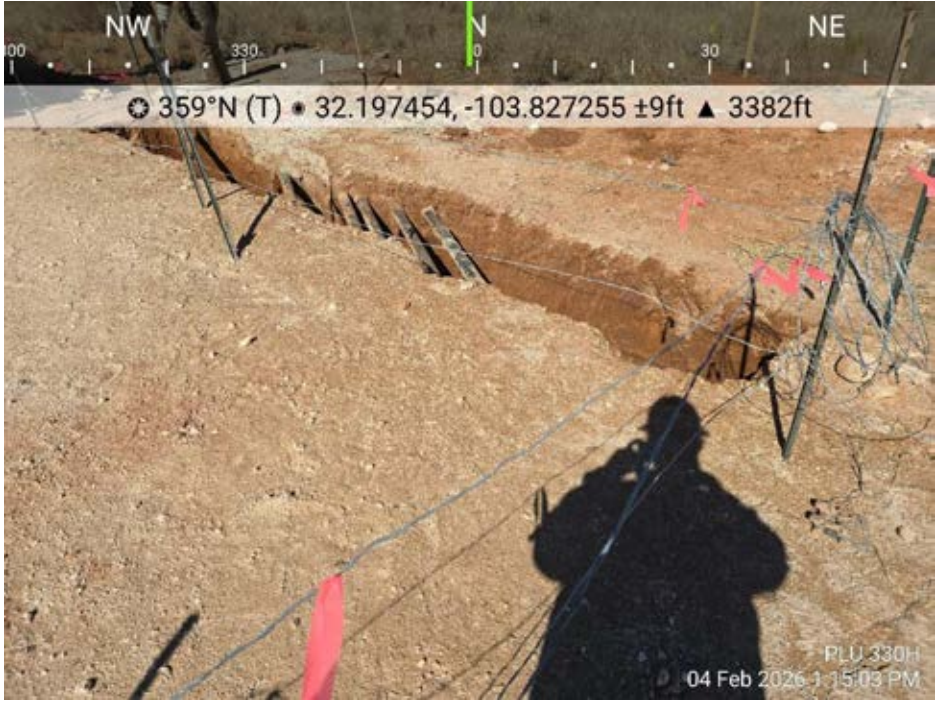
<p><u>Photograph</u> 11</p>	<p><u>Date</u> 02/04/2026</p>

<p><u>Description</u> Additional excavation activities near SW01</p>		
<p><u>View</u> North</p>		
<p><u>Photograph</u> 12</p>	<p><u>Date</u> 02/04/2026</p>

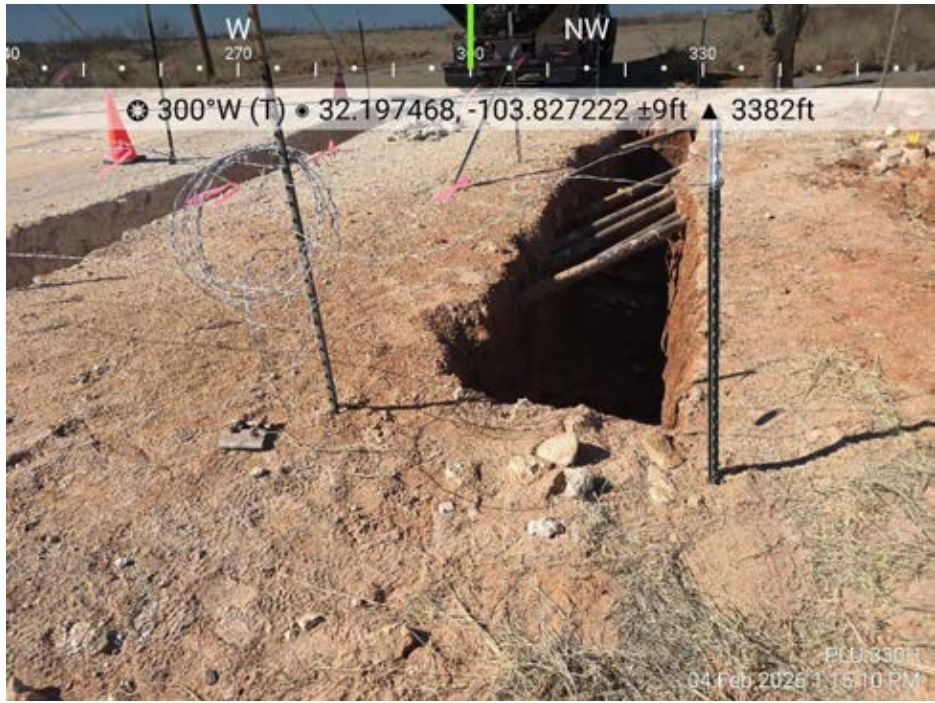
<p><u>Description</u> Additional excavation near SW01</p>		
<p><u>View</u> Northwest</p>
