Report Type: Closure Report (nAPP2531137095)

EOG Resources

Osprey 10 CTB Release

Closure Report Request

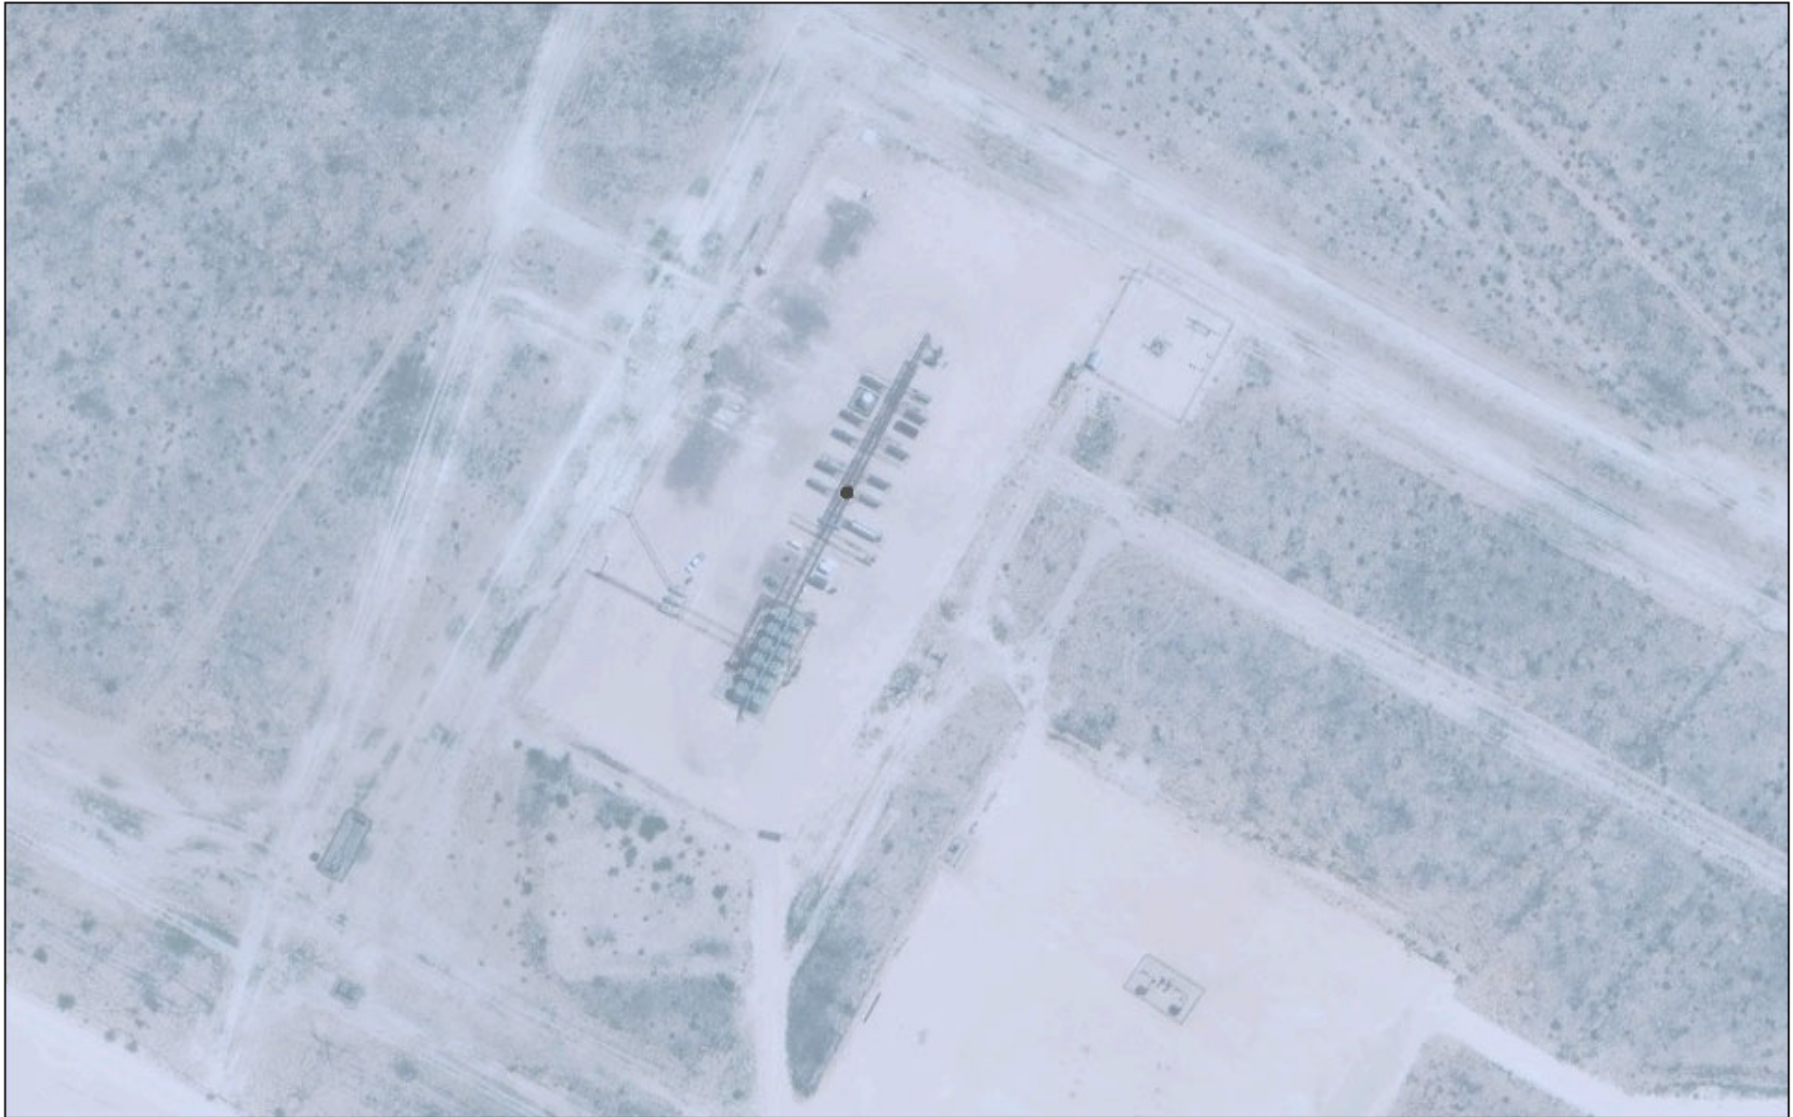
OCD - Permian Basin Karst Areas

Karst Occurrence Potential

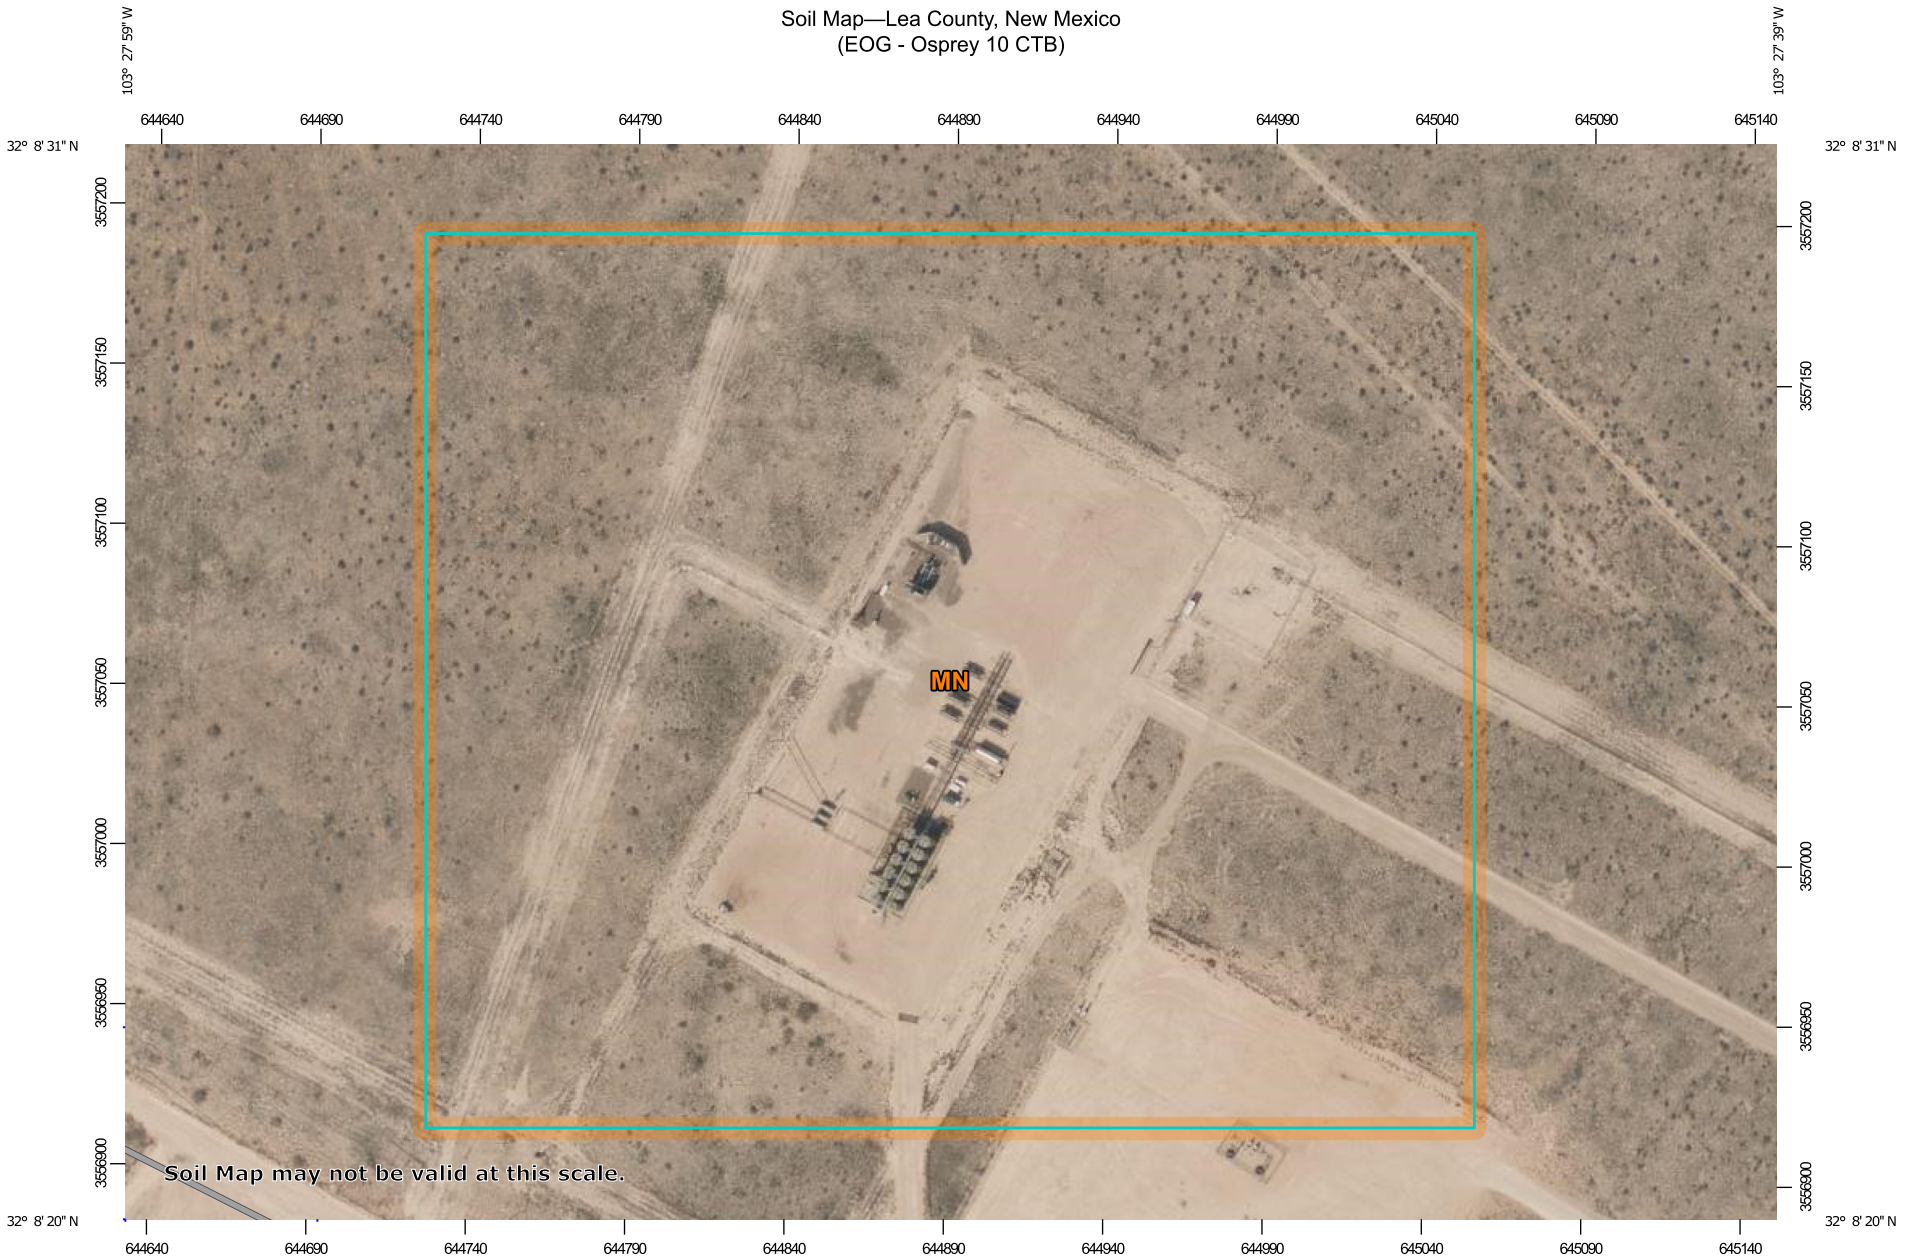
Soil Map—Lea County, New Mexico (EOG - Osprey 10 CTB)

Map Unit Symbol	Map Unit Name	Acres in AOI	Percent of AOI
MN	Ratliff-Wink fine sandy loams	22.8	100.0%
Totals for Area of Interest		22.8	100.0%

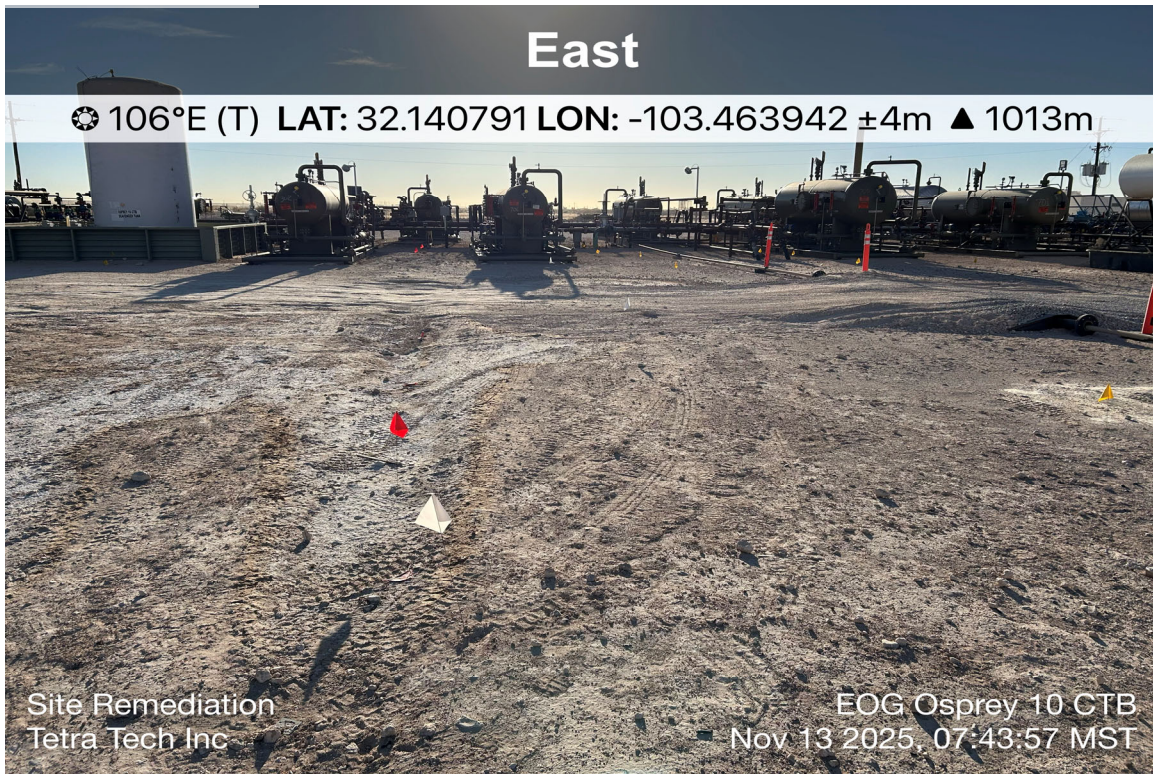
Tetra Tech Inc.	Description	View East. View of spill extend and battery equipment.	1
	Site Name	EOG Resources – Osprey 10 CTB Release	11/13/2025

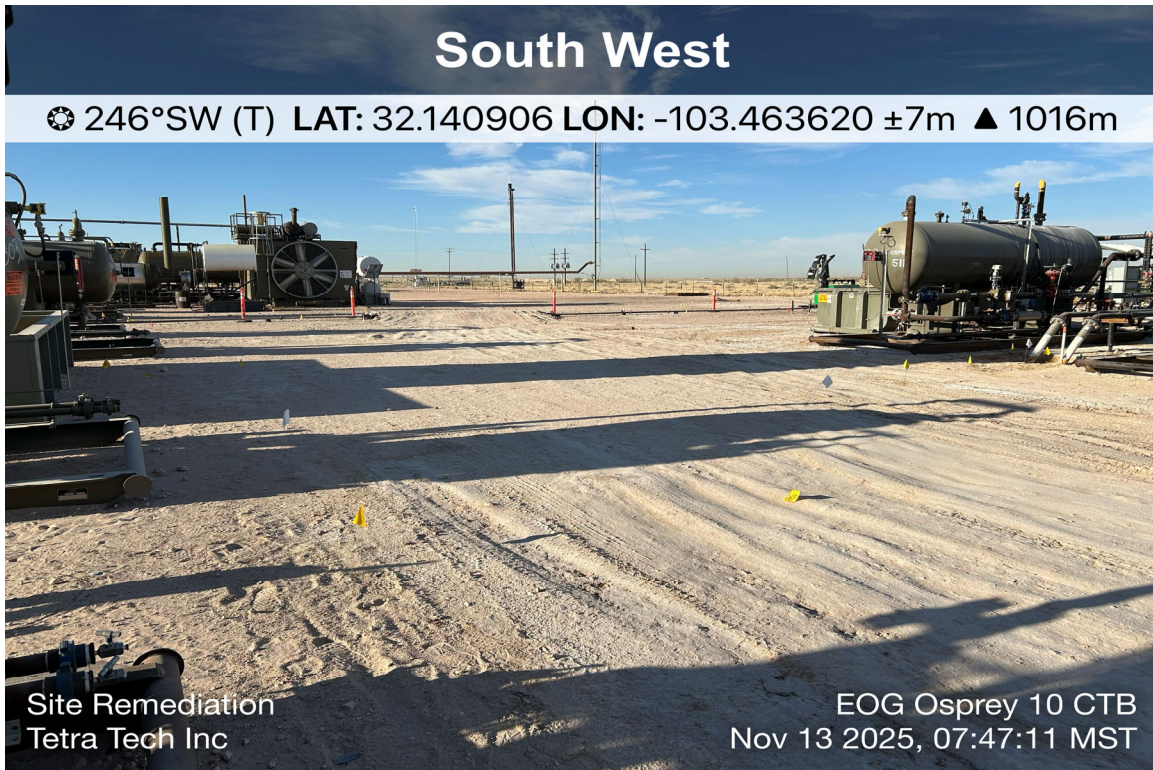
Tetra Tech Inc.	Description	View Southwest. Overview of spill extend and infrastructure.	2
	Site Name	EOG Resources – Osprey 10 CTB Release	11/13/2025

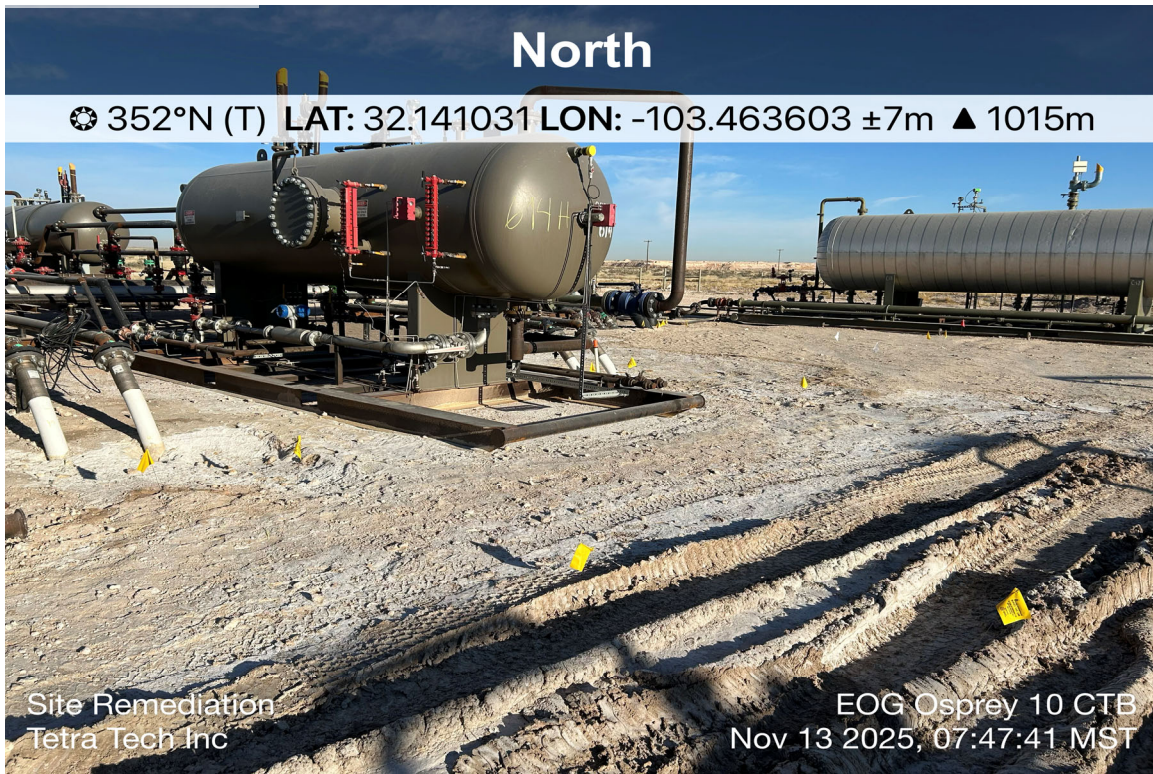
Tetra Tech Inc.	Description	View North. View of spill extend and battery equipment.	3
	Site Name	EOG Resources – Osprey 10 CTB Release	11/13/2025

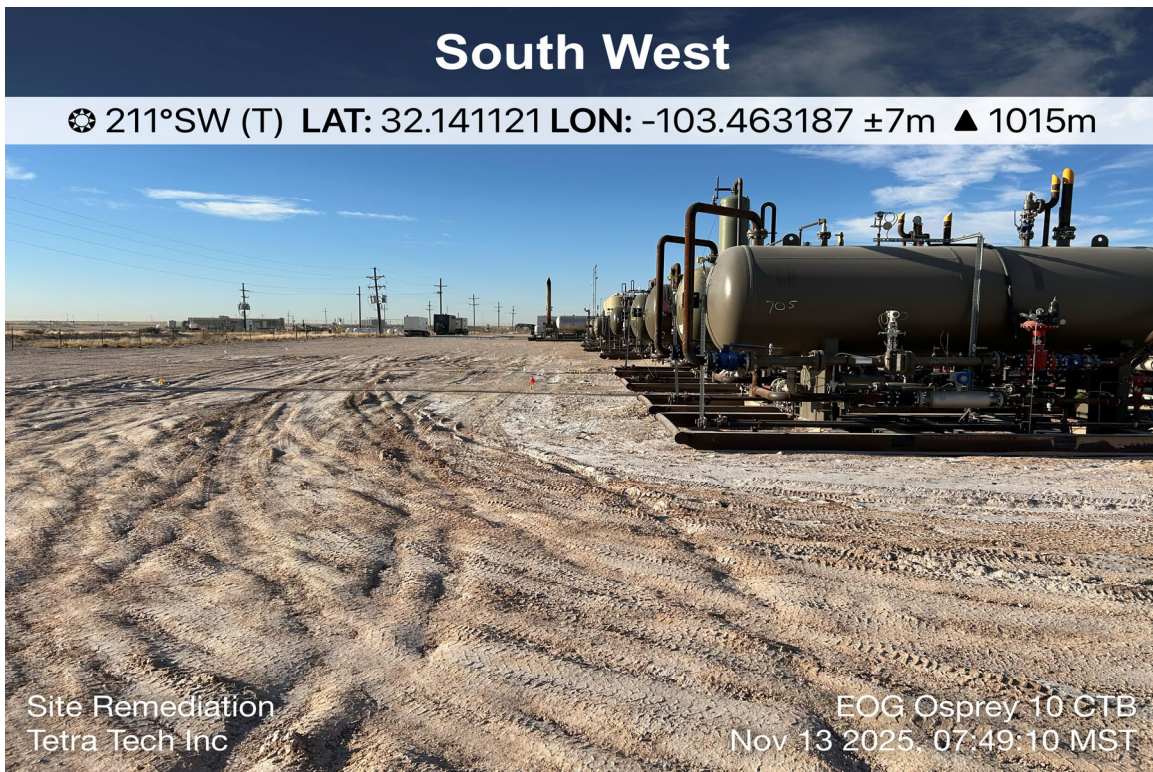
Tetra Tech Inc.	Description	View West. Overview on the infrastructure in place on top of spill extend.	4
	Site Name	EOG Resources – Osprey 10 CTB Release	11/13/2025
