**Re: Closure Request
Big Sinks 02-24-30
Facility ID: fAPP2123046888
Incident Numbers nAPP2524850355 and nAPP2531439100
Eddy County, New Mexico**

Ensolum, LLC (Ensolum), on behalf of XTO Energy, Inc. (XTO), has prepared this *Closure Request* to document a liner integrity inspection and delineation activities performed at the Big Sinks 02-24-30 (Site). The purpose of the remedial activities was to identify potential impacts to soil resulting from two releases of crude oil and produced water within a steel-walled, lined containment housing multiple tanks and associated process piping. XTO is submitting this *Closure Request*, describing the findings of the liner integrity inspection and delineation activities that have occurred, and requesting closure for Incident Numbers nAPP2524850355 and nAPP2531439100.

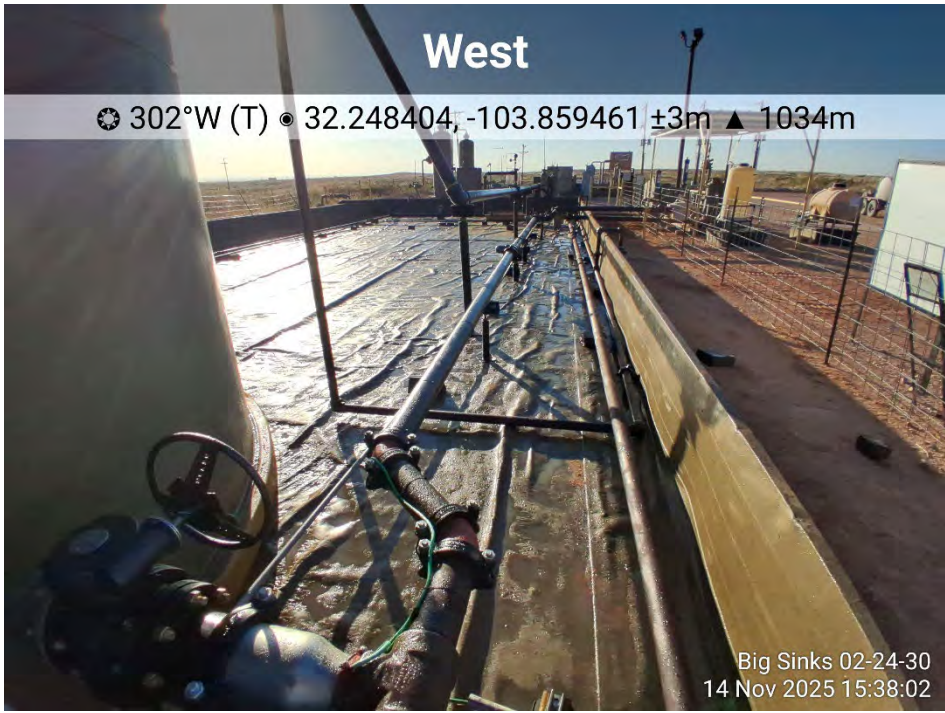
<p><u>Photograph</u> 3</p>	<p><u>Date</u> 11/14/2025</p>

<p>West</p> <p>☉ 302°W (T) • 32.248404, -103.859461 ±3m ▲ 1034m</p> <p>Big Sinks 02-24-30 14 Nov 2025 15:38:02</p>
<p><u>Description</u> Liner inspection activities</p>		
<p><u>View</u> West</p>		
<p><u>Photograph</u> 4</p>	<p><u>Date</u> 11/14/2025</p>

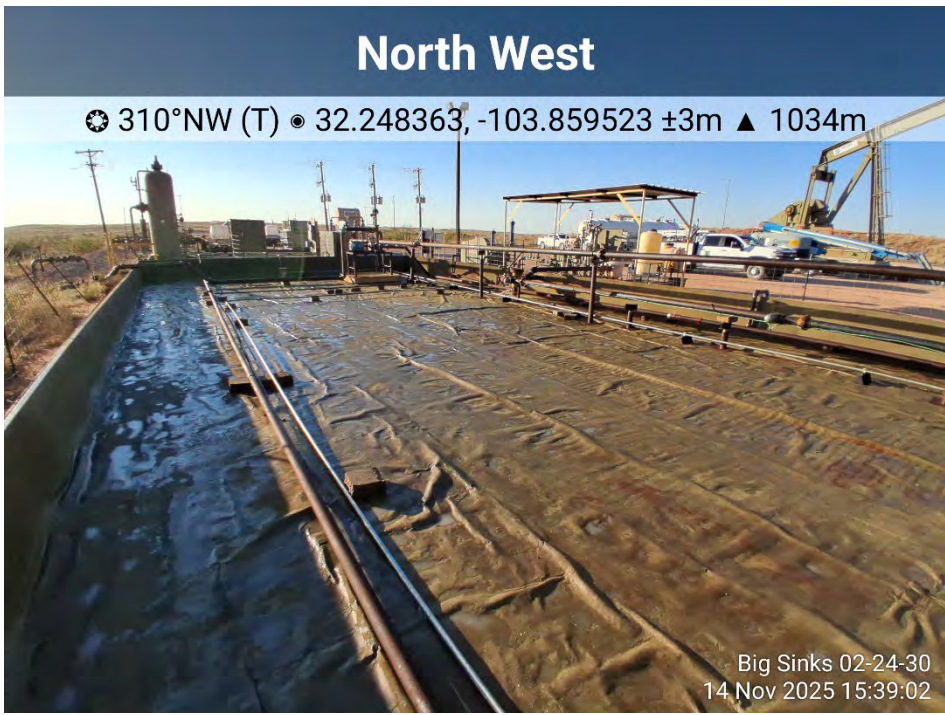
<p>North West</p> <p>☉ 310°NW (T) • 32.248363, -103.859523 ±3m ▲ 1034m</p> <p>Big Sinks 02-24-30 14 Nov 2025 15:39:02</p>
<p><u>Description</u> Liner inspection activities</p>		
<p><u>View</u> North</p>

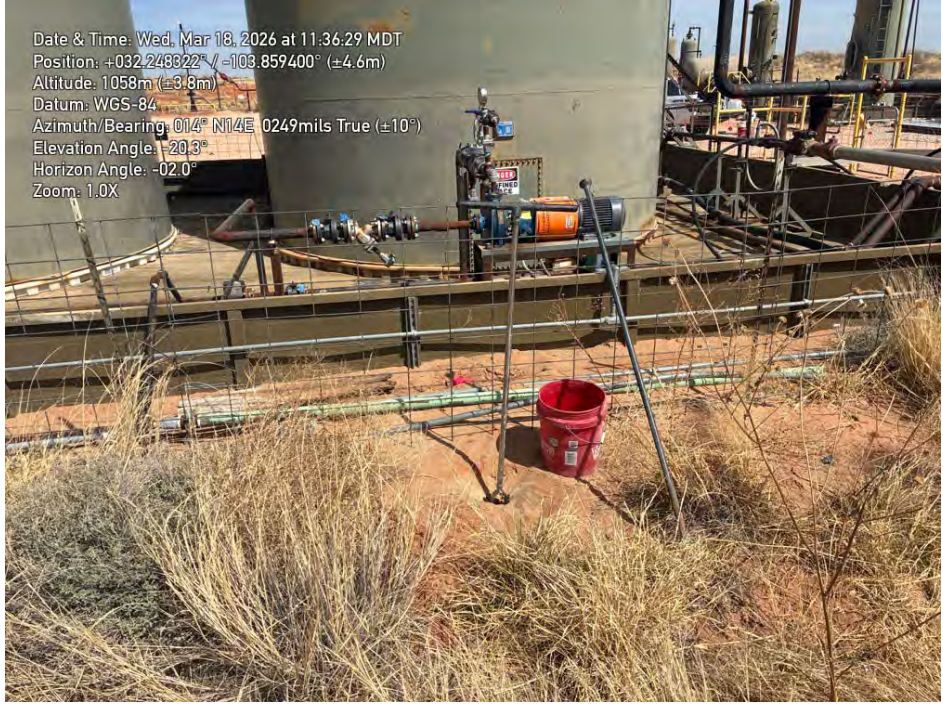
<p>Photograph 11</p>	<p>Date 03/18/2026</p>	<p>Date & Time: Wed, Mar 18, 2026 at 11:36:29 MDT Position: +032.248822° / -103.859400° (±4.6m) Altitude: 1058m (±3.8m) Datum: WGS-84 Azimuth/Bearing: 014° N14E 0249mils True (±10°) Elevation Angle: -20.3° Horizon Angle: -02.0° Zoom: 1.0X</p>

<p>Description Additional delineation activities, BH02</p>		
<p>View North</p>		
<p>Photograph 12</p>	<p>Date 03/18/2026</p>	<p>Date & Time: Wed, Mar 18, 2026 at 11:43:29 MDT Position: +032.248308° / -103.859509° (±7.5m) Altitude: 1058m (±5.9m) Datum: WGS-84 Azimuth/Bearing: 358° N02W 6364mils True (±10°) Elevation Angle: -22.5° Horizon Angle: +01.6° Zoom: 1.0X</p>

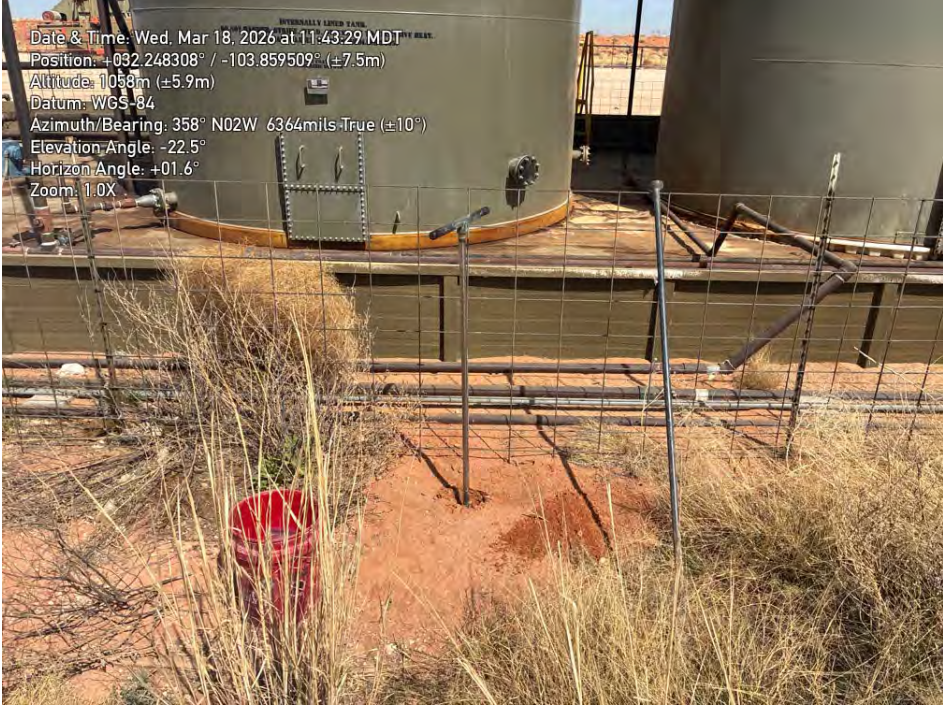
<p>Description Additional delineation activities, BH03</p>		
<p>View North</p>
