**Closure Report**  
**Boyd Y CTB (08.07.2025)**  
**Incident ID: nAPP2521940601**  
**Eddy County, New Mexico**  
**Unit O, Sec 14, T19S R25E**  
**32.655308°, -104.454257°**

### Crude Oil Release

**Point of Release: Fluids Routed to High-Pressure Flare Causing a Fire.**

**Prepared by:**  
**Carmona Resources, LLC**  
**310 West Wall Street**  
**Suite 500**  
**Midland, Texas 79701**

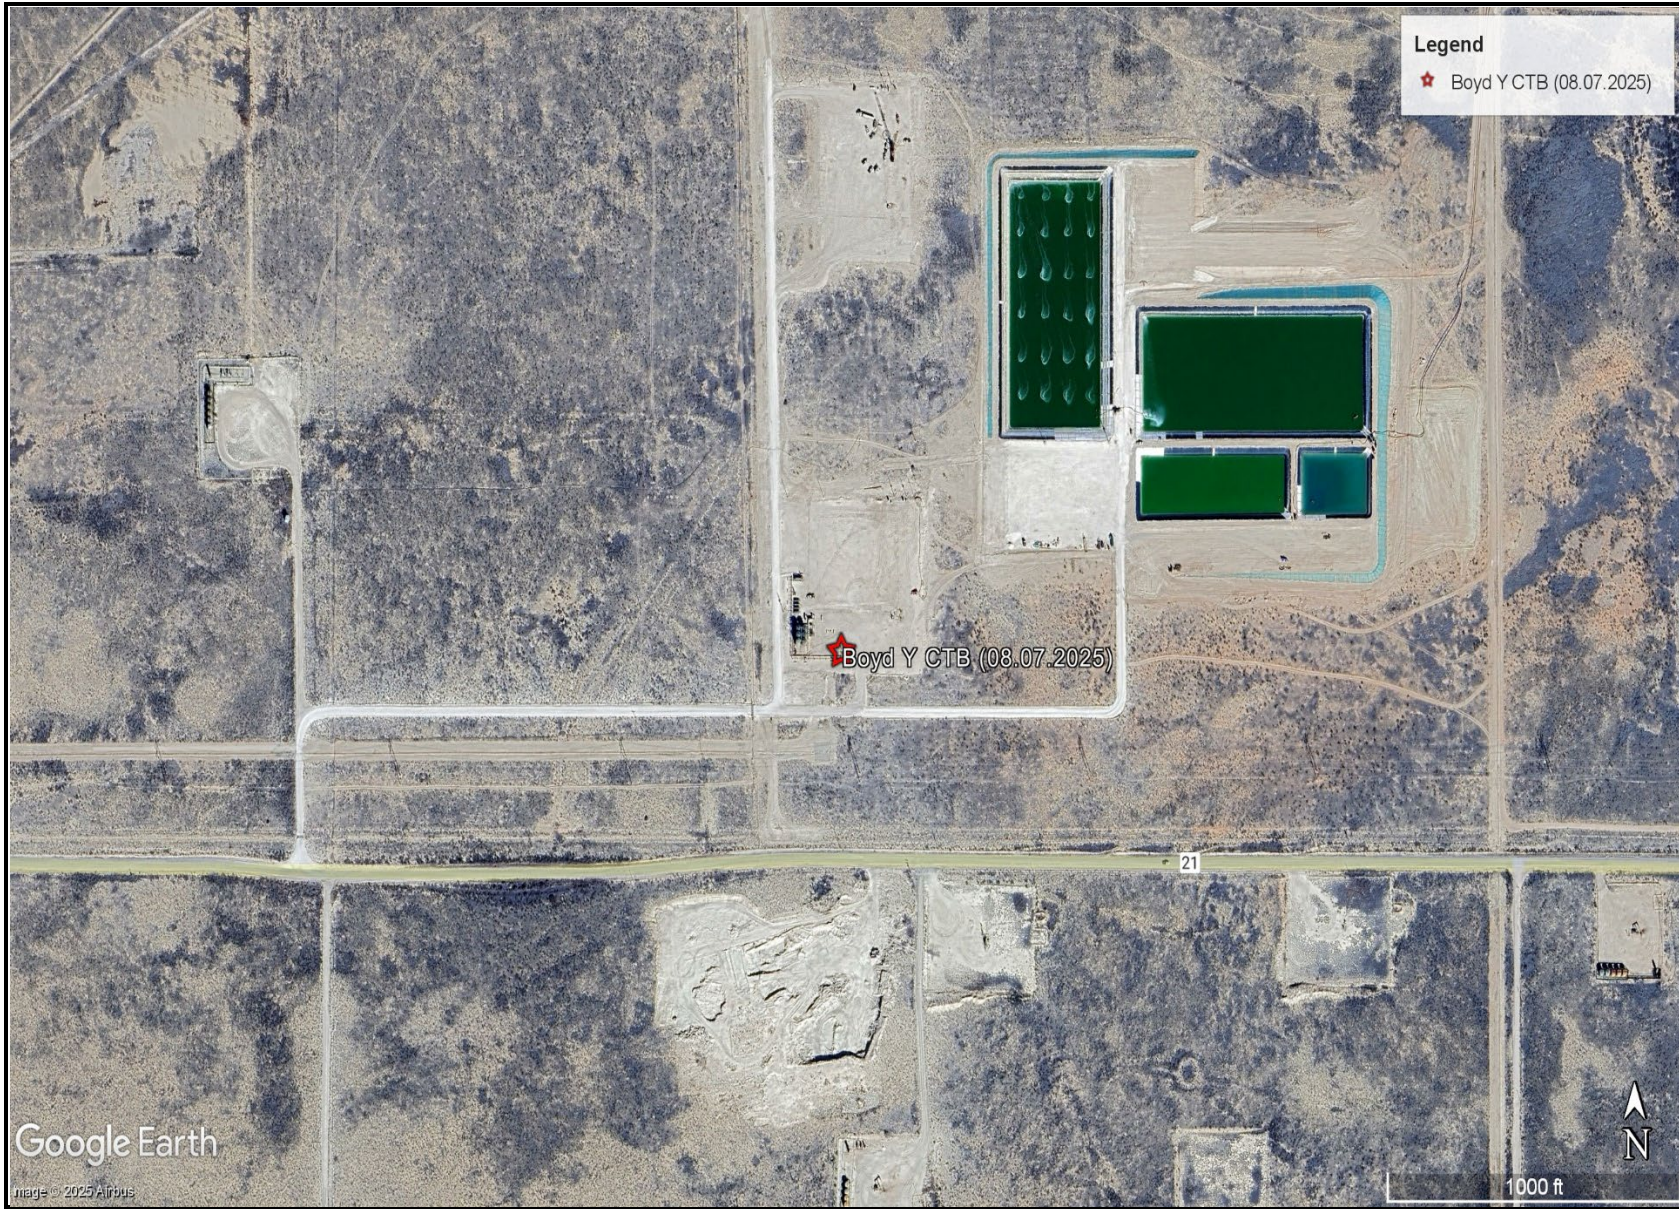
</p>	<p>FIGURE 1</p>
---	--	-----------------

<p>OVERVIEW MAP SILVERBACK EXPLORATION BOYD Y CTB (08.07.2025) EDDY COUNTY, NEW MEXICO 32.655308, -104.454257</p>	<p>CARMONA RESOURCES

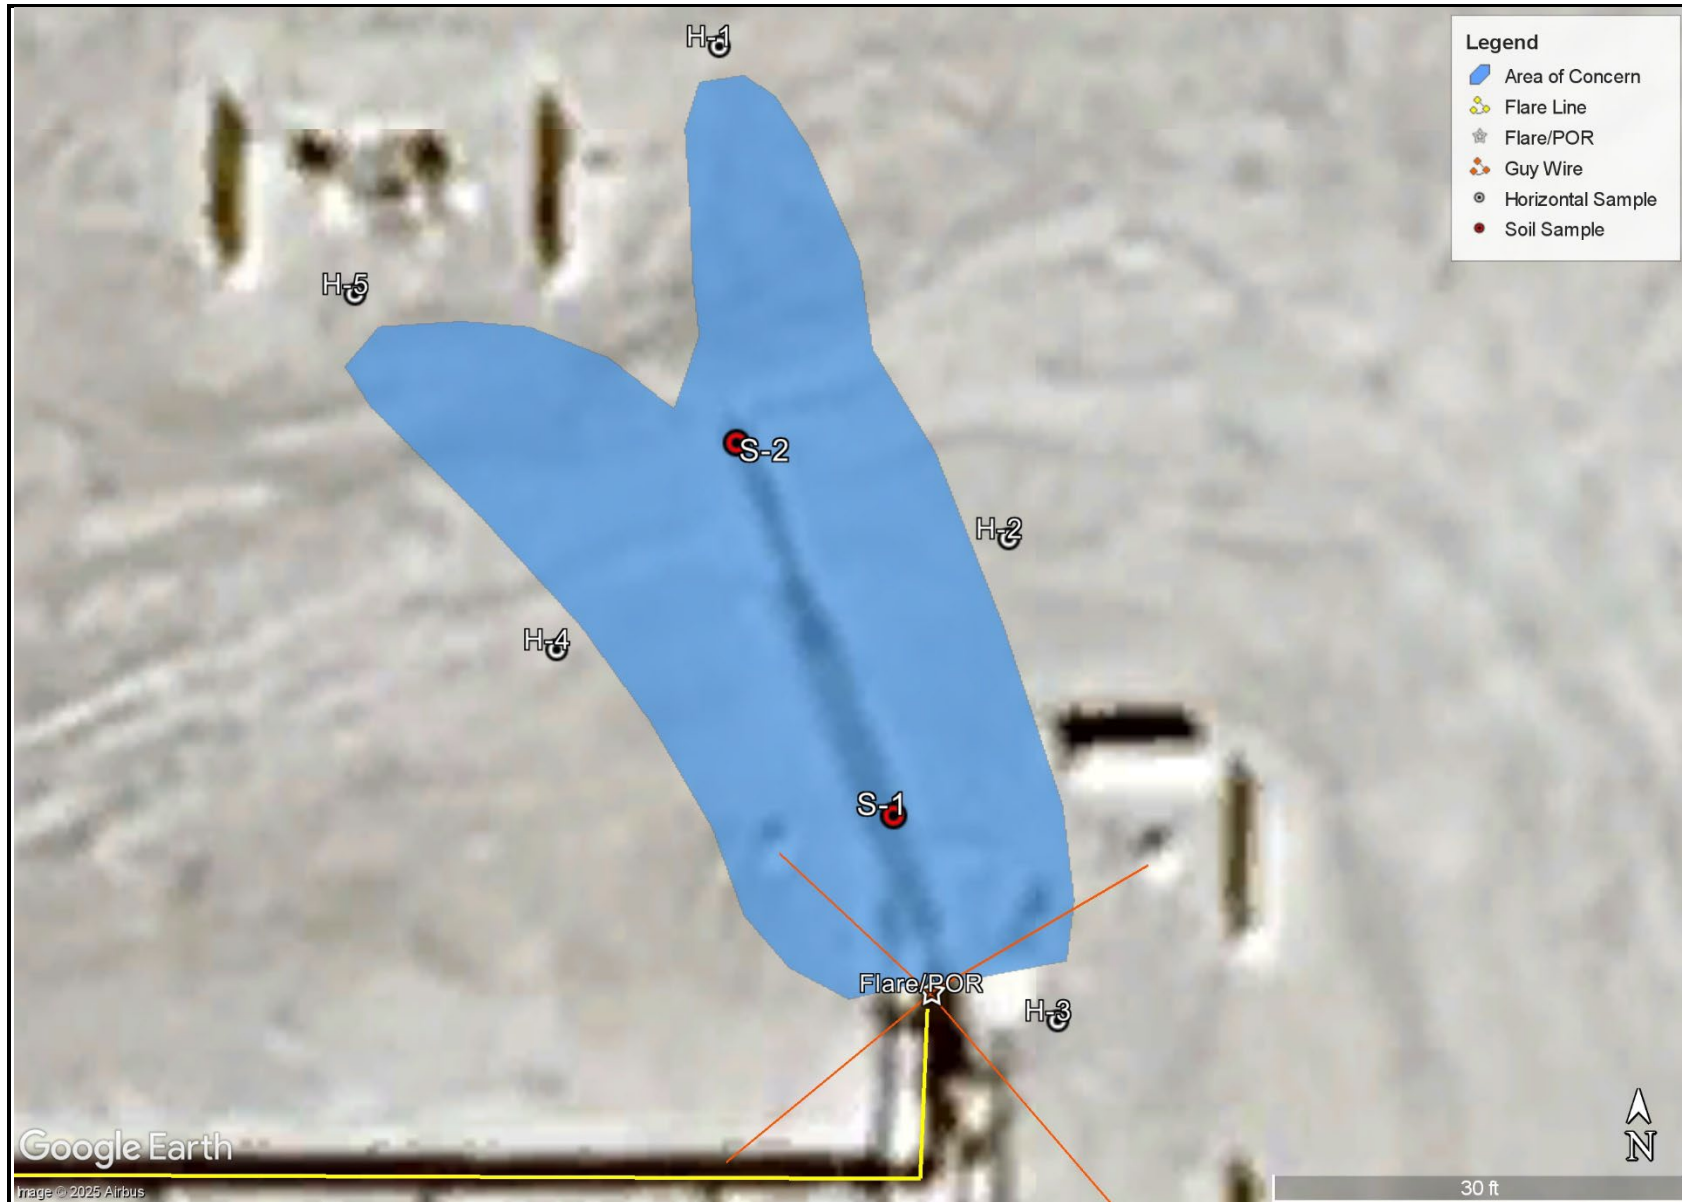
</p>	<p>FIGURE 3</p>
--	--	-----------------

<p>SAMPLE LOCATION MAP SILVERBACK EXPLORATION BOYD Y CTB (08.07.2025) EDDY COUNTY, NEW MEXICO 32.655308, -104.454257</p>	<p>CARMONA RESOURCES

Based on the initial C-141 obtained from the New Mexico Oil Conservation Division (NMOCD), the release was discovered on August 7, 2025, due to a liquid level switch not engaging at the heater and flare knockout. This caused fluids to be routed to the high-pressure flare, which then caught fire. It resulted in approximately two (2) barrels of crude oil being released on pad, with zero (0) barrels recovered. The release area is approximately 2,515 sq ft. The spill boundaries are shown in Figure 3. The initial C-141 form is attached in Appendix C.

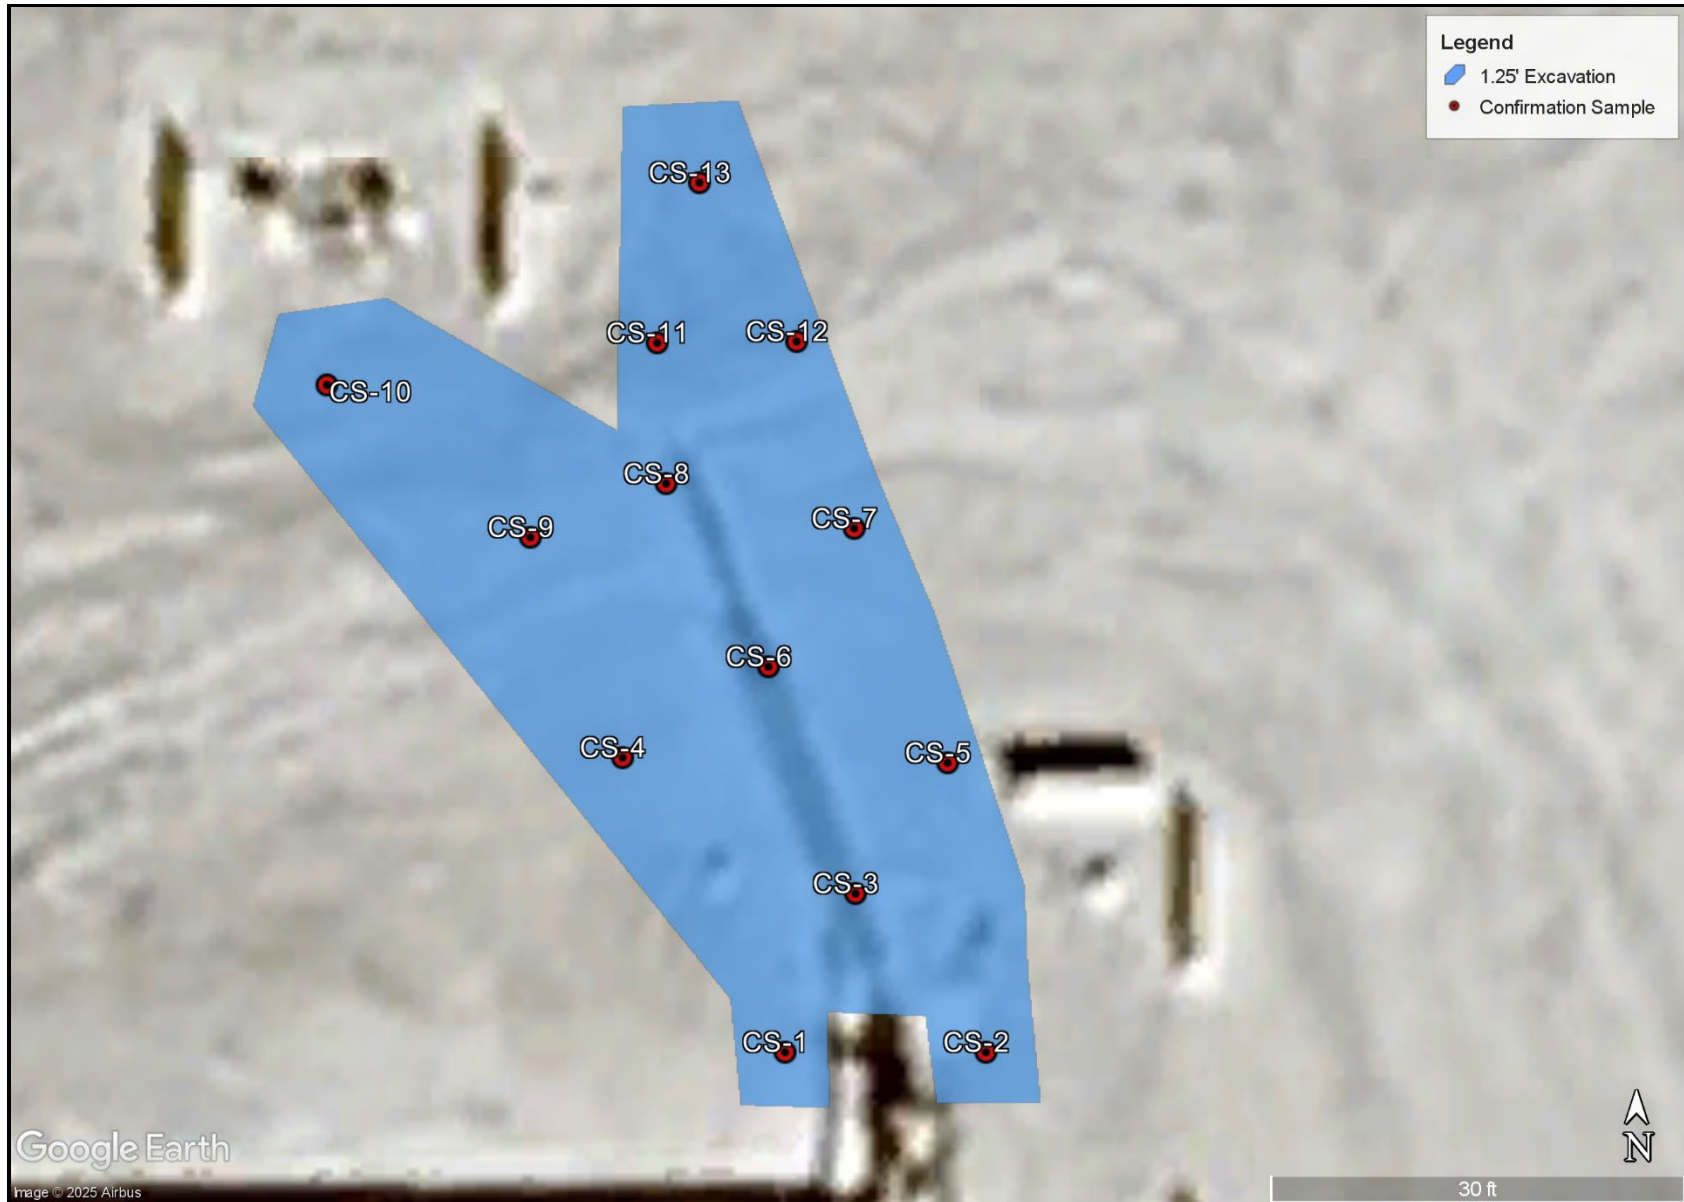
</p>	<p>FIGURE 4A</p>
---	--	------------------

<p>EXCAVATION DEPTH MAP SILVERBACK EXPLORATION BOYD Y CTB (08.07.2025) EDDY COUNTY, NEW MEXICO 32.655308, -104.454257</p>	<p>CARMONA RESOURCES

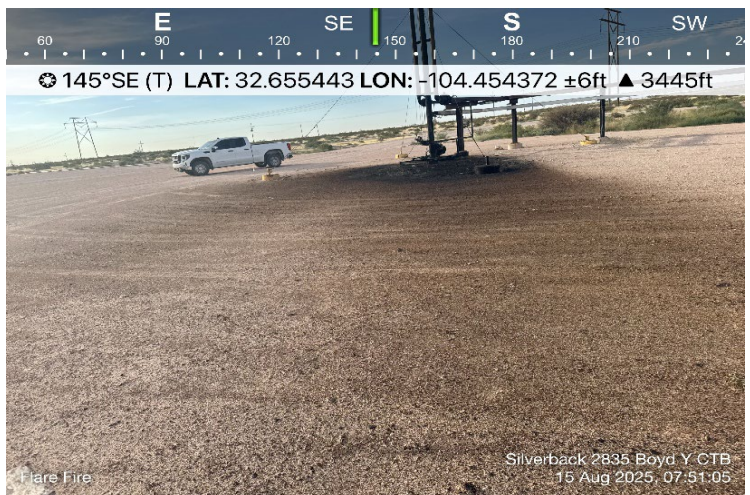
### Photograph No. 3

**Description:**  
View Southeast of the area of concern.

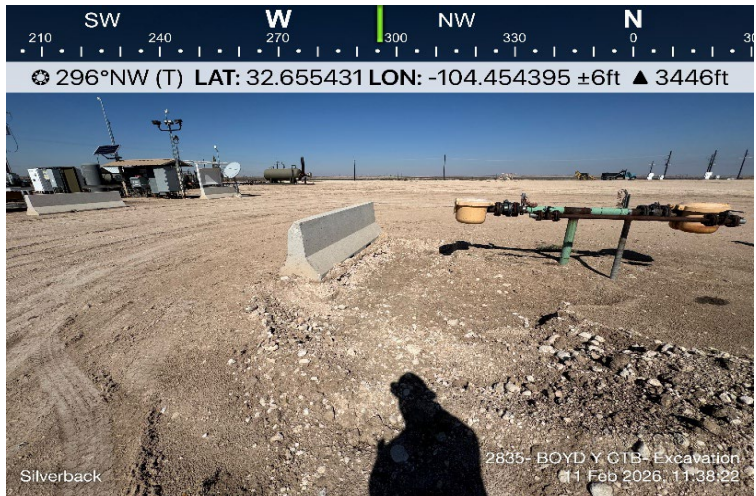
**Description:**  
View Northwest of CS-1 and CS-2.

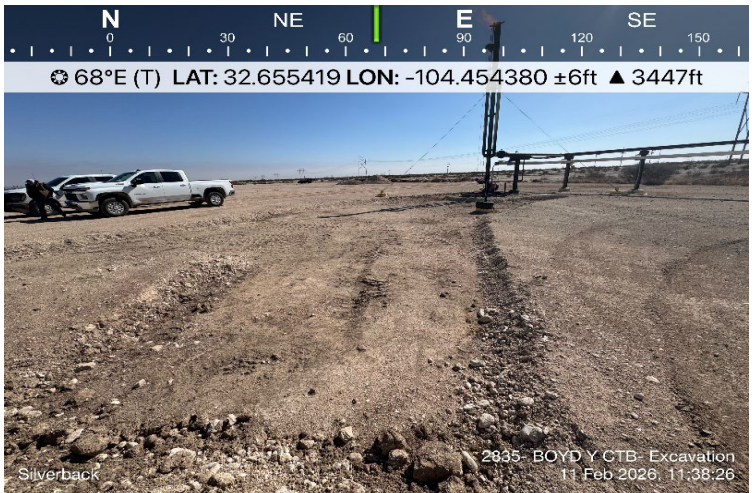
### Photograph No. 5

**Description:**  
View East of CS-3 through CS-13.

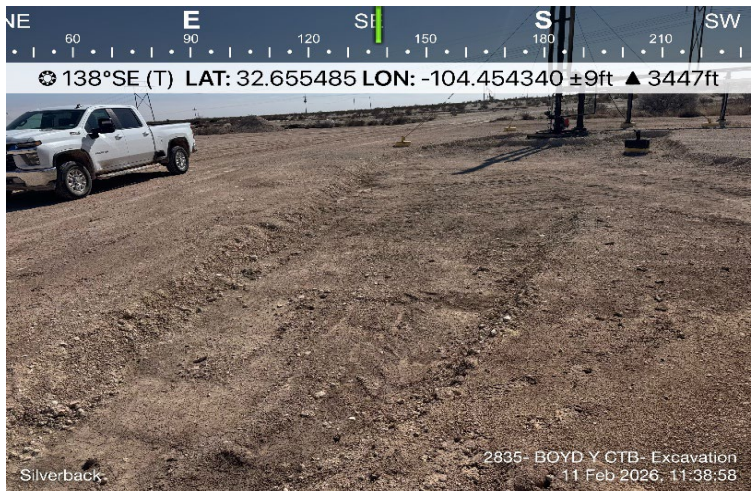
### Photograph No. 6

**Description:**  
View Southeast of CS-5 through CS-13.
