Incident Number: nAPP2529639365

Remediation Assessment and Deferral

White Dove 17 CTB 3

Vertex File Number: 25A-05744

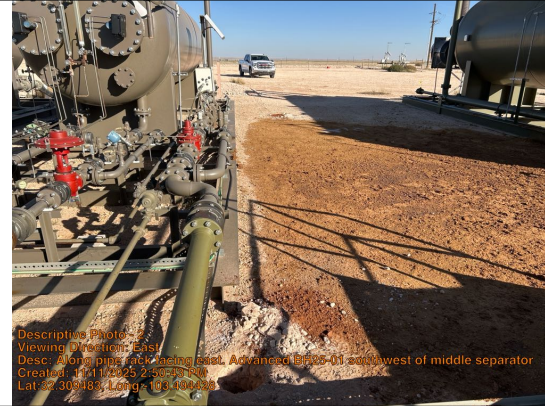
Viewing Direction: East

Along pipe rack facing east. Advanced BH25-01 southwest of middle separator.

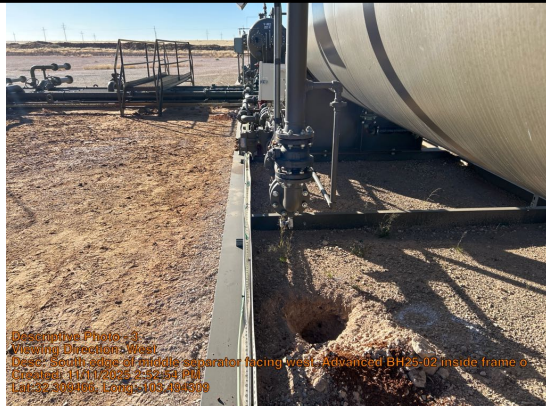
Viewing Direction: West

South edge of middle separator facing west. Advanced BH25-02 inside frame of middle separator.

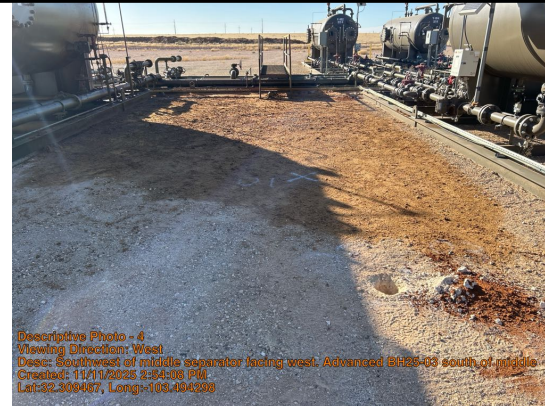
Viewing Direction: West

Southwest of middle separator facing west. Advanced BH25-03 south of middle separator.

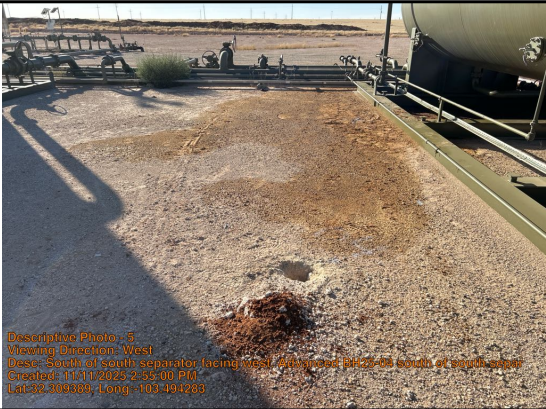
Description Photo: 3
Viewing Direction: West
Desc: South of south separator facing west. Advanced BH25-04 south of south separator.
Created: 11/11/2025 2:35:00 PM
Lat: 32.309689, Long: -103.491288

South of south separator facing west.
Advanced BH25-04 south of south separator.

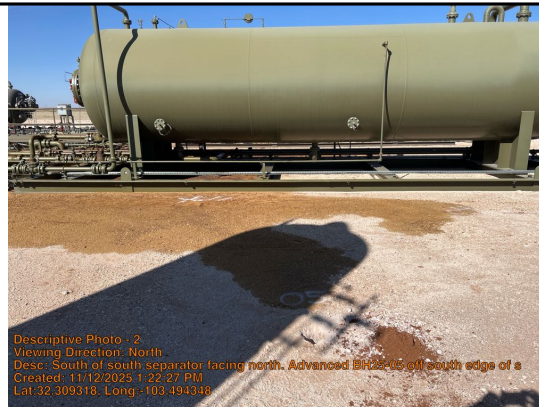
Descriptive Photo - 2
Viewing Direction: North
Desc: South of south separator facing north. Advanced BH25-05 off south edge of a
Created: 11/12/2025 1:22:27 PM
Lat: 32.309318, Long: -103.494348

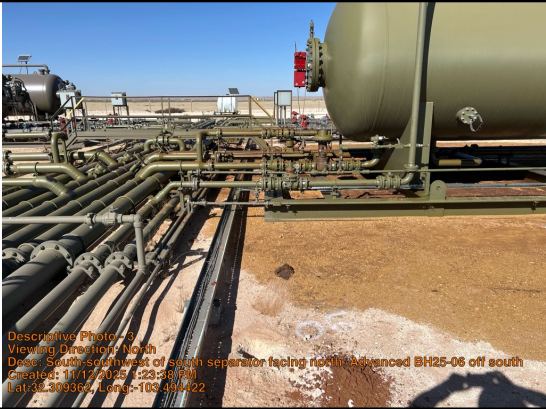
Descriptive Photo - 4
Viewing Direction: North
Desc: South-southwest of south separator facing north. Advanced BH25-06 off southwest edge of stained area.
Created: 11/12/2025 1:23:38 PM
Lat:32.309363, Long:-103.494422

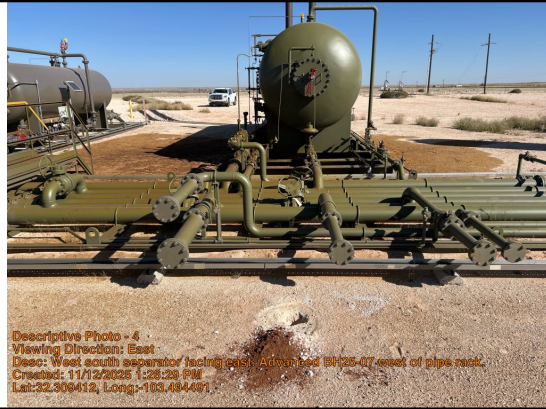
Descriptive Photo - 4
Viewing Direction: East
Desc: West south separator facing east. Advanced BH25-07 west of pipe rack.
Created: 11/12/2025 1:28:29 PM
Lat:32.309412, Long:-103.494491

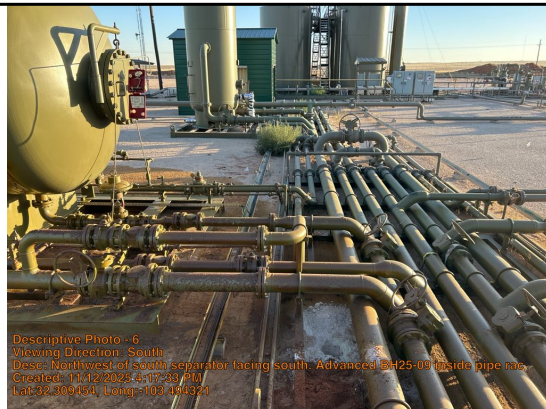
Descriptive Photo - 6
Viewing Direction: South
Desc: Northwest of south separator facing south. Advanced BH25-09 inside pipe rack and stained area.
Created: 11/12/2025 1:17:29 PM
Lat:32.309454, Long:-103.494324

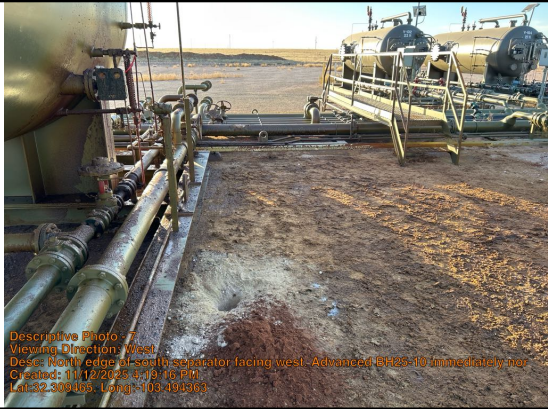
Descriptive Photo - 7
Viewing Direction: West
Desc: North edge of south separator facing west. Advanced BH25-10 immediately north of south separator near release point.
Created: 11/12/2025 4:19:16 PM
Lat:32.309085, Long:-103.490367

North edge of south separator facing west.
Advanced BH25-10 immediately north of south separator near release point.

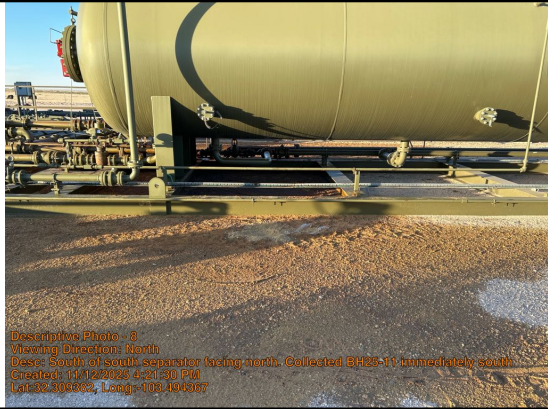
Descriptive Photo - 8
Viewing Direction: North
Desc: South of south separator facing north. Collected BH25-11 immediately south of south separator.
Created: 11/12/2025 4:21:30 PM
Lat:32.309085, Long:-103.490367

South of south separator facing north.
Collected BH25-11 immediately south of south separator.

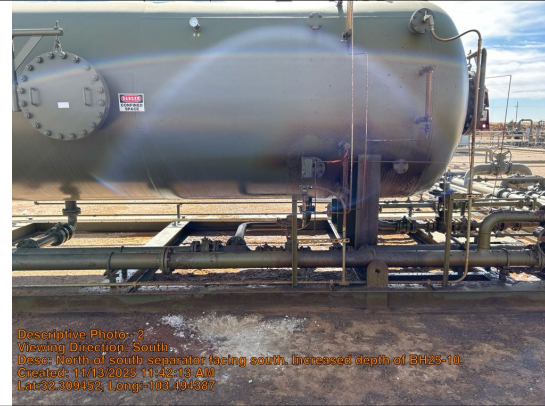
Viewing Direction: South

North of south separator facing south. Increased depth of BH25-10.

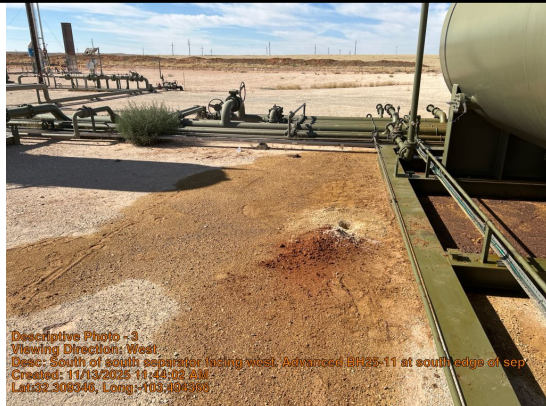
Viewing Direction: West

South of south separator facing west. Advanced BH25-11 at south edge of separator.

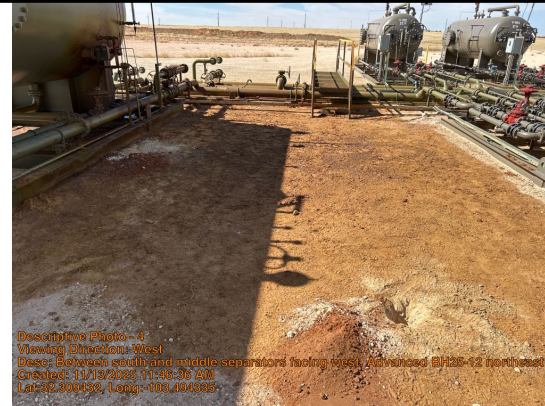
Viewing Direction: West

Between south and middle separators facing west. Advanced BH25-12 northeast of BH25-10.

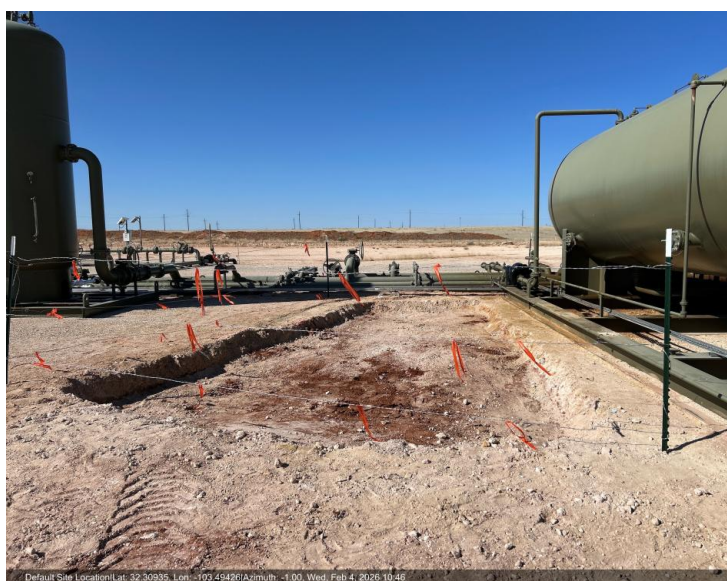
Date: 2/4/2026
Time: 10:45
Notes: Site view of the 1ft excavation
Latitude: 32.309352777777775
Longitude: -103.4942638888889
Direction: N

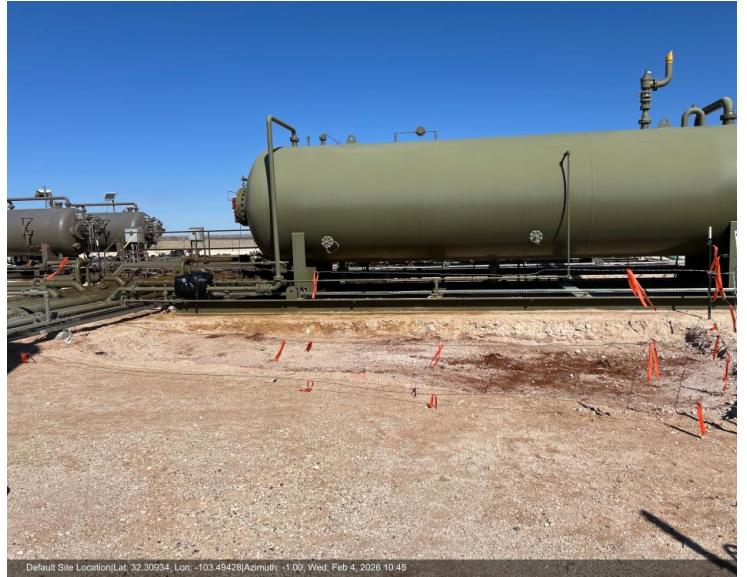
Date: 2/4/2026
Time: 10:45
Notes: Site view of the 1ft excavation
Latitude: 32.30934166666666
Longitude: -103.49427777777778
Direction: W

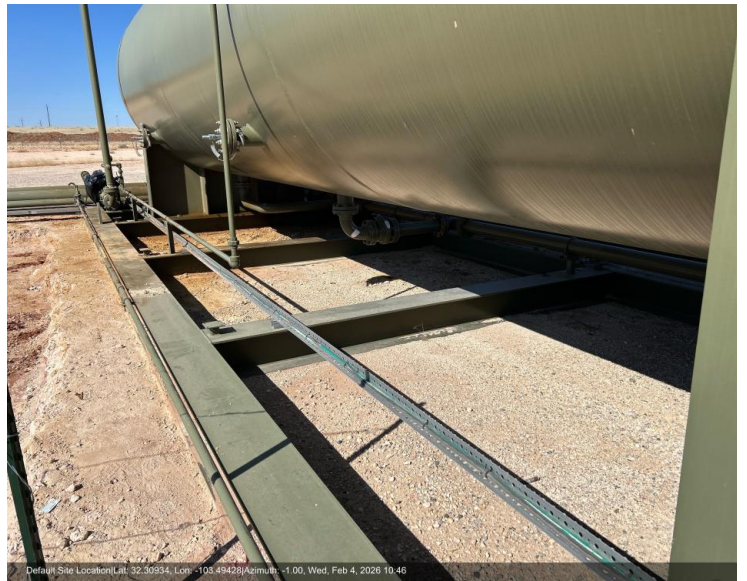
Date: 2/4/2026
Time: 10:46
Notes: Site view of area that was scraped
Latitude: 32.30934166666666
Longitude: -103.49427777777778
Direction: S

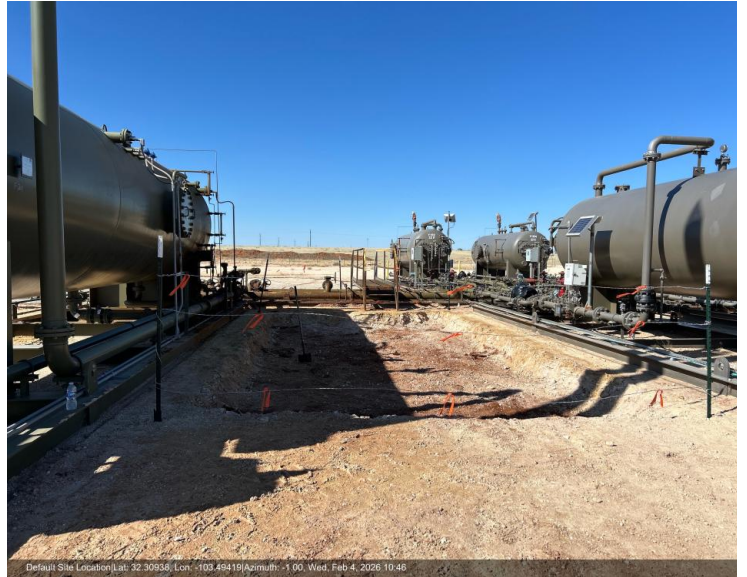
Date: 2/4/2026
Time: 10:46
Notes: Site view of 1ft excavation
Latitude: 32.30938333333333
Longitude: -103.49419444444445
Direction: NW

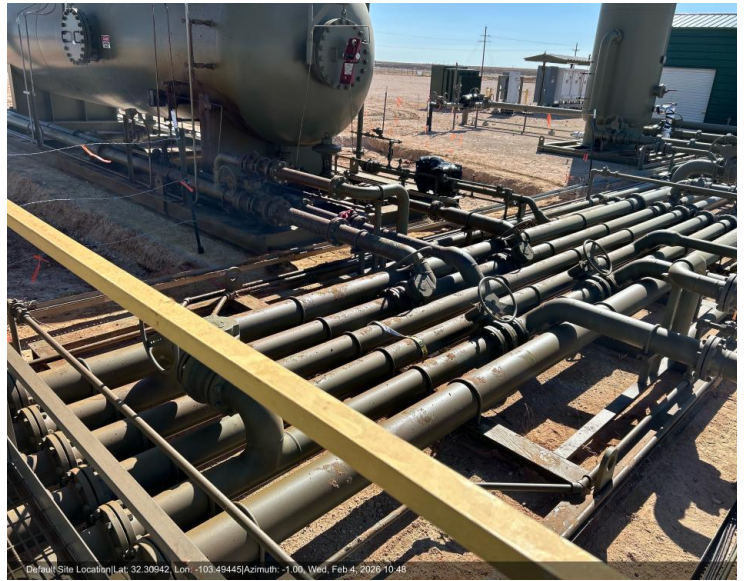
Date: 2/4/2026
Time: 10:48
Notes: Site view of area that was scraped
Latitude: 32.30942222222222
Longitude: -103.49445277777778
Direction: NW

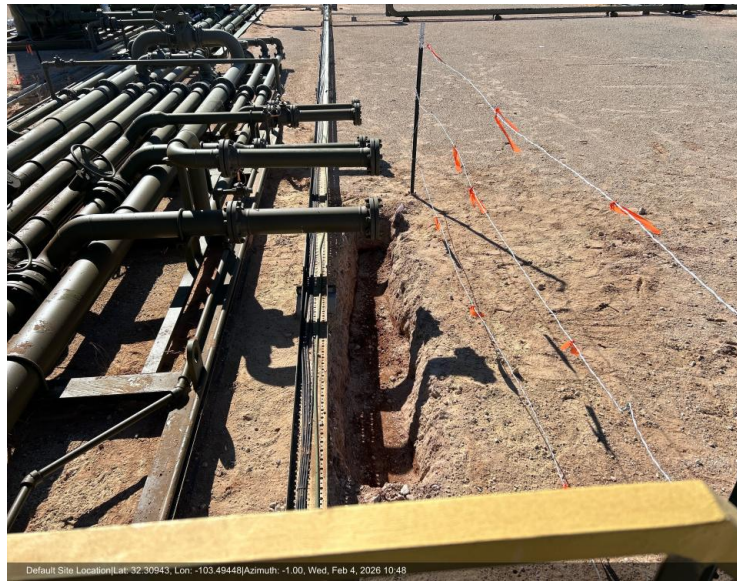
Date: 2/4/2026
Time: 10:48
Notes: Site view of 1ft excavation
Latitude: 32.30943333333333
Longitude: -103.49447777777777
Direction: N

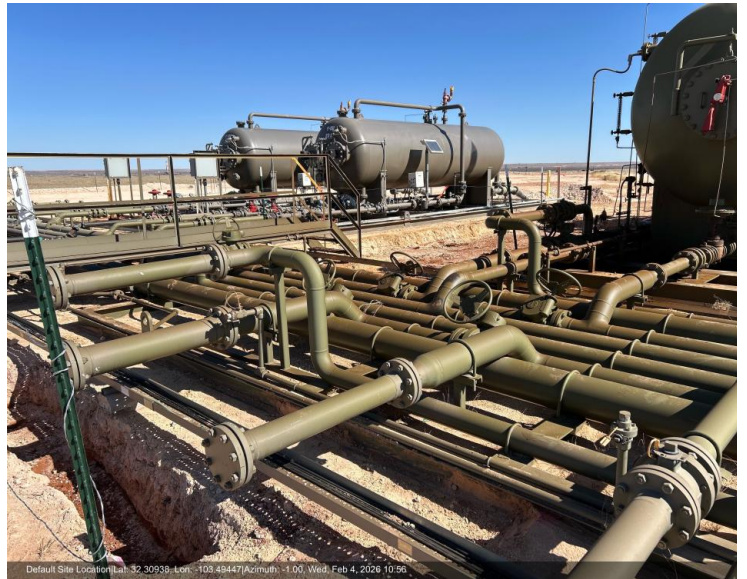
Date: 2/4/2026
Time: 10:56
Notes: Site view of area that was scraped
Latitude: 32.30938333333333
Longitude: -103.49446944444445
Direction: S

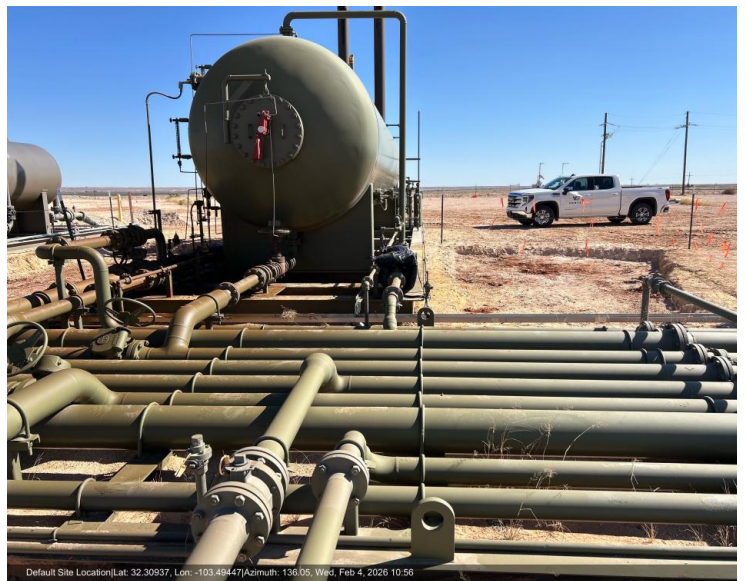
Date: 2/4/2026
Time: 10:56
Notes: Site view of area that was scraped
Latitude: 32.30937222222222
Longitude: -103.49446944444445
Direction: SE

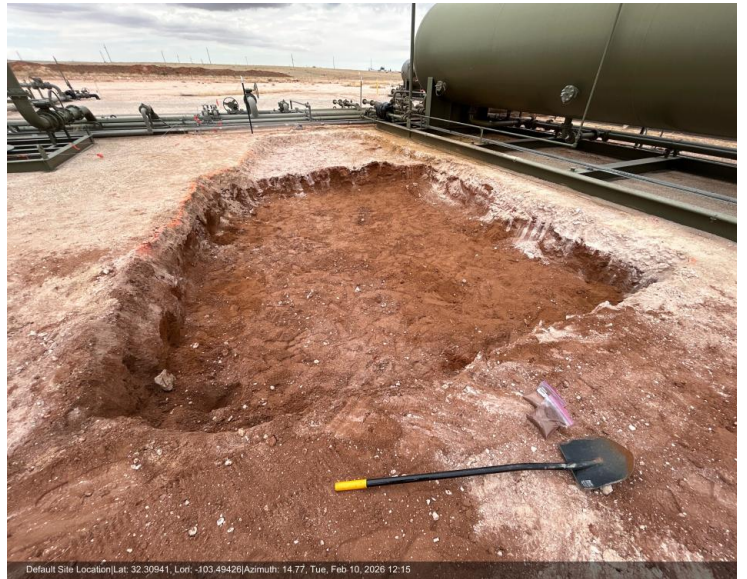
Date: 2/10/2026
Time: 12:15
Notes: South excavation after 1' vertical expansion and 1' south and east wall expansion
Latitude: 32.30941111111111
Longitude: -103.4942638888889
Direction: NW

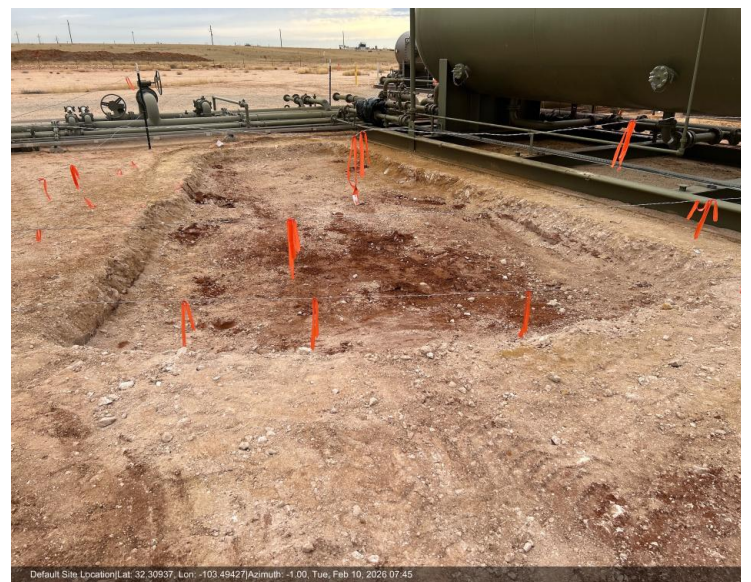
Date: 2/10/2026
Time: 07:45
Notes: Excavation south side of horizontal heater treater
Latitude: 32.309374999999996
Longitude: -103.49426944444444
Direction: NE

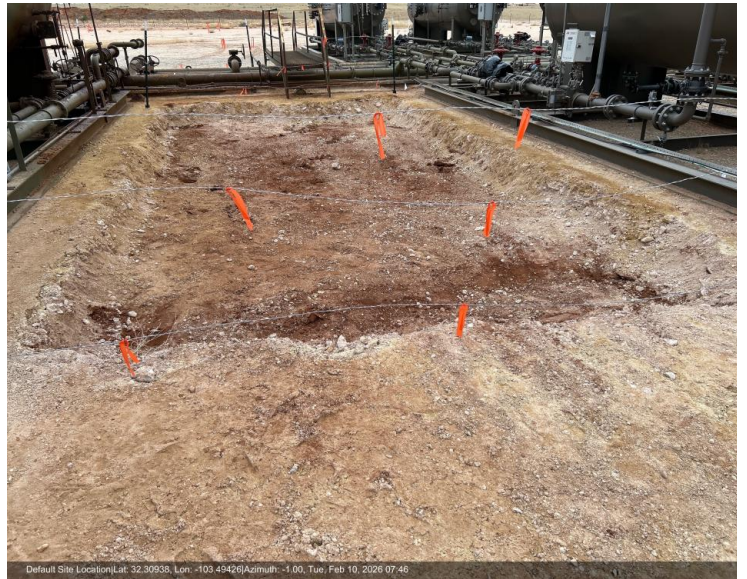
Date: 2/10/2026
Time: 07:46
Notes: Excavation north side of horizontal heater treater
Latitude: 32.30938055555556
Longitude: -103.4942638888889
Direction: E

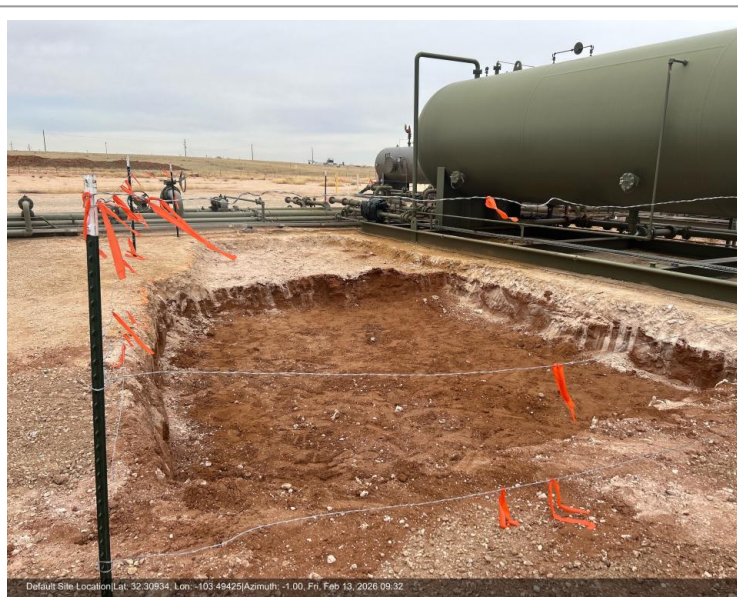
Date: 2/13/2026
Time: 09:28
Notes: Site view of the 1ft and 2ft excavation.
Latitude: 32.30934166666666
Longitude: -103.49424722222223
Direction: E

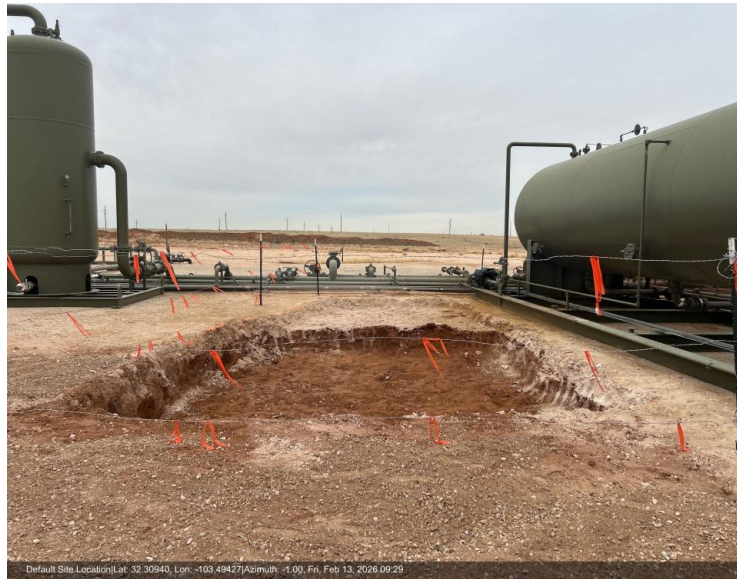
Date: 2/13/2026
Time: 09:29
Notes: Site view of the 1ft and 2ft excavation.
Latitude: 32.30940277777778
Longitude: -103.49426944444444
Direction: S

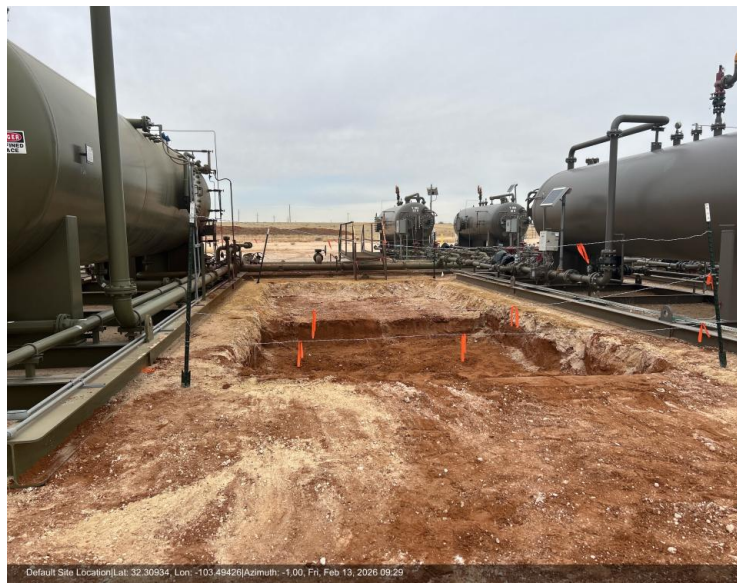
Date: 2/13/2026
Time: 09:29
Notes: Site view of the 1ft and 2ft excavation.
Latitude: 32.30933888888889
Longitude: -103.49425555555555
Direction: SW

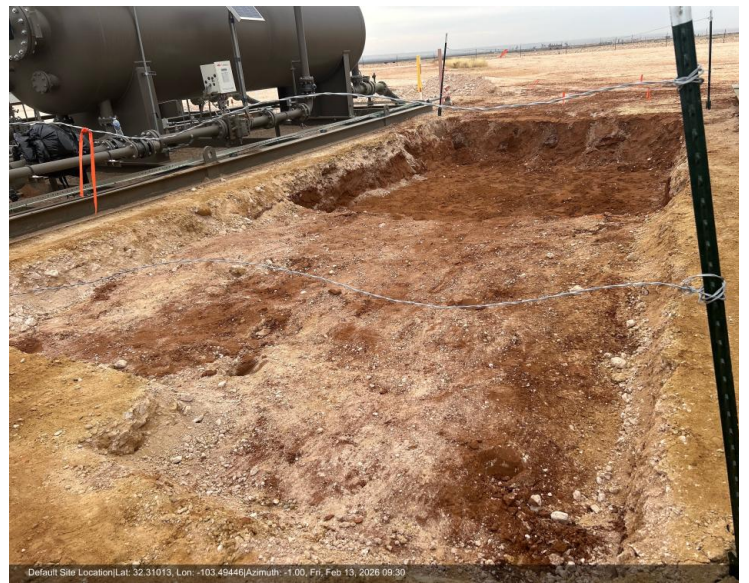
Date: 2/13/2026
Time: 09:30
Notes: Site view of the 1ft and 2ft excavation.
Latitude: 32.31013055555555
Longitude: -103.49446111111111
Direction: SE

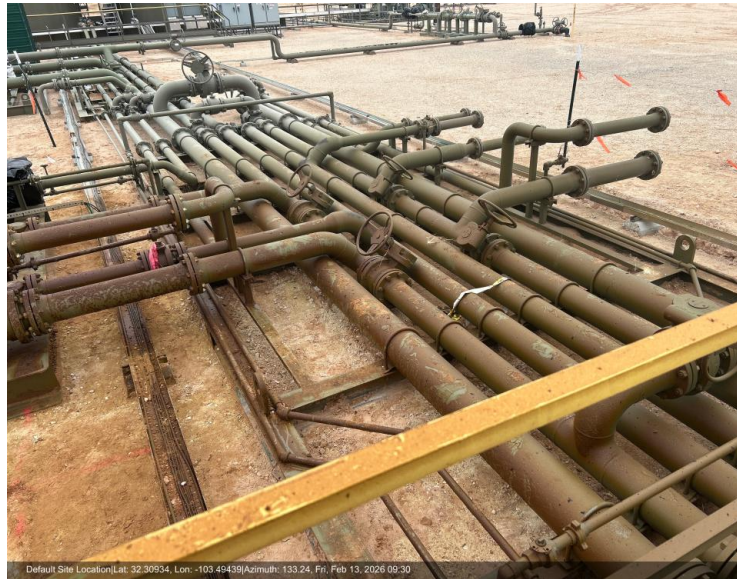
Date: 2/13/2026
Time: 09:30
Notes: Site view of area tha go scraped
Latitude: 32.30934166666666
Longitude: -103.49438611111111
Direction: E

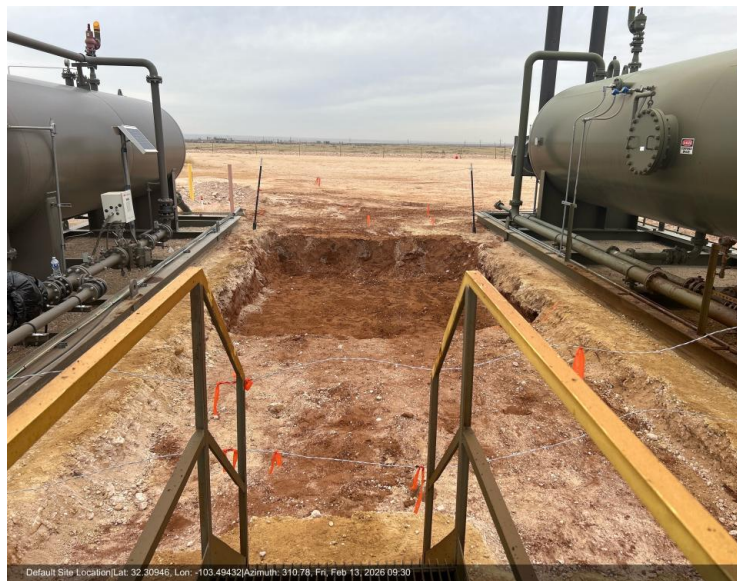
Date: 2/13/2026
Time: 09:30
Notes: Site view of the 1ft and 2ft excavation.
Latitude: 32.309463888888885
Longitude: -103.49432222222222
Direction: S

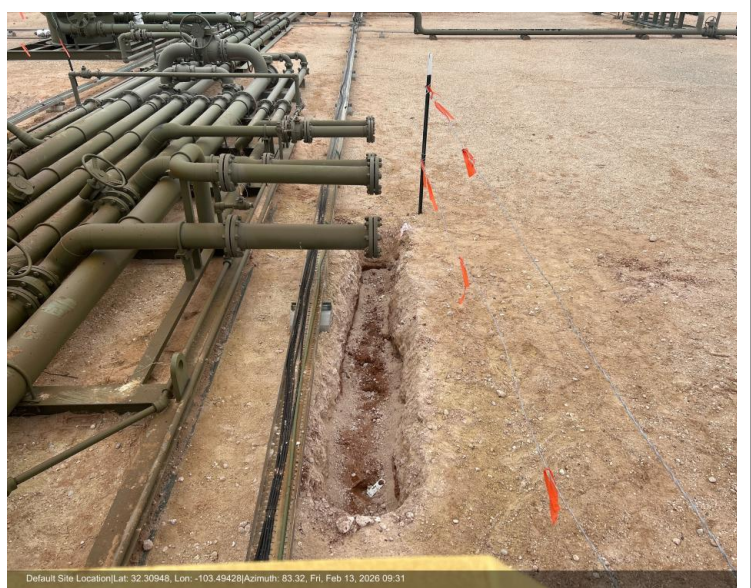
Date: 2/13/2026
Time: 09:31
Notes: Site view of the 1ft excavation
Latitude: 32.30948333333333
Longitude: -103.49427777777778
Direction: S

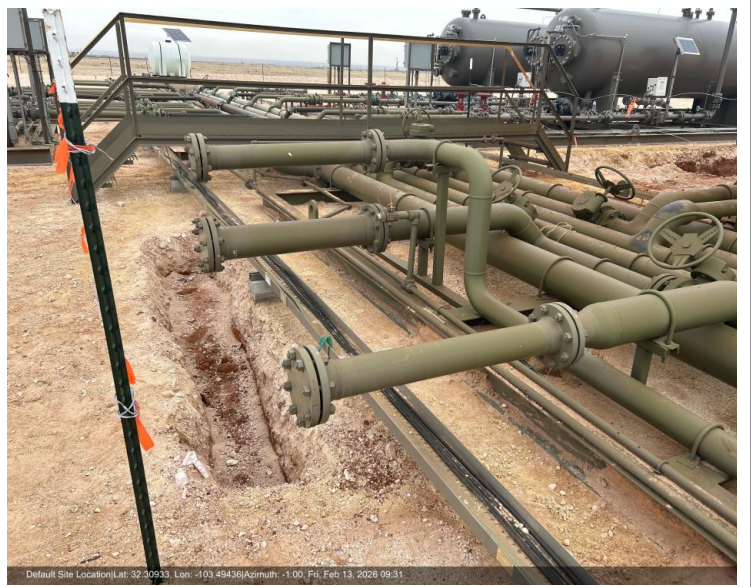
Date: 2/13/2026
Time: 09:31
Notes: Site view of the 1ft excavation and area that got scraped
Latitude: 32.309327777777774
Longitude: -103.49436111111112
Direction: N

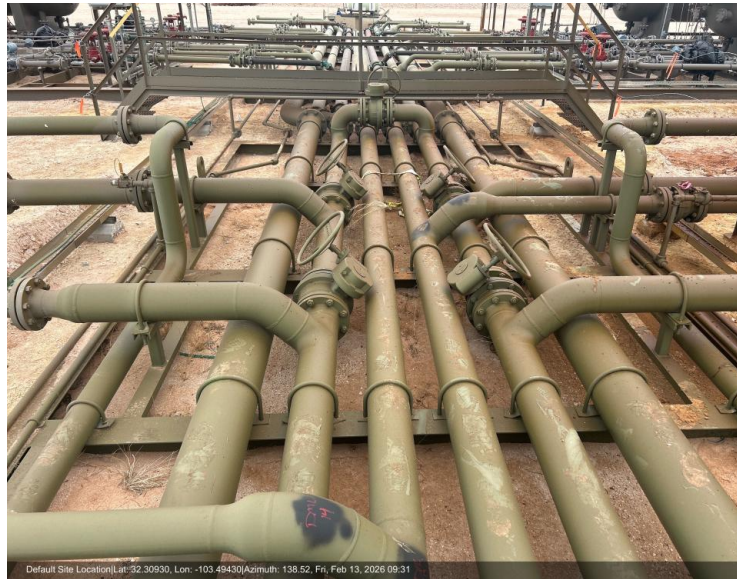
Date: 2/13/2026
Time: 09:31
Notes: Site view of area that got scraped
Latitude: 32.30930277777777
Longitude: -103.49430277777778
Direction: NW

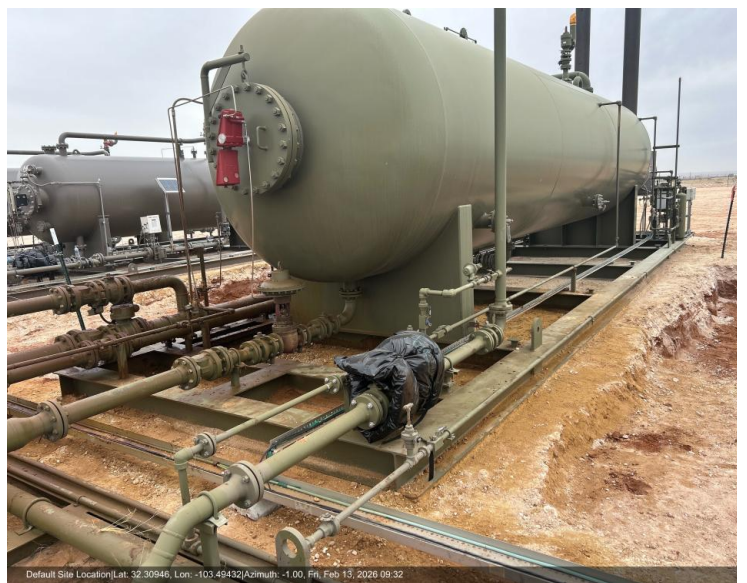
Date: 2/13/2026
Time: 09:32
Notes: Site view of area that got scraped
Latitude: 32.309461111111105
Longitude: -103.49432222222222
Direction: NW

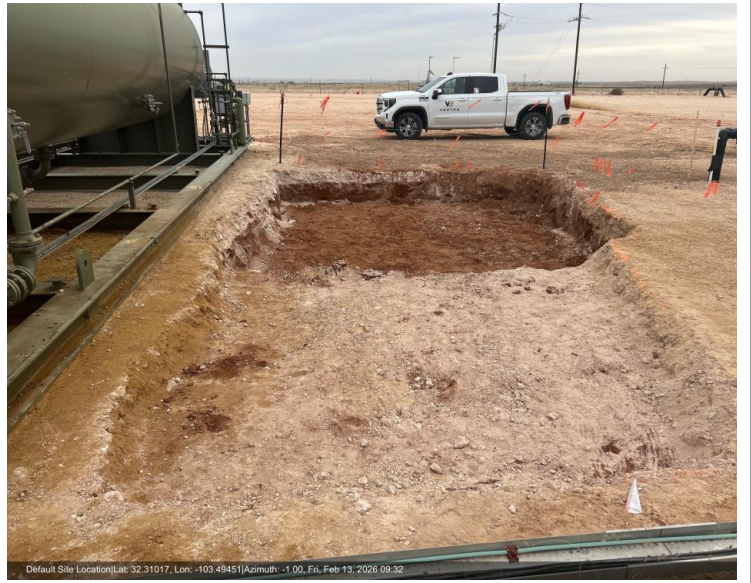
Date: 2/13/2026
Time: 09:32
Notes: Site view of the 1ft and 2ft excavation.
Latitude: 32.31016944444444
Longitude: -103.49450555555556
Direction: NW

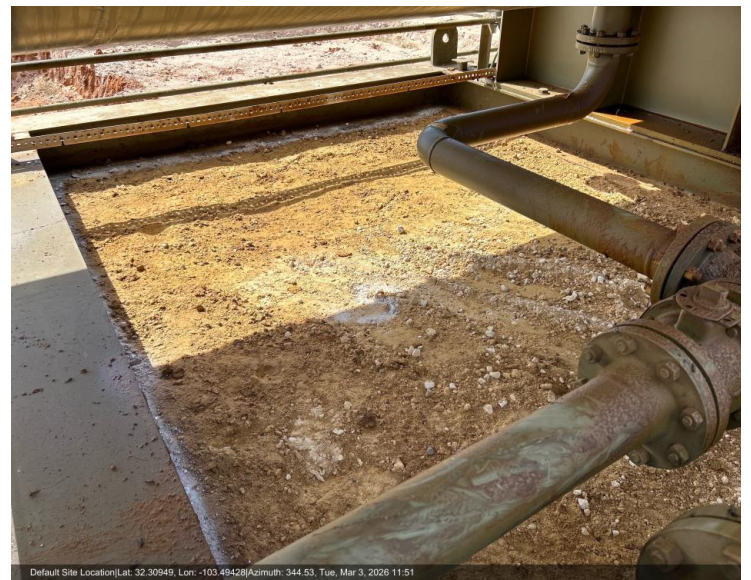
Date: 3/3/2026
Time: 11:17
Notes: Area under HT around BS26-06 to be taken down to .5' bgs.
Latitude: 32.309488888888886
Longitude: -103.49427777777778
Direction: SW

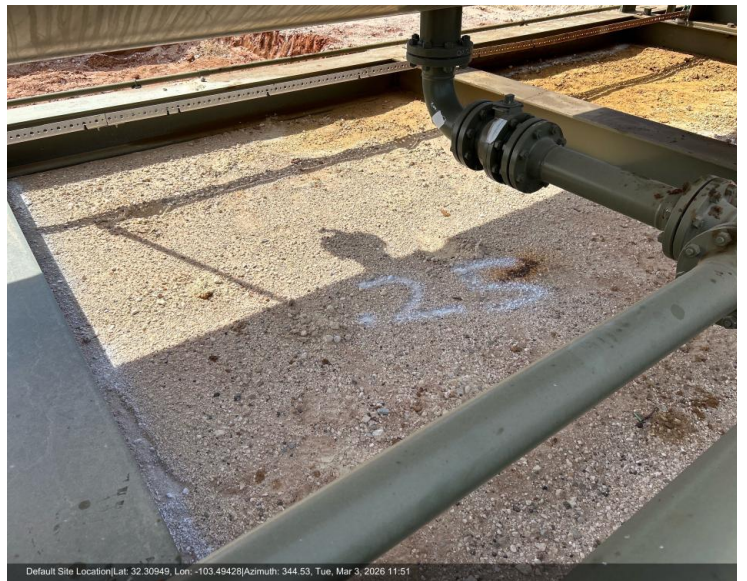
Date: 3/3/2026
Time: 11:17
Notes: Area east of BS26-06 which represents WS26-03 to be taken down .25'
Latitude: 32.309488888888886
Longitude: -103.49427777777778
Direction: SW

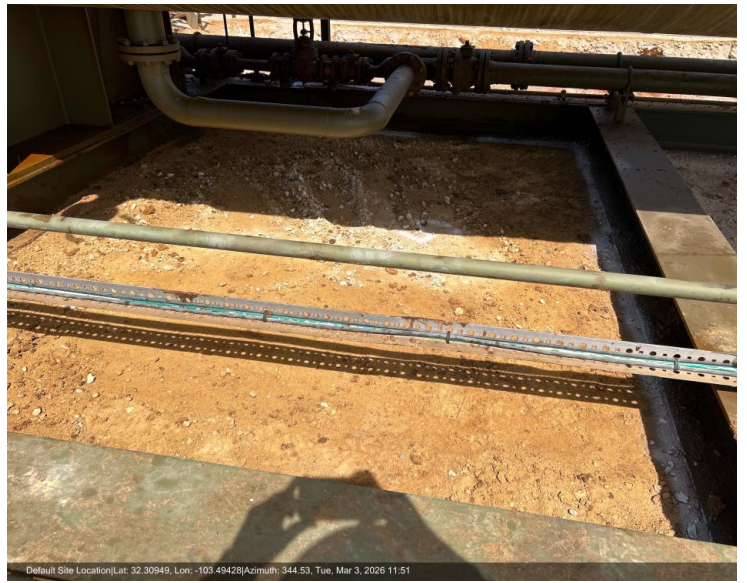
Date: 3/3/2026
Time: 11:17
Notes: Area under HT around BS26-06 to be taken down to .5' bgs.
Latitude: 32.309488888888886
Longitude: -103.49427777777778
Direction: SW

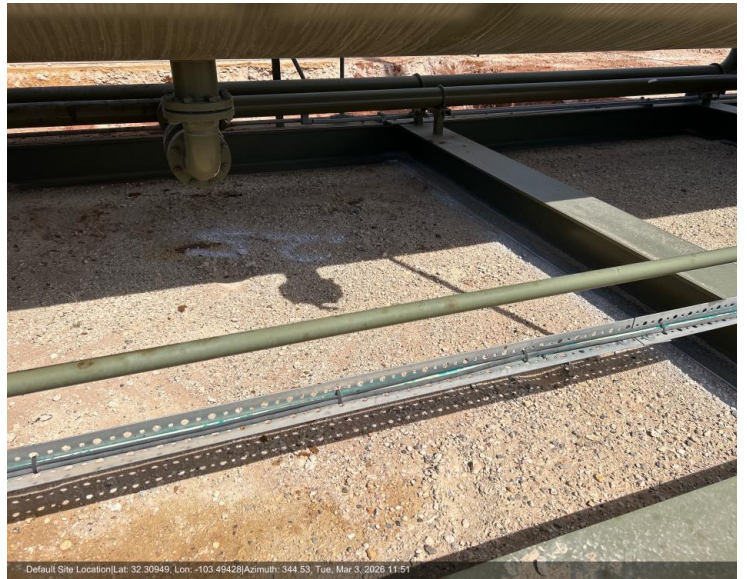
Date: 3/3/2026
Time: 11:17
Notes: Area under HT to be expanded .25' down and eastward by 6"
Latitude: 32.309488888888886
Longitude: -103.49427777777778
Direction: SW

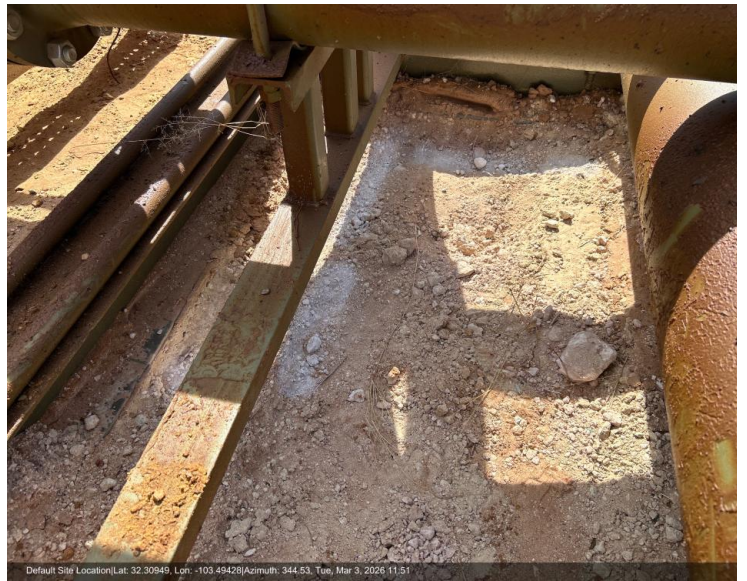
Date: 3/3/2026
Time: 11:17
Notes: SE corner of box around BS26-08
Latitude: 32.309488888888886
Longitude: -103.49427777777778
Direction: SW

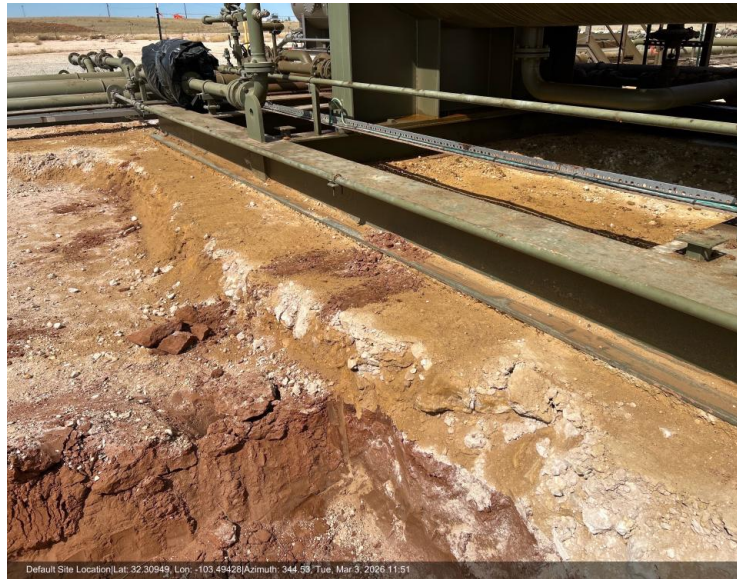
Date: 3/3/2026
Time: 11:17
Notes: North of HT to be scraped and tidied up
Latitude: 32.30948888888886
Longitude: -103.49427777777778
Direction: SW

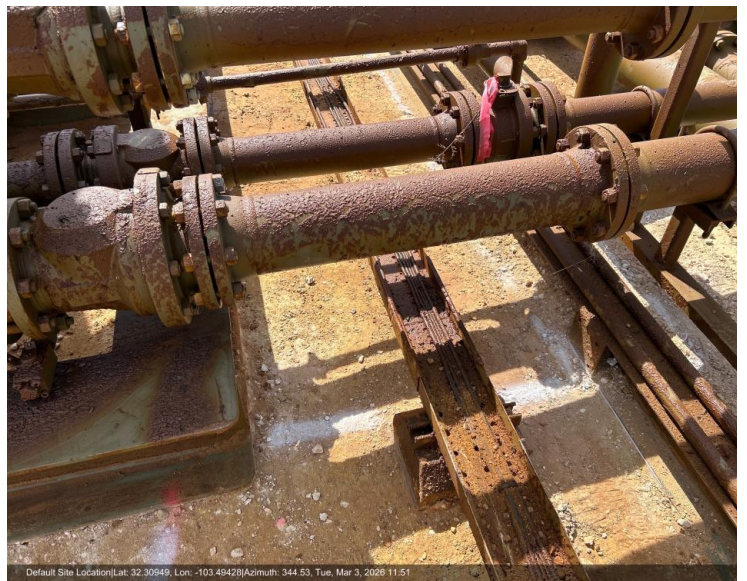
Date: 3/3/2026
Time: 11:17
Notes: SE corner of box around BS26-08
Latitude: 32.30948888888886
Longitude: -103.49427777777778
Direction: SW

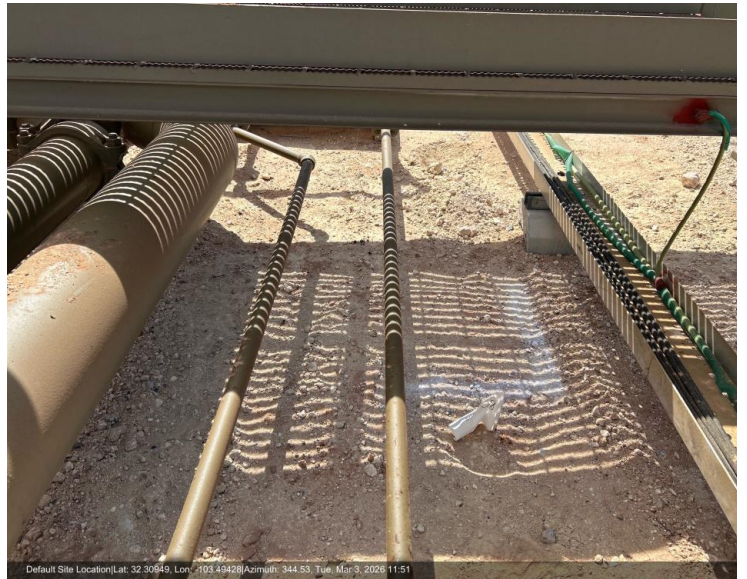
Date: 3/3/2026
Time: 11:17
Notes: NW corner of box around BS26-08
Latitude: 32.309488888888886
Longitude: -103.49427777777778
Direction: SW

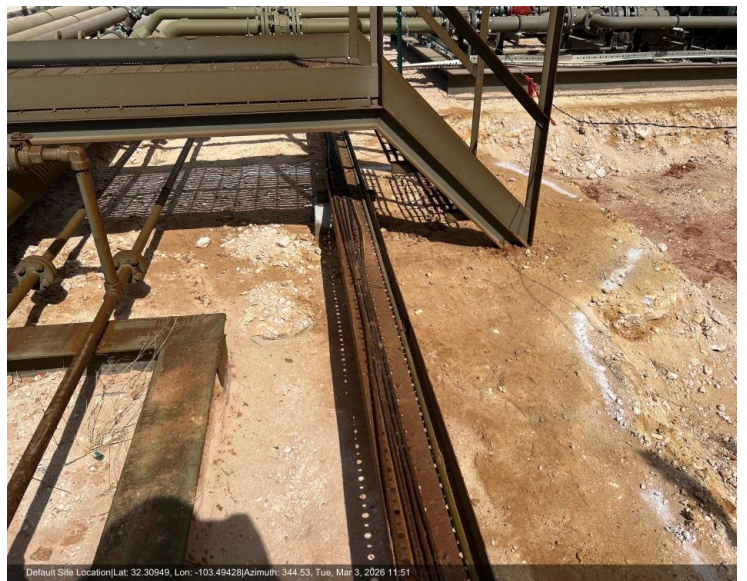
Date: 3/3/2026
Time: 11:17
Notes: East side and of box around BS26-08
Latitude: 32.309488888888886
Longitude: -103.49427777777778
Direction: SW

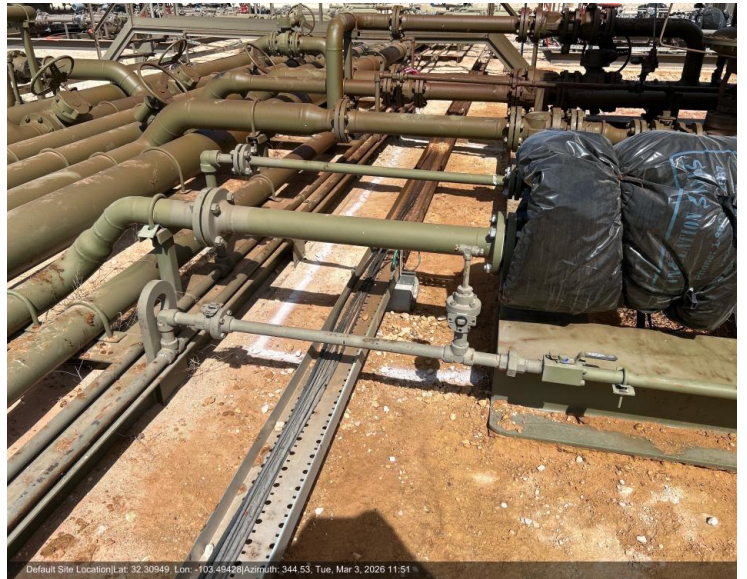
Date: 3/3/2026
Time: 11:17
Notes: SW corner of box around BS26-06 to be taken down .5'
Latitude: 32.309488888888886
Longitude: -103.49427777777778
Direction: SW

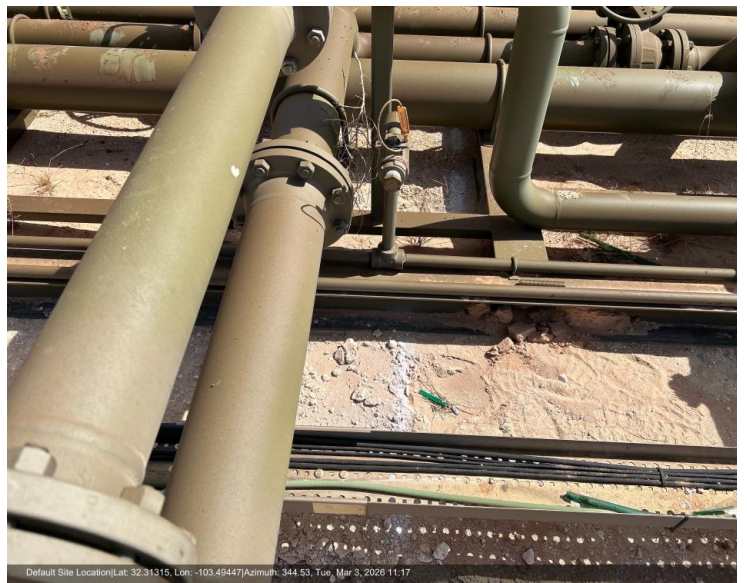
Date: 3/3/2026
Time: 11:17
Notes: SW corner of box around BS26-08
Latitude: 32.313147222222222
Longitude: -103.494469444444445
Direction: W

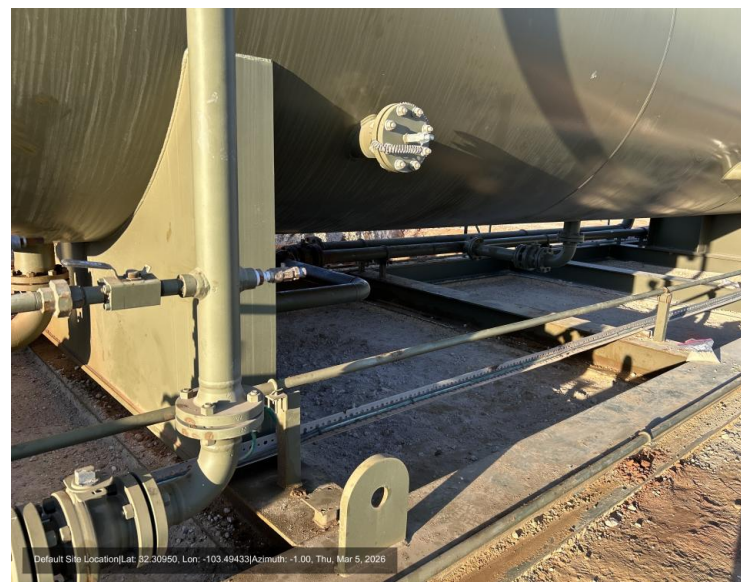
Date: 3/5/2026
Time: 17:12
Notes: 5-point composite confirmation samples in 200sq ft (or less) for BS26-06 0.5' and WS26-03 0.5' to east.
Latitude: 32.309502777777777
Longitude: -103.49433055555555
Direction: S

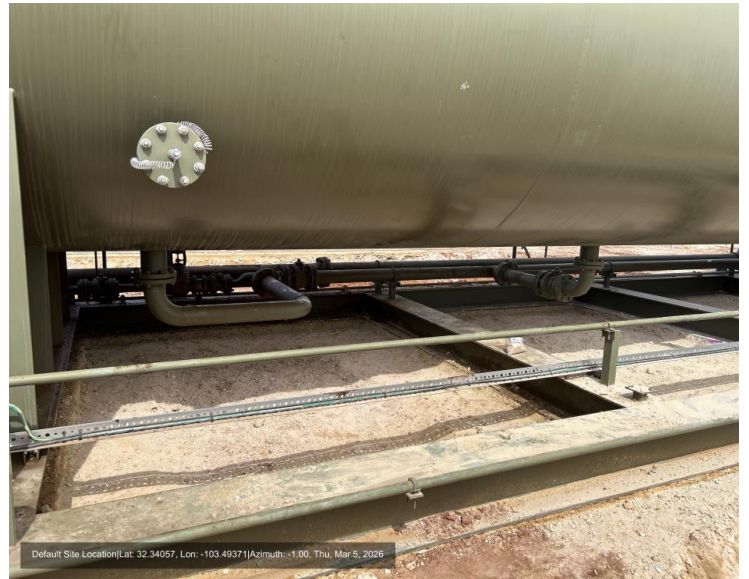
Date: 3/5/2026
Time: 12:58
Notes: Field screen sample for BS26-06 and WS26-03 for guiding excavation.
Latitude: 32.34057222222223
Longitude: -103.49370555555555
Direction: NE

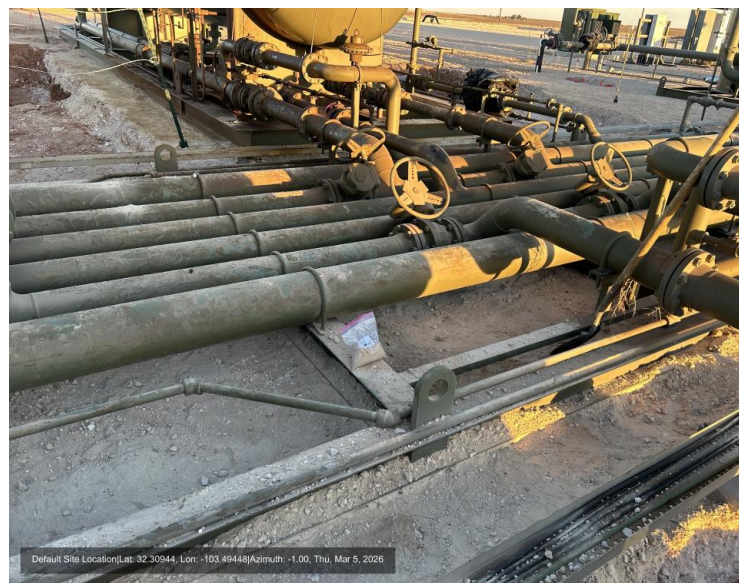
Date: 3/5/2026
Time: 17:58
Notes: 5-point composite confirmation samples in 200sq ft (or less) for BS26-08 0.5' to northwest.
Latitude: 32.30943611111111
Longitude: -103.49447777777777
Direction: W

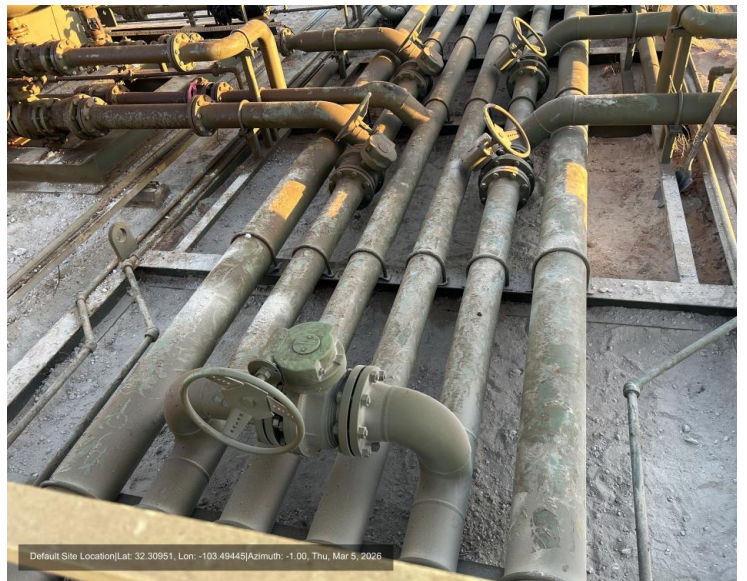
Date: 3/5/2026
Time: 17:58
Notes: Area around BS26-08 hand excavated to 0.5' under and around lines.
Latitude: 32.30951111111111
Longitude: -103.49445277777778
Direction: W

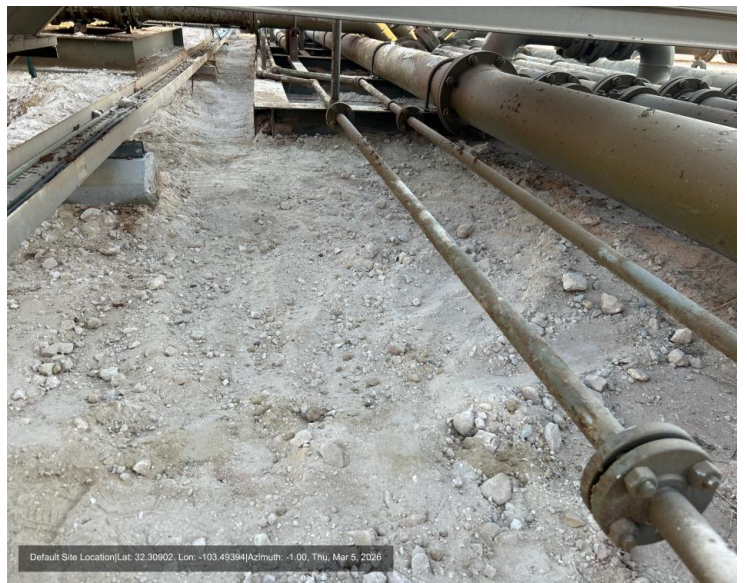
Date: 3/5/2026
Time: 17:58
Notes: Ground level photo of area around BS26-08 hand excavated to 0.5' under and around lines.
Latitude: 32.309016666666665
Longitude: -103.49393611111111
Direction: W

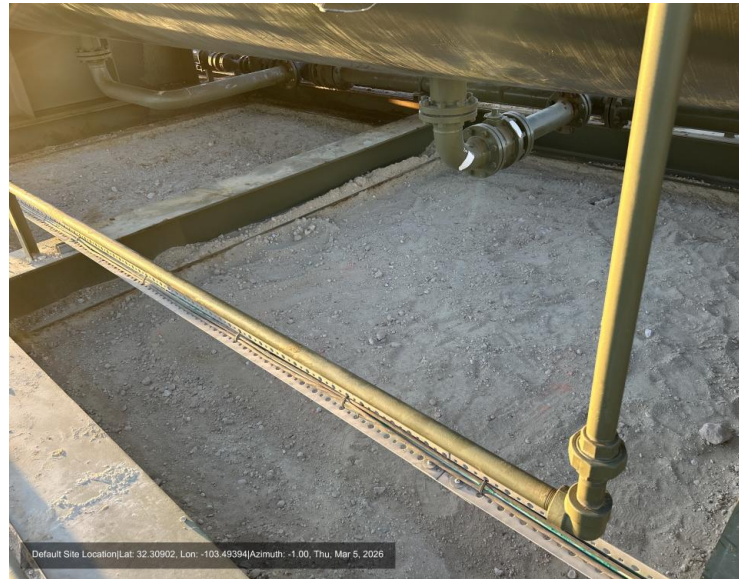
Date: 3/5/2026
 Time: 17:58
 Notes: Ground level and close up photo of area around BS26-06 hand excavated to 0.5' and to Devon safety standards under separator.
 Latitude: 32.309016666666665
 Longitude: -103.49393611111111
 Direction: W

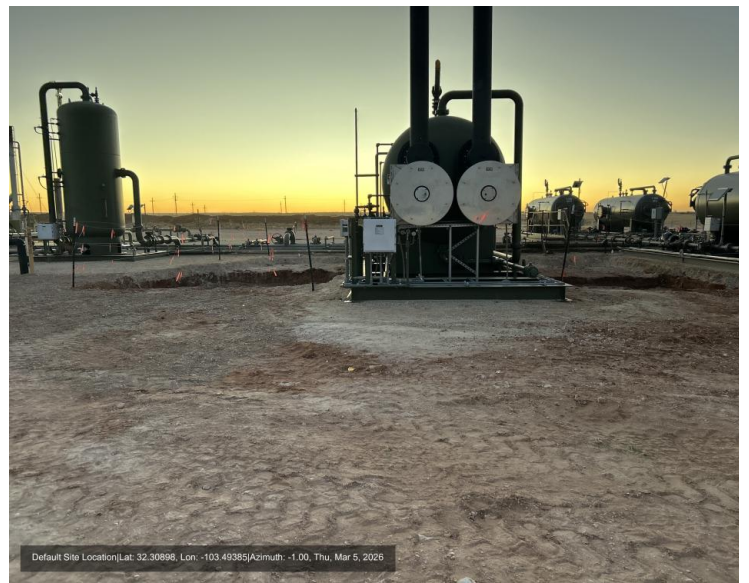
Date: 3/5/2026
 Time: 18:05
 Notes: Photo of end of day site with safety fencing erected securing excavations. Red soils are seen on surface.
 Latitude: 32.308977777777778
 Longitude: -103.49385
 Direction: E
