Incident Number: nAPP2529639365

Remediation Assessment and Deferral

White Dove 17 CTB 3

Vertex File Number: 25A-05744

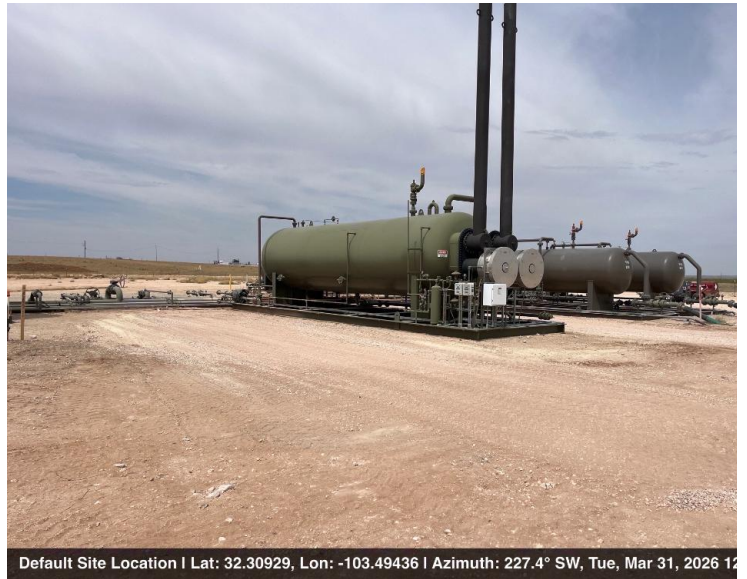
Date: 3/31/2026
Time: 12:05
Notes: Southeast corner of the previously excavated area
Latitude: 32.309286111111106
Longitude: -103.49436111111112
Direction: SW

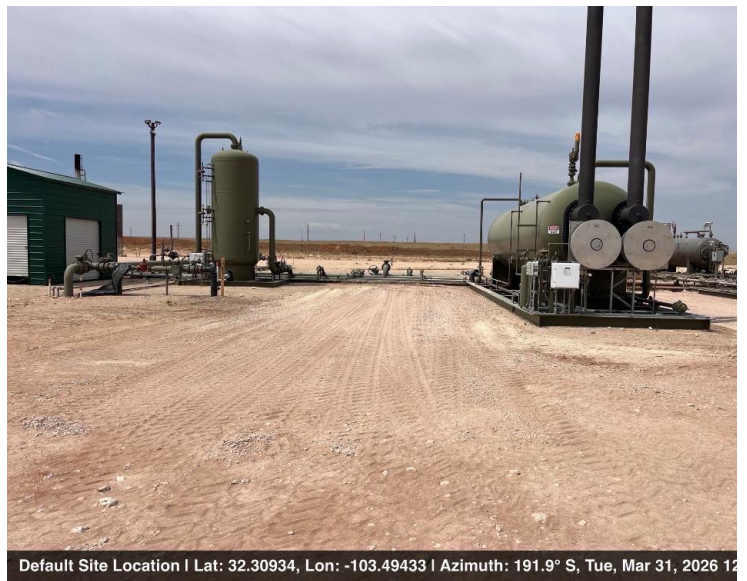
Date: 3/31/2026
Time: 12:06
Notes: Southeast corner of the previously excavated area
Latitude: 32.309344444444444
Longitude: -103.49433055555555
Direction: S

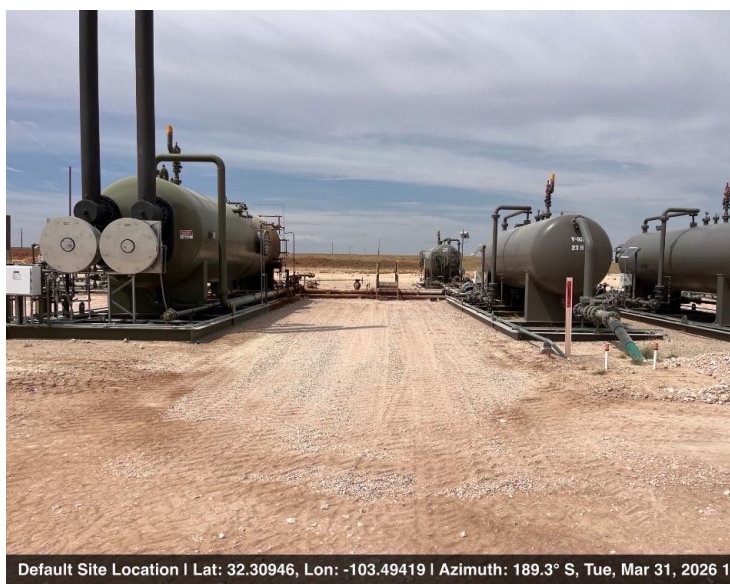
Date: 3/31/2026
Time: 12:07
Notes: Area to the south of separator V-101 23 H
Latitude: 32.30945555555555
Longitude: -103.49419444444445
Direction: S

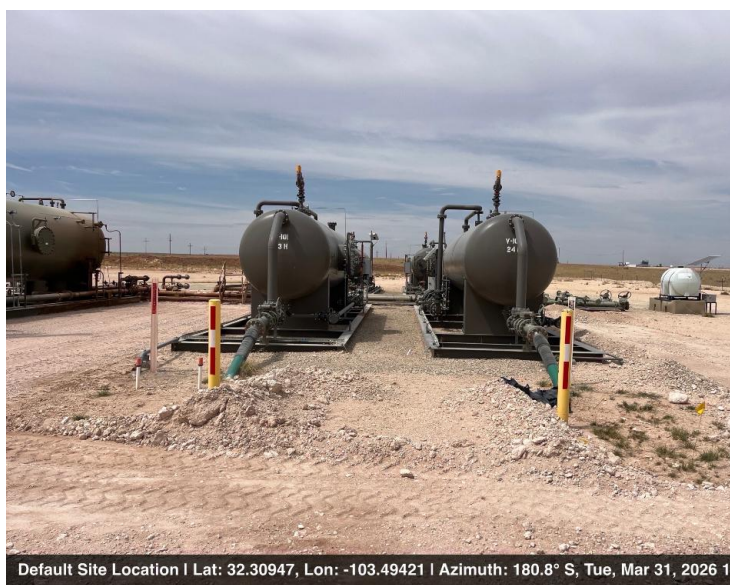
Date: 3/31/2026
Time: 12:10
Notes: Area between separators V-101 23 H and V-103 24 H
Latitude: 32.30947222222222
Longitude: -103.49421111111111
Direction: S

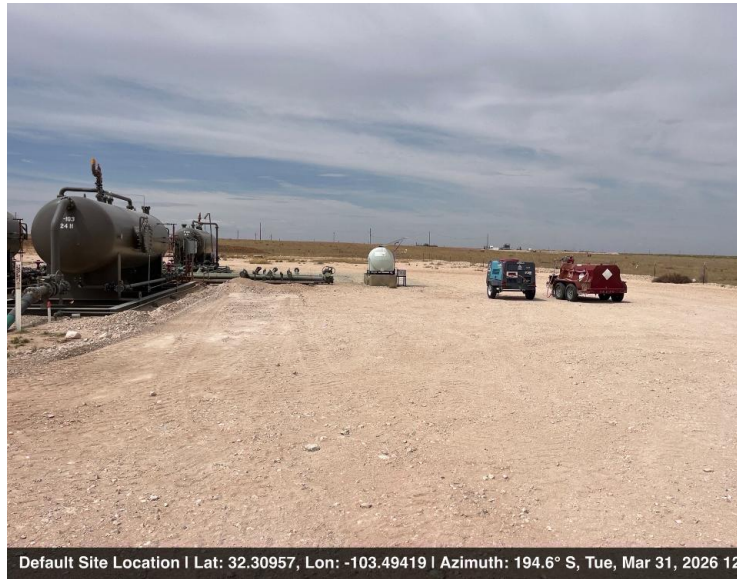
Date: 3/31/2026
Time: 12:10
Notes: Area to the north of separator V-103 24 H
Latitude: 32.30956944444444
Longitude: -103.49418611111111
Direction: S

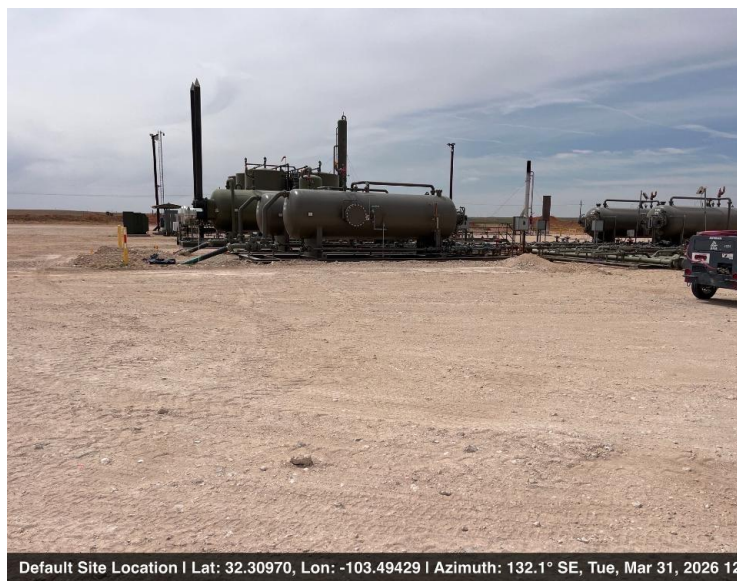
Date: 3/31/2026
Time: 12:12
Notes: Area to the north of separator V-103 24 H
Latitude: 32.3097
Longitude: -103.49429444444445
Direction: SE

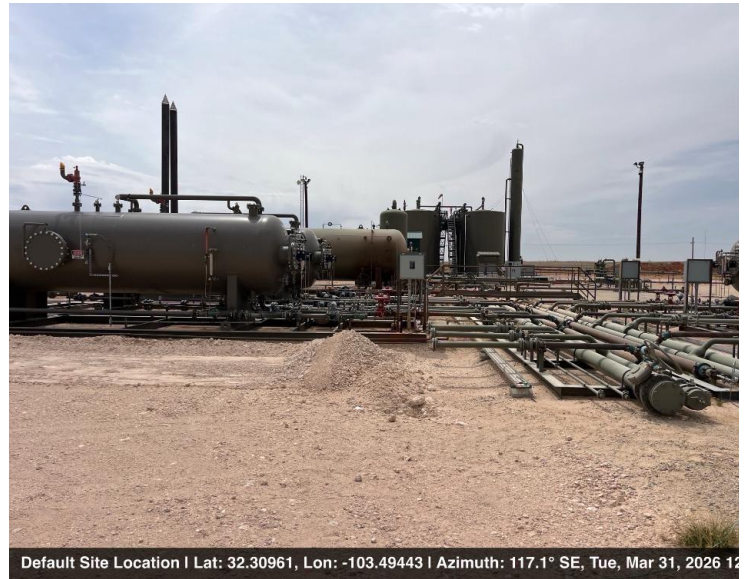
Date: 3/31/2026
Time: 12:12
Notes: Area to the north of separator V-103 24 H
Latitude: 32.30961111111111
Longitude: -103.49443055555555
Direction: E

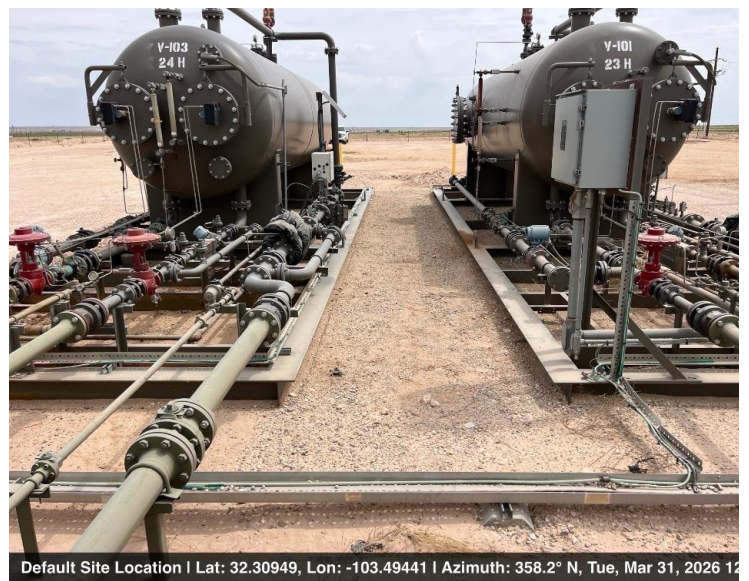
Date: 3/31/2026
Time: 12:13
Notes: Area between separators V-101 23 H and V-103 24 H
Latitude: 32.309486111111106
Longitude: -103.49440833333334
Direction: N

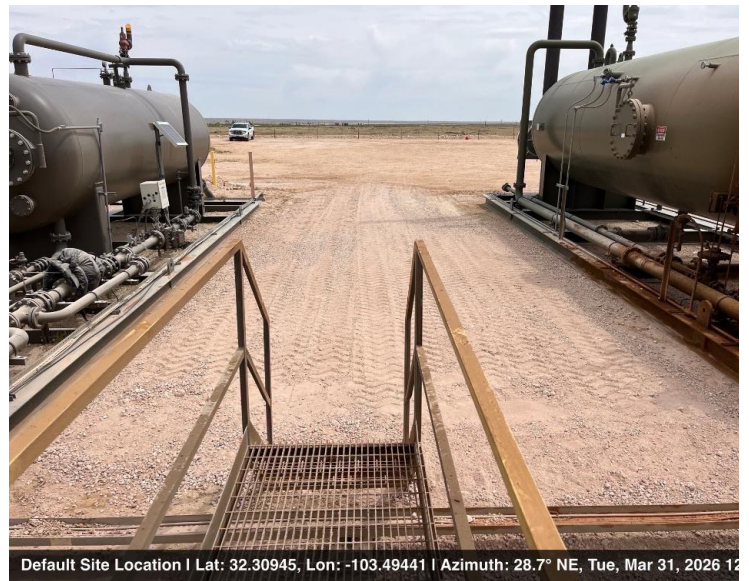
Date: 3/31/2026
Time: 12:15
Notes: Area south of separator V-101 23 H
Latitude: 32.30944722222222
Longitude: -103.49441388888889
Direction: N

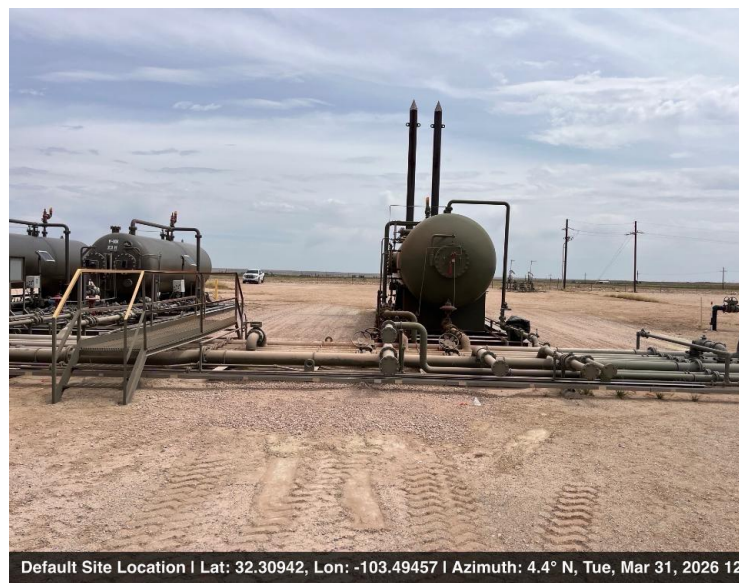
Date: 3/31/2026
Time: 12:16
Notes: Area west of piperack
Latitude: 32.309425
Longitude: -103.49456944444445
Direction: N

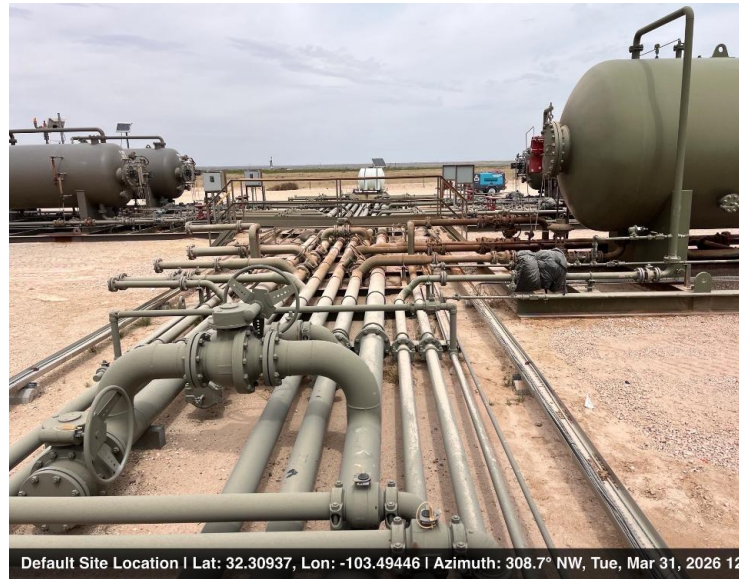
Date: 3/31/2026
Time: 12:19
Notes: Piperack from south end of previous excavation facing north
Latitude: 32.309374999999996
Longitude: -103.49446111111111
Direction: NW

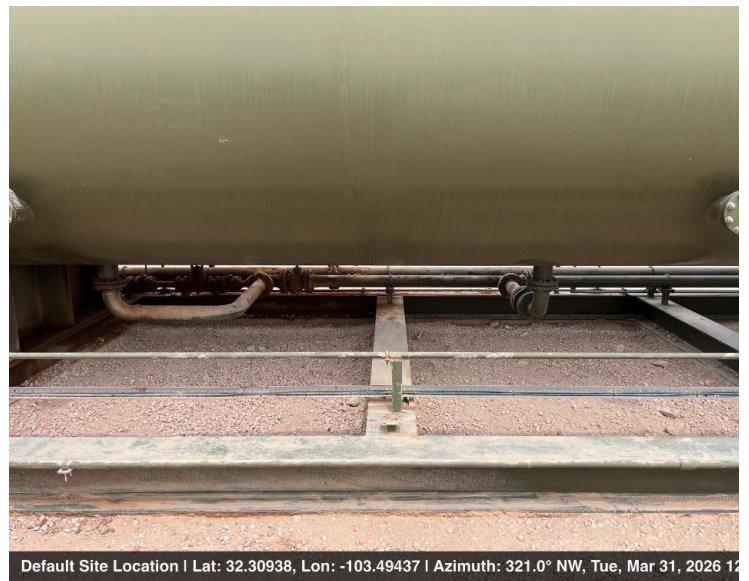
Date: 3/31/2026
Time: 12:21
Notes: Under southernmost separator (F-201)
Latitude: 32.309380555555556
Longitude: -103.494369444444444
Direction: NW
