**Re: Remediation Work Plan  
James Ranch Unit Legg Pond  
Incident Number nAPP2533525860  
Facility ID fAB1902552191  
Eddy County, New Mexico**

# Site Receptor Map

XTO Energy, Inc  
 James Ranch Unit Legg Pond  
 Incident Number: nAPP2533525860  
 Unit E, Section 14, T 21S, R 29E  
 Eddy County, New Mexico

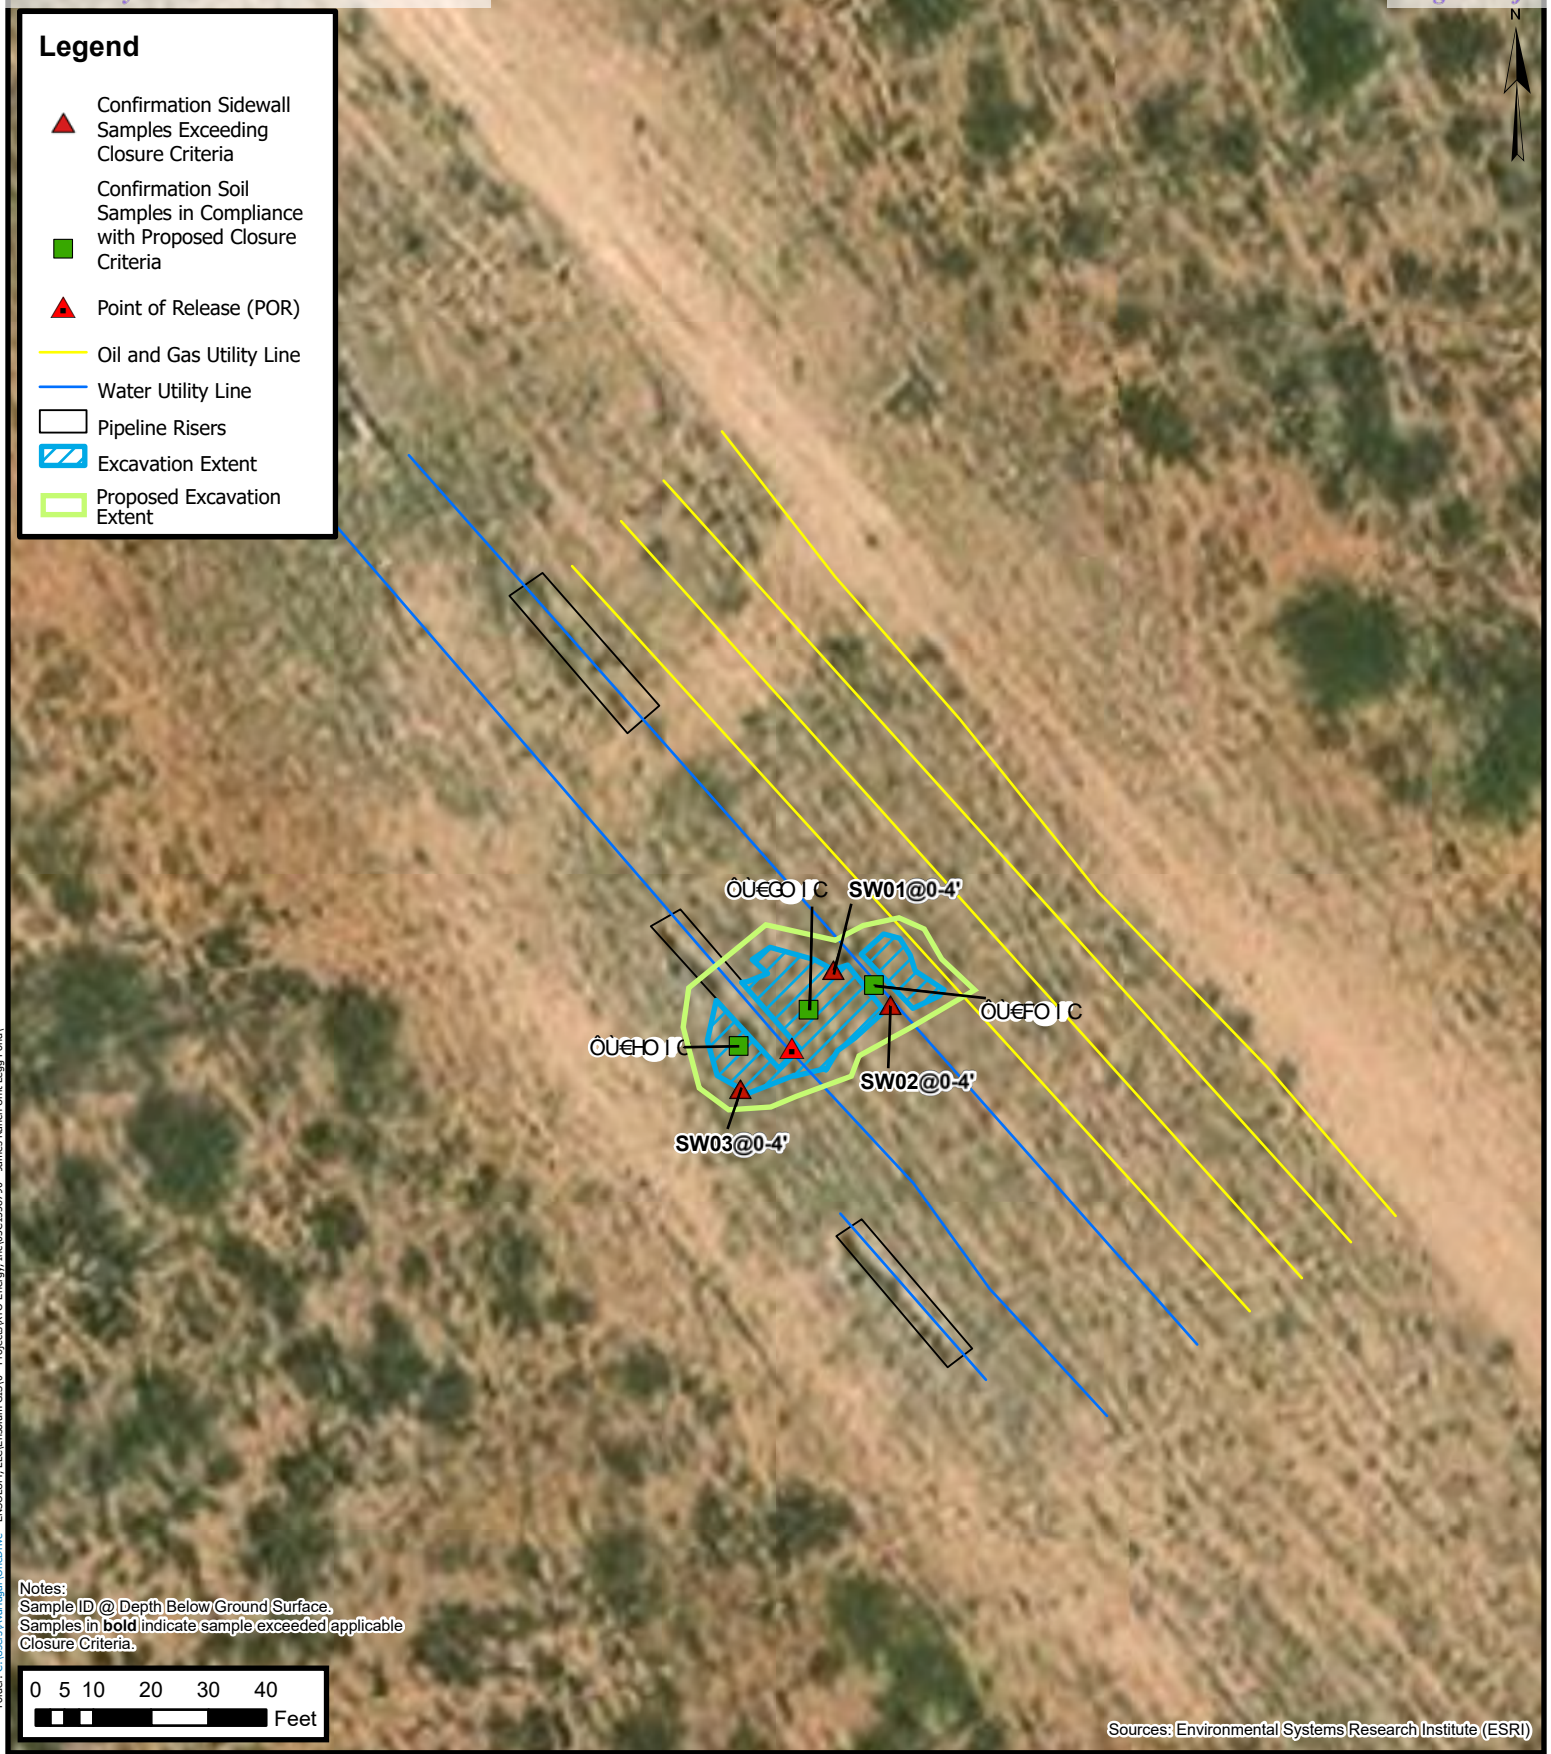
- ▲ Confirmation Sidewall Samples Exceeding Closure Criteria
- Confirmation Soil Samples in Compliance with Proposed Closure Criteria
- ▲ Point of Release (POR)
- Oil and Gas Utility Line
- Water Utility Line
- Pipeline Risers
- Excavation Extent
- Proposed Excavation Extent

Notes:  
 Sample ID @ Depth Below Ground Surface.  
 Samples in **bold** indicate sample exceeded applicable Closure Criteria.

- The excavation will be backfilled with non waste-containing, locally purchased topsoil and recontoured to match pre-existing Site conditions. One sample will be collected from the backfill material and analyzed for BTEX, TPH and chloride using the methods described above to ensure all COCs are compliant with Site Closure Criteria. The pasture will be reseeded with an SLO-approved seed mixture.

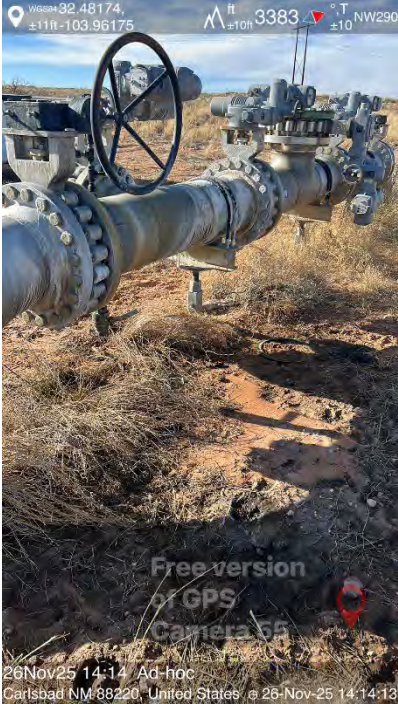
<p><u>Photograph</u> 3</p>	<p><u>Date</u> 11/26/2025</p>

<p><u>Description</u> Release extent near pipeline riser in pasture</p>		
<p><u>View</u> Northwest</p>		
<p><u>Photograph</u> 4</p>	<p><u>Date</u> 02/19/2026</p>

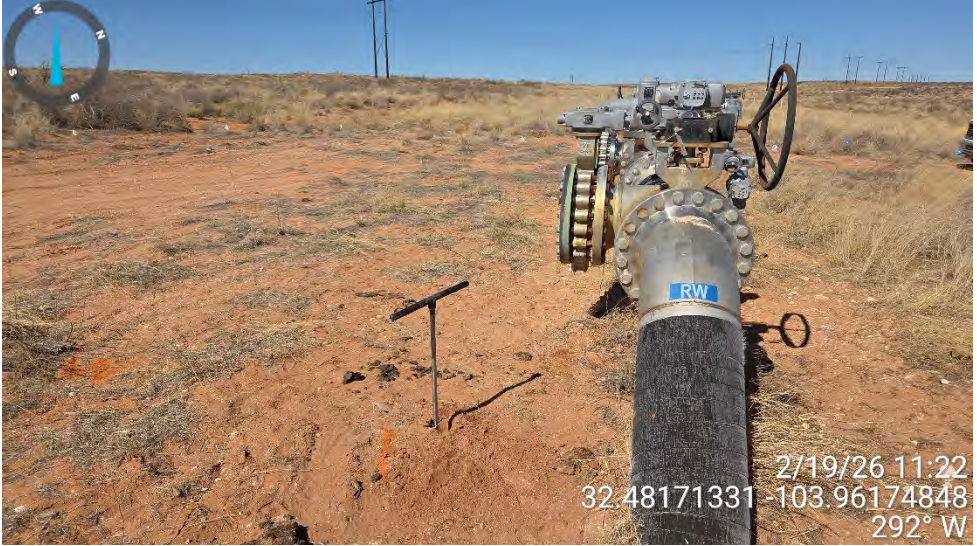
<p><u>Description</u> Vertical delineation, BH01</p>		
<p><u>View</u> Northwest</p>

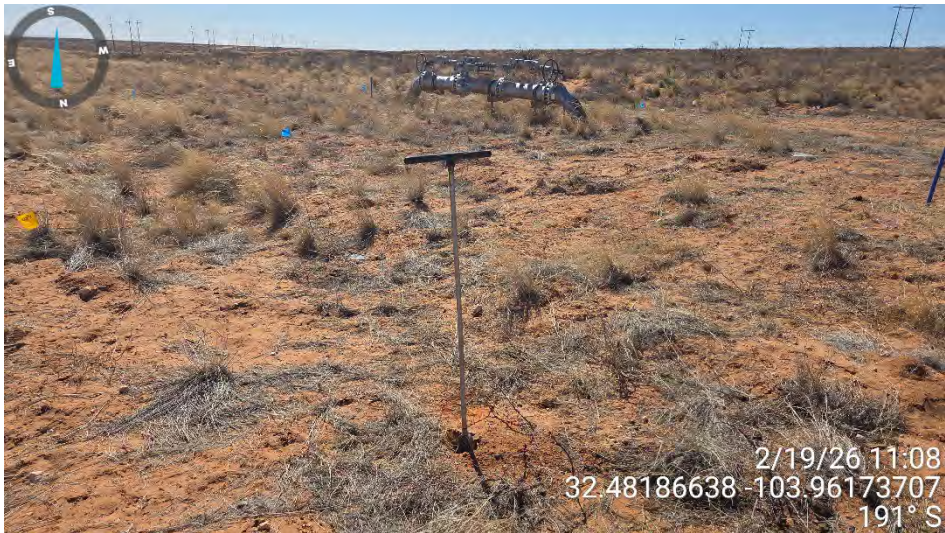
<p><u>Photograph</u> 5</p>	<p><u>Date</u> 02/19/2026</p>

<p>2/19/26 11:08 32.48186638 -103.96173707 191° S</p>
<p><u>Description</u> Vertical delineation, BH02</p>		
<p><u>View</u> South</p>		
<p><u>Photograph</u> 6</p>	<p><u>Date</u> 04/07/2026</p>

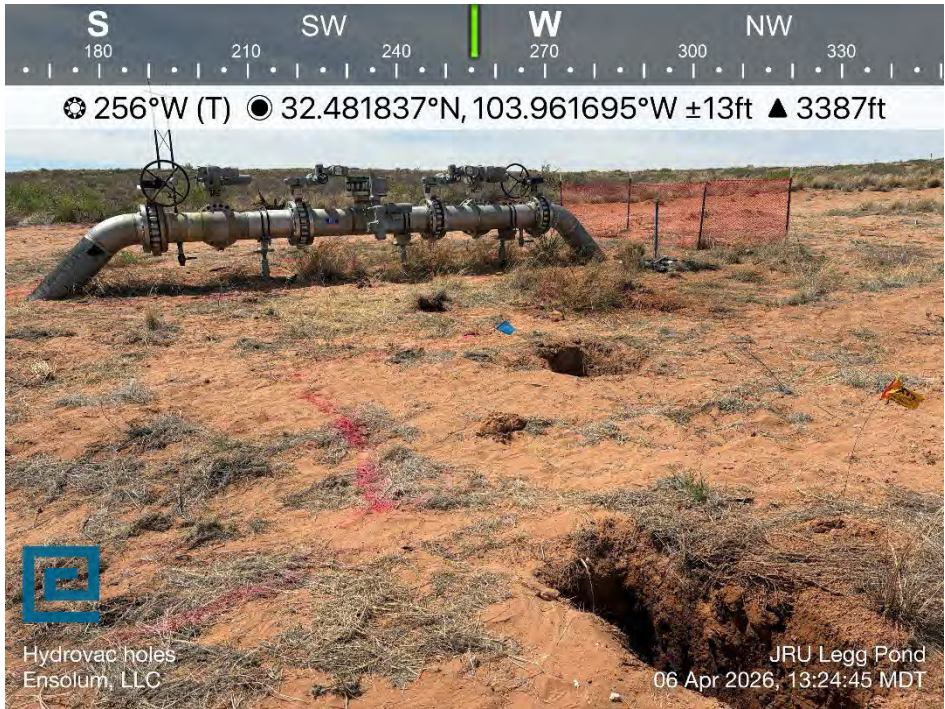
<p>S 180 SW 210 W 270 NW 300 330 256°W (T) 32.481837°N, 103.961695°W ±13ft ▲ 3387ft</p> <p>Hydrovac holes Ensolum, LLC</p> <p>JRU Legg Pond 06 Apr 2026, 13:24:45 MDT</p>
<p><u>Description</u> Hydrovac activities, near CS01</p>		
<p><u>View</u> West</p>
