Pit, Below-Grade Tank, or
Proposed Alternative Method Permit or Closure Plan Application

1.
Operator: DJR Operating, LLC OGRID #: 371838
Address: 1 Road 3263 Aztec, NM 87410
Facility or well name: Jicarilla Apache F 10
API Number: 30-039-82339 OCD Permit Number: _____
U/L or Qtr/Qtr C Section 16 Township 25N Range 05W County: Rio Arriba
Center of Proposed Design: Latitude 36.403740 Longitude -107.368217 NAD83
Surface Owner: ☐ Federal ☐ State ☐ Private ☒ Tribal Trust or Indian Allotment

Project #17035-0181
NMOCD Incident #nRM2006557992Ms. Larissa Farrell
DJR Operating, LLC
1 Road 3263
Aztec, New Mexico 87410Phone: (505) 632-3476
E-mail: lfarrell@djrlc.com**RE: BGT and Release Closure Report for the Jicarilla Apache F-10 Compressor Station Located in Section 16, Township 25N, Range 5W, Rio Arriba County, New Mexico**

**SITE PHOTOGRAPHY
BGT AND RELEASE CLOSURE REPORT
DJR OPERATING, LLC.
JICARILLA APACHE F #010 COMPRESSOR STATION
PROJECT #17035-0181
FEBRUARY 2020**

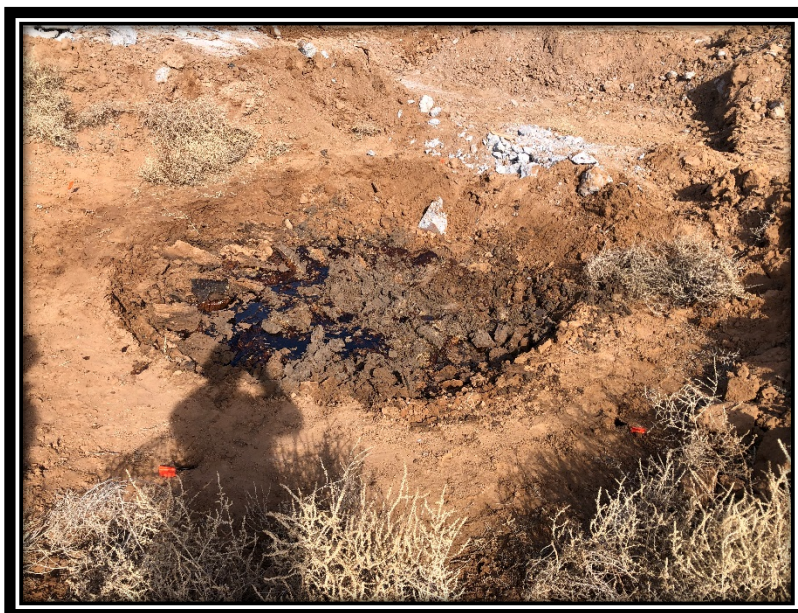
Picture 1: View of BGT Removal

On February 21, 2020, Envirotech personnel performed confirmation sampling of soil beneath the BGT at the Jicarilla Apache F-10 well site. Based on the field screening results and visual observations of stained soil a release was confirmed. DJR subsequently completed a remediation excavation, and confirmation sampling was performed on February 28, 2020. Upon receipt of laboratory analytical results, on March 24, 2020, DJR personnel backfilled and re-contoured the location of the former BGT. The site was reseeded with the approved Jicarilla Mesa seed mixture.

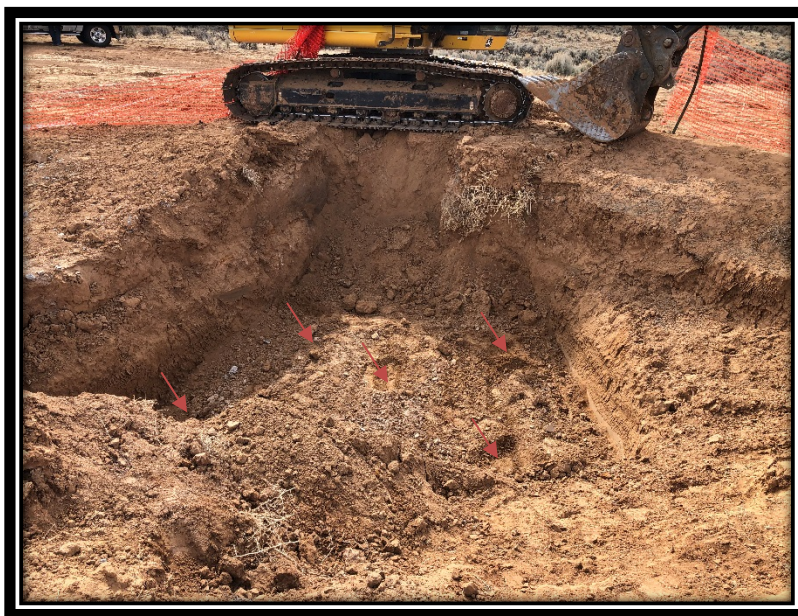
Picture 2: View of Excavation of Former BGT

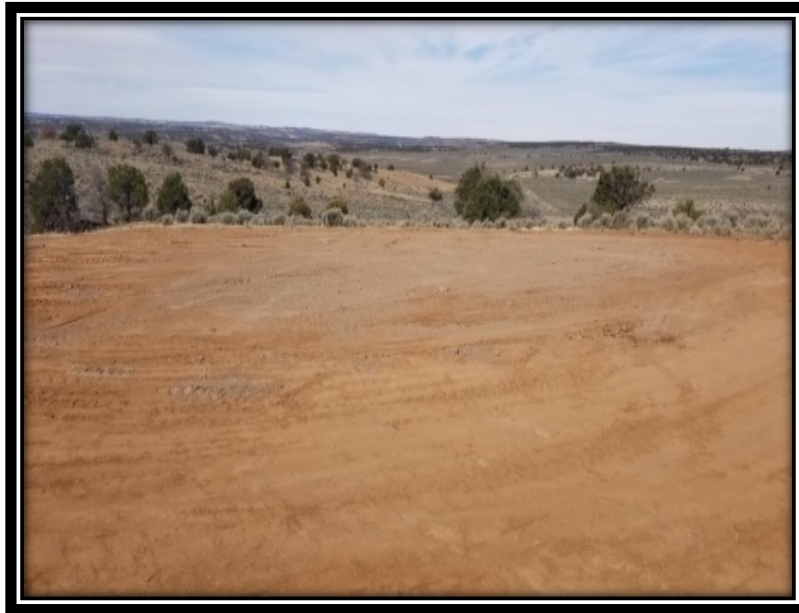
Picture 3: View of Backfilled and Recontoured Area (View 1)

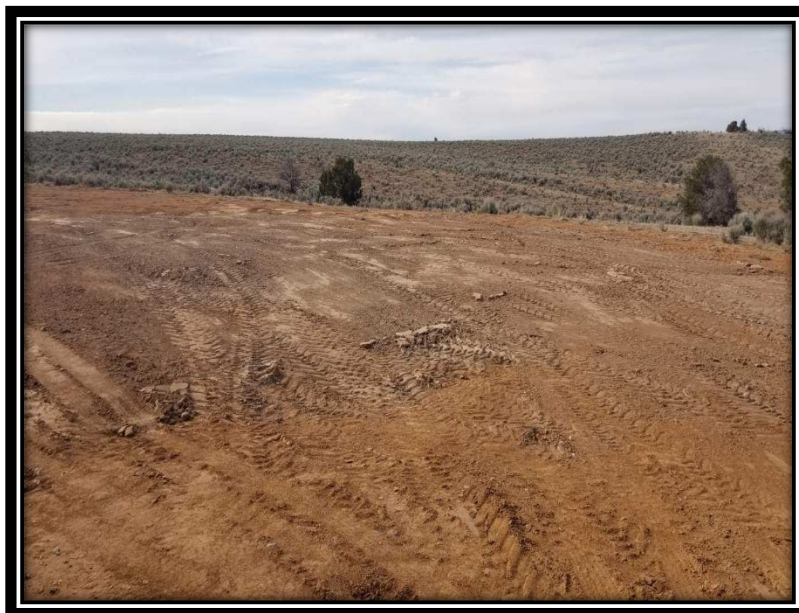
Picture 4: View of Backfilled and Recontoured Area (View 2)

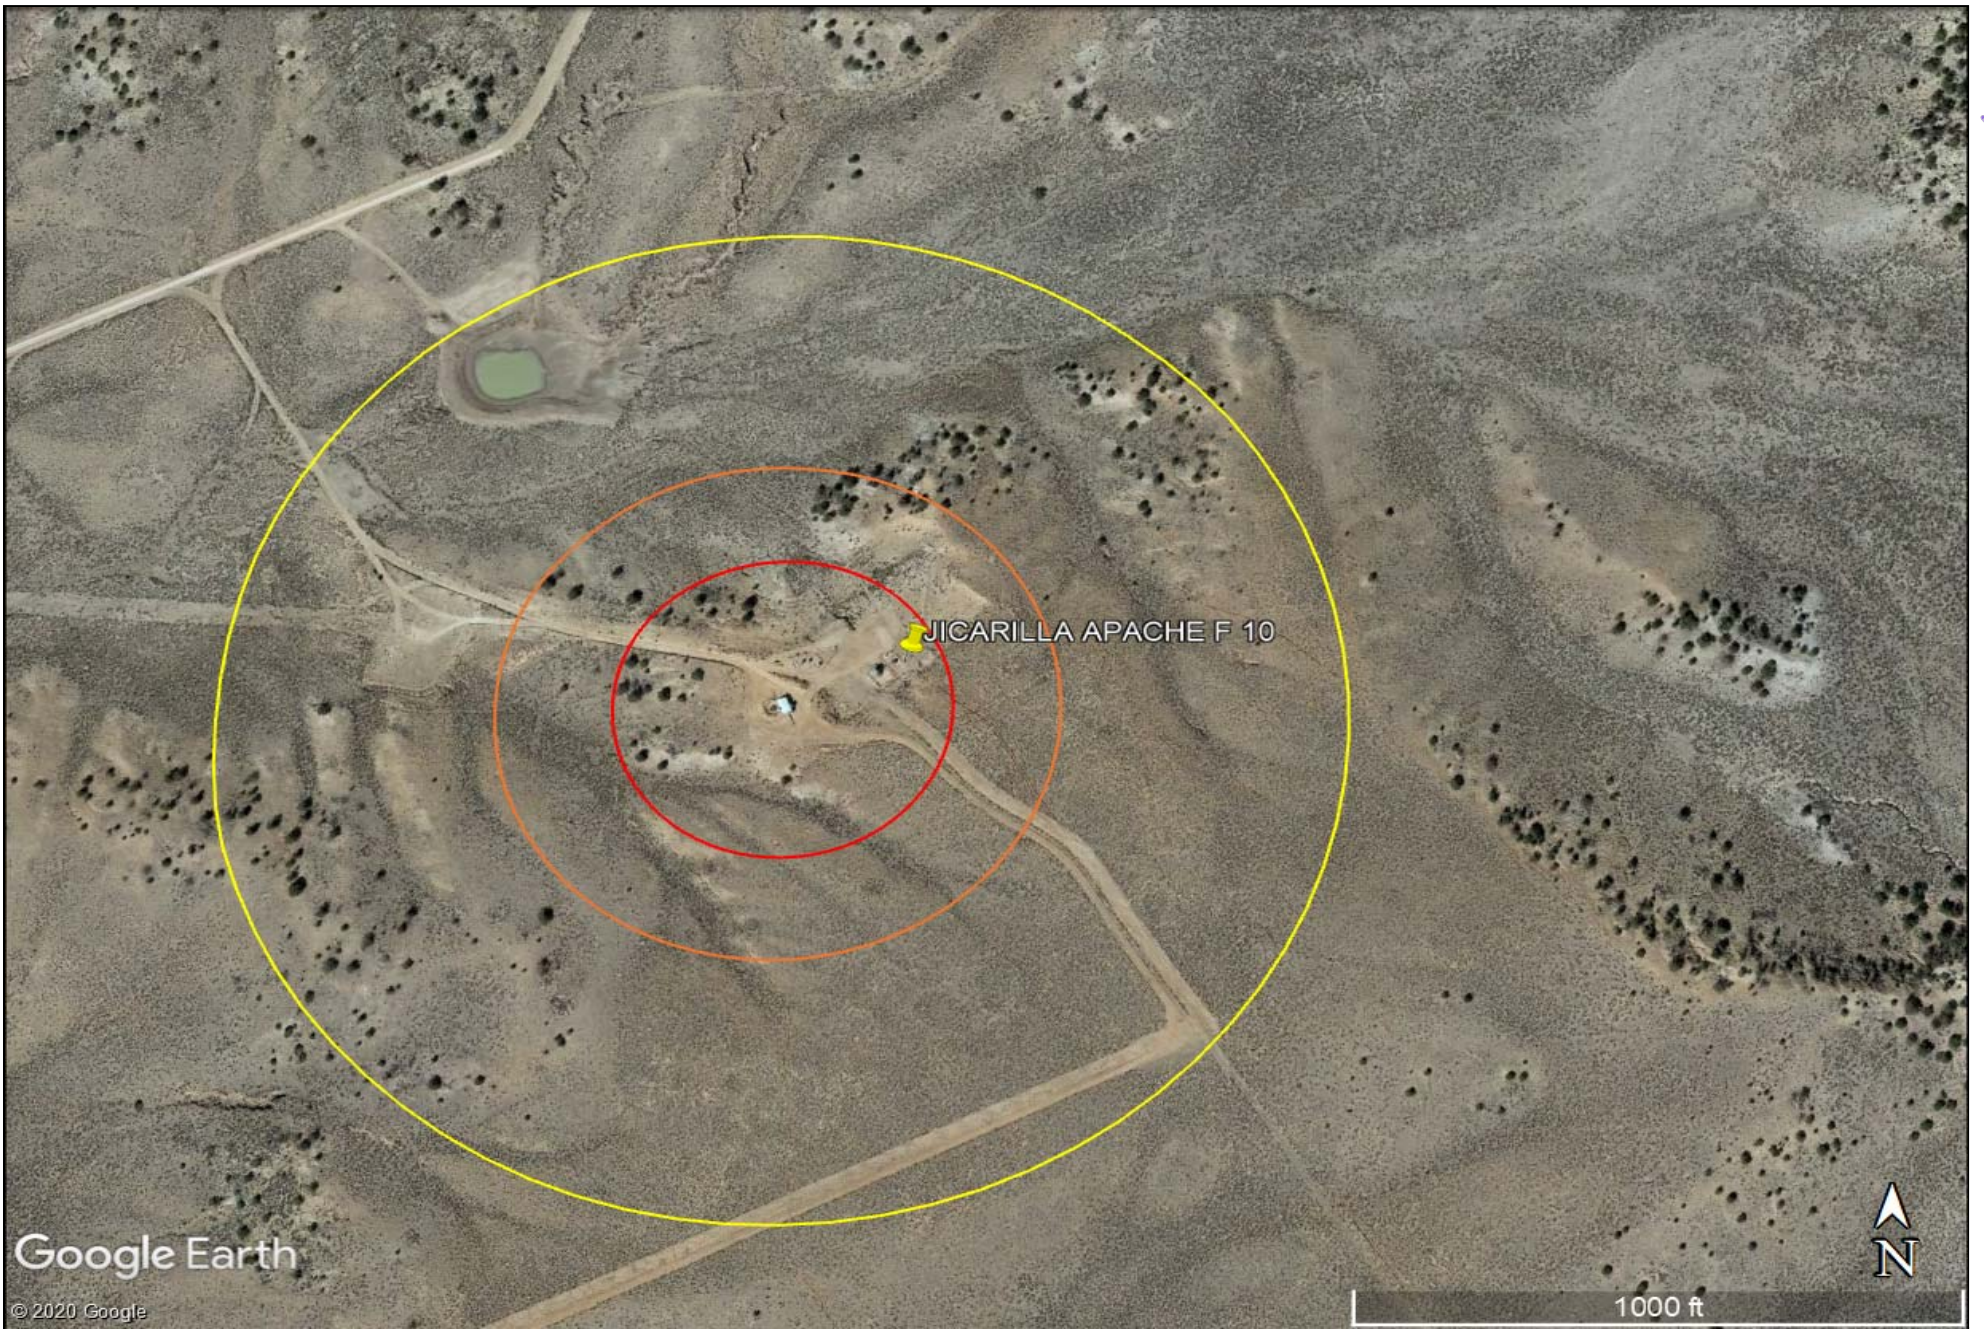
-   300' Radius
-   500' Radius
-   1000' Radius

Jicarilla Apache F 10
30-039-82339
UL-C, Section 16, T25N, R05W
Distance to Surface Water 693'
