Pit, Closed-Loop System, Below-Grade Tank, or Proposed Alternative Method Permit or Closure Plan Application

Atlantic B LS #020
API 30-045-23496
(M) Section 33 – T31N – R10W
San Juan County, New Mexico

BELOW-GRADE TANK CLOSURE PLAN

Atlantic B LS 020 Tank ID: A

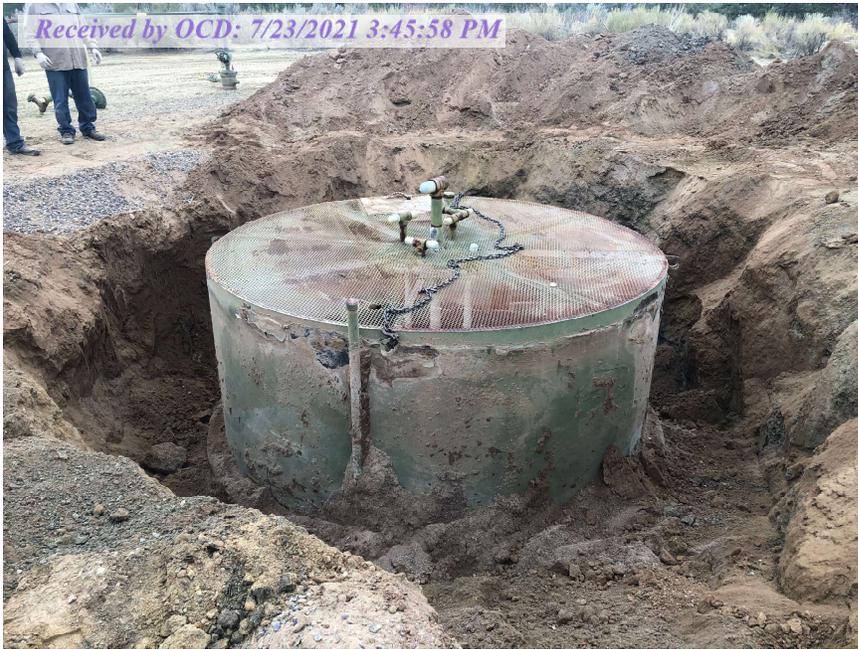
95 bbl tank prior to removal.

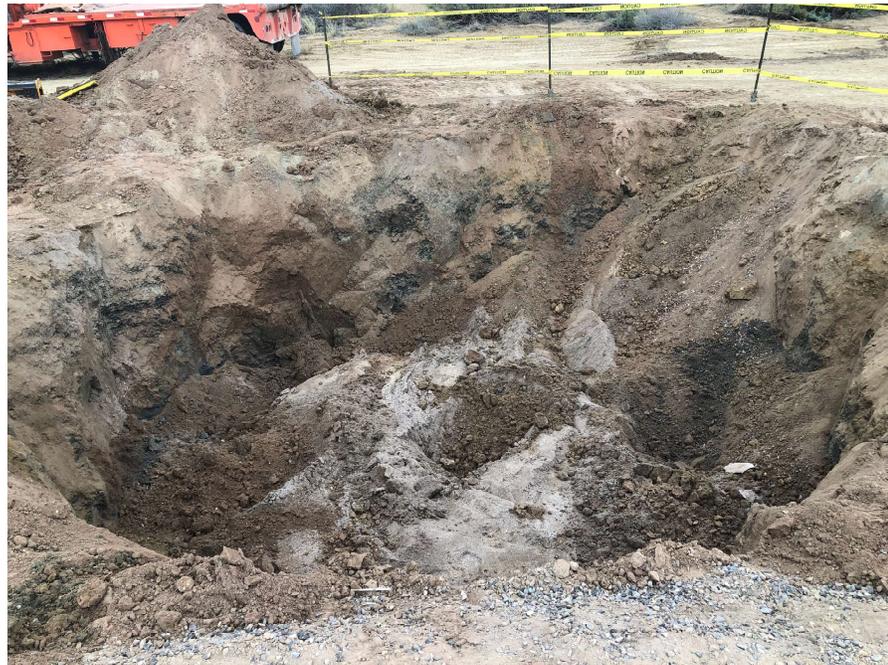
Composite sampling locations of tank base, using a backhoe for sample collection. BLM was on site to observe.

Soils beneath the BGT were sampled for TPH, BTEX, and chloride. All test parameters were below the stated limits. A field and laboratory reports are attached.

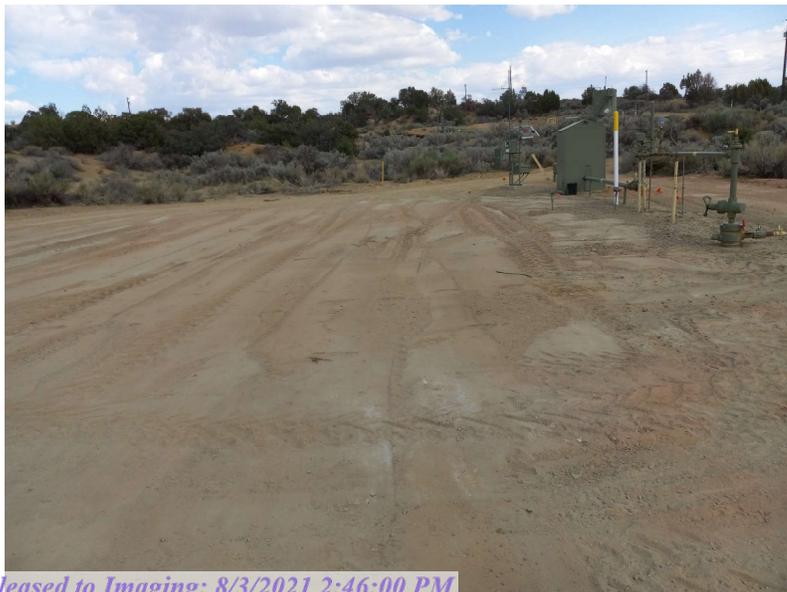
Area of 95 bbl tank backfilled

Sampling results reveal no evidence of a release had occurred. BGT area has been backfilled with clean, earthen material.
