XTO 9 Stake #1
API# 30-025-41960

SUNDRY NOTICES AND REPORTS ON WELLS (DO NOT USE THIS FORM FOR PROPOSALS TO DRILL OR TO DEEPEN OR PLUG BACK TO A DIFFERENT RESERVOIR. USE "APPLICATION FOR PERMIT" (FORM C-101) FOR SUCH PROPOSALS.) 1. Type of Well: <input type="checkbox"/> Oil Well <input type="checkbox"/> Gas Well <input checked="" type="checkbox"/> Other P&A		WELL API NO. 30-025-41960

Texland Petroleum - Hobbs, LLC
XTO 9 State #1
Sec. 9-T17S-R36E, Lea Co., NM
GPS Coordinates: 32.856267 -103.358594
Closure Report

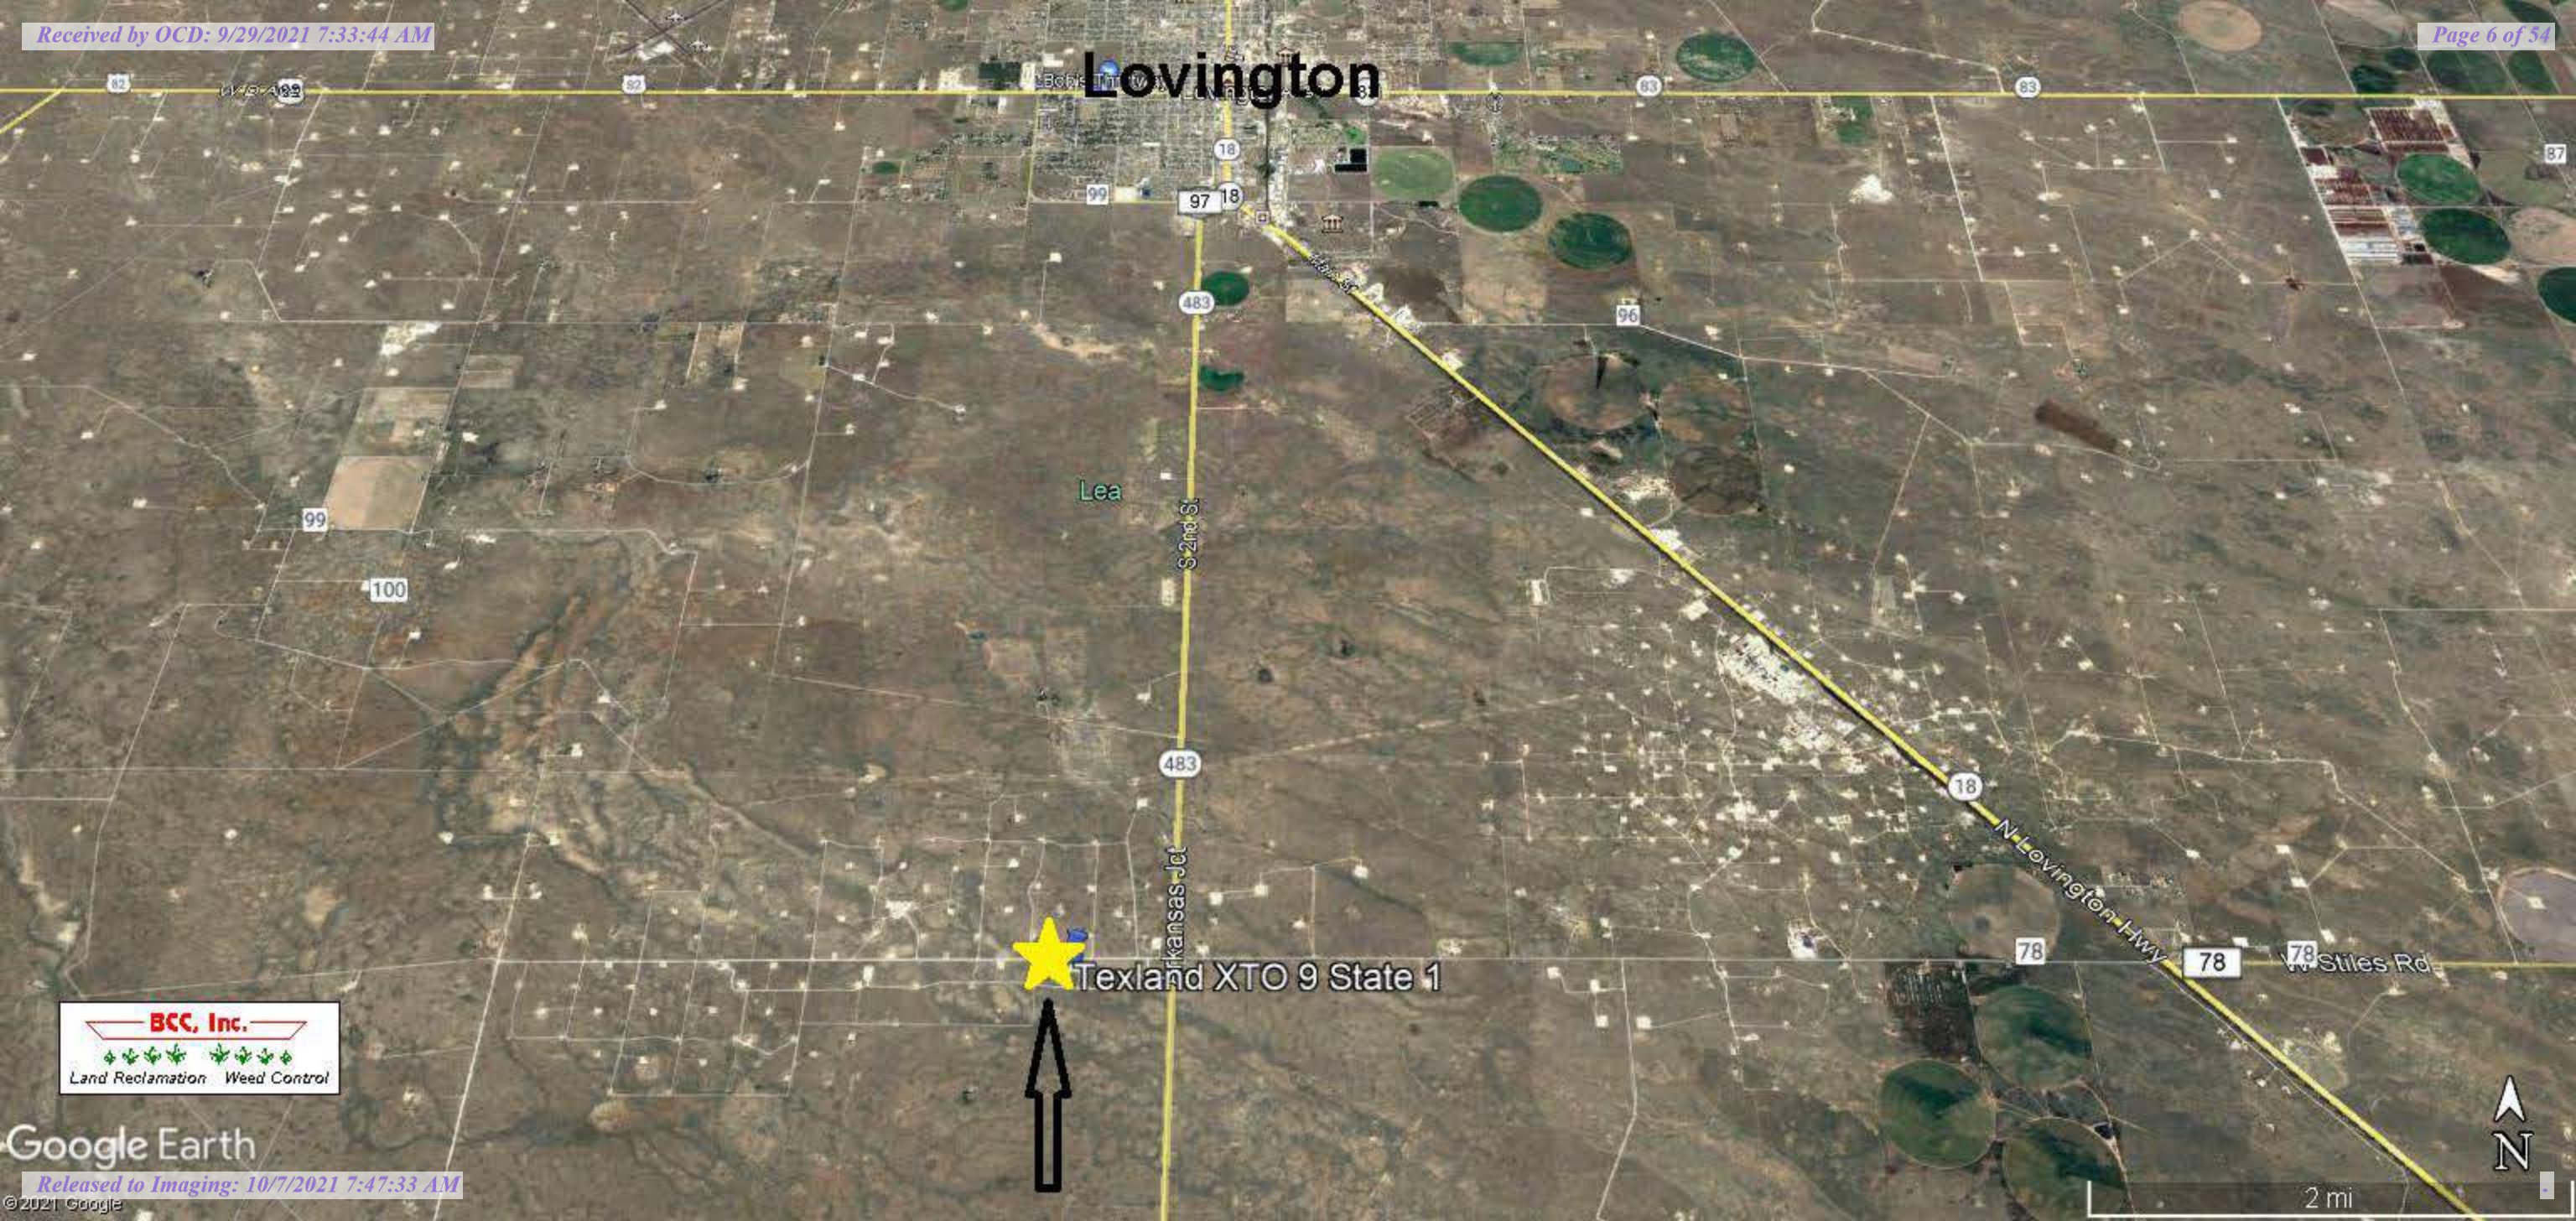
Excavated Area - 1,015 sq. ft. / .02 acre

Approximately 75 cubic yards

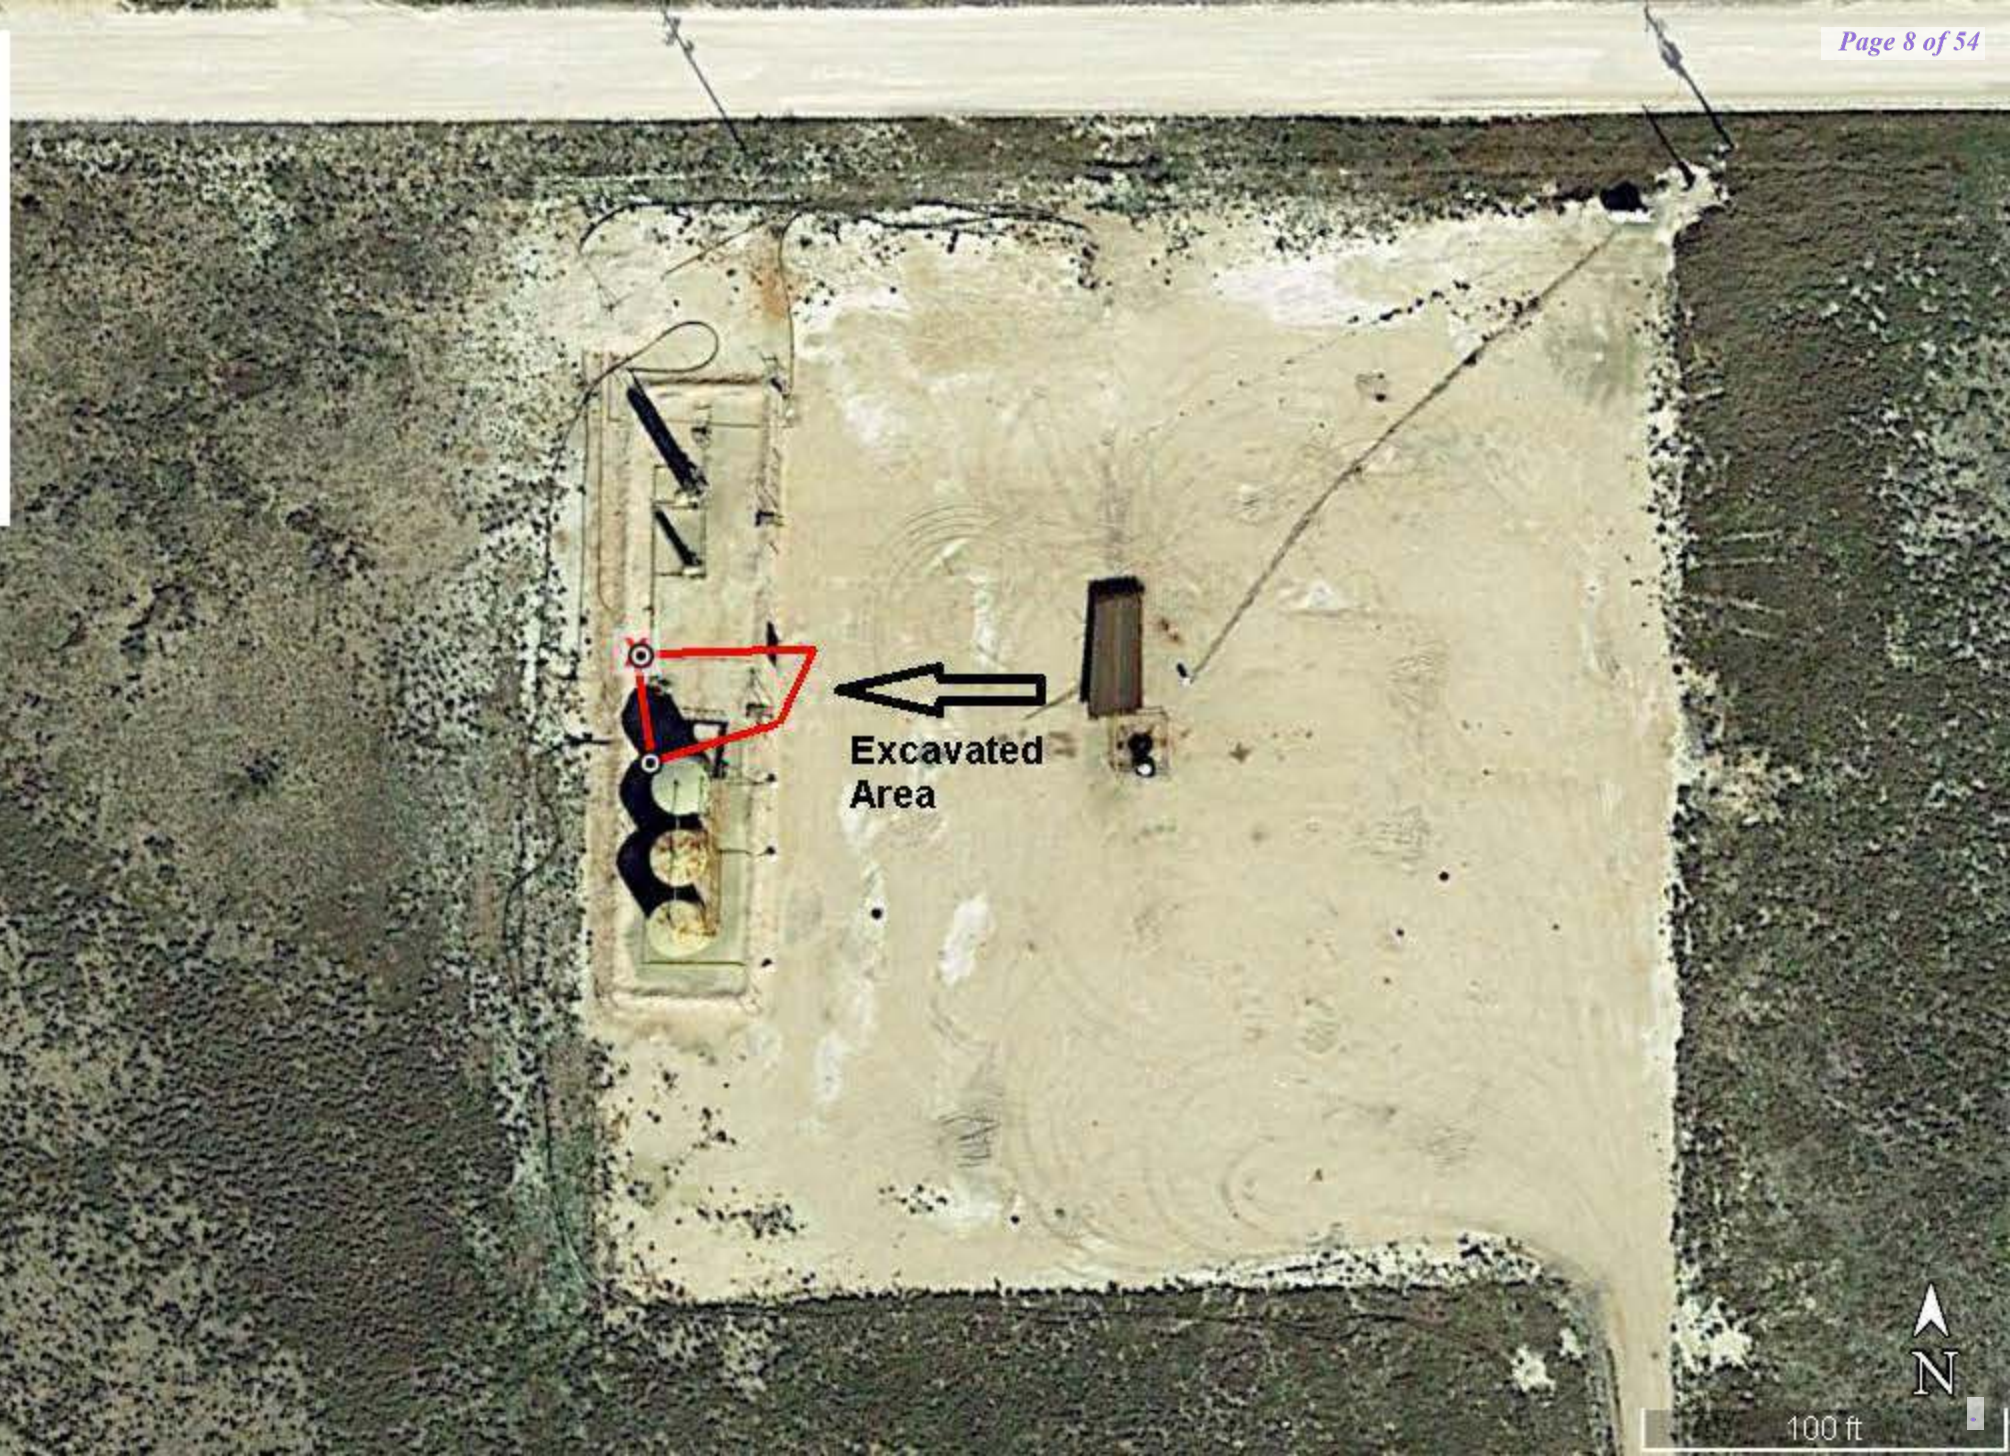
Excavated
Area

Soil Sample Locations & Results

Background (0-6" Depth)
<50.0 ppm - TPH
<4.99 ppm - Chloride
32.856351 -103.359506

Bottom 1A (24" Depth)
<49.9 ppm - TPH
<4.97 ppm - Chloride
32.856401 -103.359003

West Sidewall (12" Depth)
<49.8 ppm - TPH
<5.01 ppm - Chloride
32.856378 -103.359023

Bottom 1C (24" Depth)
<49.9 ppm - TPH
<4.95 ppm - Chloride
32.856368 -103.358957

North Sidewall (12" Depth)
<49.9 ppm - TPH
15.0 ppm - Chloride
32.856420 -103.358955

Bottom 1B (12" Depth)
<49.8 ppm - TPH
<4.95 ppm - Chloride
32.856396 -103.358924

East Sidewall (12" Depth)
<49.9 ppm - TPH
7.67 ppm - Chloride
32.856393 -103.358890

South Sidewall (12" Depth)
<49.8 ppm - TPH
8.03 ppm - Chloride
32.856354 -103.358954

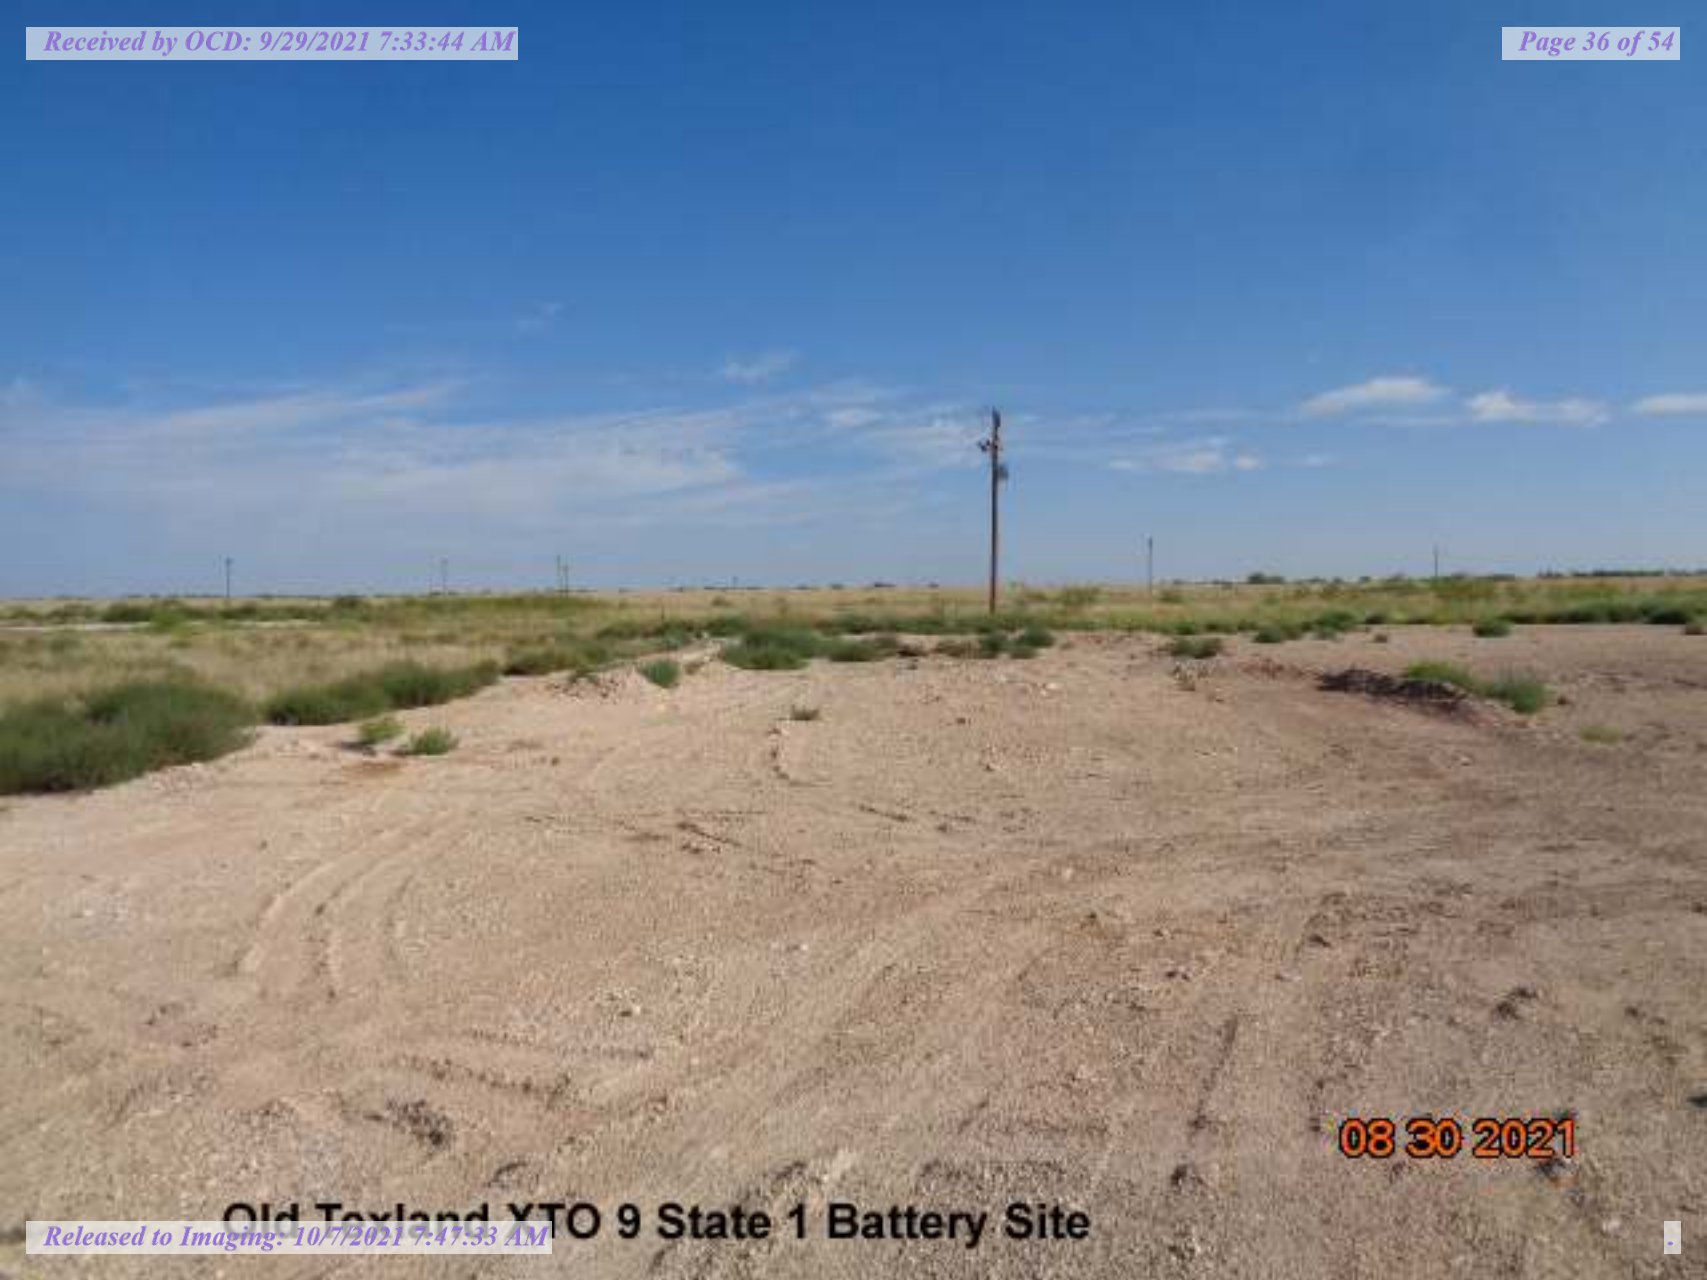
Old Texland YTO 9 State 1 Battery Site

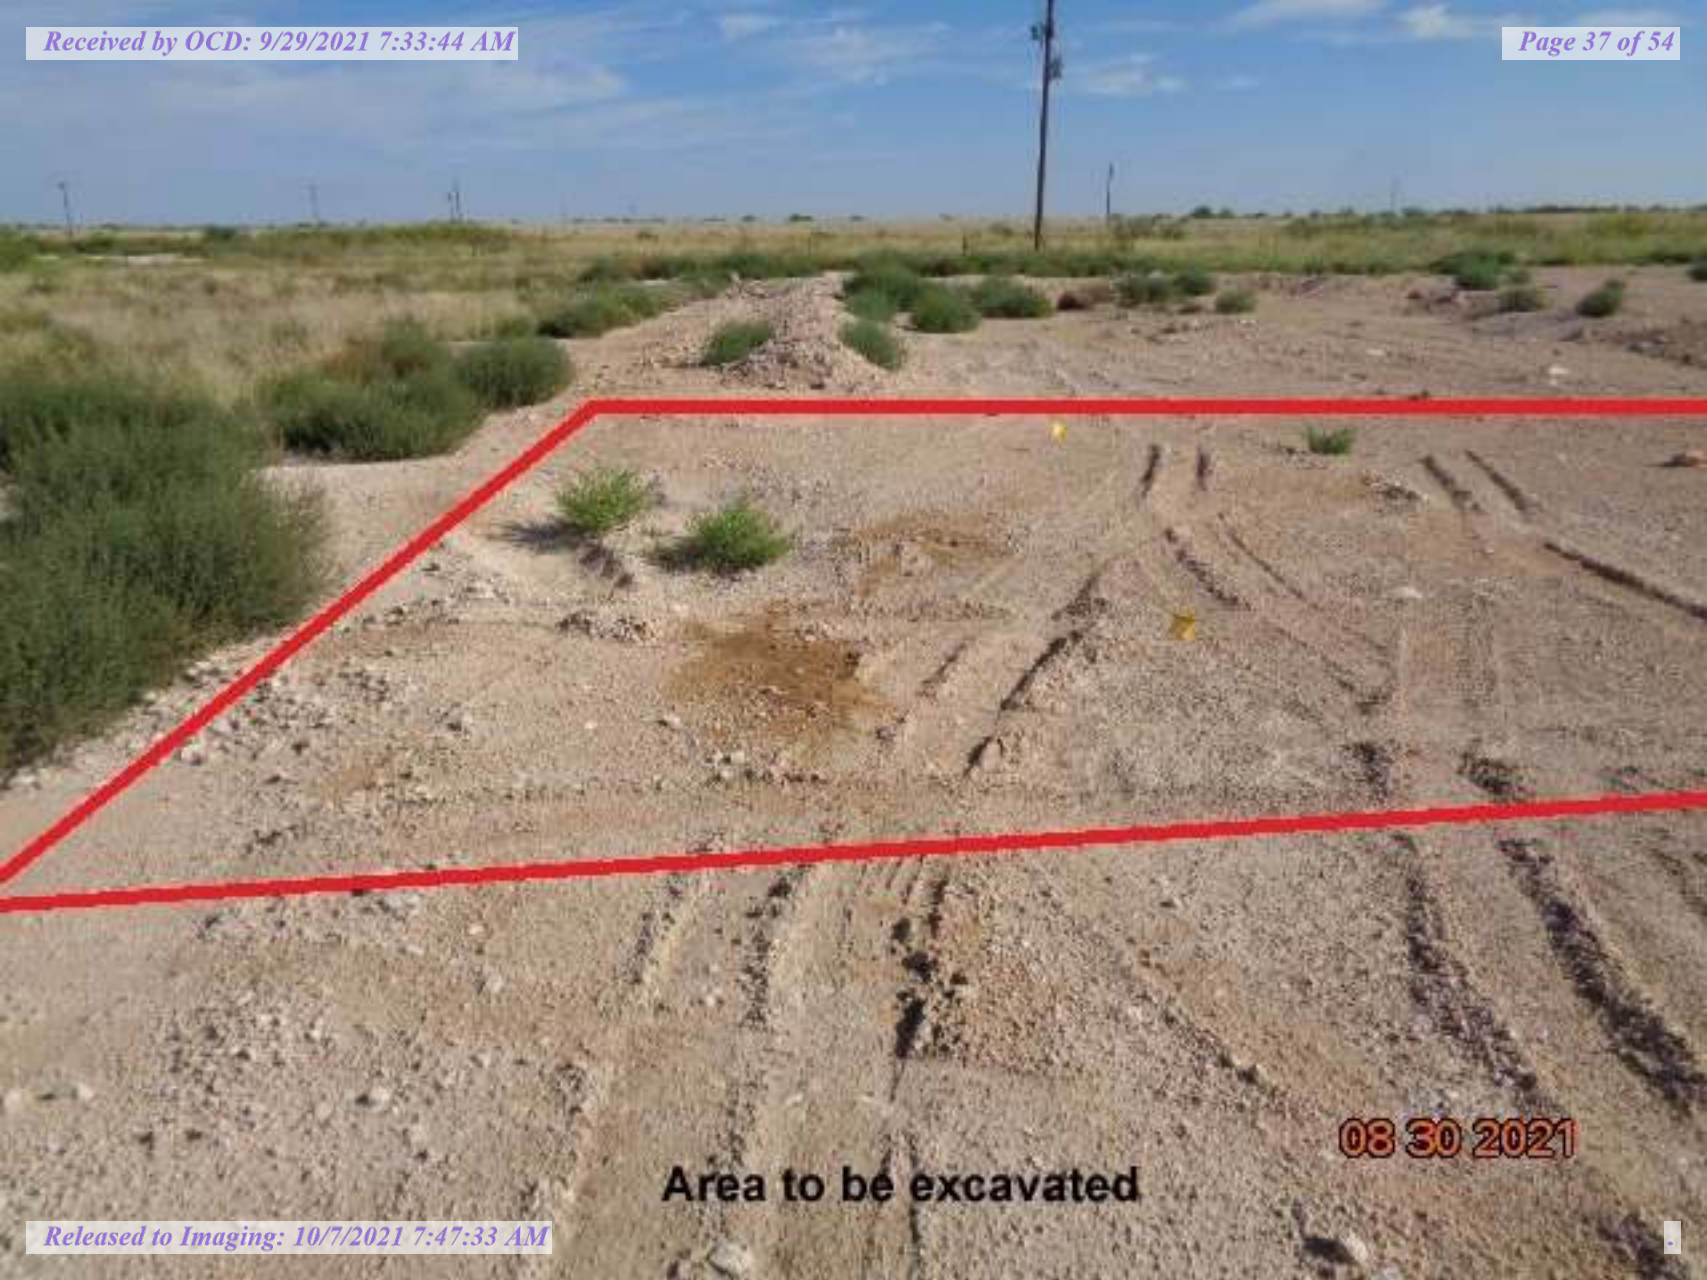
Area to be excavated

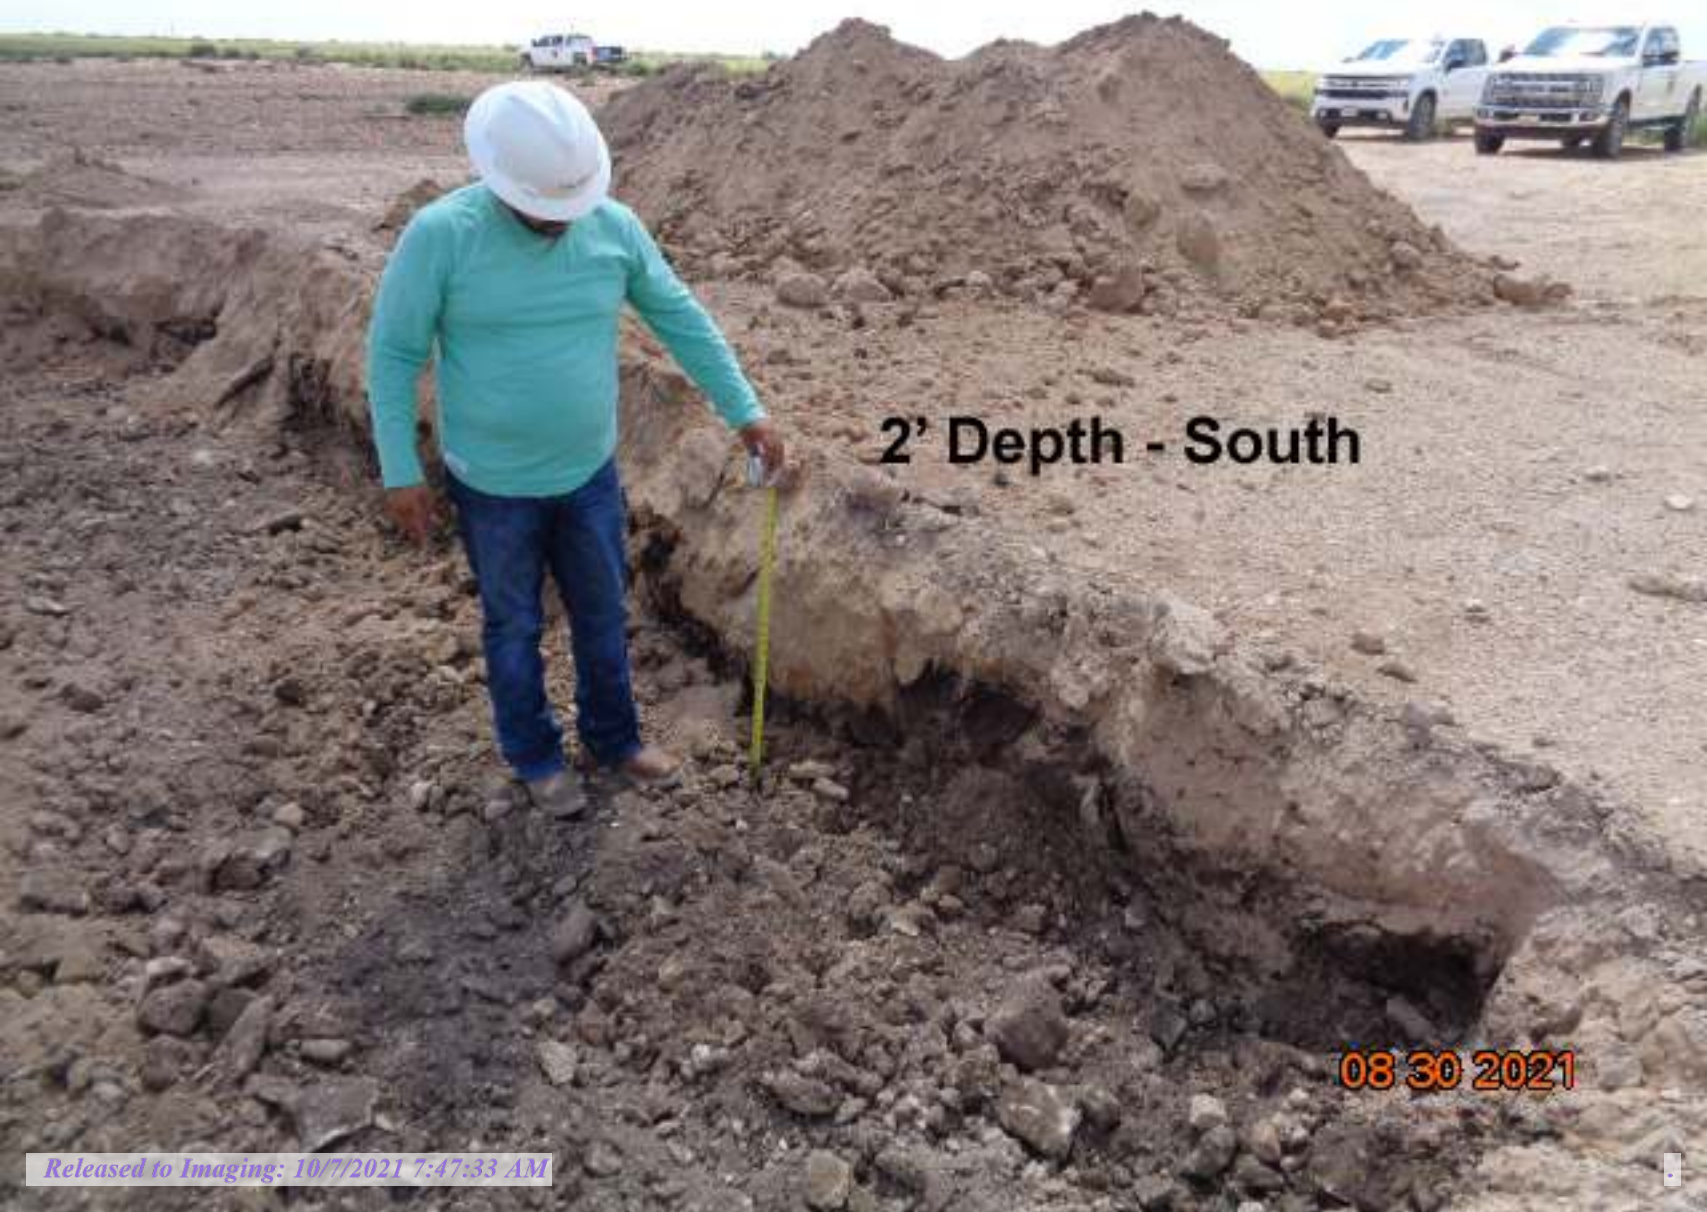
2' Depth - South

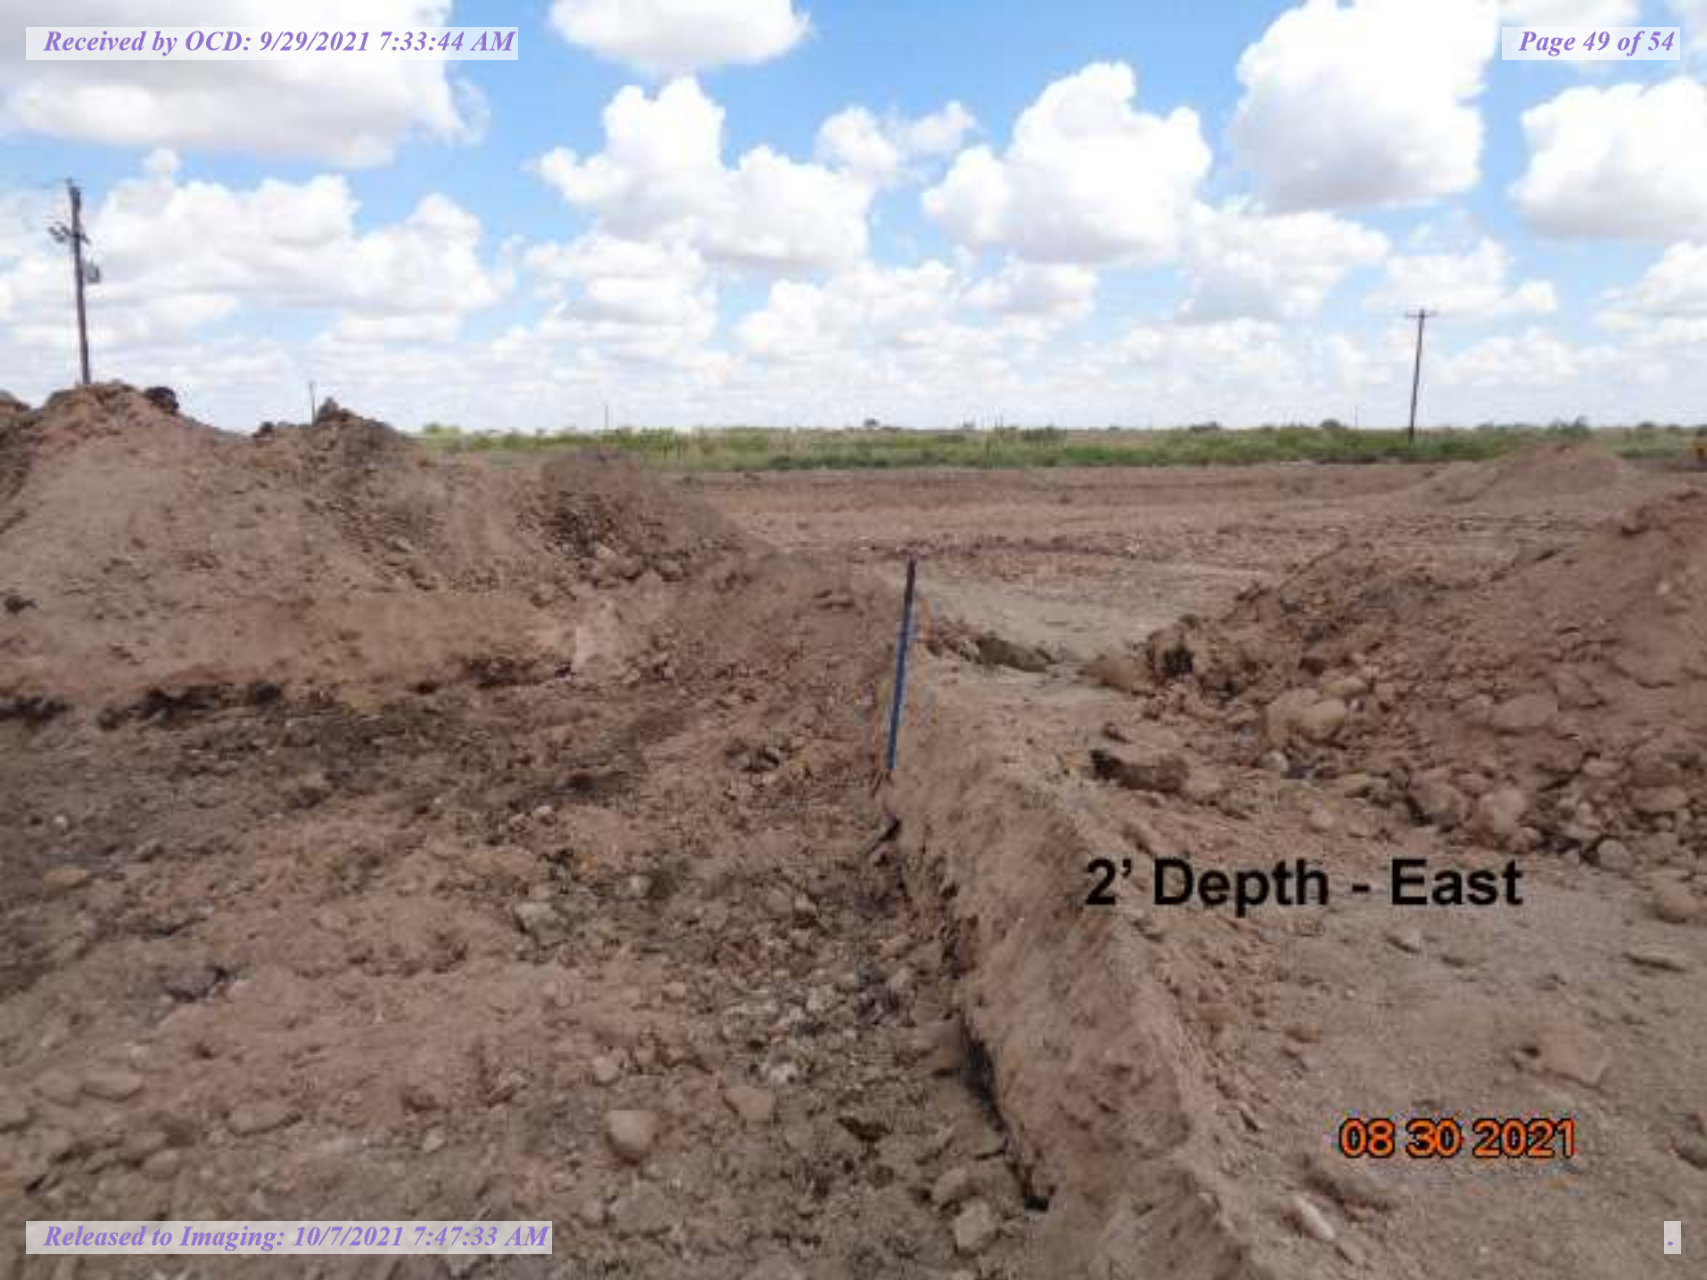
2' Depth - East

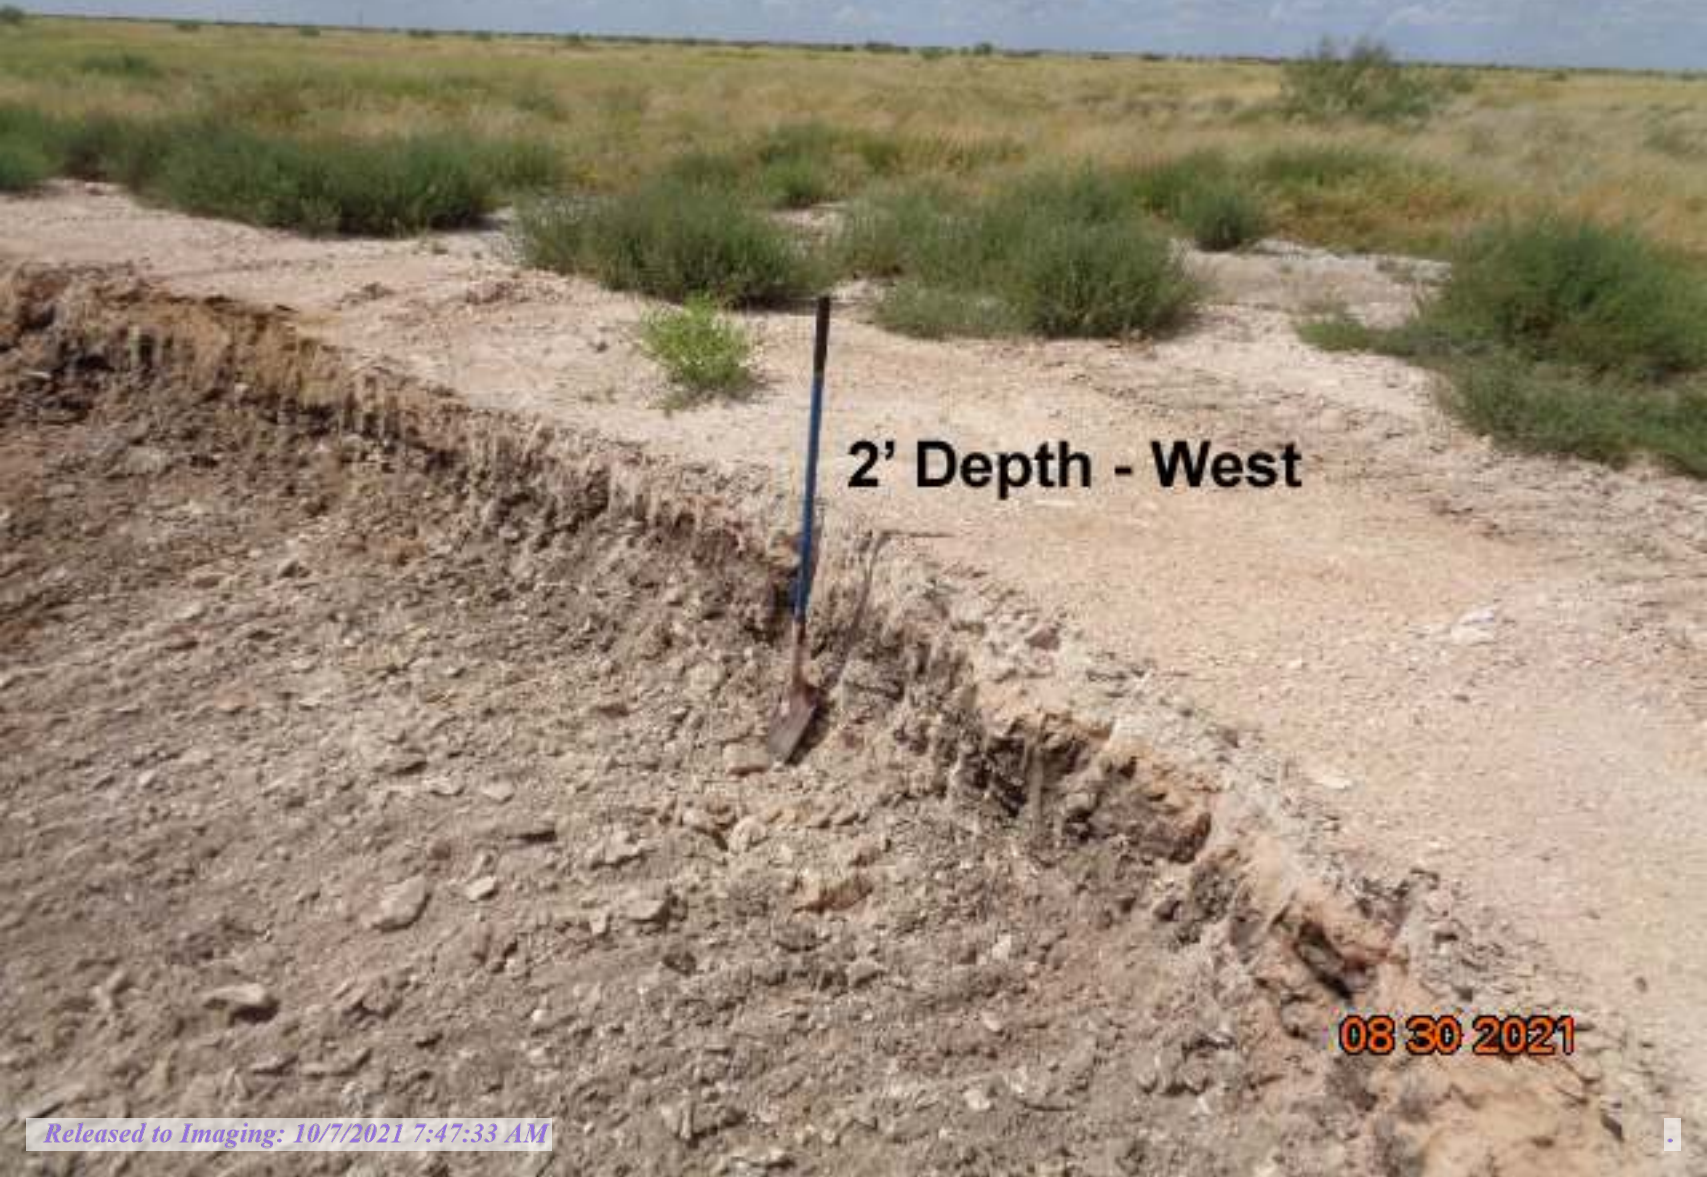
2' Depth - West
